Author's Response to the second round of reviews

Title: Arctic tsunamis threaten coastal landscapes and communities – survey of Karrat Isford 2017 tsunami effects in Nuugaatsiaq, western Greenland. Thank you to the authors for revising their paper. It is improved, but I remain underwhelmed. The authors state that the lack of detail in their observation is at least partly related to having only spent 2.5 days on site. But this, in my opinion, does not negate the fact that the observations are pretty sparse. I cannot recommend publication in its current state.

MANUSCRIPT COMPLETE NO TRACKED CHANGES

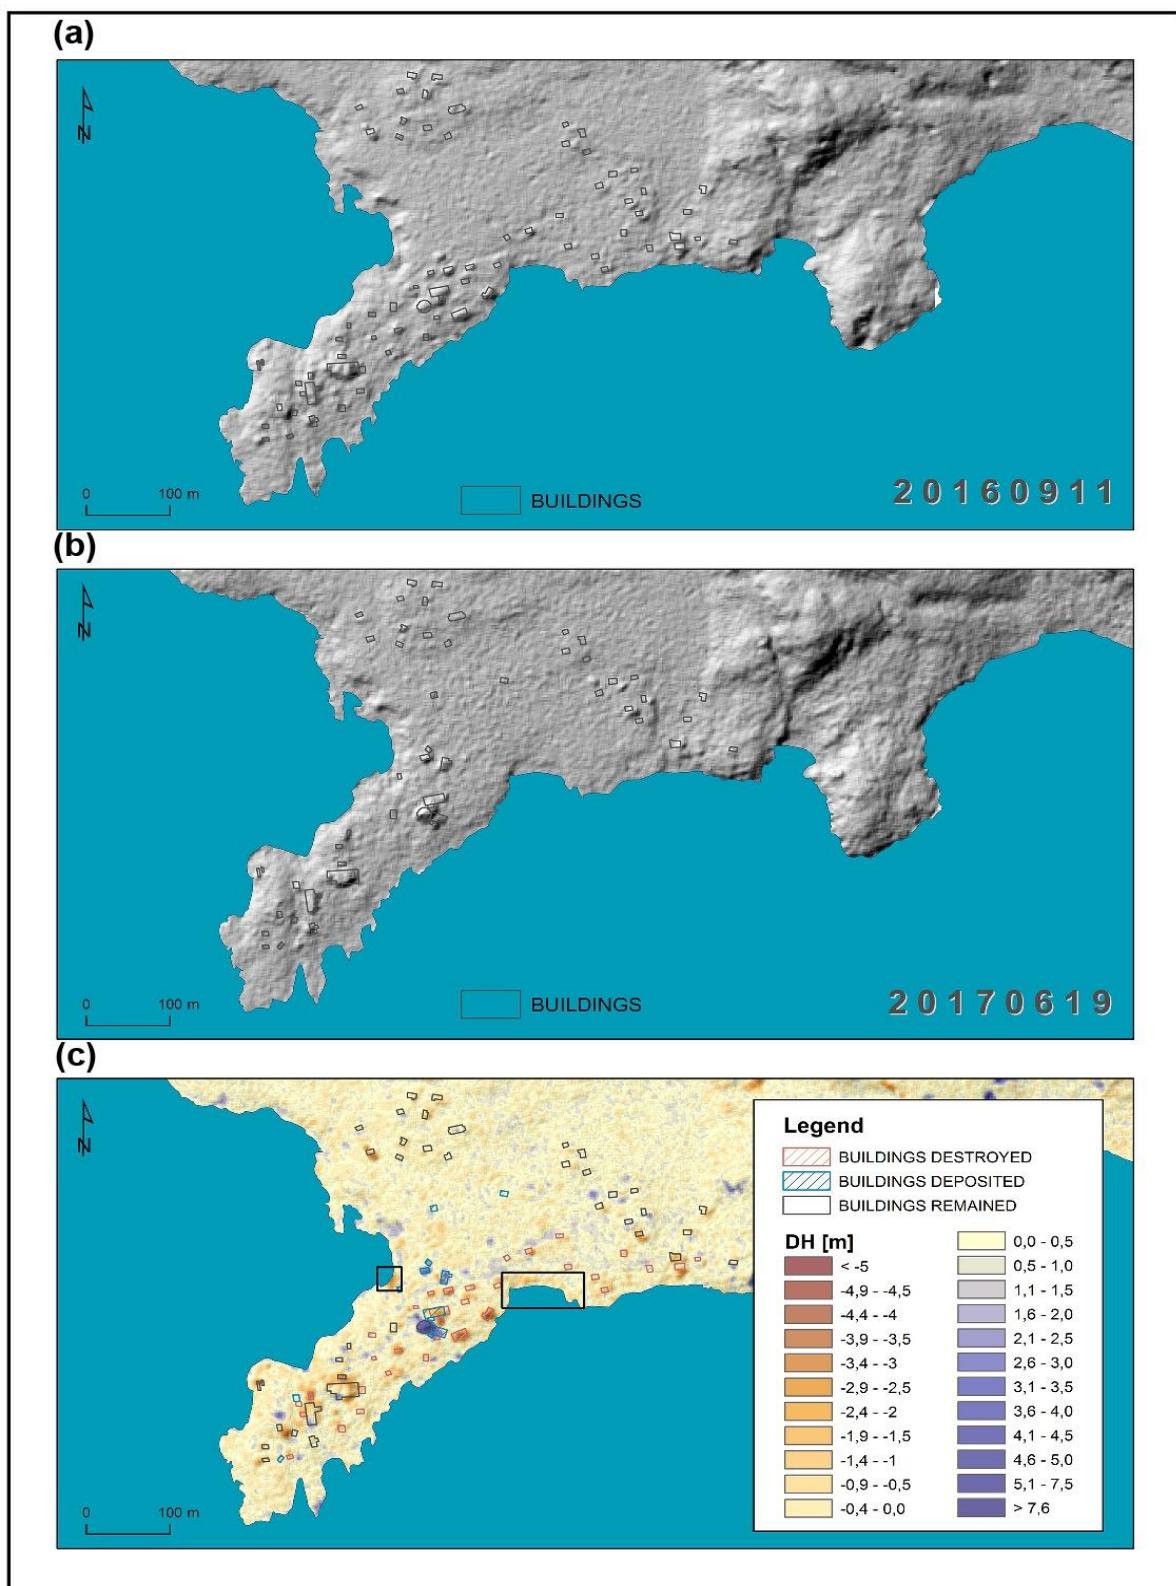
Figure 6. Post-tsunami terrain change in the Nuugaatsiaq area. (a) DTM of study site on the 11th September 2016 – pre-tsunami conditions; (b) DTM of study site on the 19th September 2017 – post-tsunami conditions.; (c) Terrain change calculated from two digital terrain model (DTM) data. The colour scale illustrates values of terrain change (DH), where warm colours stand for an elevation decrease due to erosion, and cold colours represent an elevation increase led by the effects of deposition. Please notice that major changes in the terrain are associated with construction, destruction or relocation of buildings. The resolution of model (2 m) precluded detection of small-scale landscape modifications observed during the fieldwork. Two sites were both field observations and remote sensing analyses detected significant change (erosion) was beach (site 4 in Fig. 1) and cliff edge in the harbour (site 7 in Fig.1) on the opposite sites of the saddle (marked by red rectangles).

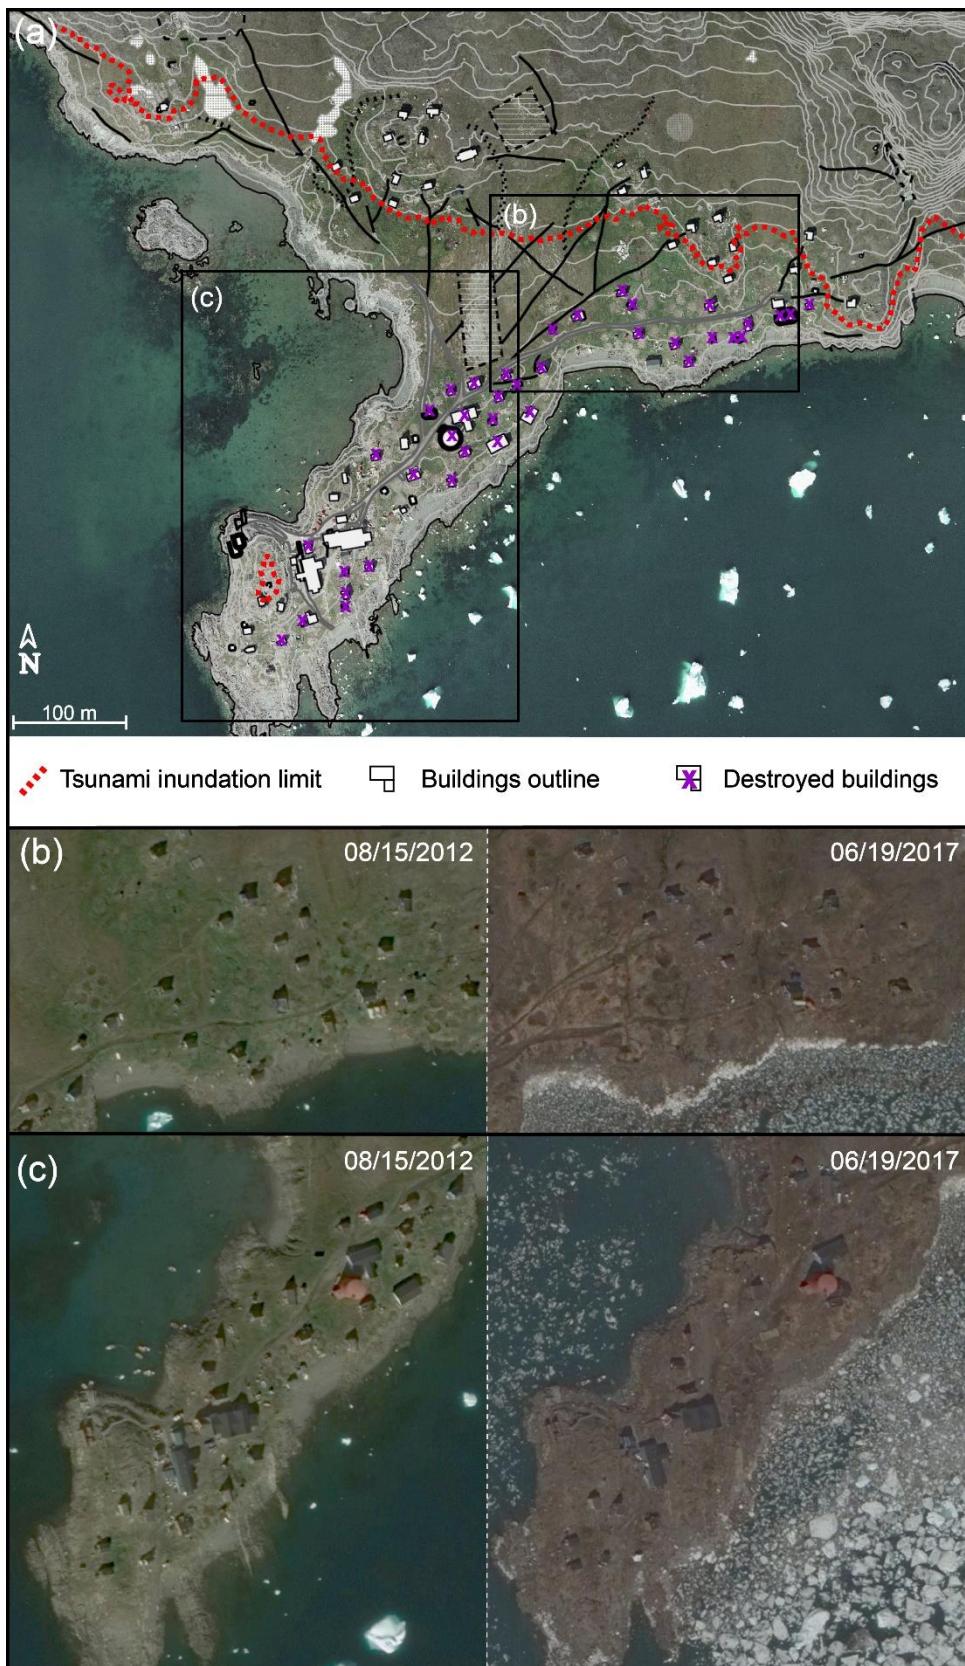
Figure 7. Scale of destruction in settlement infrastructure. (a) General overview of area inundated by tsunami with location of damaged buildings. The inventory of tsunami-induced changes of settlement infrastructure are based on interpretation of aerial images, local spatial plans and field surveying. Background orthophoto and topographic map: nunagis.gl.; (b) Satellite image of settlement before the tsunami impact (15th August 2012) and; (c) Satellite image of settlement after the tsunami impact illustrate the scale of destruction and dislocation of buildings (19th June 2017) Background Google Earth Image © 2020 Maxar Technologies.

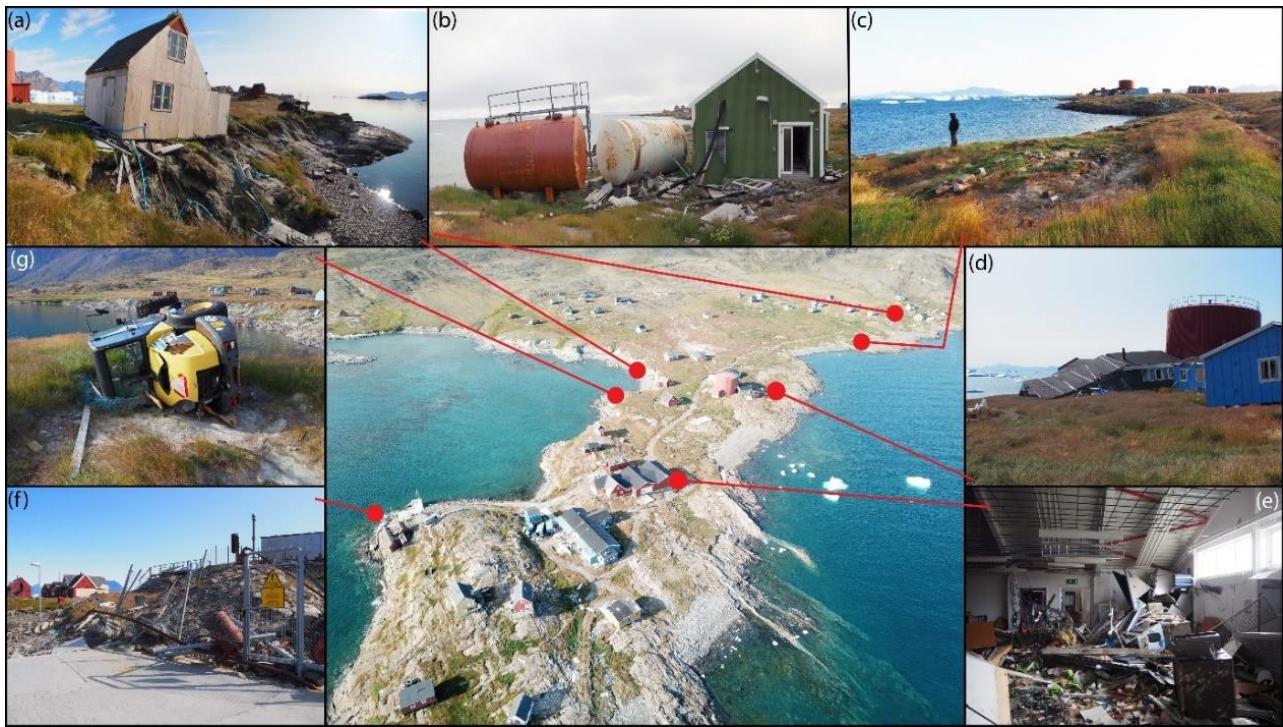
Figure 8. Examples of infrastructure damages caused by 2017 tsunami in Nuugaatsiaq. (a) Wooden house removed by wave from point foundation transported several dozen of meters; (b) Fuel tanks washed away from concrete frames and pushed towards power plant. Note large accumulation of litter and tsunami deposits around and inside the buildings; (c) site of former building position, which was destroyed and swept away by tsunami. Note broken wooden point foundations, media connections and erosional gullies; (d) Smashed and collapsed wooden school building moved towards major water tank; (e) Interior of local shopping centre passed by tsunami. Note large amounts of litter and rotting food supplies and twisted and bowed metal frame construction; (f) Partly-torn metal fence around fuel storage site which acted as a trap for litter transported by tsunami; (g) example of heavy machine knocked over by waves.
