Arctic tsunamis threaten coastal landscapes and communities - survey of Karrat Isfjord 2017 tsunami effects in Nuugaatsiaq, western Greenland

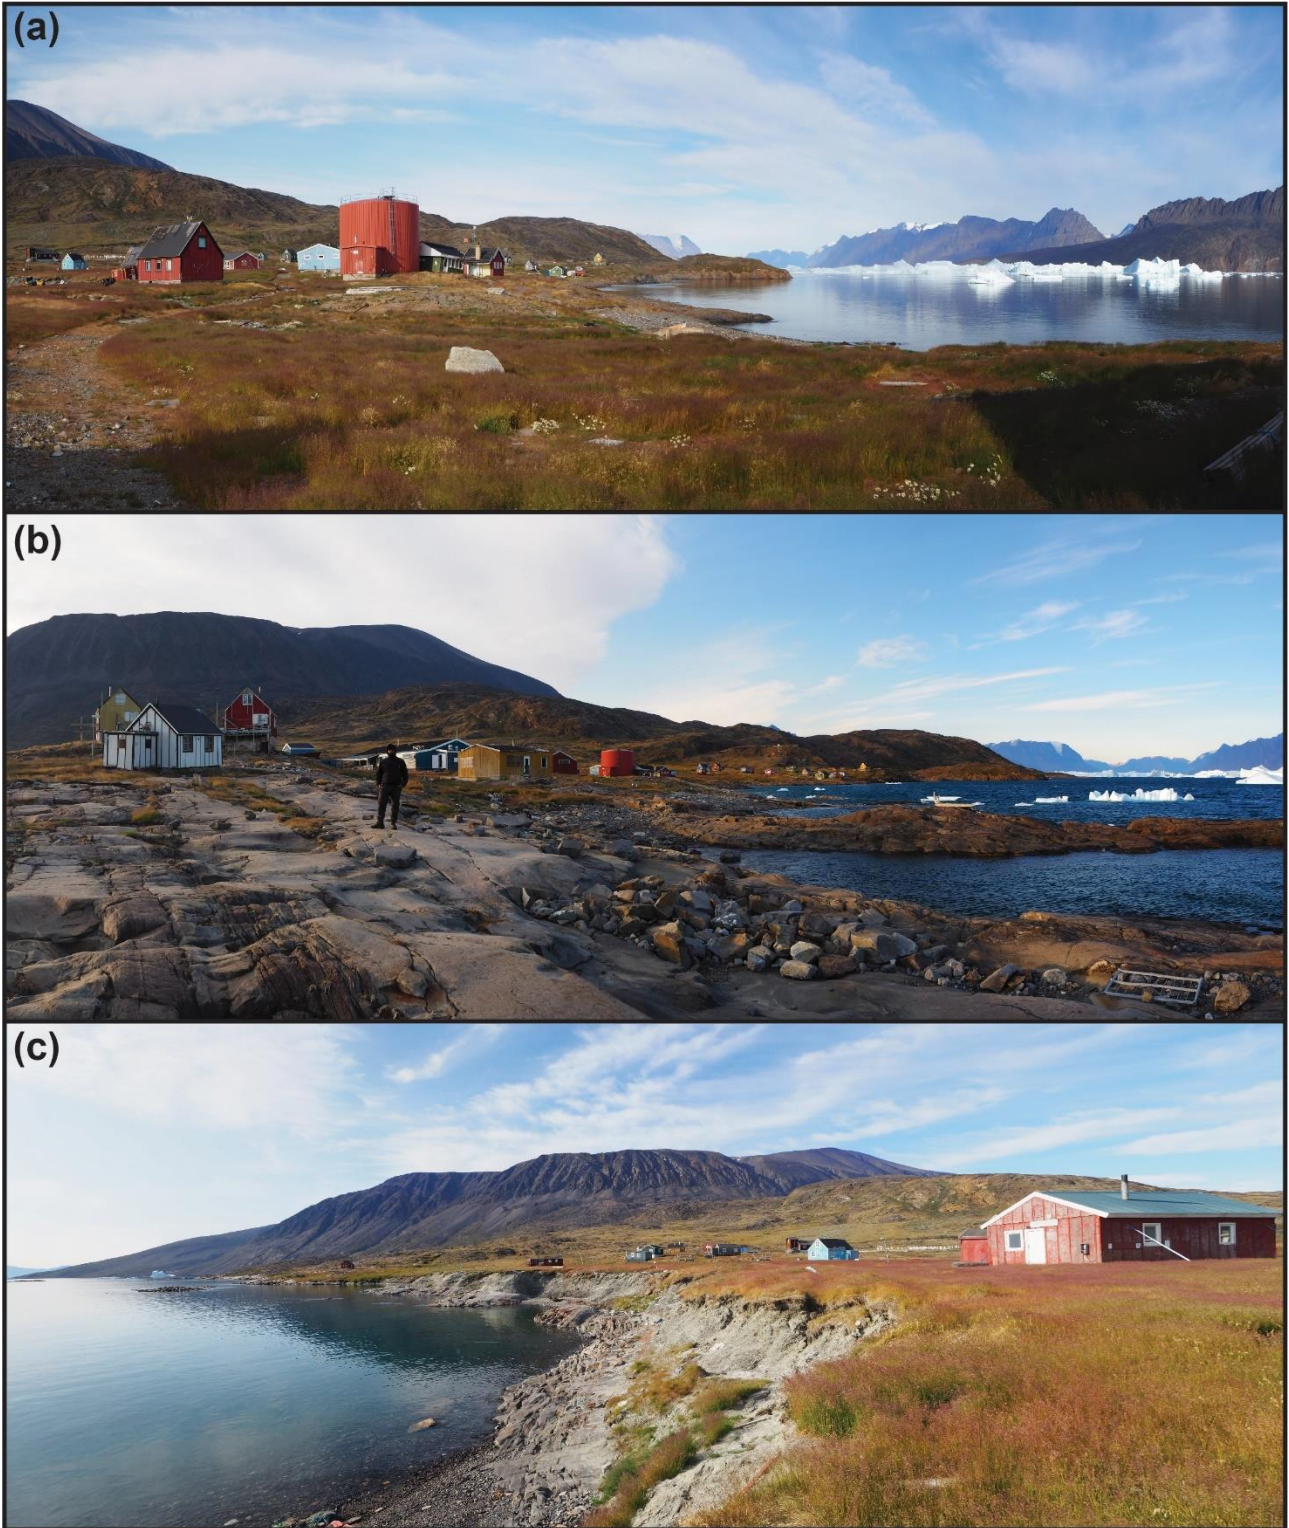
520 **Figure 2.** Coastal landscapes in **Nuggatsiaq**. (a) Densely vegetated (grasses and shrubs) coastal lowland with ragged shoreline dissected by rocky capes and coves with narrow beaches; (b) Main headland with exposed glacially scoured bare rock surfaces, note accumulations of boulders in rocky hollows; (c) Cliffed coast in Nuugaatsiaq harbour. Tops of the cliff were eroded and gullied by tsunami.

Nuugaatsiaq coastal landscape is predominantly rocky with an undulating and ragged coastline dissected by narrow coves and headlands (Fig.2a). Rocky coves **along southern** coast of Nuugaatsiaq are filled with narrow beaches underlain by rocky bedrock (Fig. 2a). Beach deposits are thin (< 1m) and composed of mixed coarse sand and gravel deposits as well as boulders deposited by icebergs or left along the shores by retreating ice streams. The largest cape in the area, located to the SW of the settlement centre is characterized by bare rocky surface with well-preserved signs of glacial scour e.g. striations and polished bedrock (Fig.2b). Close to the shoreline most of smooth rocky hollows were filled with accumulations of boulders (ca. 0.2-0.5 m in diameter). The Nuugaatsiaq harbour (site 7 in Fig. 1c) is backed by the cliffed coast (between 2-4 m high) formed in bedrock (**ca. 0-2 m .a.s.l.**) and **overlaid** by 1.5 – 3 m layer of soils/glacial deposits and covered with **dense tundra** (Fig. 2c). At the base of the cliff narrow (1-3 m wide) mixed sand-gravelly beaches are present.

180 The striking feature of the Nuugaatsiaq post-tsunami landscape is a dense and high (0.4-0.6 m) grass that covers a significant part of the settlement (Fig. 2a). Two years after the event most of the blocks of eroded soil, rafts of tundra,

We recognized two main effects on coastal geomorphology induced by tsunami impact. The tsunami erosion was concentrated on the low bluffs of tundra along the coast between narrow beaches (section of the coast between sites 1-4-5 in Fig. 1c, Fig 2a). Eroded blocks of tundra cover were deposited on land (Fig. 4b). The returning wave caused additional erosion of bluffs edges and dissected them by a series of rills/gullies (Fig. 4d). The direction of the wave flow recorded in the orientation of deposited litter, buildings, marine deposits, boulders, and tundra blocks suggest that the wave overwashed the section of settlement through a saddle (site 6 in Fig. 1c) between the middle beach (site 4 in Fig. 1c) and local harbour (site 7 in Fig. 1c), and modified the relief of cliffs in the harbour. The edges of the sedimentary cliffs were gullied, and the steep cliff slopes were spread with eroded blocks of tundra and litter (Fig. 4e). Two years after the event, normal coastal processes (wave and tidal action) did not manage to remove or redistribute the eroded blocks of tundra and litter from the slopes and bases of the cliffs (Fig.2c).
