# Arctic tsunamis threaten coastal landscapes and communities - survey of Karrat Isfjord 2017 tsunami effects in Nuugaatsiaq, western Greenland

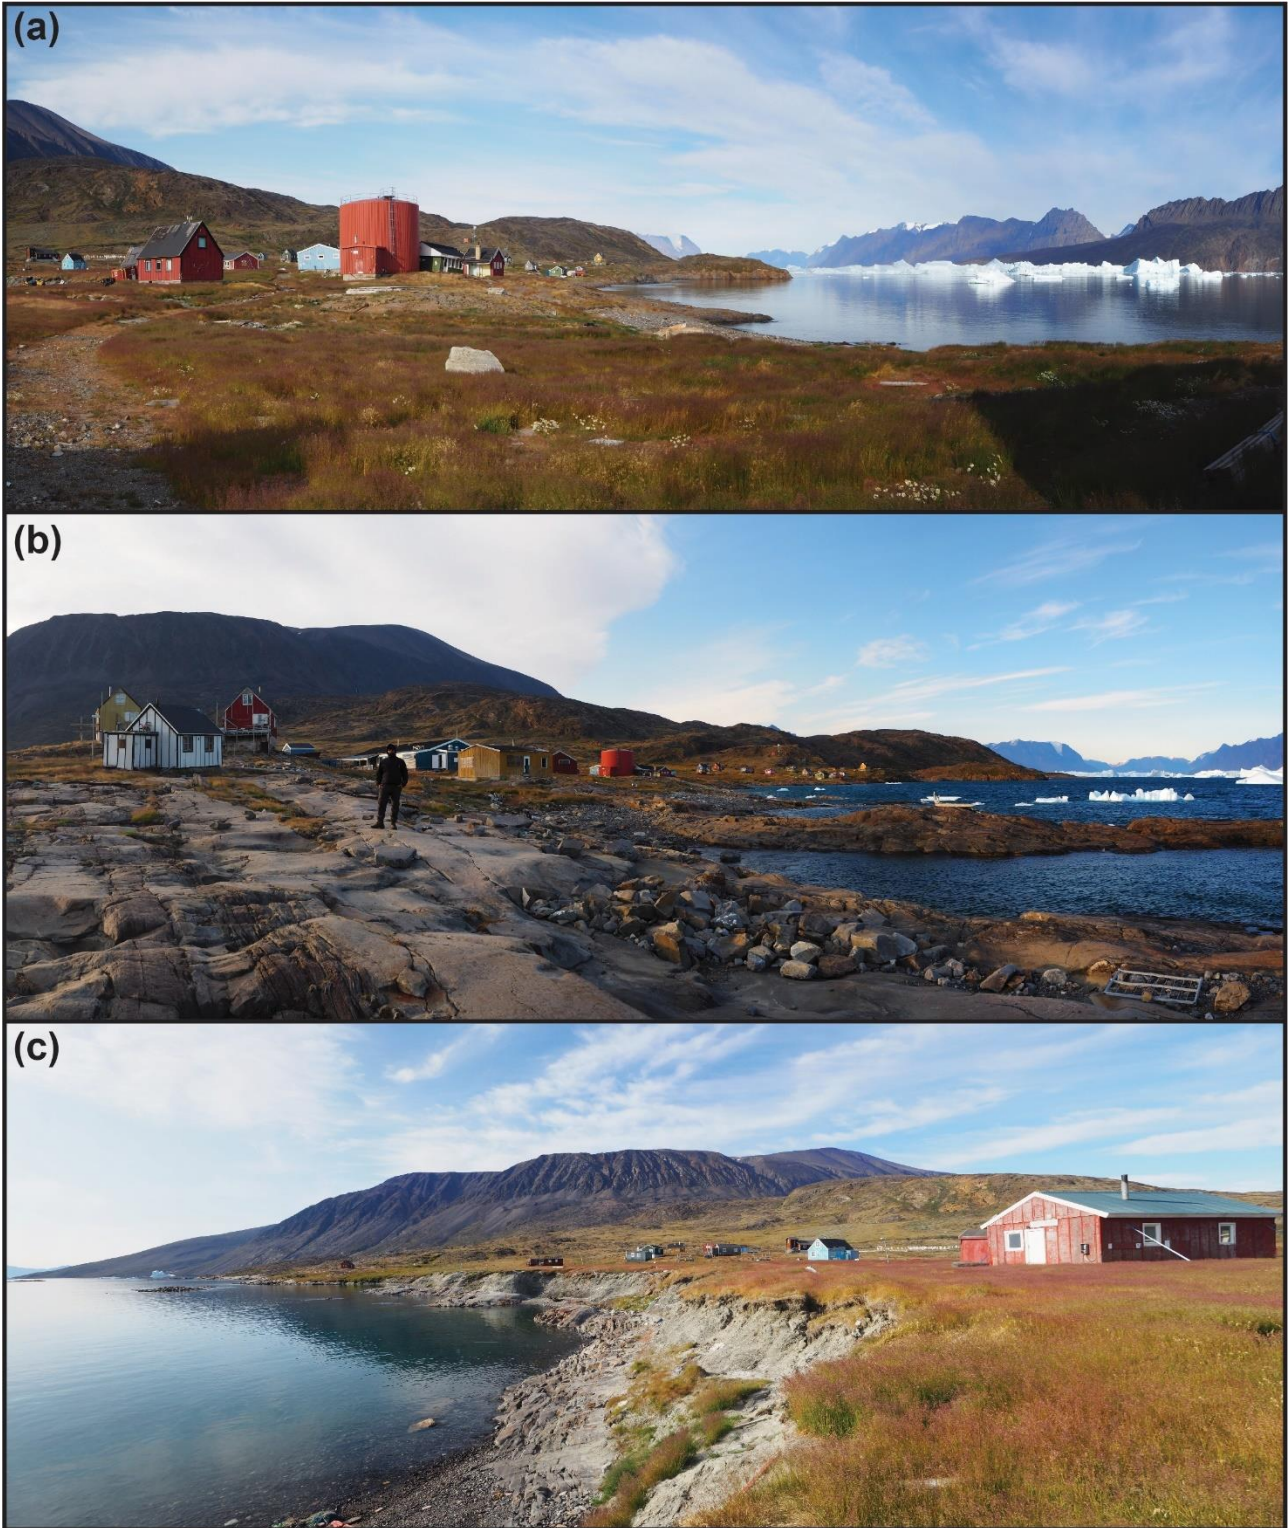
555 **Figure 2.** Coastal landscapes in Nuugaatsiaq. (a) Densely vegetated (grasses and shrubs) coastal lowland with ragged shoreline dissected by rocky capes and coves with narrow beaches; (b) Main headland with exposed glacially scoured bare rock surfaces, note accumulations of boulders in rocky hollows; (c) Cliffed coast in Nuugaatsiaq harbour. Tops of the cliff were eroded and gullied by tsunami.

The coastal landscape of Nuugaatsiaq is predominantly rocky with an undulating and ragged coastline dissected by narrow coves and headlands (Fig.2a, Fig. 3). Rocky coves along the southern coast of Nuugaatsiaq are filled with narrow beaches 95 underlaid by rocky bedrock (Fig. 2a). Beach deposits are thin (< 1m) and composed of mixed coarse sand and gravel deposits as well as boulders deposited by icebergs or left along the shores by retreating ice streams. The largest cape in the area, located to the SW of the settlement centre is characterized by bare rocky surface with well-preserved signs of glacial scour e.g. striations and polished bedrock (Fig.2b). Close to the shoreline most of smooth rocky hollows were filled with accumulations of boulders (ca. 0.2-0.5 m in diameter). The Nuugaatsiaq harbour (site 7 in Fig. 1c) is backed 100 by the cliffed coast (between 2-4 m high) formed in bedrock and overlain by layer of soils/glacial deposits and covered with well-vegetated tundra (Fig. 2c). At the base of the cliff narrow (1-3 m wide) mixed sand-gravelly beaches are present.

205 We recognized two main effects on coastal geomorphology induced by tsunami impact. The tsunami erosion was concentrated on the low bluffs of tundra along the coast between narrow beaches (section of the coast between sites 1-4-5 in Fig. 1c, Fig 2a). Eroded blocks of tundra cover were deposited on land (Fig. 4b). The returning wave caused additional erosion of bluffs edges and dissected them by a series of rills/gullies (Fig. 4d). The direction of the wave flow recorded in the orientation of deposited litter, buildings, marine deposits, boulders, and tundra blocks suggest that the wave 210 overwashed the section of settlement through a saddle (site 6 in Fig. 1c) between the middle beach (site 4 in Fig. 1c) and local harbour (site 7 in Fig. 1c), and modified the relief of cliffs in the harbour. The edges of the sedimentary cliffs were gullied, and the steep cliff slopes were spread with eroded blocks of tundra and litter (Fig. 4e). Two years after the event, normal coastal processes (wave and tidal action) had not yet removed or redistributed the eroded blocks of tundra and litter from the slopes and bases of the cliffs (Fig.2c).

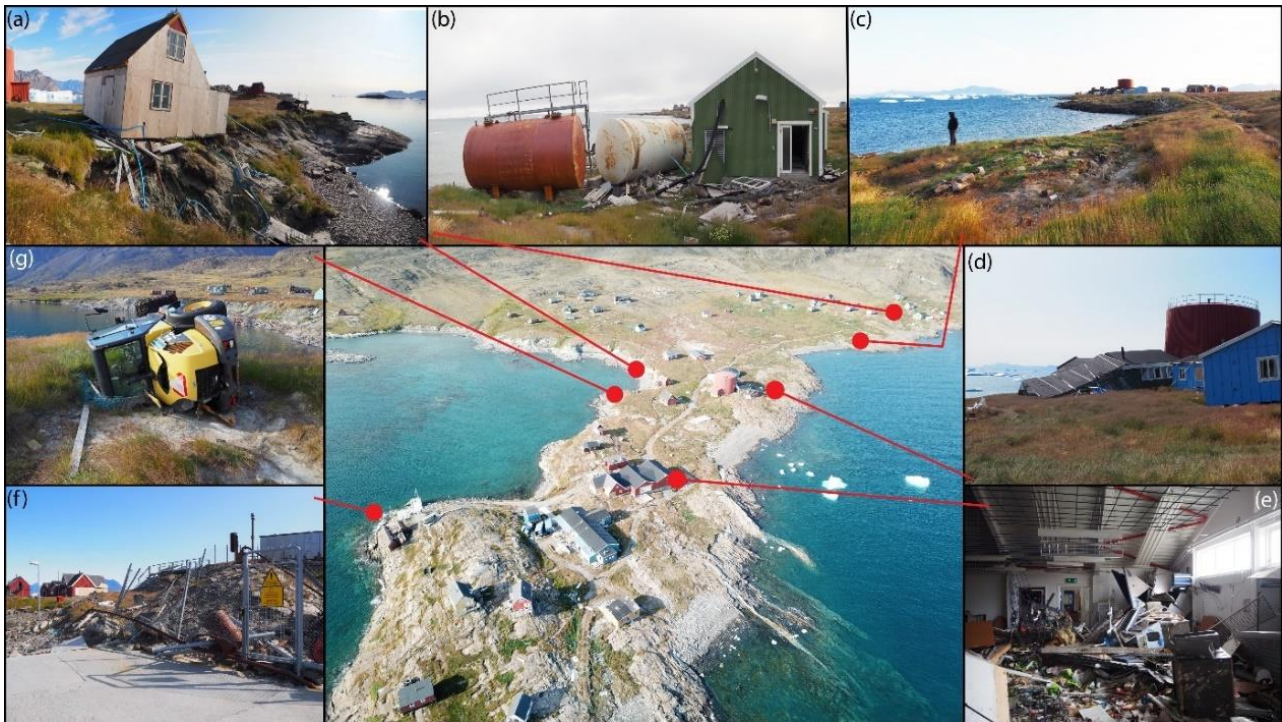
605 **Figure 8.** Examples of infrastructure damages caused by 2017 tsunami in Nuugaatsiaq. (a) Wooden house removed by wave from point foundation transported several dozen of meters; (b) Fuel tanks washed away from concrete frames and pushed towards power plant. Note large accumulation of litter and tsunami deposits around and inside the buildings; (c) site of former building position, which was destroyed and swept away by tsunami. Note broken wooden point foundations, media connections and erosional gullies; (d) Smashed and collapsed wooden school building moved towards major water tank; (e) Interior of local shopping centre passed by tsunami. Note large amounts of litter and rotting food supplies and twisted and bowed metal frame construction; (f) Partly-torn metal fence around fuel storage site which acted as a trap for litter transported by tsunami; (g) example of heavy machine knocked over by waves.

Before the tsunami event the Nuugaatsiaq community infrastructure was composed of 94 buildings (houses, services and  
administration buildings, dog kennels, technical facilities etc.). The wave destroyed 45 buildings (48% of the original  
250 infrastructure) viz. 22 buildings were fully swept away from land, 23 buildings were partly damaged, and 11 were moved  
between 2 m to over 100 m from original location (Fig. 7). Most of the buildings were constructed on a wooden frame,  
covered with wooden boards and settled on pier foundations. Only a few of the settlement buildings were built on a metal  
frame coated with corrugated metal sheet settled on a concrete frame foundation. The first type of building (with pier  
255 foundations) was not strong enough to resist the wave impact and these structures were pushed by the tsunami or in some  
cases washed away to the fjord (Fig. 8 a,c).

In those buildings which were not moved but still affected by the wave, we observed some damage of their wooden  
cladding, as well as a deposition of marine sediments and litter in the ground floor area. The typical damages observed in  
buildings which were pushed by the tsunami but remained on land were: *broken windows and doors, devastated interior*.  
260 In contrast to buildings with pier foundations, much smaller damages were observed in buildings with concrete frame  
foundations. These, due to a more stable anchoring in the ground, gave a much higher resistance to the wave impact. The  
most common damages included broken walls, bowed and twisted metal construction frames (Fig. 8 b, d). It should be  
considered extremely fortunate that the fuel tanks situated at the power plant (which were one of the first parts of  
infrastructure hit by tsunami) were not destroyed and no leakage of petrol was reported (Fig. 8b).
