Hidden Hazards: the conditions that potentially enabled the mudflow disaster at Villa Santa Lucía in Chilean Patagonia

Marcelo A. Somos-Valenzuela^{1,2}, Joaquín E. Oyarzún-Ulloa³, Ivo J. Fustos-Toribio^{3*}, Natalia Garrido-Urzuá⁴, Chen Ningsheng^{5,6}

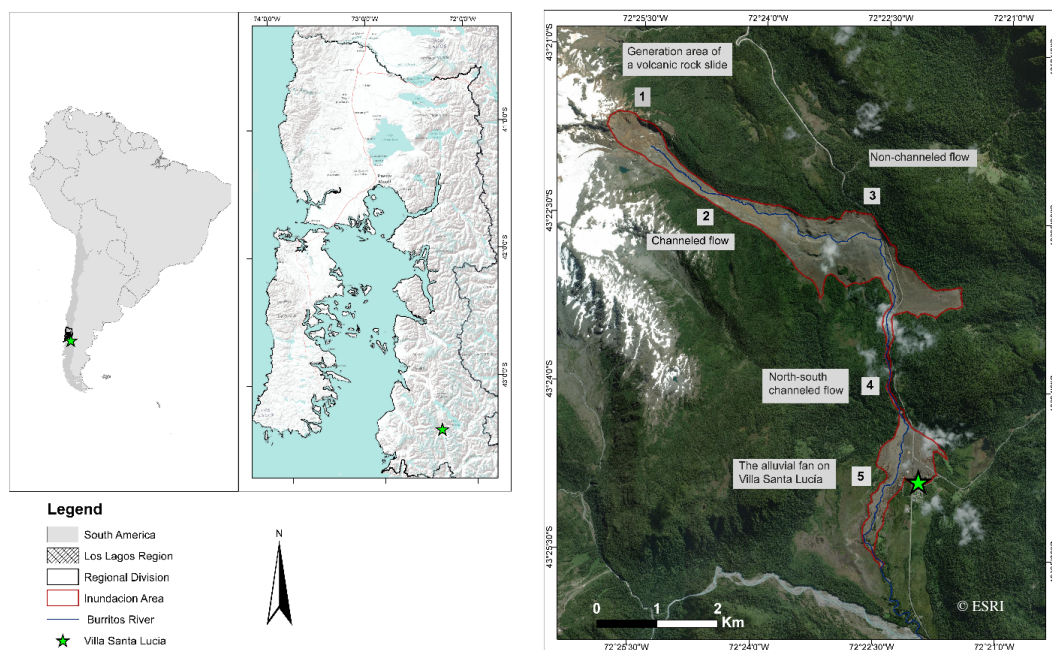
Figure 1: Study area and extension of the inundation (South America and Los Lagos Region layer from <https://tapiquen-sig.iimdo.com>, Burritos River blue line layer from <http://datos.cedeus.cl/>, background © ESRI).

Villa Santa Lucia is located in the valley of the Frio River, 75 kilometers south from Chaitén (closer town), along
the Carretera Austral, in the Los Lagos region, Chile. The avalanche event started at the head of the Burritos river
basin (43.413°S , 72.367°W) that runs to the west of Villa Santa Lucía (Figure 1). It begins at the eastern slope of the
110 western side of the regional Andes.

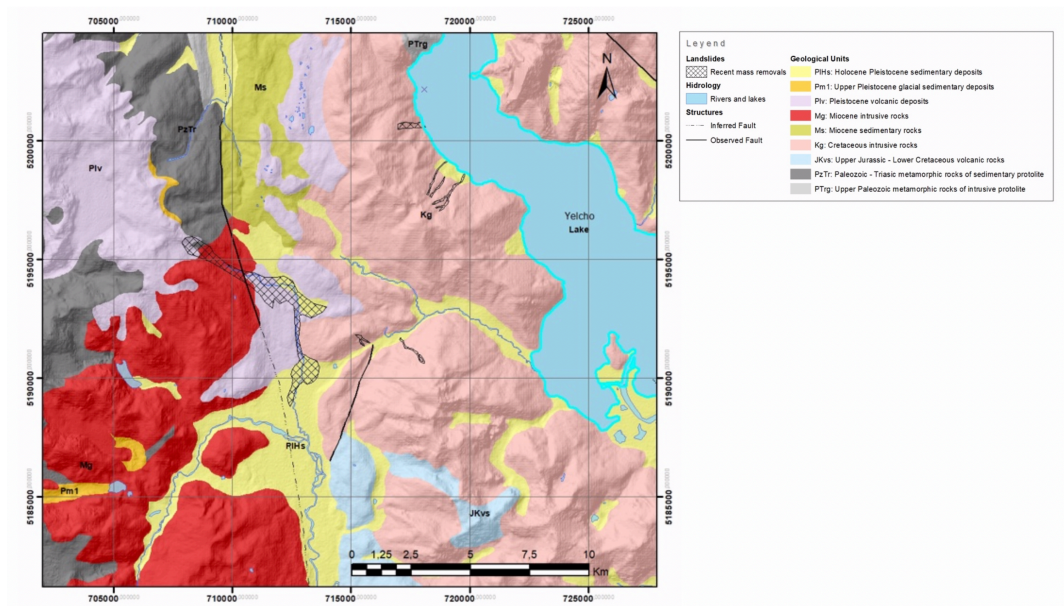
The study area consists mainly of 9 geological units (Figure 2). The dominant geological unit corresponds to an intrusive rock (Cretaceous and Miocene age) composed of tonalites, granodiorites, granites, diorites, among others. Moreover, the basement material is an old metamorphic rock. This unit is composed of micaceous shales, amphibolites, mafic, and ultramafic rocks. Volcanic and volcanoclastic rocks represent, in part, the NO-SE volcanic cord, called the Cordon Yelcho Volcanic Complex (Sernageomin, 1995). While sedimentary rocks, mainly sandstone, shales, conglomerates, are presented as intercalations. Recent sedimentary deposits are mainly associated with rivers, alluvial, colluvial, morenic, and glaciolacustrine deposits (Aguilera et al., 2014) (Figure 2).

130 Figure 2: Geology of the study area (Modified from Sernageomin (1995))

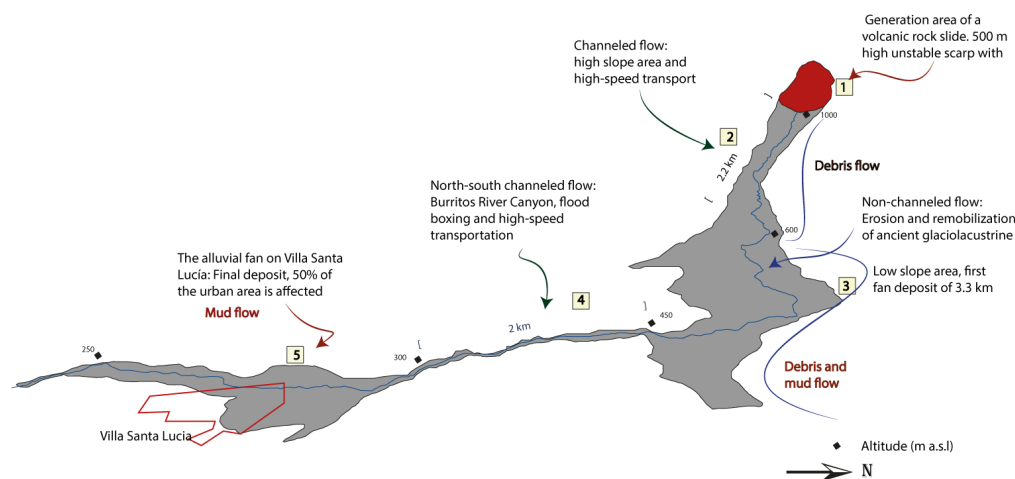
Figure 3: Flow trajectory scheme and details of the five key sections identified by Sernageomin and our fieldwork.

Through field observations, we identified five key sections that describe what happened in Villa Santa Lucía (Figure 1 and 3).

Additionally, the soil was almost saturated, which added water to the mix, transforming the avalanche flow into a mudflow. Moreover, dense forest was present, which added a significant amount of biomass to the mix. Then the mudflow reaches an area with low slopes at a distance of 8.6 km from its origin through the Burritos River to the east. In its trajectory, the mudflow crossed Route 7 (Carretera Austral) in a stretch estimated of 2 km and filled an old wetland. In that sector, the flow was channeled in a canyon oriented north-south toward Villa Santa Lucia in a section of 1.5 km (Figure 1 and 3, point 4). Once the flood reached Villa Santa Lucia, it slowed down and deposited the sediment in a radial fan of 600 to 1,000 m with a height of 1 to 5 m (Figure 1 and 3, point 5).

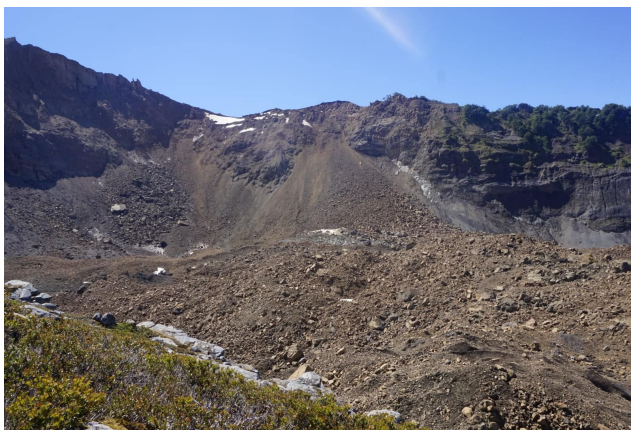
1. Generation area: It has a range of peaks between 1,000 to 1,400 m a.s.l., with the main escarpment of 900 m long and 520 m wide. The north wall has maximum slopes between 77 to 81° (Figure 3 and 4)

Figure 4: Area of slope failure slid and deposit.

As a result of the avalanche, the material deposited acts as a dam creating two small lakes. The largest lake has a length of 180 m and an average width of 50 m (Sernageomin, 2018c).

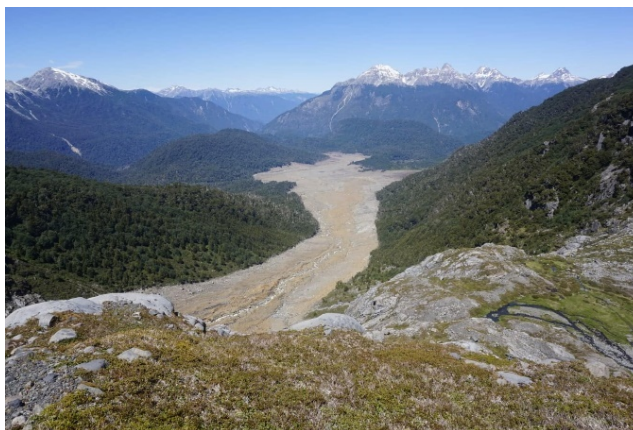
2. Channeled flow: Corresponds to the upper segment at the foothills, the flow is channeled and traveled 2 km. The flow width was between 200 to 400 m wide. Using photo-interpretation of the digital elevation models (SAF, 2017) and aerial photos, Sernageomin personnel (Sernageomin, 2018c) estimated an approximate wave of 20 m height (Figure 3 and 5).

Figure 5: Channeled flow at the foothills.

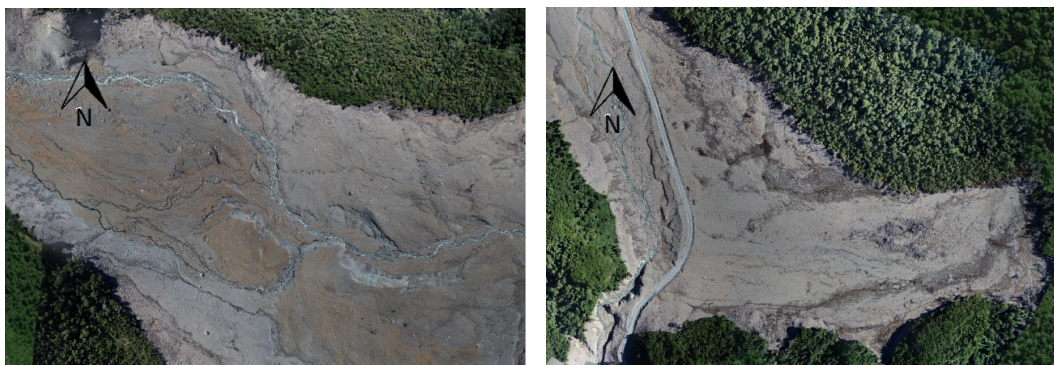
3. Non-channeled flow: This section has a length of 2.3 km in a west to east direction until the Burritos river changes its orientation to a north-south direction. The elevation goes from 600 to 380 m a.s.l. The slopes decrease slowing down the flow, which deposited sediments. The non-channeled flow width reaches 1.4 km. In this sector,
195 the flow went over the road (Carretera Austral) to the east in 1.3 km affecting an old wetland (Figure 3 and 6).

Figure 6: Aerial photo of non-channeled flood deposited in an old wetland captured with an InspireII UAV.

The speed of the flow at the Burritos river canyon (Figure 6) and at the beginning of Villa Santa Lucía when the
flow opens (Figure 7) is approximately 20 m s⁻¹ (Sernageomin, 2018c)

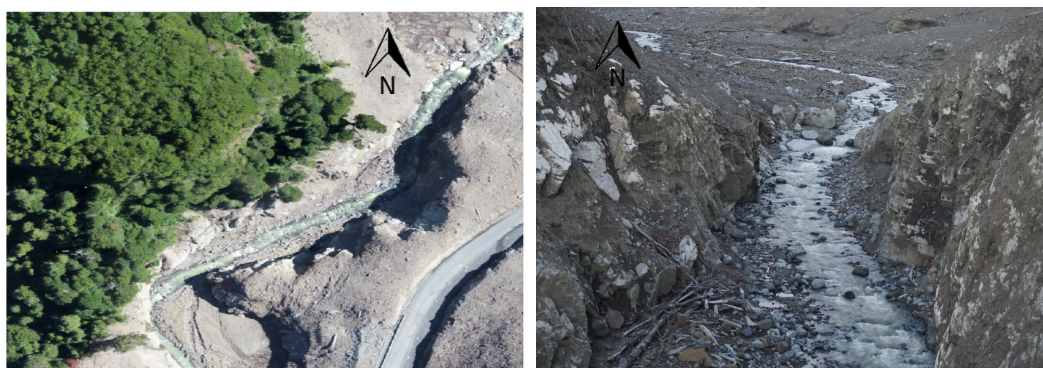
4. North-south channeled flow: The flow descends through the enclosed channel at the Burritos river canyon from
200 380 to 250 a.m.s.l. on a 2 km long section (Figure 3 and 7).

Figure 7: Aerial photo of the channel in the last section before entering Villa Santa Lucia (left) captured with an InspireII UAV. Picture of the channel facing downstream (right).

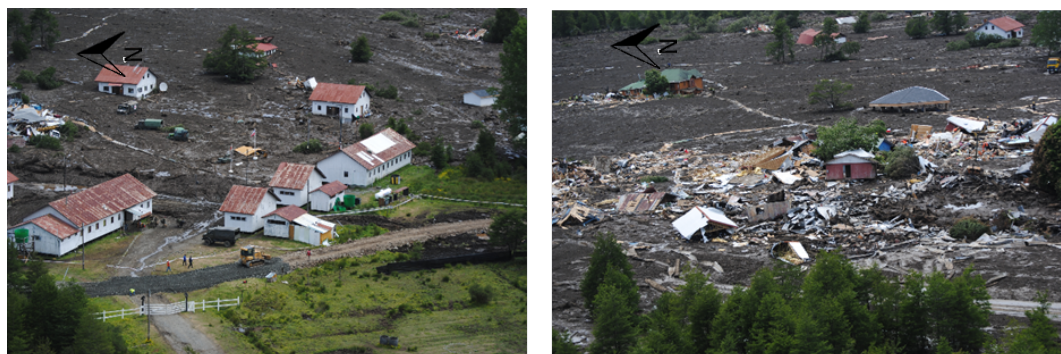
5. The alluvial fan on Villa Santa Lucia: due to the lost in confinement the flow expands with a radial distribution
205 in a southeast-southwest direction of 600 to 1,000 m (Figure 3 and 8)

Figure 8: Villa Santa Lucia after the mudflow (Used with permission from Sernageomin (2018c)).

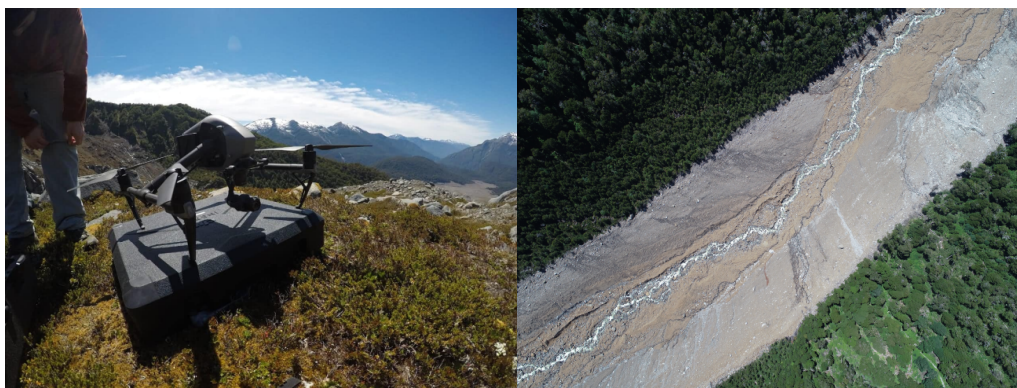
220 A fieldwork campaign was carried out in January 2019 to map in high resolution the area using an unmanned aerial
vehicle (UAV). We used aerial photogrammetry to produce a high-resolution DEM for some parts of the study area.
Aerial photogrammetry allows creating 3D models from 2D images, obtaining geometric characteristics of the
objects they represent. We used a UAV Inspire II with a Zenmuse X4 camera to capture aerial images (Figure 9).
We did not have differential GPS at the moment of this survey to take control points to correct the DEM generated.
225 Therefore, we just used this DEM to corroborate that the DEMs with lower resolution and freely available were able
to capture specific features such as canyons or small changes in slopes that could affect the hydrodynamic
simulation and the path of the flood. We also generated a high resolution mosaic to observe details of the flood. We
used the software Agisoft PhotoScan Professional 1.4 desktop to process the images. The software performs the

Figure 9: UAV mapping survey

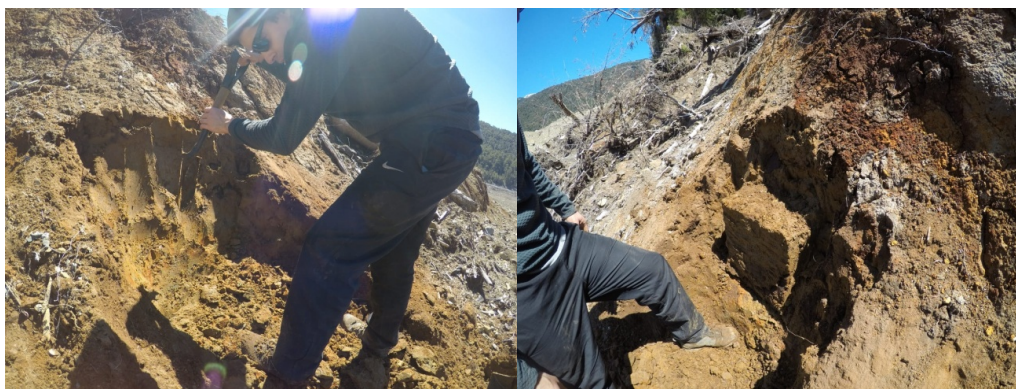
235 Additionally, we extracted an intact soil sample (Figure 10) to determine the physical and mechanical parameters
extracted from an undisturbed sample following the American Society of Testing Materials ASTM D3080 (ASTM,
2017a).

Figure 10: Extraction of an undisturbed soil sample

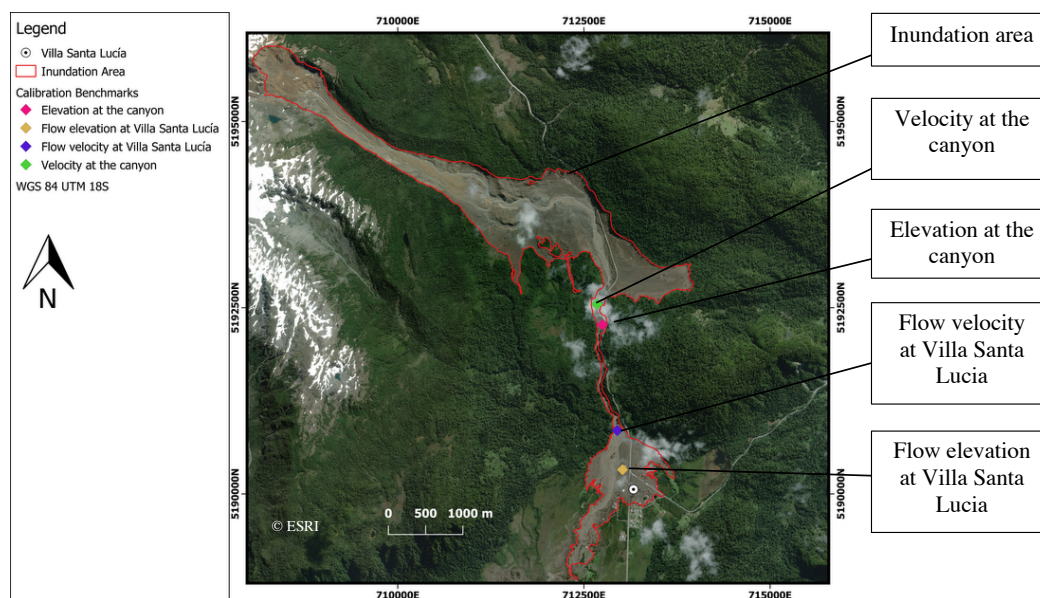
the canyon; and (3) Flow velocities in the canyon curve and at the beginning of Villa Santa Lucia (Figure 11). See Table 1 for the values.

285 Figure 11: Location of the parameter estimation for the calibration of the models (Background © ESRI)

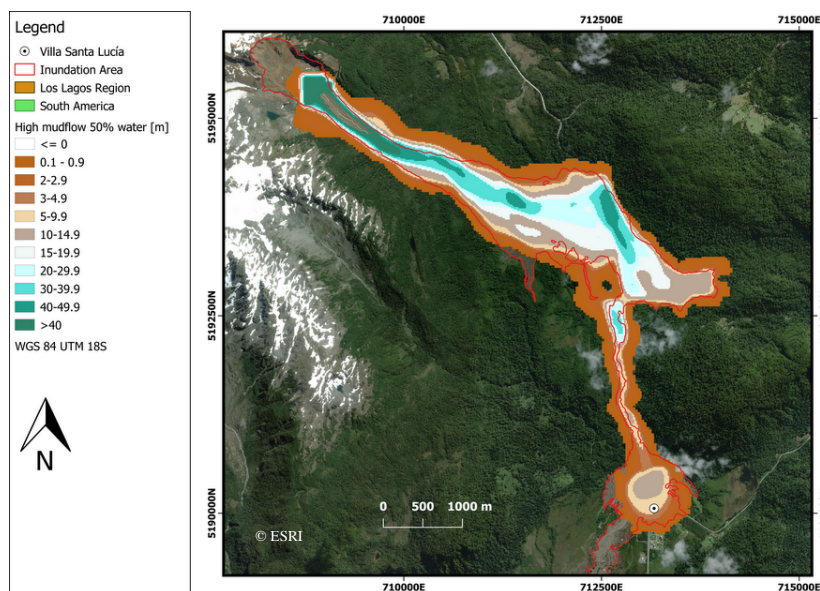
335 The best set of parameters is 5.75, 2, 0.022 and 0.0005 for the drag coefficient, base friction angle, environmental resistant coefficient, and fluid friction coefficient, respectively, and the corresponding map result is in Figure 12.

Figure 12: R-avaflow modeling results for a concentration by volume of 50%.

Figure 12 shows good agreement with what was reported by (Sernageomin, 2018c). However, the mixture is still
 340 largely fluidized, and it does not follow the edges of the inundation. For this reason, we performed simulations with
 the same input parameters but a varying percentage of initial water. We changed the percentage of water from 20%
 to 70%. The error for the heights, speeds, and pressures calculated in each model are in Figure 13.

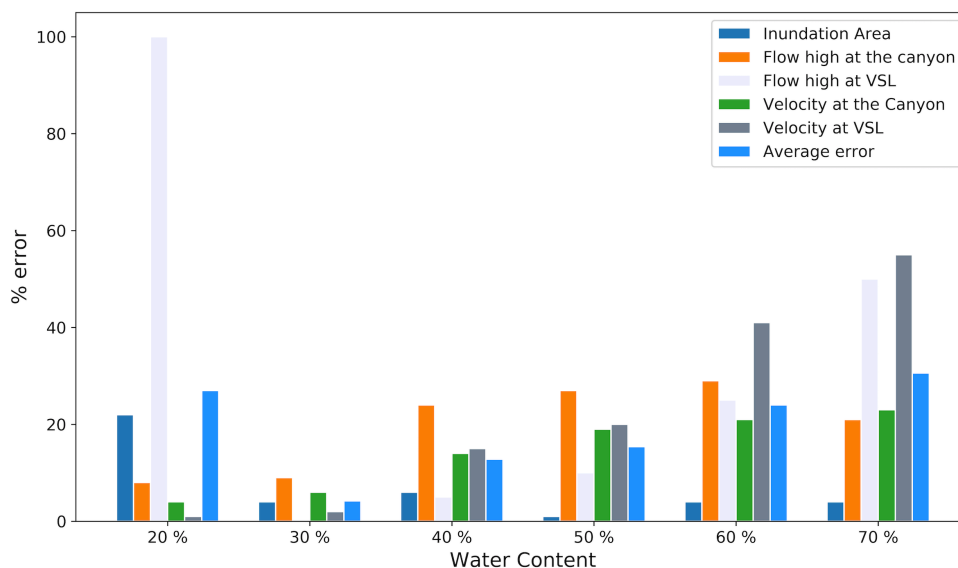
345 Figure 13: Error obtained with different water content and the best set of parameters obtained in the first calibration.

From Figure 13, we concluded that a mudflow with a volume of water of 30% could reproduce best the VSL event (Figure 14).

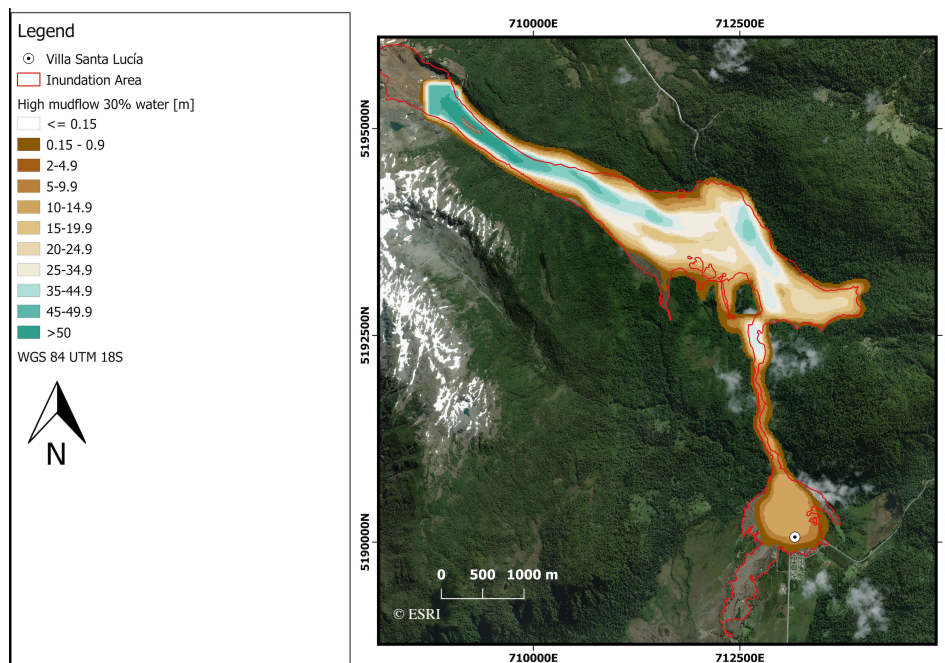
Figure 14: Best simulation results using the calibrated parameters for r-avaflow and water content of 30%

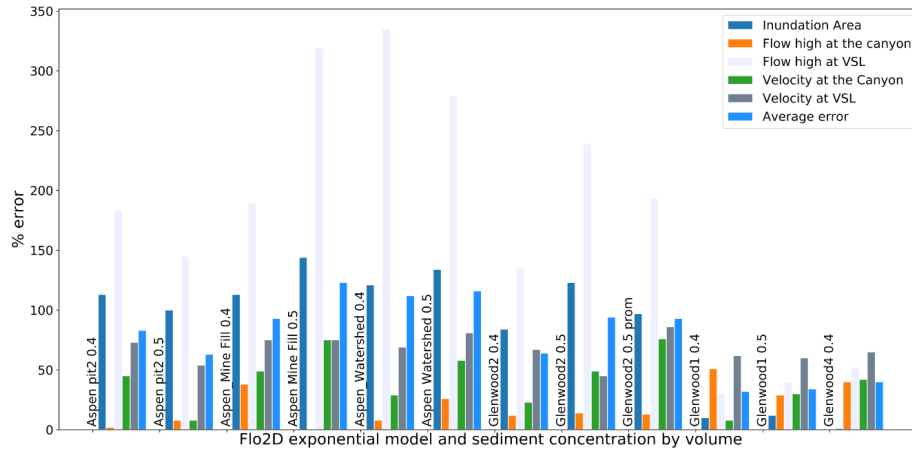
355 For the laminar resistance k , we used the default number 3000. The influence of the value of K does not affect simulations significantly compared to other parameters related to flow resistance (Hsu et al., 2010). The specific gravity of sediments G_s is equal to 2.65 g cm^{-3} . For the sediment concentration by volume, we used values between 40% to 50%, which correspond to hyper-concentrated flows. The error for the heights, speeds, and pressures calculated in each model are in Figure 15. Moreover, Figure 16 shows the extension of the best model using Flo2D.

360 Figure 15: Sensitivity analysis for different dynamic viscosity and shear stress models (FLO-2D, 2018)

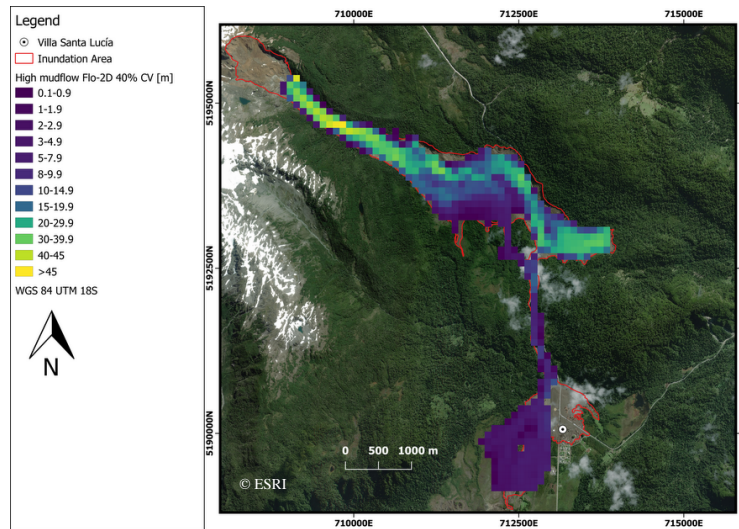
Figure 16: Result for Glenwood 1 using a 40% concentration by volume (Background © ESRI)
