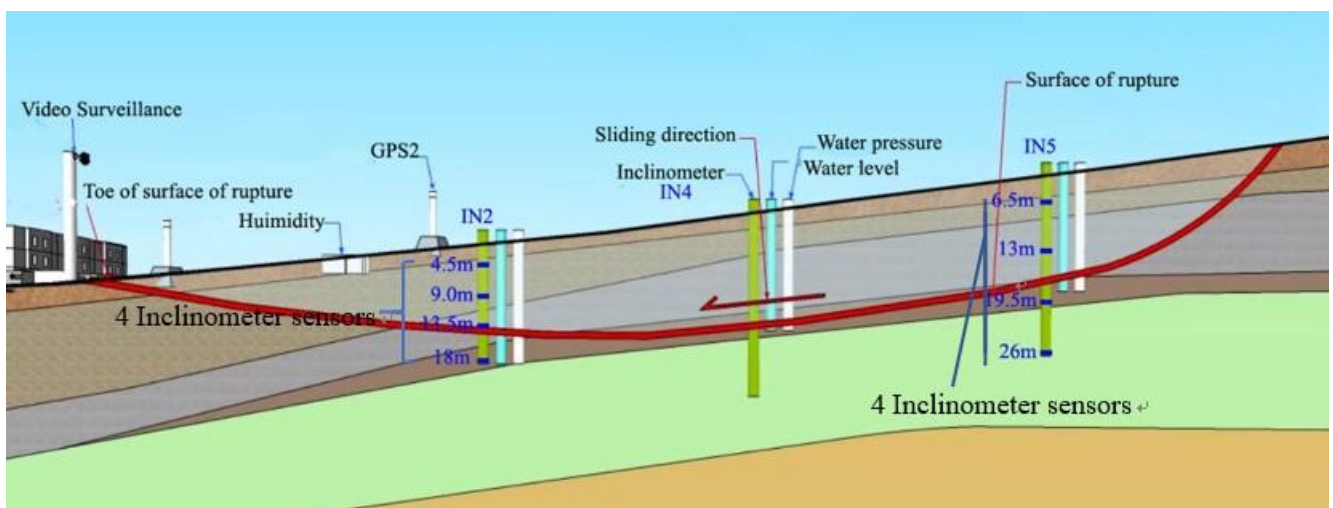
Figure 2 Positions of the monitoring instruments

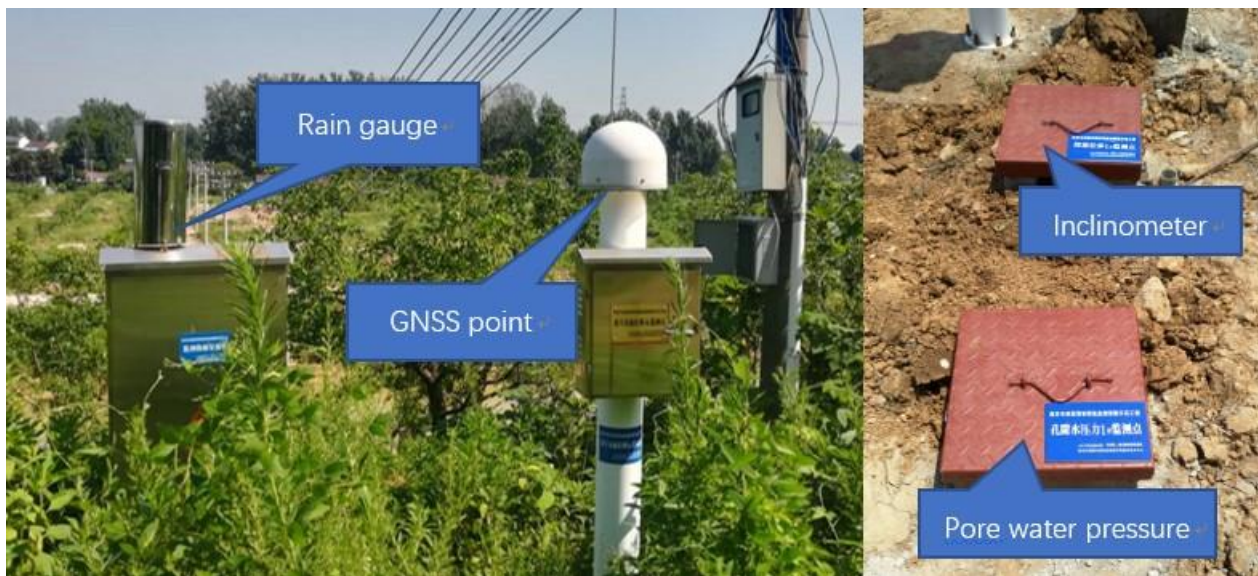
Figure 3 Monitoring instruments on the landslide

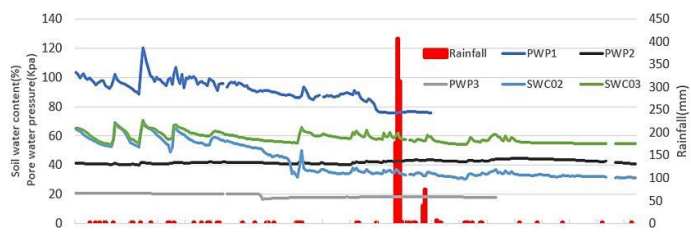
(a) Soil water content, pore water pressure and rainfall

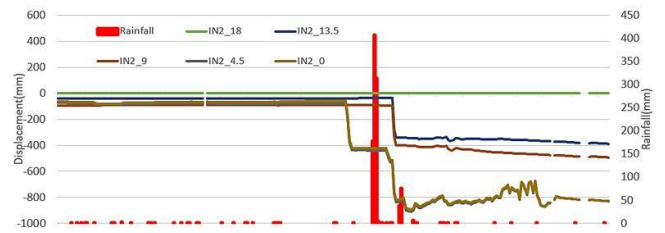
(b) Inclinometer and rainfall

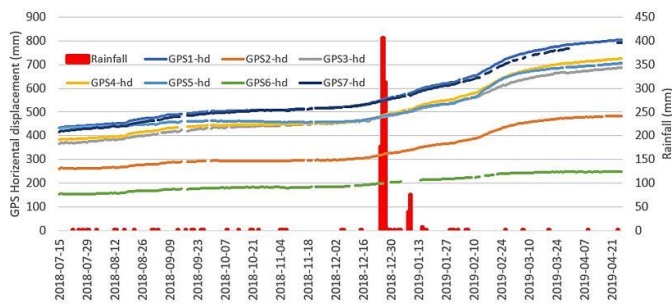
(c) GPS horizontal displacement and rainfall

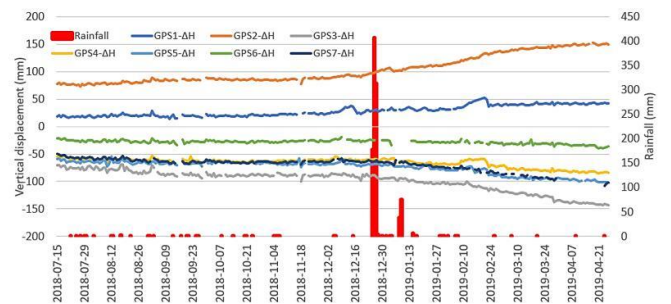
(d) GPS vertical displacement and rainfall

Figure 4 Relationship between rainfall and the other monitoring data

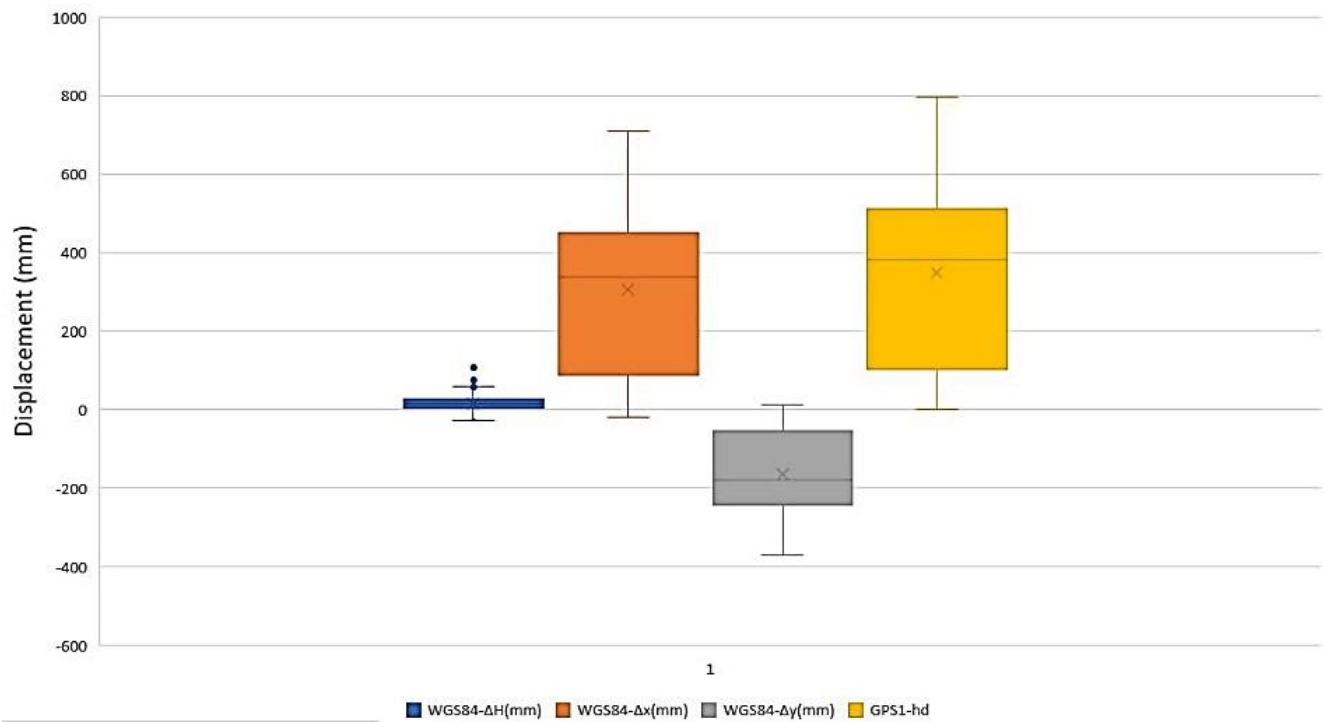
Figure 5 Box plots of GPS

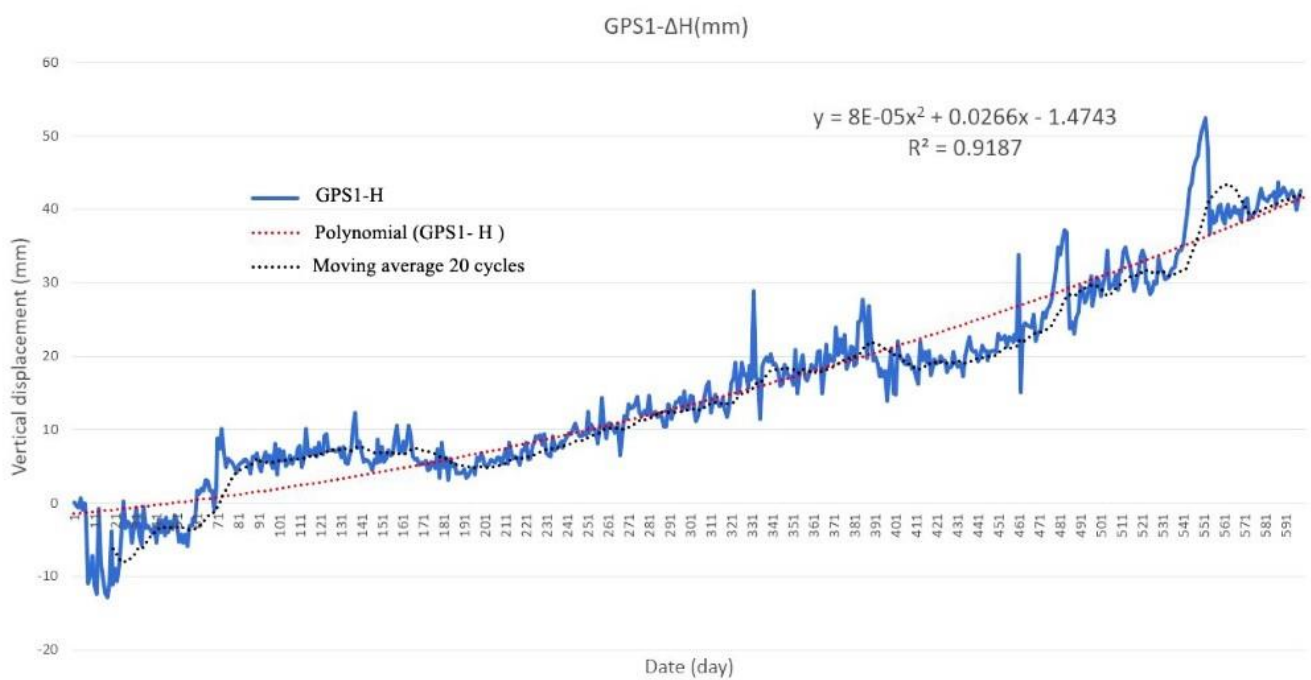
Figure 6 Vertical displacement and its fitting

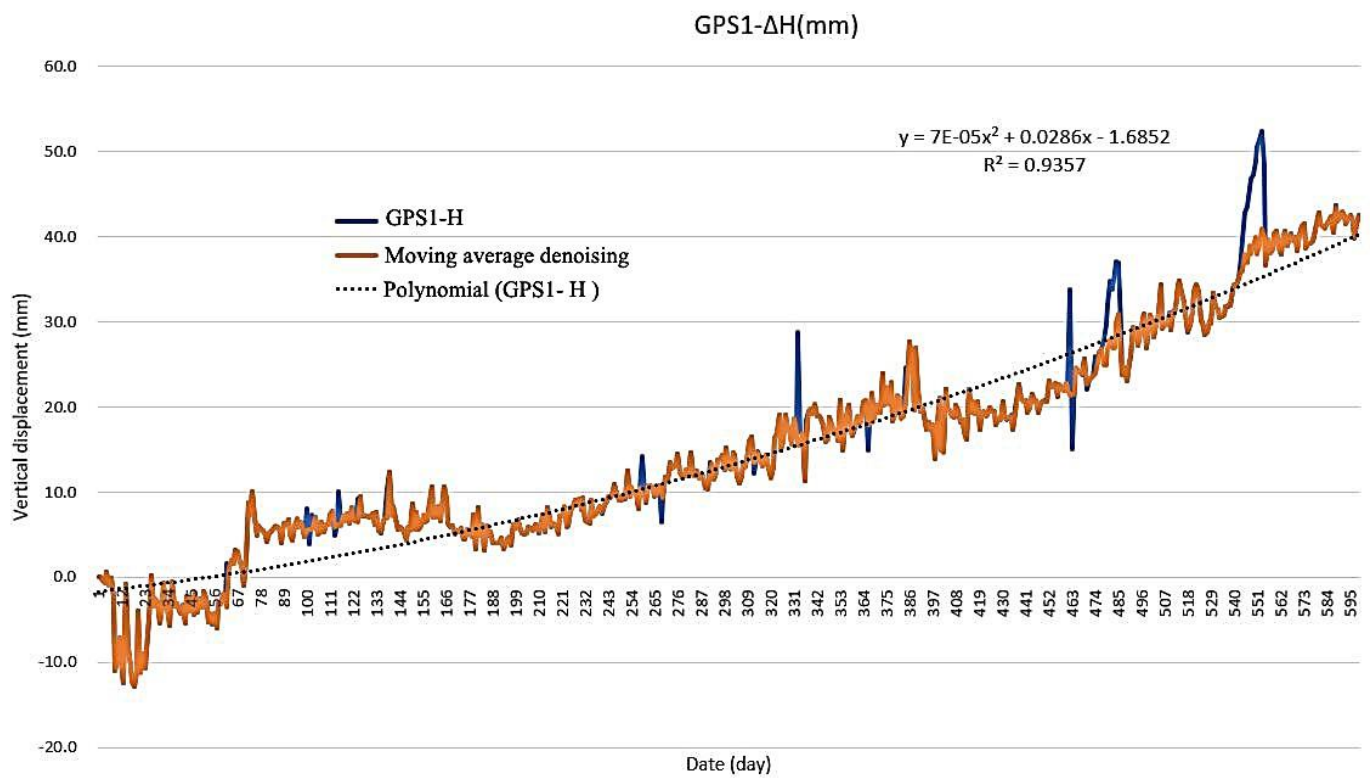
Figure 7 Vertical displacement and its fitting

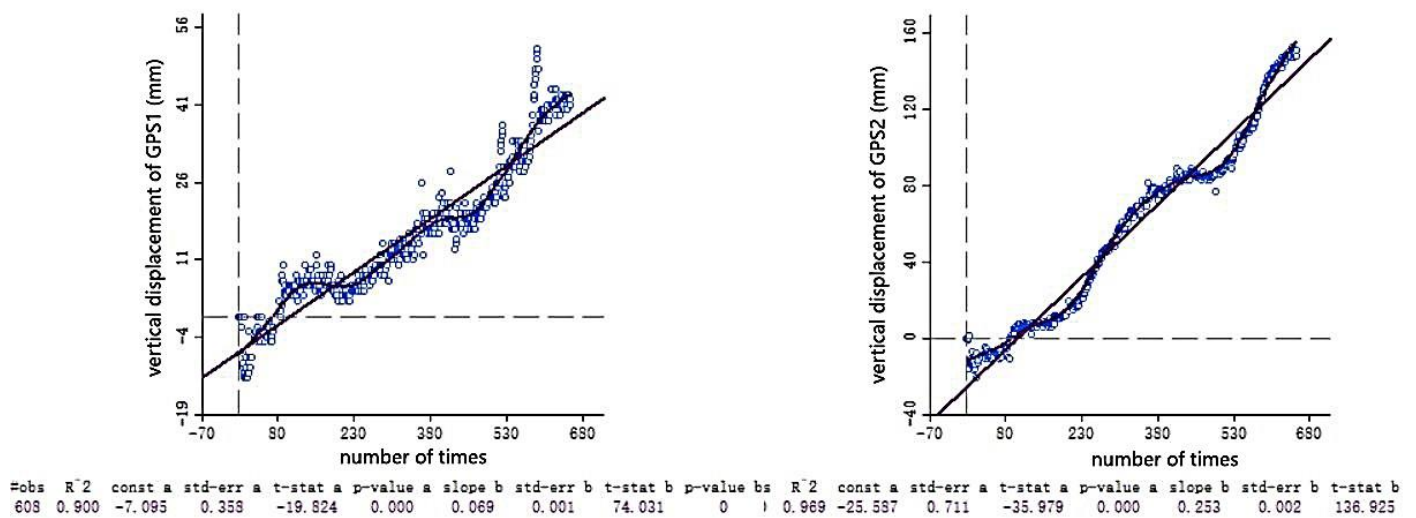
Figure 8 Scatter plots of GPS1 and GPS2

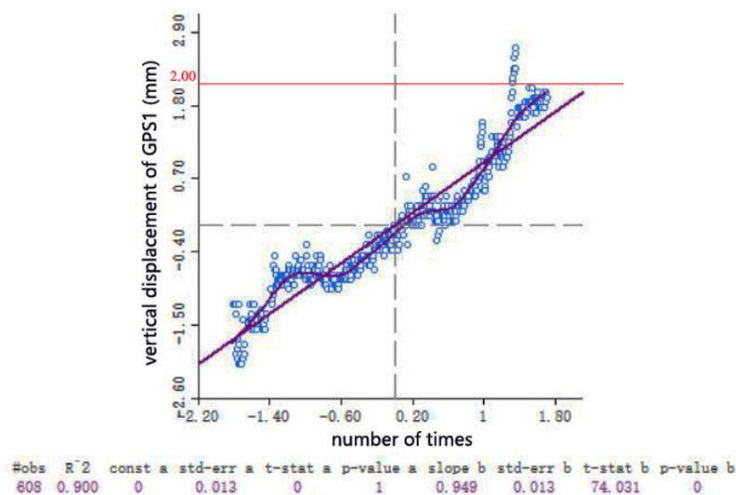
(a) Standardized data of GPS1

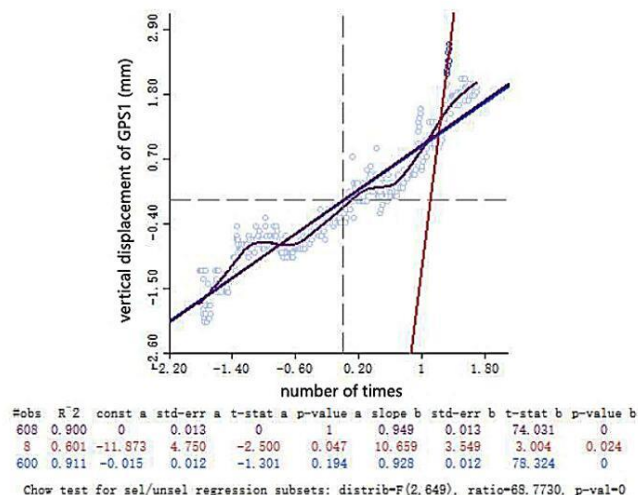
(b) Brushing the scatter plot of GPS1

Figure 9 Analysis data of GPS1

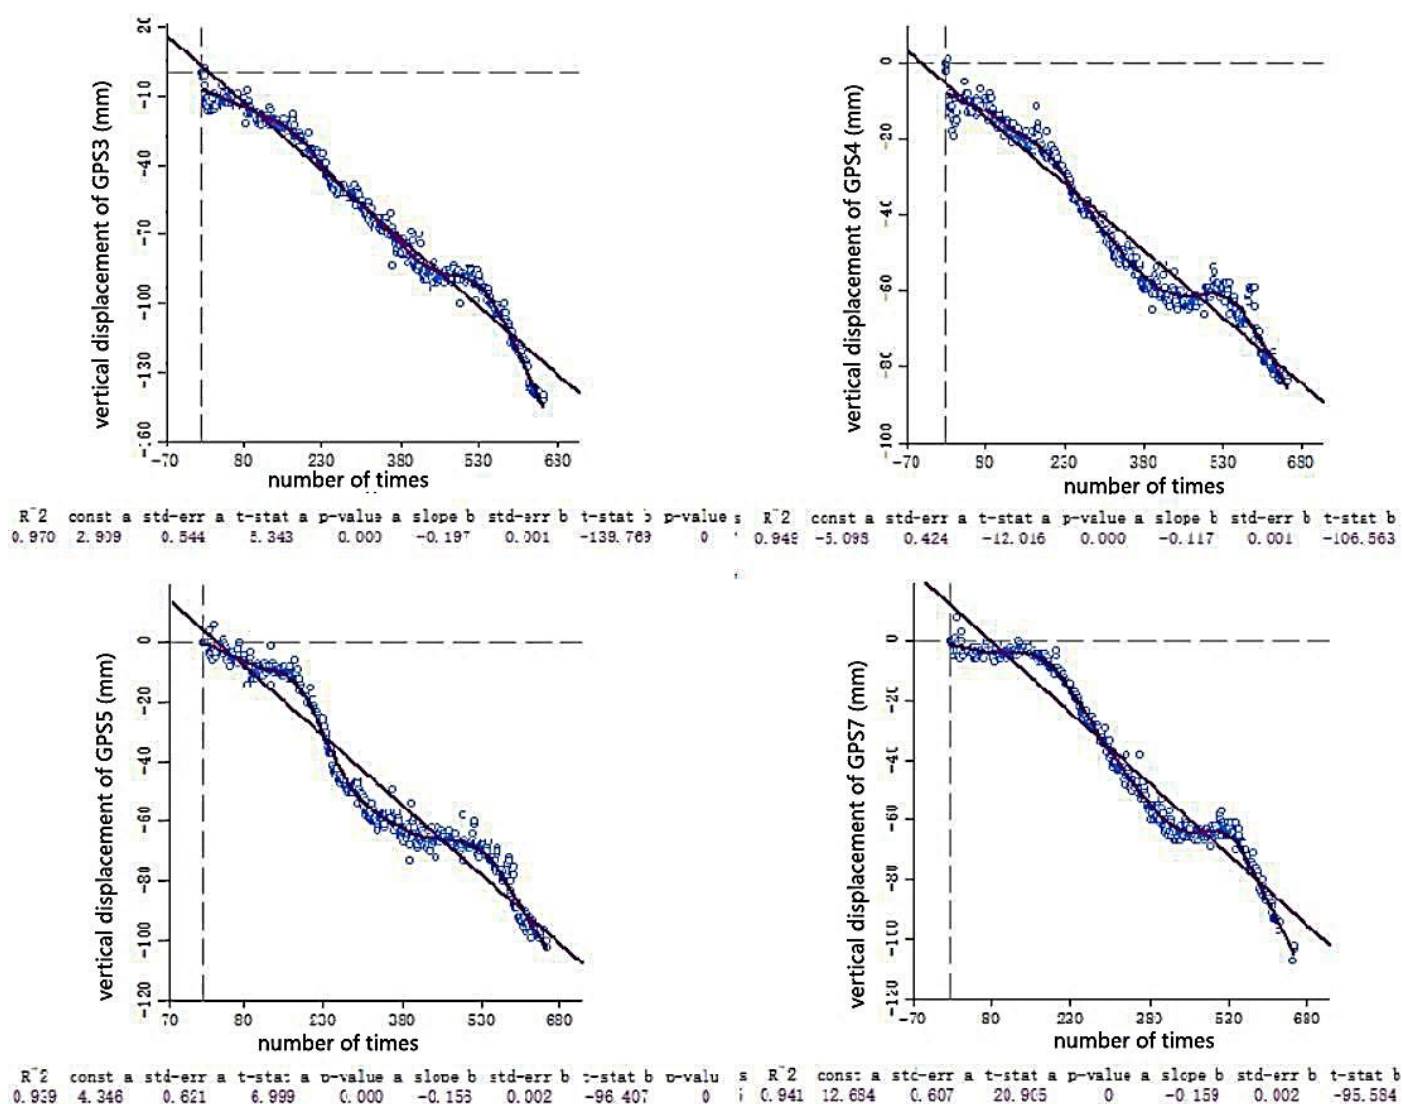
Figure 10 Scatter plots of GPS3 GPS4 GPS5 and GPS7

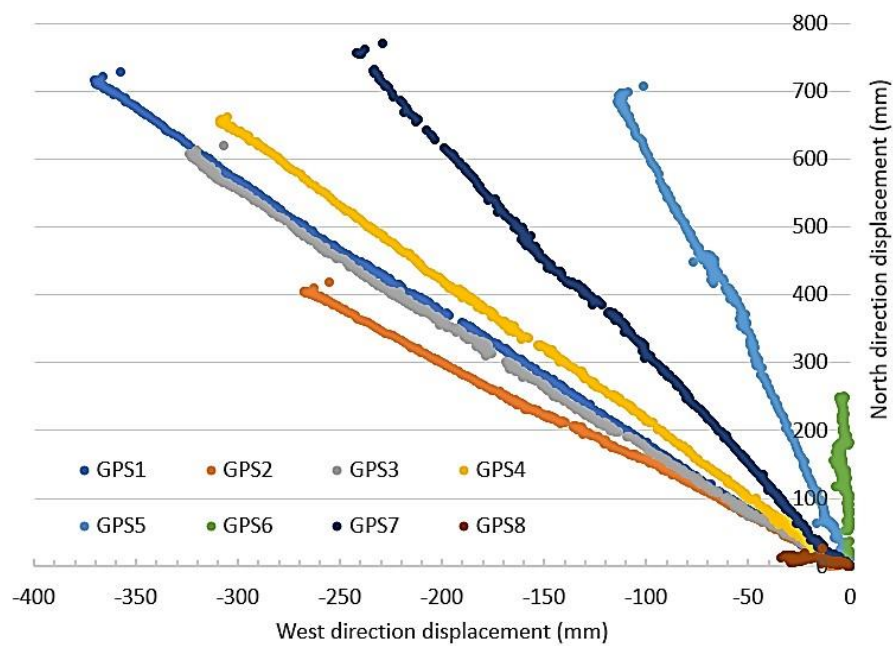
Figure 12 GPS displacement from July 14th 2017 to May 1st 2019

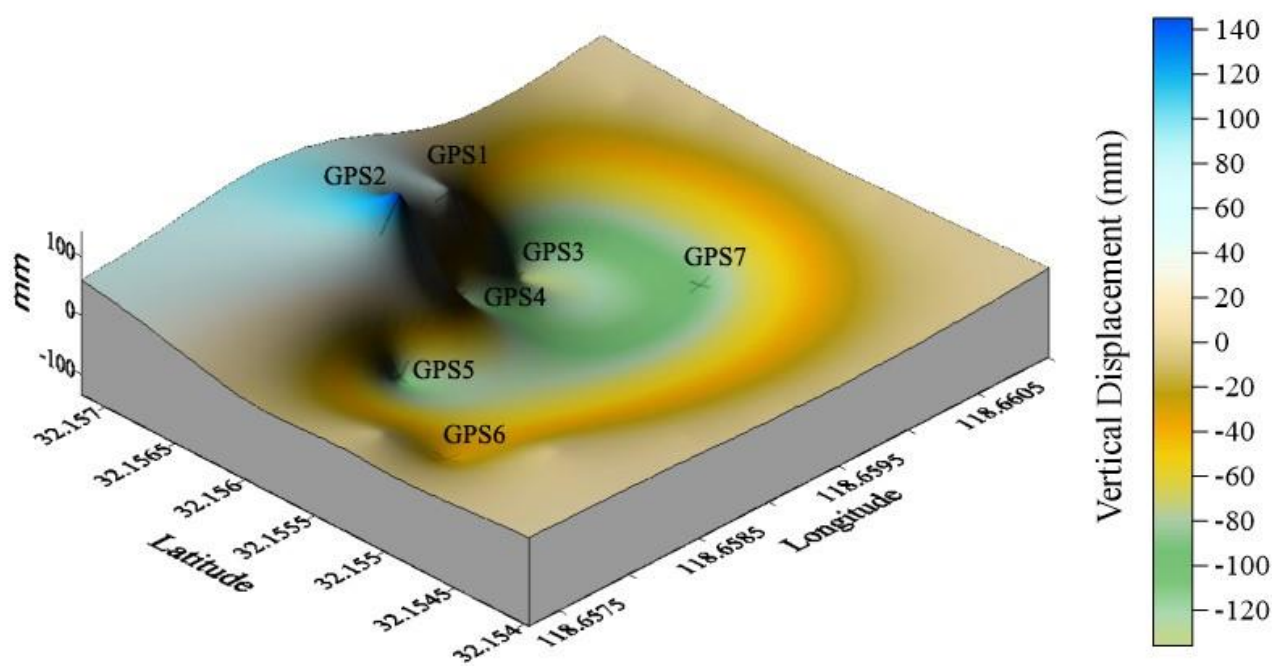
Figure 14 3D graph on April 8th 2019

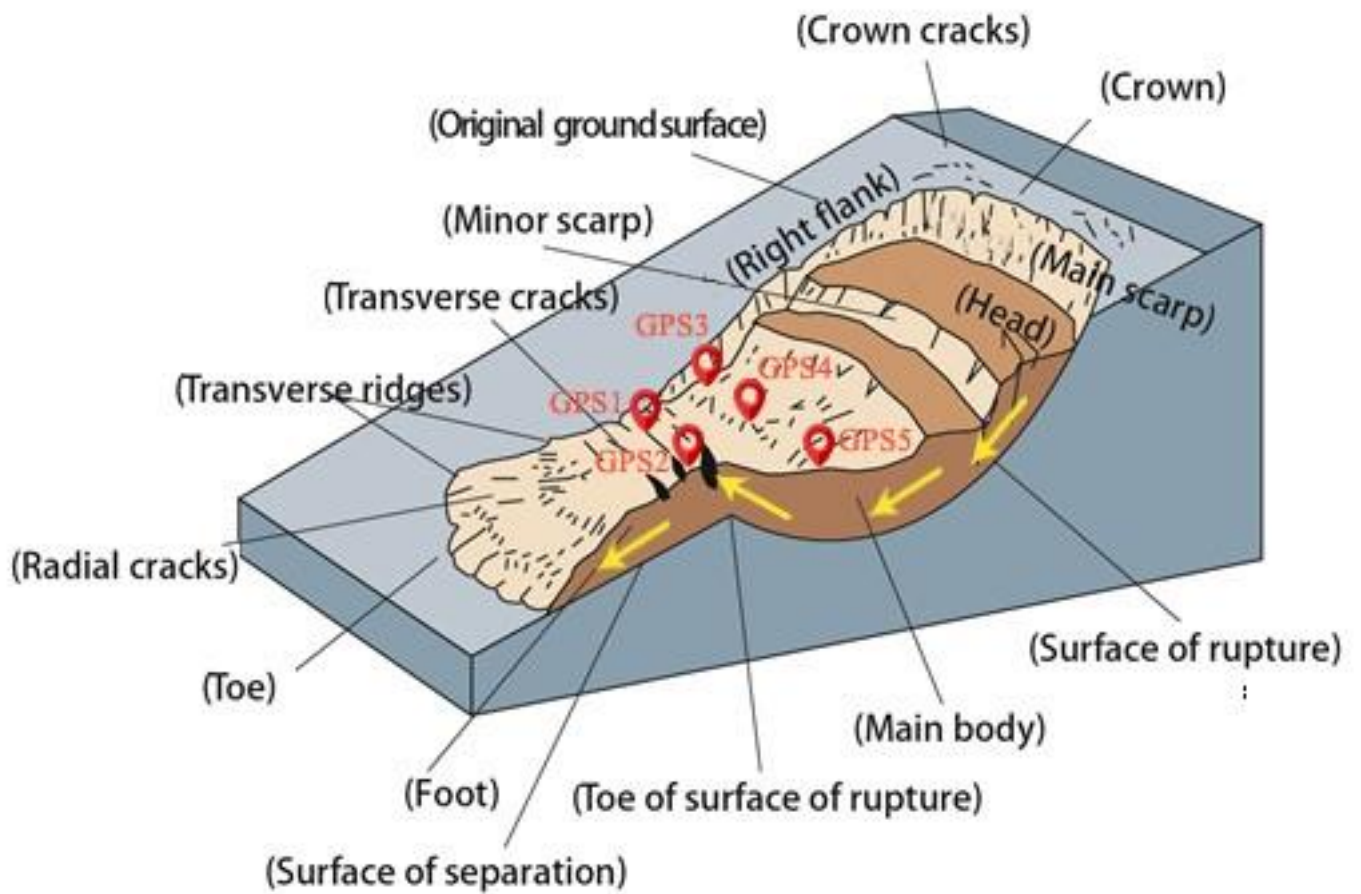
Figure 15 Zhutoushan landslide type based on Varnes 1978
