Formation, evolution and drainage of short-lived glacial lakes in permafrost environments of the northern Teskey Range, Central Asia

10 **Abstract.** In the Teskey Range of the Tien Shan (Kyrgyz Republic), four outburst flood disasters from short-lived glacial lakes caused severe damages in the downstream part in 2006, 2008, 2013, and 2014 caused severe damages in the downstream part. Short-lived glacial lakes grow rapidly and drain within a few months, due to closure and opening of an outlet ice-tunnel in an ice-cored moraine complex at the glacier front. In addition to these factors, summer meltwater from the glacier can cause rapid growth increasing of meltwater from glacier during summer causes the lake variations positive between drainage and storage, during summer. The Outburst floods of this lake type is are a major hazard in this region and differ from the many cases, it differs from many cases of moraine-dam failures common to in the eastern Himalaya. To clarify how short-lived glacial lakes store and drain water over for short periods, we use results from a field survey and satellite data to analyse the examined recent changes of Korumdu lake we examined its recent chang

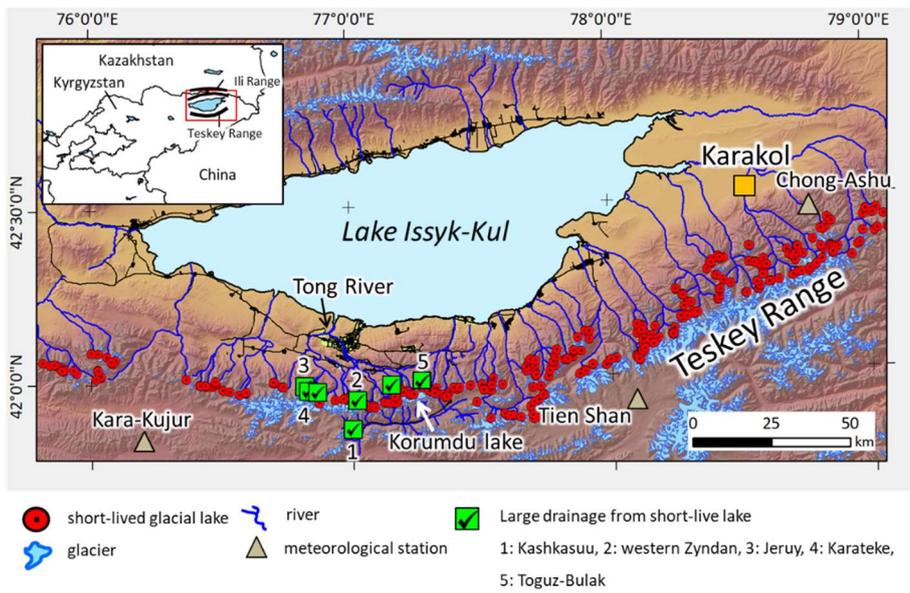
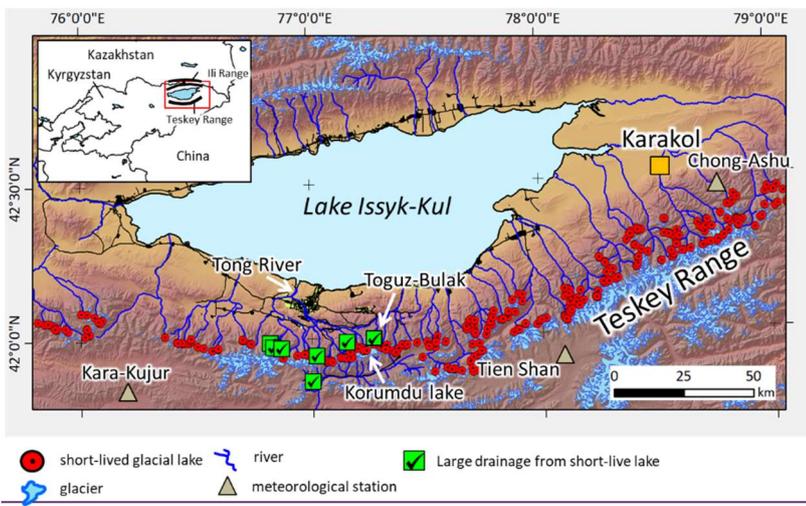
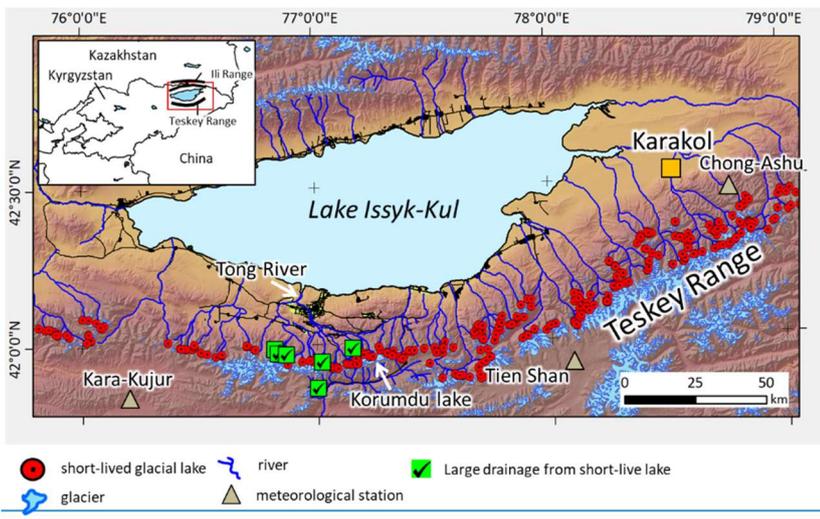
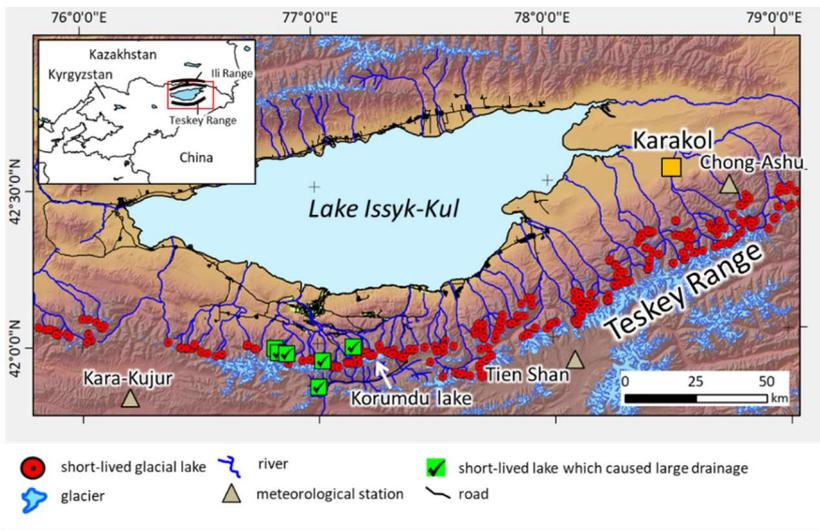
Figure 1: Study area in the northern part of the Teskey Range located on the south shoreline of Lake Issyk-Kul, Kyrgyz Republic. Red circles indicate locations of short-lived glacial lakes that appeared in 2013–2018. Green squares with checks show short-lived glacial lakes that have caused large drainage events since the 1970s. The shaded relief map was created using SRTM DEM.

We ran a field survey at Korumdu lake (~~41°57'32" N, 77°13'28" E~~) at ~~3803–3806~~ m (Figs. 1, 2). ~~The Korumdu catchment gives~~ source to the largest tributary in the Tong River Basin, and according to a Sentinel-2 satellite image in 2019, ~~–Korumdu glacier occupies an area of 2.35 km² based on Sentinel 2 satellite image in 2019.~~ At the front of the Korumdu glacier lies Korumdu glacial lake (Fig. 2). ~~The Korumdu catchment gives source to~~ forms the largest tributary in the Tong River Basin. The Korumdu glacier occupies an area of 2.35 km² based on Sentinel 2 satellite image in 2019. ~~The dam of this Korumdu lake is an ice-cored moraine complex. The lake has direct contact with the glacier and. At the front of the Korumdu glacier lies the Korumdu glacial lake (Fig. 2). It developed in a depression that formed during the retreat of the glacier and retains direct contact with the glacier. The lake basin developed inside an ice-cored moraine complex. As the reason why this We lake was selected this lake for a research because site,~~ (i) the lake is a short-lived type ~~that~~ which appears every year, (ii) it is easy to access ~~the field~~, and (iii) this lake is located ~~inat~~ the Tong region where four large outburst floods occurred in the past. According to data in Narama et al. (2018), drainage from Korumdu lake is the flood-wave type in the downstream region ~~because the water stream flows on a gentle slope.~~ In addition, we investigated the timing of appearance for 160 short-lived lakes in the ~~northern Teskey Range during 2013–2018~~ is region (Fig. 1) ~~which are of the same type as Korumdu using Landsat-7/8, Sentinel-2, and PlanetScope satellite images (Supplemental Table 1) (2013–2018). These 160 lakes were chosen based on their area changes/short existence within several months of one each year though six years.~~

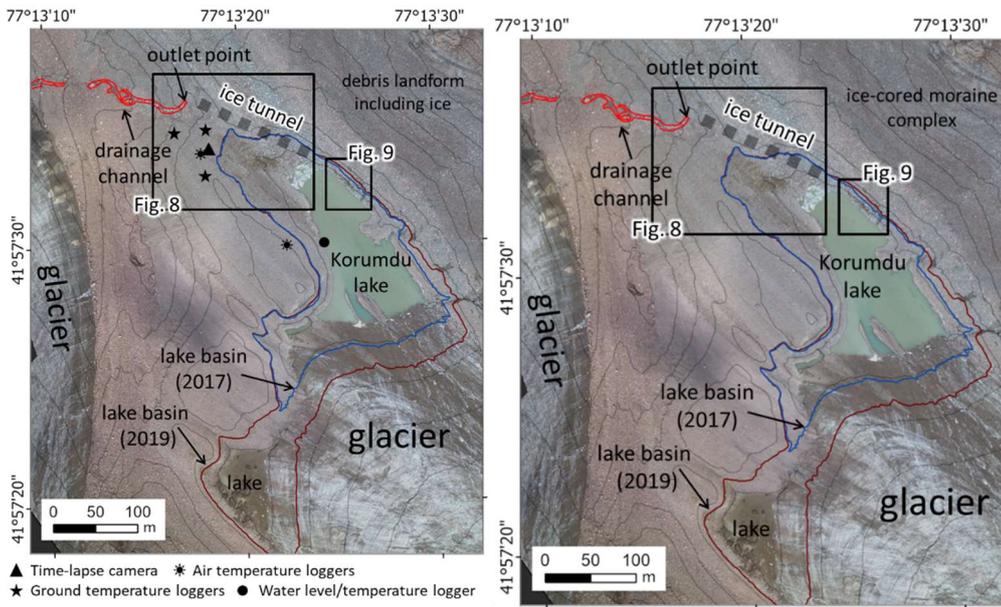
Figure 2: Overview Geomorphological map of the Korumdu glacier front. The location of the glacier is shown in Fig. 1. Orthoimages were acquired by our UAV imagery in 2019. Contour spacing is 10 m.

ALOS/AVNIR-2 data taken on 17 September 2007 indicated that At the front of the Korumdu glacier lies the Korumdu glacial lake (Fig. 2). It sits in a basin that formed during glacier recession. The basin developed inside an ice-cored moraine complex. Although most of the lake basin area had been covered by the Korumdu glacier, based on ALOS/AVNIR-2 data taken on 17 September 2007, Thus, the lake basin developed in a depression that formed during the retreat of the glacier. The UAV ortho-images in 2019 indicated a lake basin length of 360 m, a width of 110 m, with and a total area of the lake basin of 0.062 km² in 2019. The lake basin volume increased from 264,000 m³ in 2017 to 330,000 m³ from 2017 to in 2019 (Fig. 2) due to retreat of the glacier terminus. In the field, we observed ice ridging and debris sliding on the basin's slope of the lake basin, indicating that the ice was melting from around the shore, thus increasing the basin's width of the lake basin.

The lake had no discernable surface drainage channel, but we found an outlet point where meltwater from the lake emerges from a subsurface ice-tunnel within the frozen ice-cored moraine complex which is that connects to the lake (Fig. 2). The existence of the outlet shows that lake water flows through an outlet ice tunnel from the lake. The length of the outlet ice-tunnel is 60 m from the entrance of the lake basin. During the fieldwork, we observed melt draining Leakage of meltwater Drainage water was observed at the outlet point on 30 July 2015, 6 August 2017, and 4 August 2019, but not in 12 August 2016 and 20 July 2018. We found that the Korumdu lake was not release sudden appearance and expansion (and drainage) during summers 2015 and 2016.

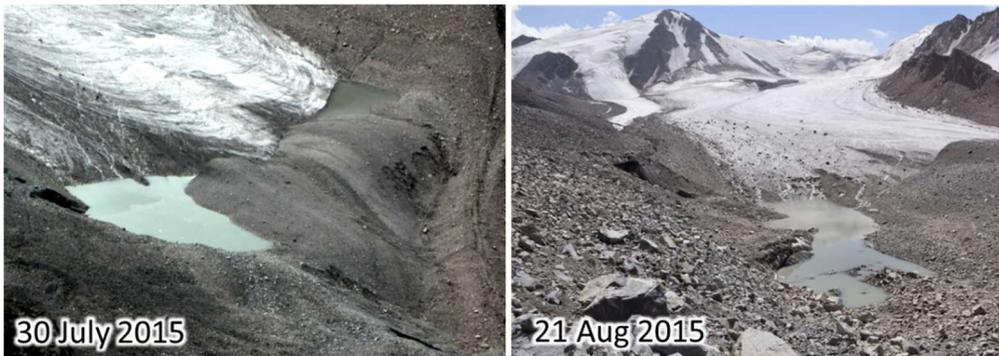
Figure 3: Korumdu glacial lake on 30 July 2015 (from a helicopter) and 21 August 2015 (from field observation). The width at the lake middle is about 85 m (left image) and 40 m (right).

Concerning lake size changes, in 2015, the lake appeared sometime before 30 in July, becoming large (reached its maximum) on 30 July, then shrank significantly by 21 August (Fig. 3). In 2016, according to the water level data and on-site time-lapse camera images, the lake area did not appear. For 2017–2019, we had more images of the area and thus a a more precise sequence of complete story of changes in lake size is shown with a sequence of PlanetScope satellite the changes appears in the images in Fig. 4, which are based on PlanetScope satellite data. The images show that the lake appears suddenly at the end of July to the beginning of August and then shrinks and vanishes by the end of August (Fig. 4a–c). Although the timing of lake expansion differs slightly over the years 2017–2019, the lake always appears in summer. The time-lapse on-site images show the same behavior from a different view (Fig. 5). These images also indicate that the lake began to expand from mid-July and reached its maximum size at some time between late July and early August. In addition, we checked Landsat-8/OLI data in

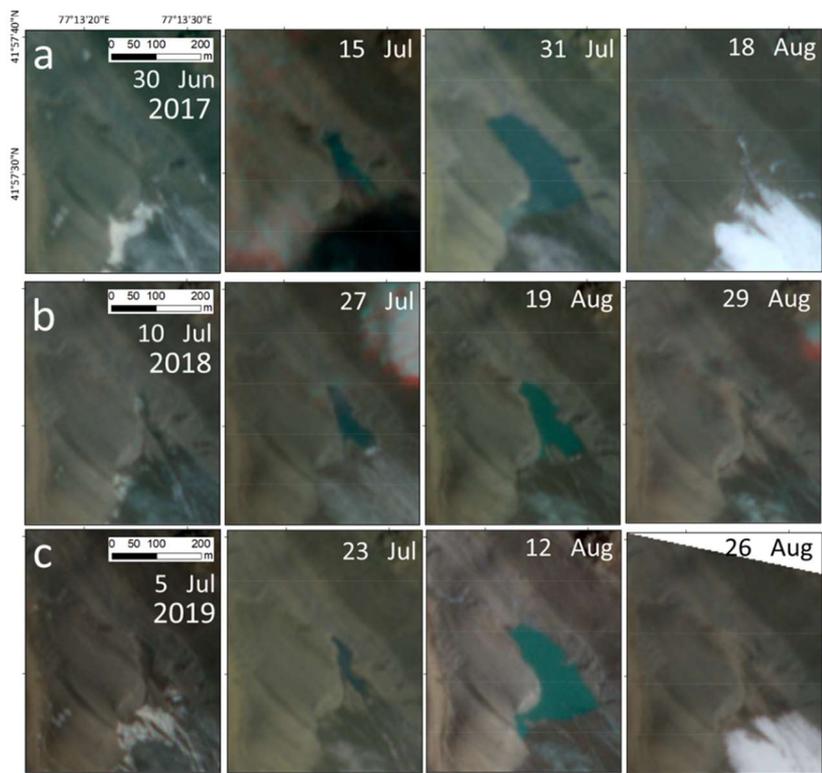
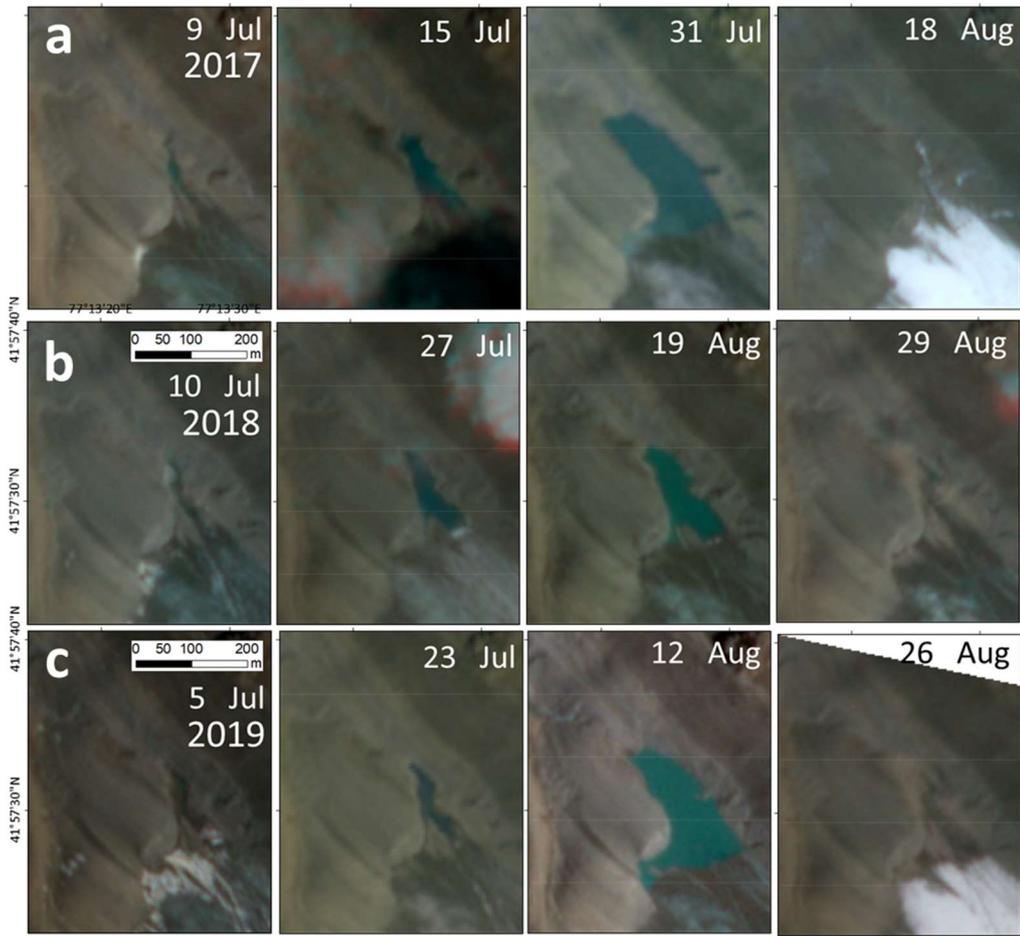
Figure 4: Time sequence of satellite images (PlanetScope) showing the evolution of the Korumdu lake in (a) 2017, (b) 2018, and (c) 2019 area during 2017–2019. Scale in b) applies also to a) and c).

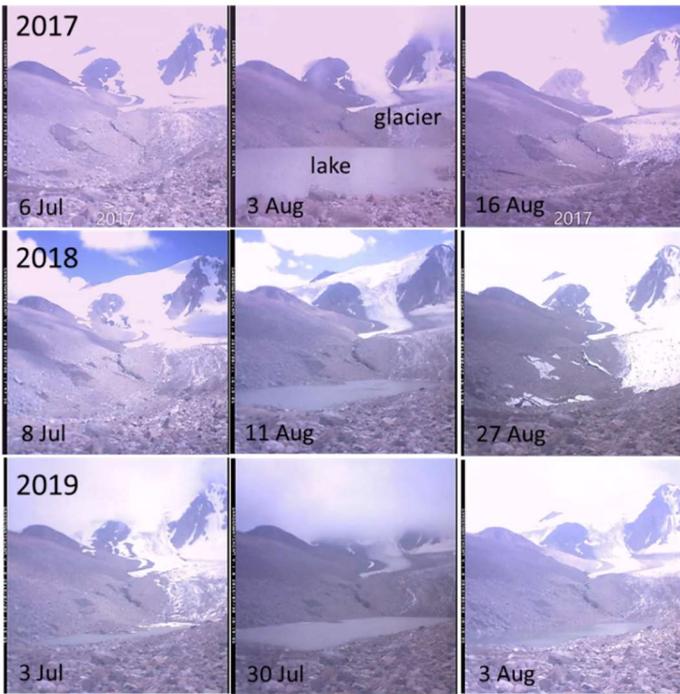
Figure 5: Evolution of Korumdu lake during 2017–2019 based from on time-lapse camera images acquired in the field. Time sequence of ground camera images of the Korumdu lake area during 2017–2019.

The time lapse on-site images show the same behavior from a different view (Fig. 5). These images also indicate that the lake began to expand from mid-July and reached its maximum level size at some time between late July and early August. In contrast, according to the on-site time lapse camera, the lake area did not change dynamically i.e. the lake area did not expand substantially in 2016. Based on Landsat 8/OLI data, we also found that the lake appeared in 2014 (May 5, June 27, and September 10) existing for four months, but unknown its drainages. Although these images show rapid drainage, we did not find evidence that the drainage caused flooding during the survey period. According to data in Narama et al. (2018), drainage from Korumdu lake is the flood-wave type in the downstream region because the water stream flows on a gentle slope.

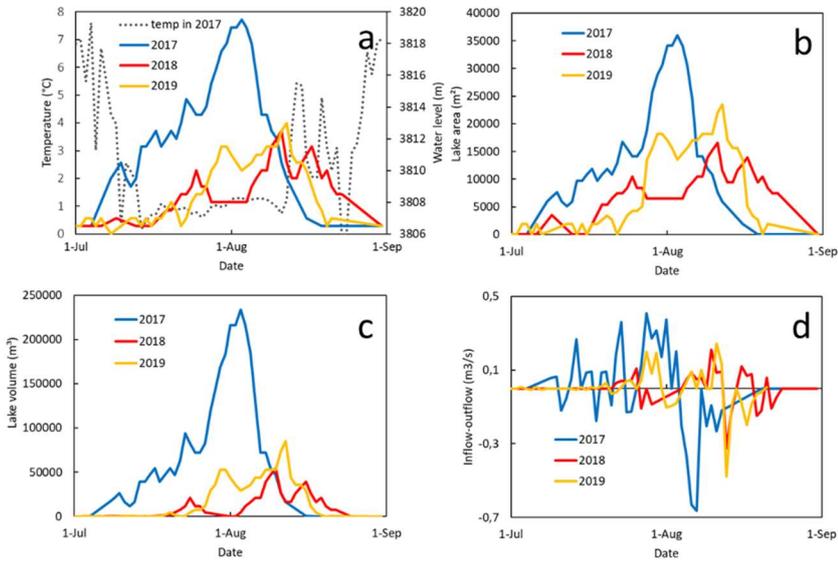
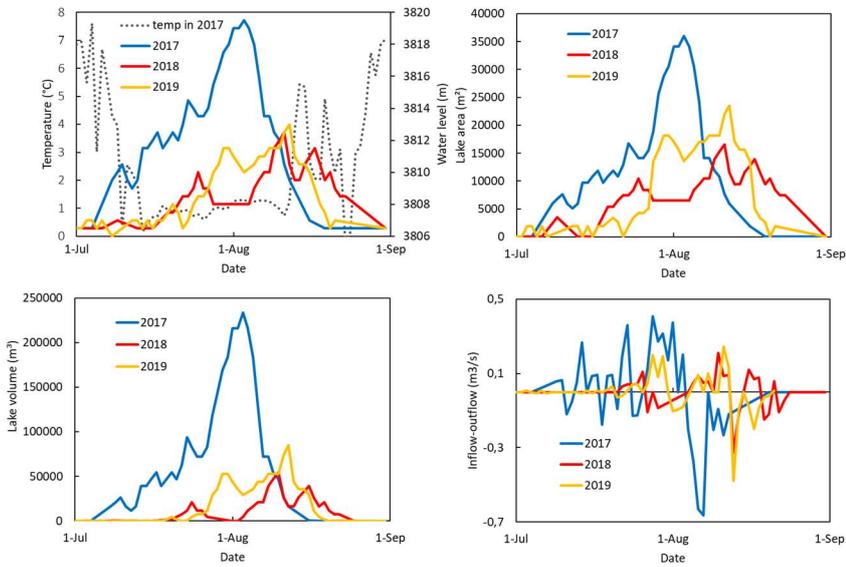
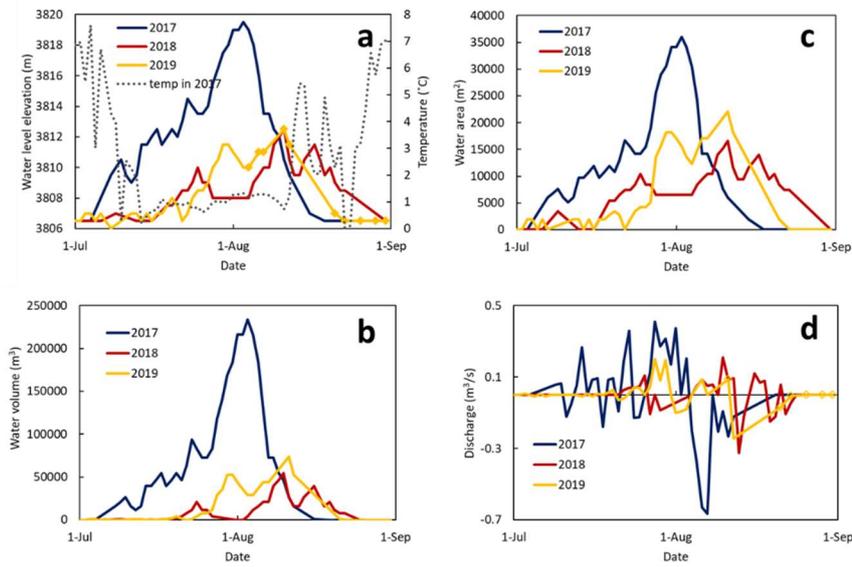
675 Figure 6: Yearly Korumdu lake properties 2017–2019. (a) Water levels of Korumdu lake in 2017–2019. (a) and air/water level (left) and temperature in 2017 (right). (b) Lake volume. (c) Water-Lake surface area. (d) Inflow–outflow discharge rate. These dData derived from 2017 to 2019 are based on water level/water level logger_(Hobo U20) data, UAV-derived DSMs, time-lapse camera images, and PlanetScope satellite images.

275 Consider the properties of Korumdu lake from 2017 to 2019. Figure 6 shows the measured water level, lake area and volume, and inflow-outflow discharge rate of Korumdu lake from 2017 to 2019. For 2017, we also show the water temperature (Fig. 6a), water temperature data were also recorded (Fig. 6a), and water level data between 4 and 31 August were reconstructed based on 10 satellite images. We also show the water temperature (Fig. 6a). We also reconstructed the water level data between August 4 and 31 based on 10 satellite images (yellow points in Fig. 6a). Lake volume and discharge were calculated based on the water level data. We calculated volume and discharge using the water levels and the UAV-derived DSMs.

280 Consider the trends in Korumdu lake during the three summers of 2017–2019. For 2017, Fig. 6a shows the water level starts increasing from 6 July, reaching a maximum on 3 August, and then the lake is empty vanishes on 19 August (Fig. 6a). Within the first 29 days, the water lake level increases 13 m, the volume reaches 234,000 m³, and the area reaches 0.36 km² (Fig. 6b–e), and the volume reaches 234,000 m³ (Fig. 6c). The resulting rate of lake volume increase was 8,070 m³/per day. During the emptying of the lake, 234,000 m³ of water drain discharge, 234,000 m³ of water drains in 17 days, with half of the volume draining from 3 to 7 August 2017 (Fig. 6b–c), resulting in a maximum net outflow discharge of 0.66 m³/s (Fig. 6d). Although the water level increases intermittently before 3 August, the net outflow is relatively smooth. The lake water temperature averaged about 1°C (Fig. 6a). The temperature fluctuates more when the lake is shallower because the heating of shallower water by solar irradiance is stronger than cooling from inflowing ice meltwater.

In 2018 and 2019. In 2018, the water level peaks three times, though reaches only about half that of 2017 (Fig. 6a). The first peak, on 25 July, occurs with showing a lake depth of reaches 3.5 m and a volume of 21,000 m³ (Fig. 6a, b–c). The second, and maximum peak, occurs, the yearly maximum, on 11 August, with a lake depth of reaches 6 m and a volume of 53,000 m³, which corresponds to the maximum values in 2018. The third peak occurs on 17 August with, showing a lake depth. Finally, the third peak, on 17 August, reaches a level of 5 m and a volume of 39,000 m³. The maximum net discharge occurs after the second peak, reaching 0.32 m³/s (Fig. 6d). Compared to the case in 2017–2018, the maximum lake level and volume are much

In 2019, the ~~lake water level rises and falls before water level goes up and down until~~ 22 July, when it rises sharply (Fig. 6a). Then, ~~the water level shows an intermittent a local maximum around the level has a local maximum on~~ 30–31 July, reaching a ~~lake depth of~~ 5 m and a volume of 53,000 m³. ~~The 2019 maximum level occurs values were recorded followed by a yearly maximum on on~~ 11 August, with a lake depth of 6.5 m and a corresponding volume of ~~reaching 6.5 m and~~ 74,000 m³ (Fig. 6a, 305 ~~bc~~). The maximum discharge occurs right after the second peak, reaching 0.24 m³/s (Fig. 6d).

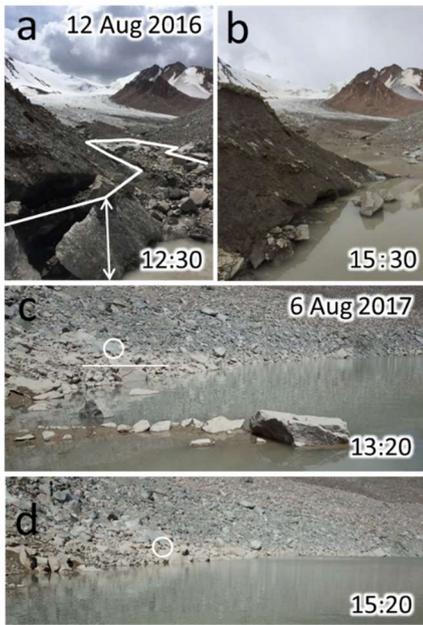
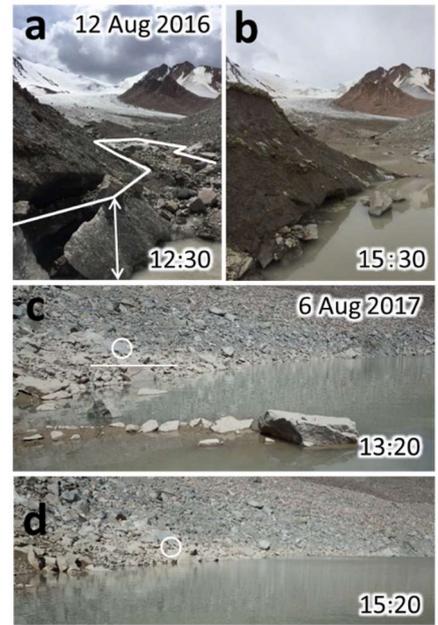
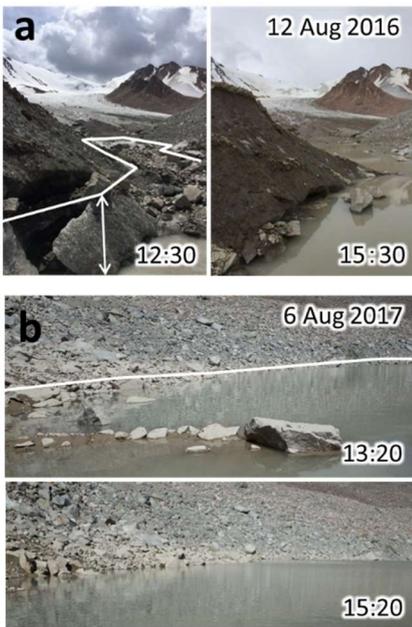
Figure 7: Two examples of a sudden small increase in water level of Korumdu lake. (a) On 12 August 2016. (b) Same as (a) except 3 hours later. (c) On 6 August 2017. (d) Same as (c) except 2 hours later. Images taken in the field.

In addition, with for Korumdu lake exhibited we observed sudden fluctuations of water level over several hours, which we argued was related to closure of the small outlet ice-tunnel is behavior consistent with closure of a small channel caused by deposition of and blockage by debris. The relatively small tunnel size of this lake resulted in slower lake discharge even when lake volume reached its maximum ensured a slower discharge even when it became full (330,000 m³). During 2017–2019, the lake size was largest in 2017, yet the discharge rates were nearly the same every year. These results show that, at least for Korumdu lake, the lake size and the dimensions of the outlet ice-tunnel were the dominant factor controlling lake are related to the scale of discharge rates.

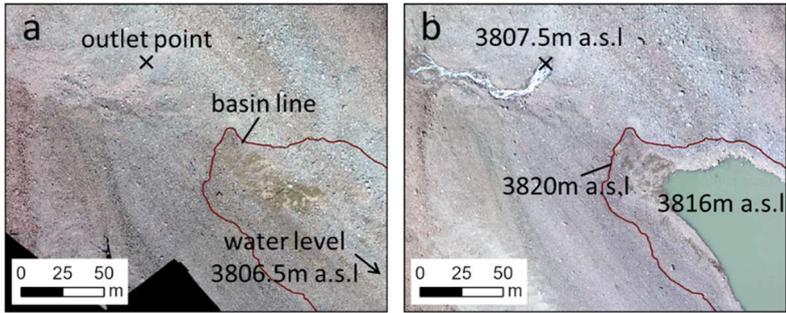
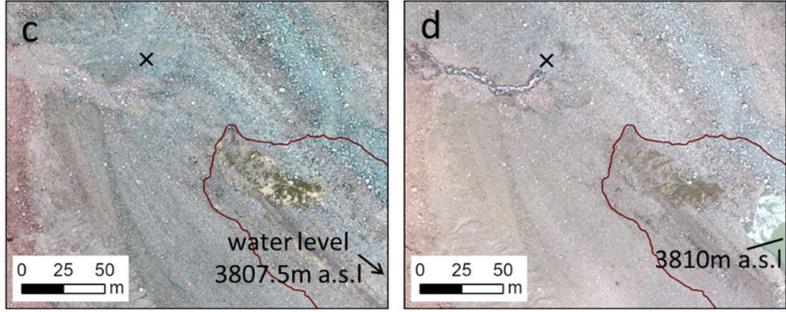
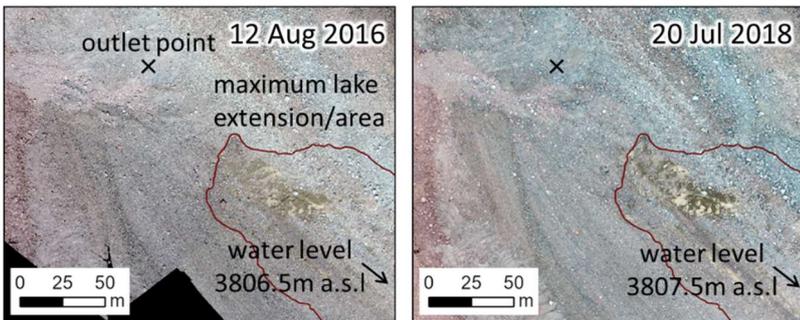
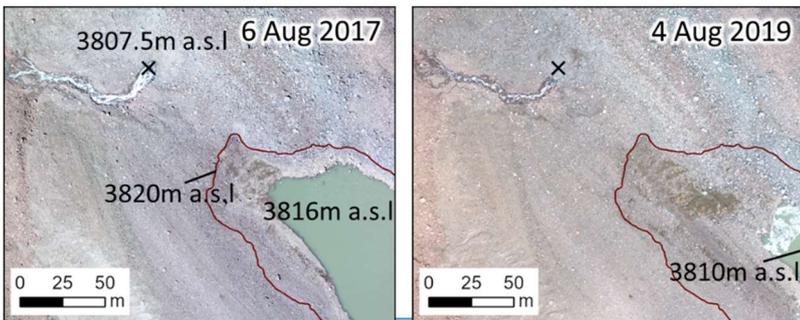
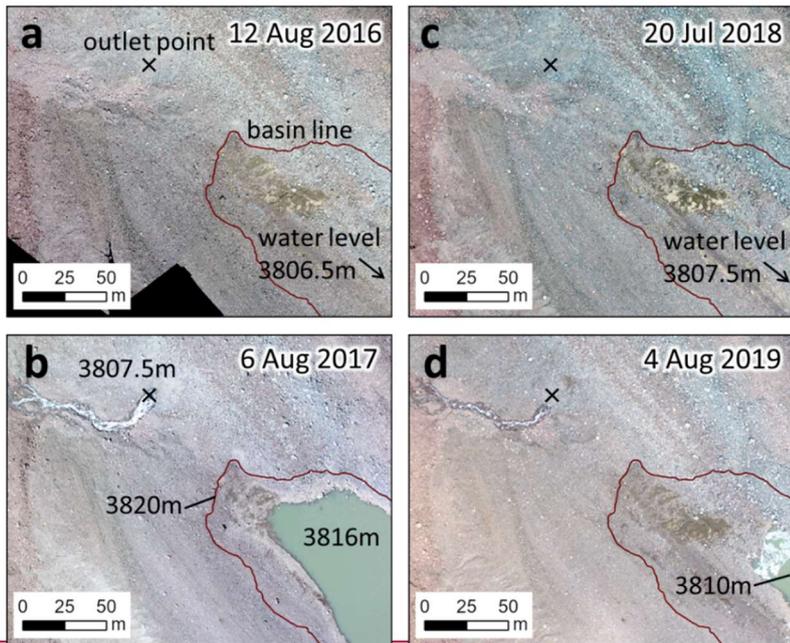
Figure 8: One-day drainage events from Korumdu lake on the listed dates. (a) On 12 August 2016. (b) On 6 August 2017. (c) On 20 July 2018. (d) On 4 August 2019. (a) On 12 August, 2016. (b) On 6 August, 2017. (c) On 20 July, 2018. (d) On 4 August, 2019. Orthoimages were acquired from are from our UAV surveys imagery.

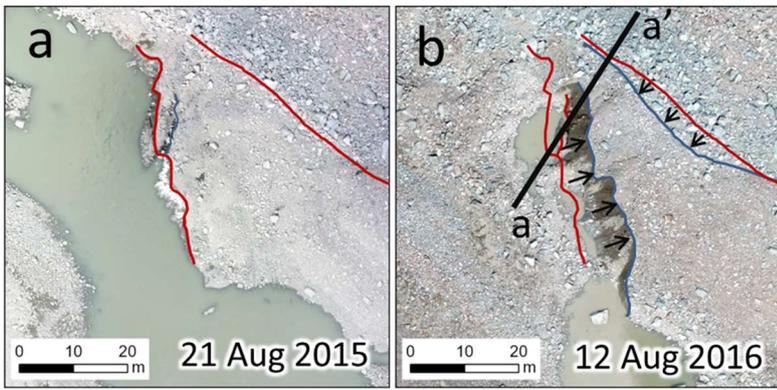
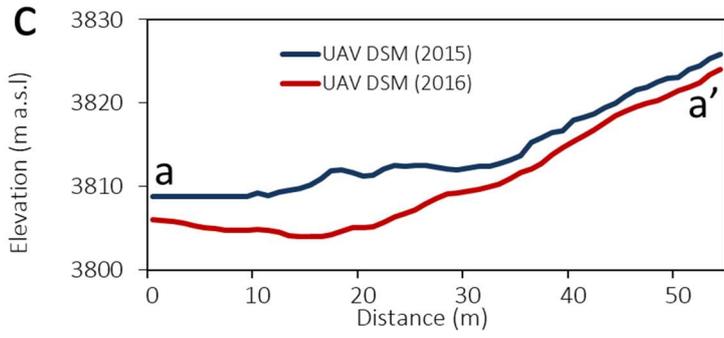
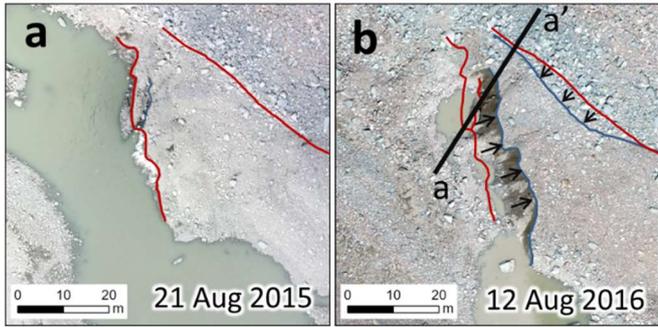
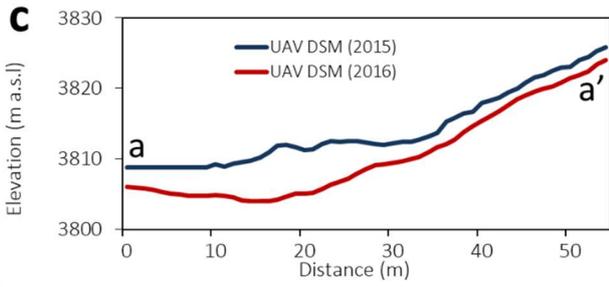
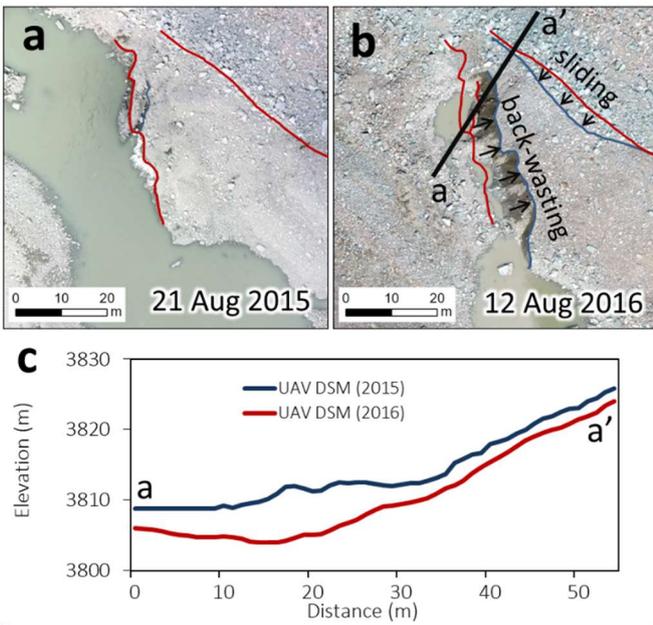
Figure 9: Surface features and elevation profiles of the debris-covered stagnant ice/dead ice landform at the entrance of the outlet ice-tunnel based on UAV ortho-images. (a) On 21 August 2015. Left red line shows the position of the exposed ice edge line of the debris surface before the ice-cliff underwent backwasting and melting. Right red line shows the deposition line of boulders on the slope. (b) Same as (a) except 12 August 2016. The blue lines show the new positions of the respective surface features after one year. (c) Elevation profile of the surface along line a-a' in (b).

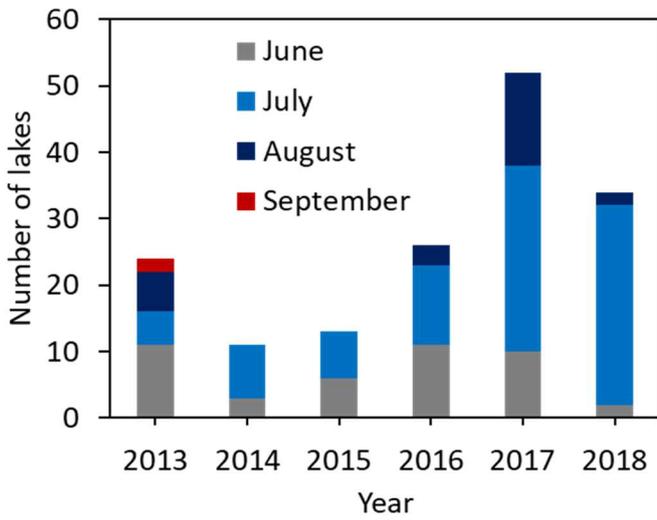
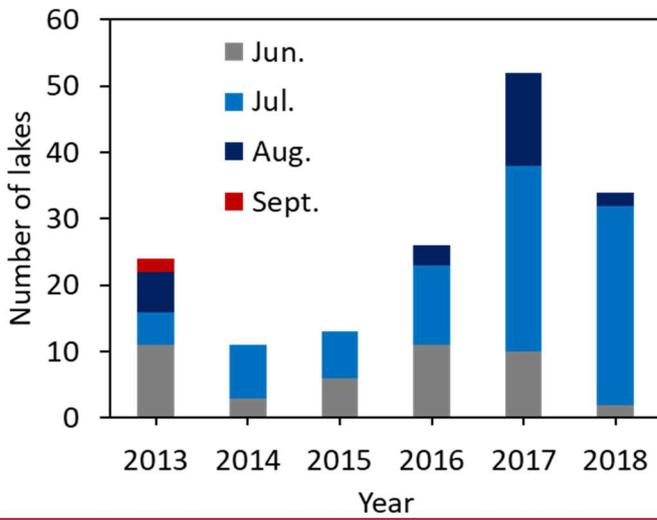
Figure 10: Total number of short-lived lakes in the months of June–September during 2013–2018 in the northern part of the Teskey Range derived by Landsat-7/8, Sentinel-2, and PlanetScope satellite images.

370 Concerning re-appearances, 81 lakes appeared only once during for six years. Of the remaining, 19 lakes appeared twice, 7 lakes appeared 3–three times, 2 lakes appeared 4–four times, and 2 lakes appeared every year all 6 years. These results are consistent with indicating that tunnel closure caused short-lived of these 111 glacial lakes in the northern Teskey Range occurred with a different month each year being the main cause of formation. In addition, S Short-lived glacial lakes that reappear during many years likely has an environment that either favors show geomorphological settings at the drainage tunnel entrance which favor tunnel closure and hence lake formation, or an positive water balance between drainage and storage, related to increase in meltwater from glacier during summer (Daiyrov et al., 2020). or water balance related to increasing of meltwater from glacier during summer (Daiyrov et al., 2020). at the drainage tunnel entrance which favor tunnel closure and hence lake formation have a tunnel condition in which closure occurs easily.

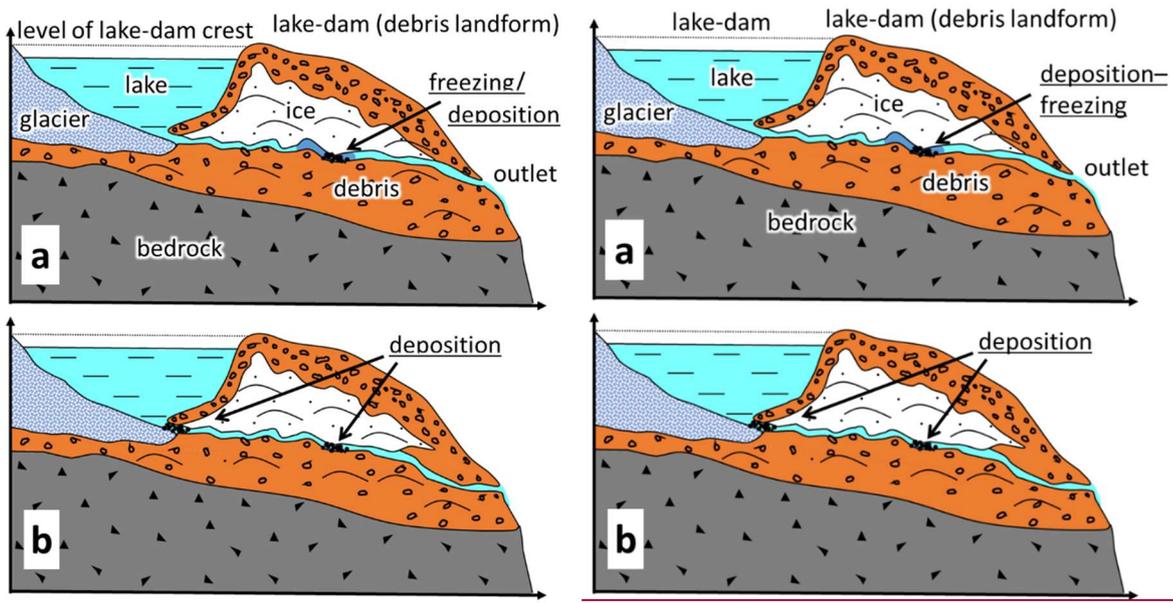
Figure 11: The two types of ice-tunnel closure occurring in the northern Teskey Range in the region. Sketches show cross-sections through a glacier, lake basin, and ice-cored moraine complex in the case of a short-lived lake (based on Popov, 1987). (a) Deposition–freezing type of closure in case of that appears when an outlet ice-tunnel being is blocked due to the by freezing of storage water or deposition of debris and ice. Dark blue in the tunnel is frozen. (b) Deposition–closure type of closure in case of that appears when an outlet ice-tunnel at the entrance or interior is being blocked due to by deposition of debris and ice by thermal erosion (ice melting).

~~In contrast, Korumdu lake appeared during July–August (except in 2016) and produced relatively little drainage during emptying. This different appearance time might reflect a different formation process. Four short-lived glacial lakes of the Teskey Range that caused four large drainage events The short-lived lakes of the Teskey Range here that caused the four large drainages (2006, 2008, 2013, and 2014) appeared between May and June in May–June and expanded in area until June–July (Narama et al., 2010a, 2018). The timing of lake appearance suggests their ice tunnels closed via the freezing of stored water during winter or deposition of ice debris mixture as sketched in Fig. 11a (Popov, 1987; Narama et al., 2010a, 2018). We call this the deposition–freezing type of ice-tunnel closure. an ice tunnel closure that is caused by the freezing of stored water during winter or ice-debris deposition of ice-debris mixture (Fig. 11a). We call this the deposition–freezing type of ice-tunnel~~

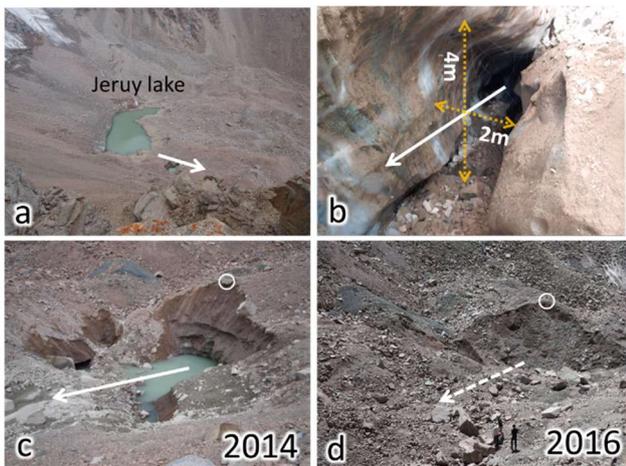
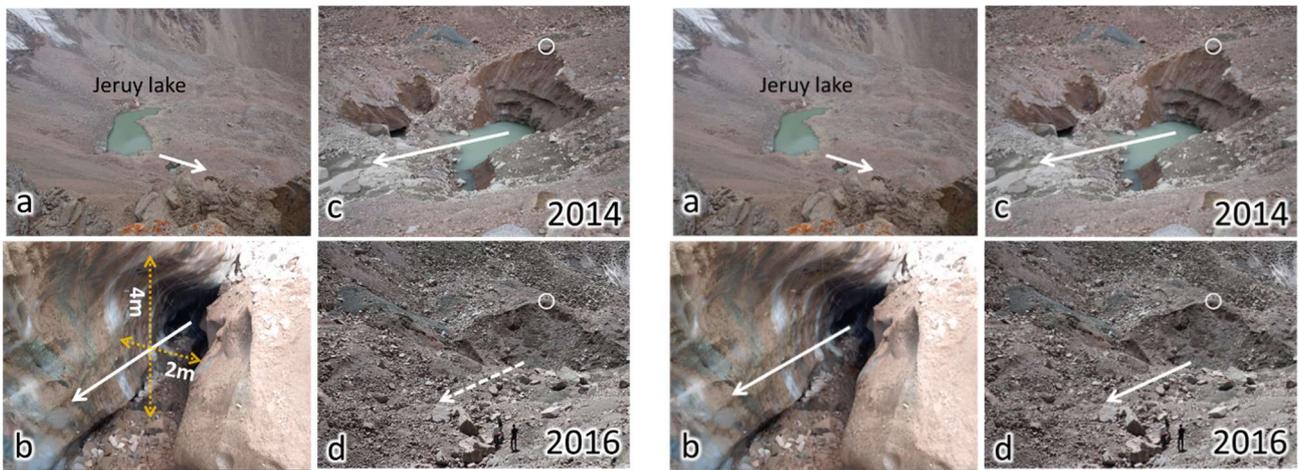
710 Figure 12: Basin and outlet ice-tunnel of Jeruy lake, which drained ~~in-on~~ on 15 August 2013. (a) Lake basin of Jeruy glacial lake on 9 August 2014. ~~The W~~white arrow shows the direction of lake drainage-flow. (b) Insight into the Outlet ~~Ice~~ice-tunnel ~~for the drainage channel~~ on 9 Aug 2014. (c) The outlet ice-tunnel area on 9 August 2014. ~~The W~~white circles in (c) and (d) shows the same location. (d) Same as (c) except on 9 August 2016.
