Water storage and drainage of short-lived lakes in the Teskey Range, Central Asia

Mirlan Daiyrov^{1,2}, Chiyuki Narama³

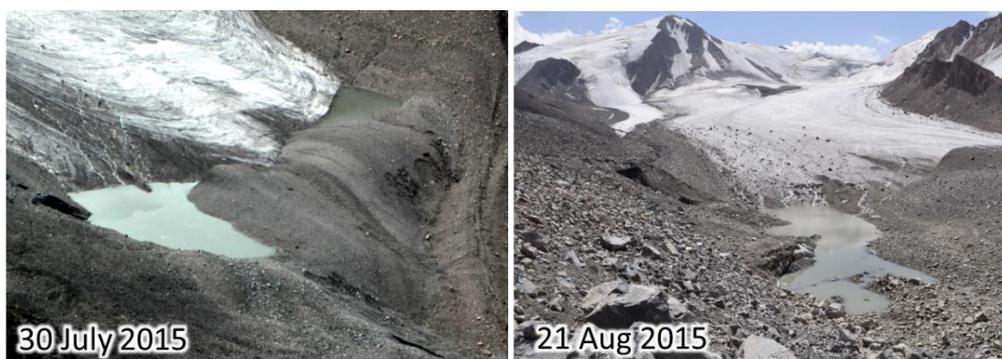
Figure 3: Korumdu glacial lake on 30 July 2015 (from a helicopter) and 21 August 2015 (from field observation).

Concerning size changes, in 2015, the lake appeared in July, becoming large on 30 July, then shrank significantly by 21 August (Fig. 3). For 2017–2019, a more complete story of the changes appears in the images in Fig. 4, which are based on PlanetScope satellite data. The images show that the lake appears suddenly at the end of July to the beginning of August and then shrinks and vanishes by the end of August (Fig. 4a–c). Although the timing of lake expansion differs slightly over the years 2017–2019, the lake always appears in summer. These satellite data demonstrate that the lake is a short-lived glacial lake.

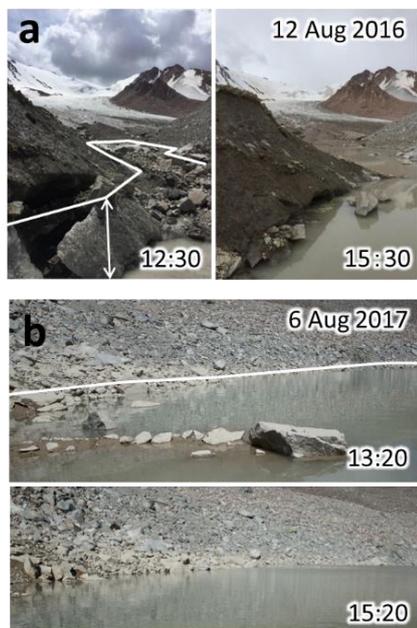
430 Figure 7: Two examples of a sudden small increase in water level. (a) On 12 August 2016. (b) Same as (a) except 3 hours later. (c) On 6 August 2017. (d) Same as (c) except 2 hours later. Images taken in the field.

Concerning fluctuations, according to the water level data for 2017–2019, the level increased with repeated storage–drainage
cycles. In the field, we observed sudden small increases of water level in 2016 and 2017, with the level increasing tens of
centimeters within 3 h (Fig. 7). These results indicate that water level fluctuations occurred frequently due to closing and
opening of the outlet ice-tunnel.
