The catastrophe of the Niedów dam – the dam break causes, development and consequences

Abstract. Due to extreme rainfalls in 2010 in the Lusatian Neisse river catchment, a flood event with a return period of over 100 years took place leading to the failure of the Niedów dam. The earth type dam was washed away with a result of a rapid release of nearly 8.5 million m³ of water volume and flooding of the downstream area with substantial material losses. The paper analyses the conditions and causes of the dam's failure, while special attention is given to the mechanism and dynamics of the compound breaching process. Several empirical formulas for the dam breach prediction are tested with regards to their usefulness in assessing breach dimensions and outflow peak discharge. The paper also describes a numerical approach to simulate the flood propagation downstream the dam with the use of a two-dimensional hydrodynamic model. Considering the specific local conditions and available data set, an iterative, reversed solution of the unsteady state problem is made. This approach enabled to deliver realistic flood propagation estimates, verification of the dam breach outflow, and several impor

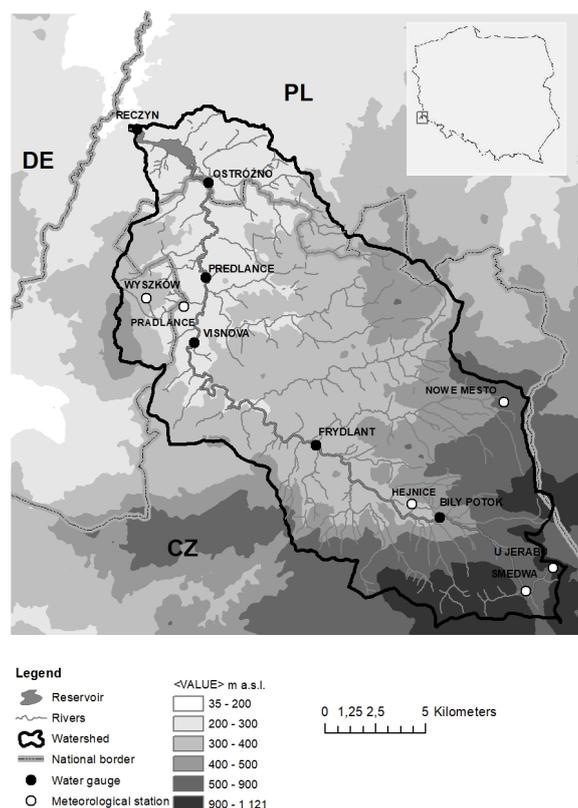
Figure 1. The catchment of the Witka river

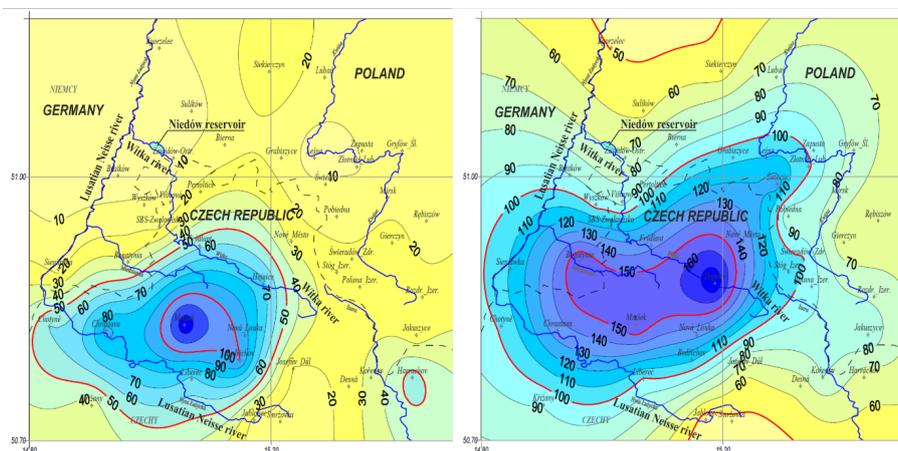
Figure 2. Rainfall values for 6.08.2010 (left) and 7.08.2010 (right) (in mm)

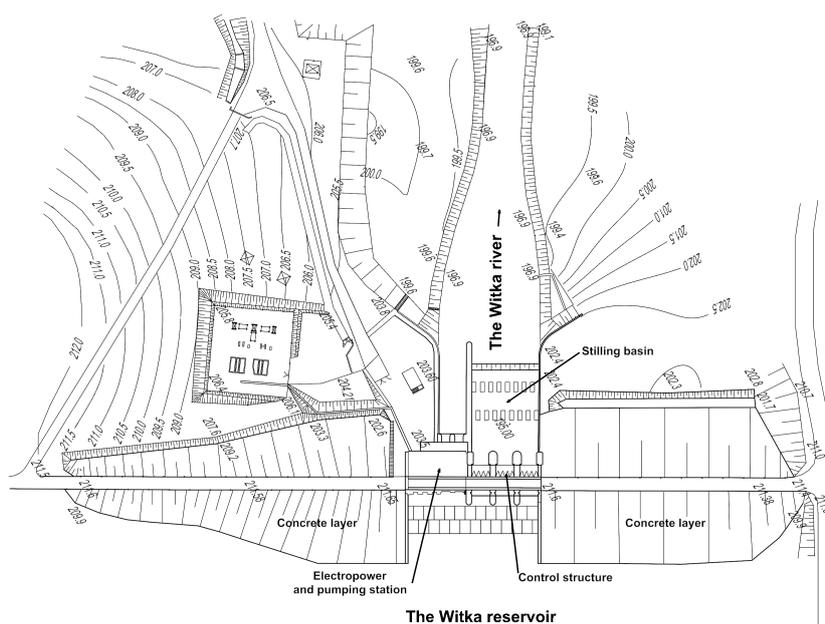
The Niedów dam consisted of three major sections: the central section with a concrete water release structure equipped with movable gates, bottom outlet and a hydropower plant, with the total length of 47.05 m. Two other sections were earth embankments on the left and right side with a length of 126 and 94 m, respectively, see Fig. 3.

Figure 3. Plan view of the Niedów Dam

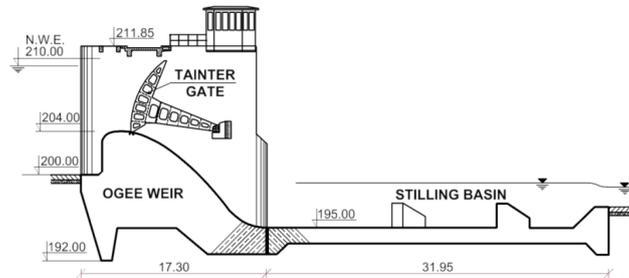
Three tainter steel gates, with a width of 6.7 m and a height of 6.6 m each, controlled the water outflow from the reservoir, see Fig. 4. The pillars contained bottom outlet openings with size of $2 \times 1 \text{ m}^2$, equipped with vertically moving flat closures.

Figure 4. Ogee weir cross-section

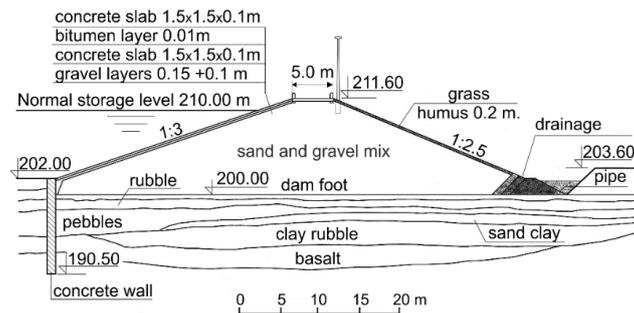
The structure and geometry of the earth dam are depicted on Fig. 5. The maximum height of the embankment in respect to the base ground level was 11.6 m. The body of the dam was well compacted sand. The slope upstream was of a ratio 1:3, while the slope downstream of 1:2.5. The total volume of earth dam was ca. $61,000 \text{ m}^3$. Because the sand had a high filtration rate of $2.8 \times 10^{-3} \text{ ms}^{-1}$, the upstream slope was shielded with a double layer of concrete slabs with dimensions of $1.5 \times 1.5 \times 0.1 \text{ m}$, sealed with a bituminous material. This shield from upstream was supported by a vertical reinforced concrete filtration screen, reaching down the basement rock. The downstream slope was covered with grass on humus. In the lower part of the slope a

drainage of mixed gravel and stone was provided. The dam crest was 5 m wide and served as a road made of concrete slabs with asphalt. The power plant and water outlet sections were connected with the dam by means of abutments.

Figure 5. Cross-section of the earth dam

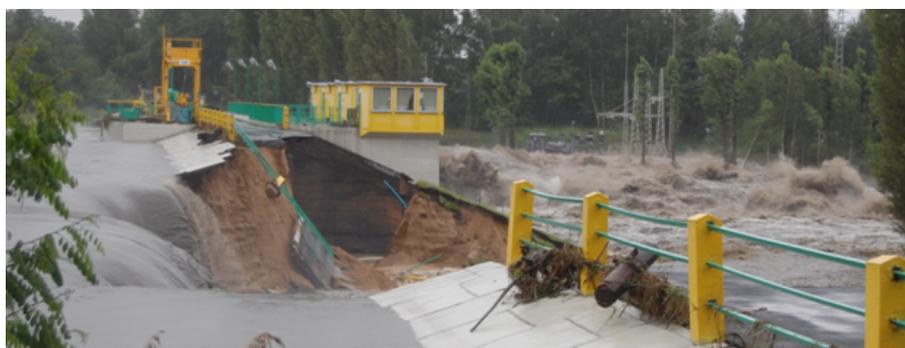
- 185 Next, another important moment took place. As the support of the earth embankment vanished, the left training wall flanking

the central concrete dam collapsed due to upstream water pressure. This resulted in a further rapid outbreak. This phase was relatively short but intense, with a result of torrential flood wave downstream documented by Fig. 6. After next 80 min. the earth dam was almost completely swept away (Fig. 7).

Figure 6. View from the right bank. Behind the concrete structure an immense outflow is visible after the abutment had collapsed. Water level in the reservoir ca. 210.60 m a.s.l.

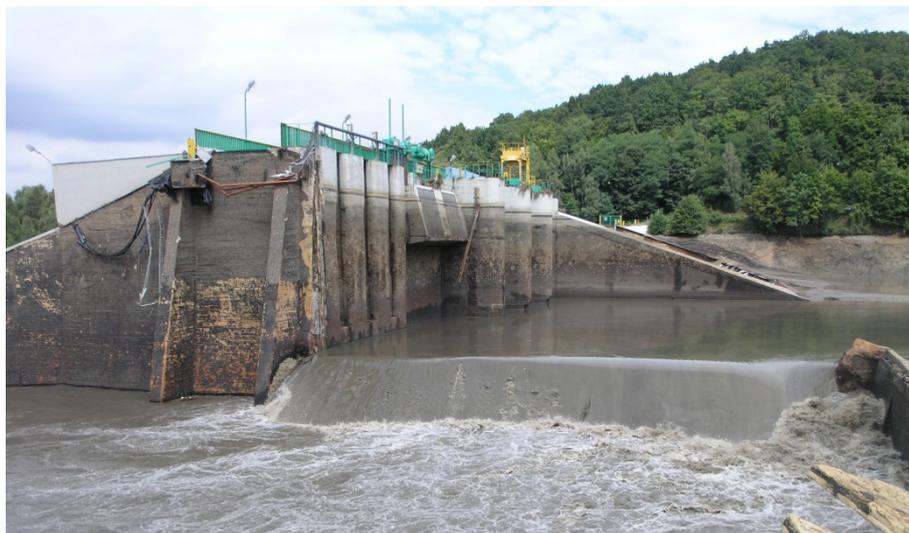
Figure 7. Broken left retaining wall of the control structure

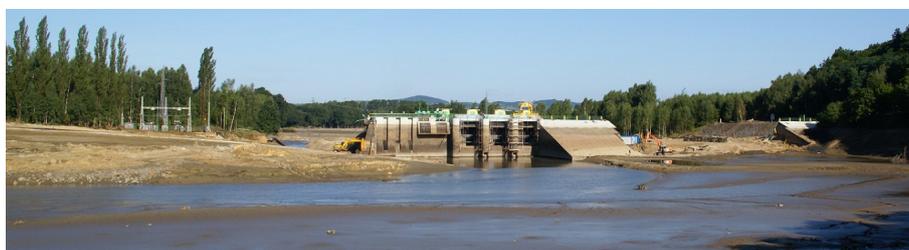
Figure 8. The final breach of the dam – an upstream view

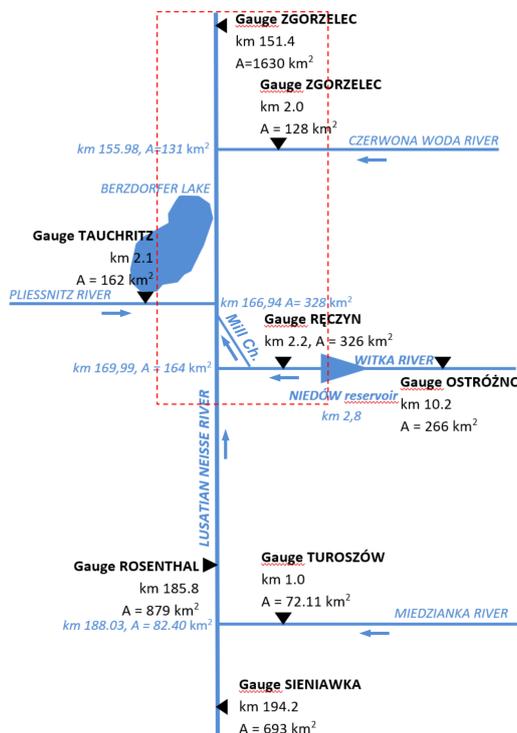
The hydrological system under concern is schematized on Fig. 9, a part of which is implemented into the 2D model. In essence, the purpose of this flood routing was balancing the inflow, outflow, and storage in the domain making use of the continuity and mass conservation principle. The unsteady state conditions were defined as follows:

Figure 9. Hydrological scheme for the modelling domain (dashed frame indicates the 2D model area)

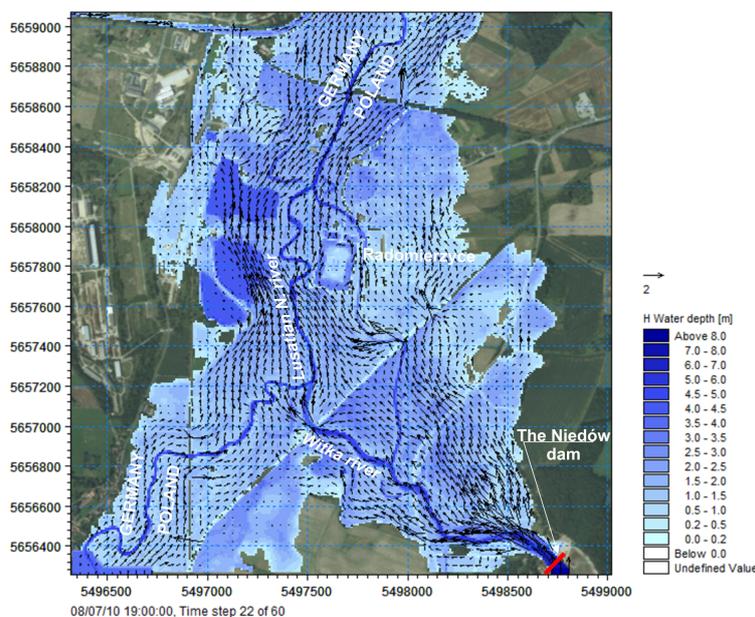
The flooding along the Lusatian Neisse in the studied reach is a combination of two major flood waves (including the catastro-
phe of the Niedów dam) at the upper boundaries (see Fig. 10) with hydrographs to be reconstructed.

Figure 10. Simulated water depths and flow velocity vectors downstream the Niedów dam

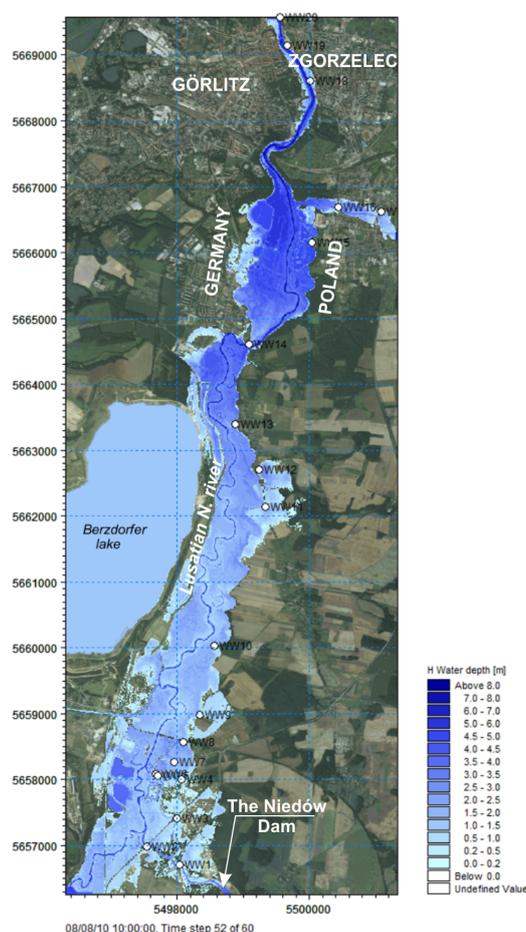
computation is considered as a consistent reconstruction of the flood in terms of water levels, flooding extend, discharge rates, timing and water volumes. The simulated water levels correspond well with the high water marks, given the complexity of the modelled domain and the inherent uncertainties; the differences are from just a few to about thirty centimeters. Remarkably, the 2D model delivered a close to reality inflow to the Berzdorfer lake due to embankment overtopping. The resulting dam breach hydrograph $Q_N(t)$ was determined with a peak discharge of $1380 \text{ m}^3\text{s}^{-1}$ appearing at 18:20, see Fig. 11. The total volume of water released due to the dam failure is 22 million m^3 , which is about 5 mln m^3 more than the inflow to the reservoir.

Figure 11. 2D simulation of the flood on the Lusatian Neisse in 2010 (WW - high water marks)

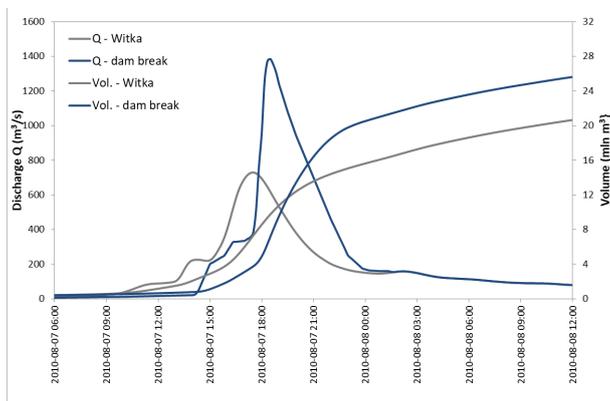
Figure 12. Hydrographs of discharge as the inflow to the reservoir and the outflow as the result of dam break determined in the course of iterative 2D modelling. Secondary axis presents the cumulated outflow volume - the final difference corresponds to the reservoir storage at normal conditions

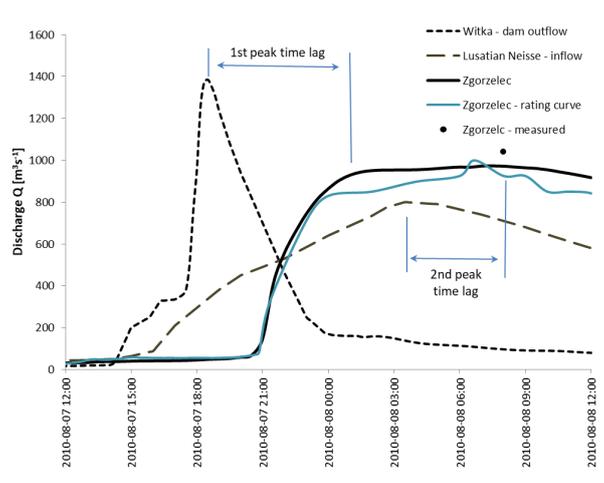
Fig. 13 presents the crucial discharge hydrographs reflecting the flood wave transformation along the river. The influence of valley retention on the flood propagation is remarkable. This retention was of about 20 mln m^3 , not counting for the Berzdorfer lake. Owing to that, there was a significant reduction of the flood peak discharge from $1730 \text{ m}^3\text{s}^{-1}$ at the cross-section near the Witka mouth (km 169.5) to $950 \text{ m}^3\text{s}^{-1}$ at the Zgorzelec gauge station (km 151.4), hence preventing larger damages in the Zgorzelec city. The Lusatian Neisse hydrograph shows two peaks – the first one is caused by the Niedów dam break, and

the second one by the flood of the Lusatian Neisse, which culminated, fortunately, about nine hours later relative to that of the Witka river. As depicted in Fig. 13, the travel time of the first flood peak, originating from the outflow from the Niedów reservoir, to the Zgorzelec gauge station was about seven hours while the second peak of the Lusatian Neisse traveled about 4.5 hours, which is reasonable, taking into account the fact that the second peak travelled over already inundated area.

Figure 13. Hydrographs of discharge for the Witka and the Lusatian Neisse river
