# Brief communication: Radar images for monitoring informal urban settlements in vulnerable zones in Lima, Peru

Luis Moya<sup>1,3</sup>, Fernando Garcia<sup>2</sup>, Carlos Gonzales<sup>1</sup>, Miguel Diaz<sup>1</sup>, Carlos Zavala<sup>1</sup>, Miguel Estrada<sup>1</sup>, Fumio Yamazaki<sup>4</sup>, Shunichi Koshimura<sup>3</sup>, Erick Mas<sup>3</sup>, and Bruno Adriano<sup>5</sup>

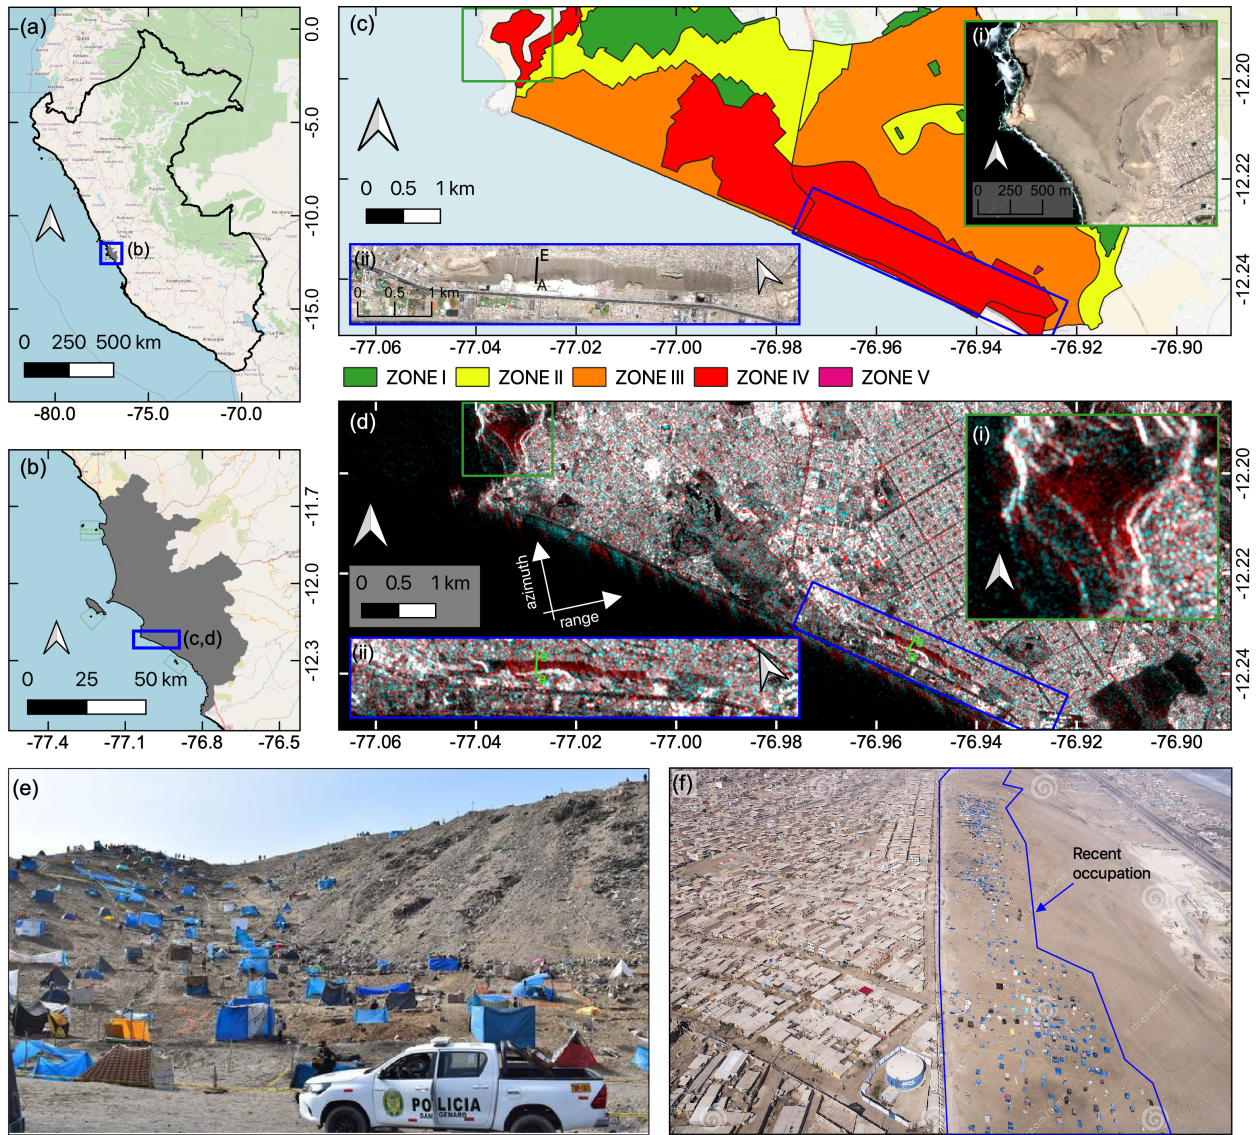
**Figure 1.** Location of the study area. (a) Location of Metropolitan Lima (blue rectangle) within Peru. (b) Location of the study area (blue rectangle) within Metropolitan Lima, which is partly located in the districts of Chorrillos and Villa el Salvador. (c) Seismic microzonation of the study area. The green rectangle denotes the location of inset (i), the Morro Solar. The blue rectangle denotes the location of the inset (ii), the Lomo de Corvina. (d) Color composite of SAR backscattering intensity images. Red band: image recorded on April 14, 2021; Green and blue band: image recorded on December 03, 2020. (e) Photograph of the squatter settlement in Morro Solar recorded by Gestion (2021). (f) Photograph of the squatter settlement in Lomo de Corvina (modified from Inga (2021)).

Lima metropolitan face very frequently critical problems regarding the illegal occupation of unused land and land trafficking. The most recent occurred in April 2021, when two large areas in the outskirts of Lima were informally occupied by citizens (Figure 1). The people who participated declared to the local news that they were affected by the pandemic and cannot afford  
35 their rents any longer. The Morro Solar, located in the Chorrillos district, was first occupied on April 5, 2021. Then, the Lomo de Corvina sector, located in Villa El Salvador District, was occupied on April 12, 2021. According to the local news, about 5000 and 3000 people occupied the Morro Solar and the Lomo de Corvina, respectively. During this sudden occupation, lots were delimited with chalk, and makeshift shelters were built with wooden sticks and plastic sheets (See Figures 1e and 1f). It is worth mentioning that the government declared the Morro Solar as an intangible area in 1977 and a historical monument in

I corresponds to the stiffest soil of the city and Zones IV and V to the most inadequate regions to be populated due to their particular bad soil conditions. In the case of Chorrillos district, it was divided into four zones, and the areas in Morro Solar are categorized as Zone IV mainly because of the steep slopes that might fail under the effect of strong motions (CISMID, 2010). Furthermore, Lomo de Corvina is also classified as Zone IV due to the existence of deep eolian sand deposits and the largest fundamental vibration period found in Lima city, which is slightly larger than 1 s (CISMID, 2011). Recent studies have shown that Lomo de Corvina might evidence important values of amplification factors due to the generation and interference of surface waves along the slope (Gonzales et al., 2019). It is worth mentioning that the collapse of the light makeshifts built during the recent invasions may not have represented an effective danger condition to the inhabitants. However, non-engineering masonry houses could have been constructed in the short term if the inhabitants were not removed. **Note, however, that the sole action of removing shelters will exacerbate the need for residence.**

Regarding the color composite SAR image shown in Figure 1c, red tones are observed in the new informal settlements, which express an increment of the backscattering in time. Such increment is originated from the double bounce scattering mechanism produced by the shelters. Figures 2b and 2c depict a scheme of the backscattering mechanism under two scenarios.

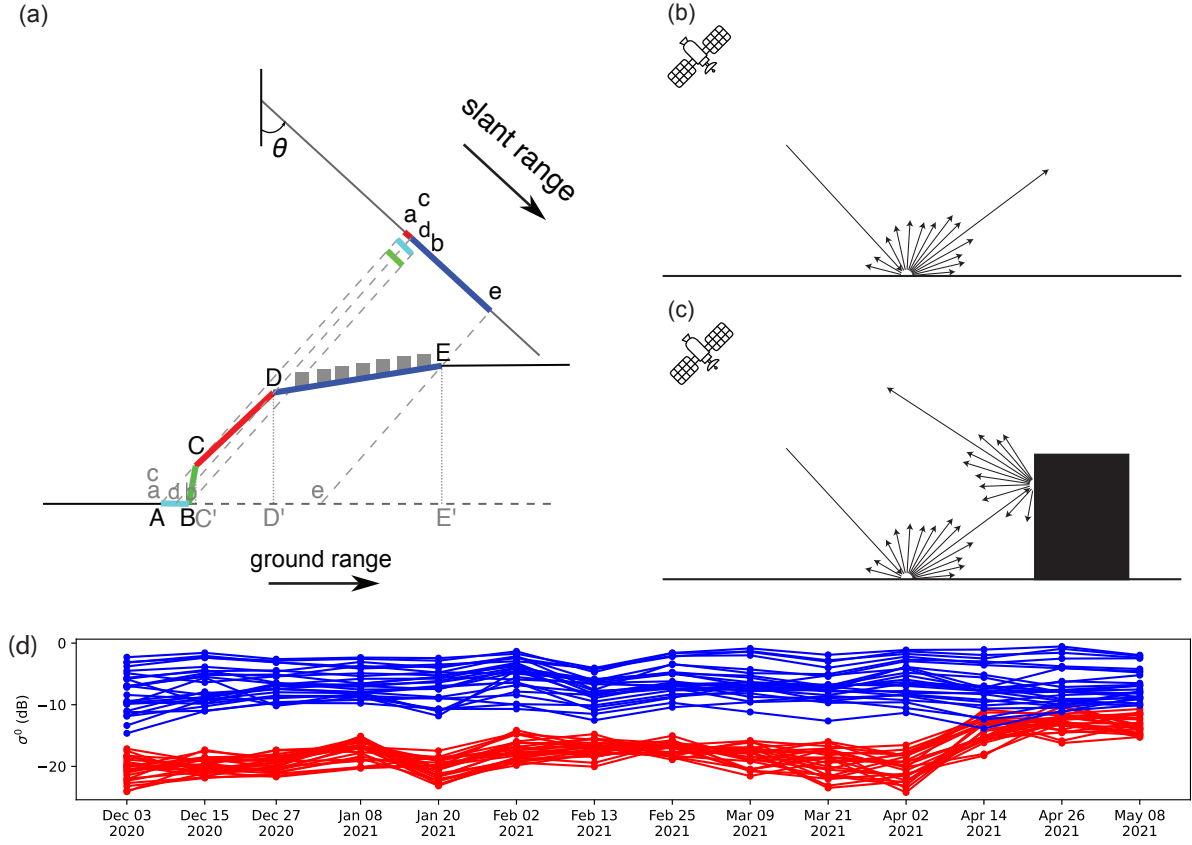
**Figure 2.** (a) Simplified scheme of the elevation profile at the line  $\overline{AE}$  in Figure 1c, inset (ii). (b) Diagram of the radar pulse,  $I_a$ , backscattered from the ground. (c) Diagram of the radar pulses backscattered from the ground,  $I_a$ , and the makeshift shelter,  $I_b$ . (d) Red lines: SAR backscattering intensity time series at some representative points of the recently invaded land in Morro Solar. The sudden increment from April 14 denotes the change of the backscatter mechanism from the mechanism shown in 2(b) to that shown in 2(c); Blue lines: SAR backscattering intensity time series at some points of an old informal settlement located close to the recently invaded land.

When the radar pulses emitted by the satellite reach a flat area, only a small fraction of the energy is backscattered to the sensor (Figure 2b). In the presence of an object (Figure 2c), the radar pulses bounce off the ground towards the object, and then it is reflected from the object to the sensor. Therefore, a larger fraction of the energy is backscattered to the sensor. In the case of the new informal settlements, such objects are indeed the makeshift shelters. We exploit this pattern to map the extent of the occupied area. Figure 2d shows the time series backscattered intensity at some representative points of the recently occupied areas (red lines) and existing built-up areas (blue lines). As expected, a clear increment is observed in the invaded area from April 14, 2021. Therefore, to map the recently occupied areas, a threshold for each pixel coordinate is computed. The threshold is set as the average plus two times the standard deviation of the time series backscattering intensity until April 2, 2021. Then,

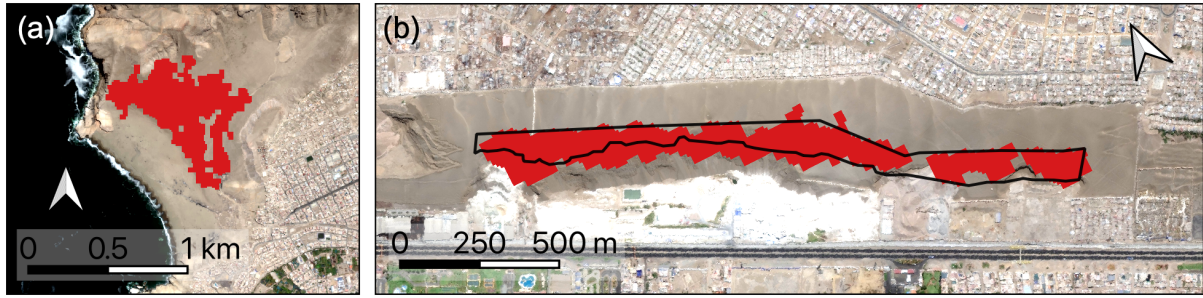
**Figure 3.** Sentinel-1 SAR-based map of the recent informal settlement in Morro Solar (a), and Lomo de Corvina (b).

if the backscatter intensity recorded on April 14, 2021, is greater than the threshold, it is assumed that the area is occupied.

95 After thresholding, the morphological operators *closing* and *opening* were applied using a kernel size of  $3 \times 3$ . Then, pixel clusters were identified, and those with sizes lower than 200 pixels were filtered out. Figure 3 depicts the extent of the invaded areas in Morro Solar and Lomo de Corvina. The black polygon shown in Figure 3b denotes the extension of the occupied area estimated from visual inspection of images recorded by an unmanned aerial vehicle (UAV). Our results from SAR images identified 84% of the area identified by visual inspection. Furthermore, only 67% of the area identified from SAR images is  
100 contained within the black polygon. We believe that the main reason for the discrepancies between SAR images' information and visual inspection lies in the complex geometric distortions in the SAR images.
