Brief communication: Radar images for monitoring informal urban settlements in vulnerable zones in Lima, Peru

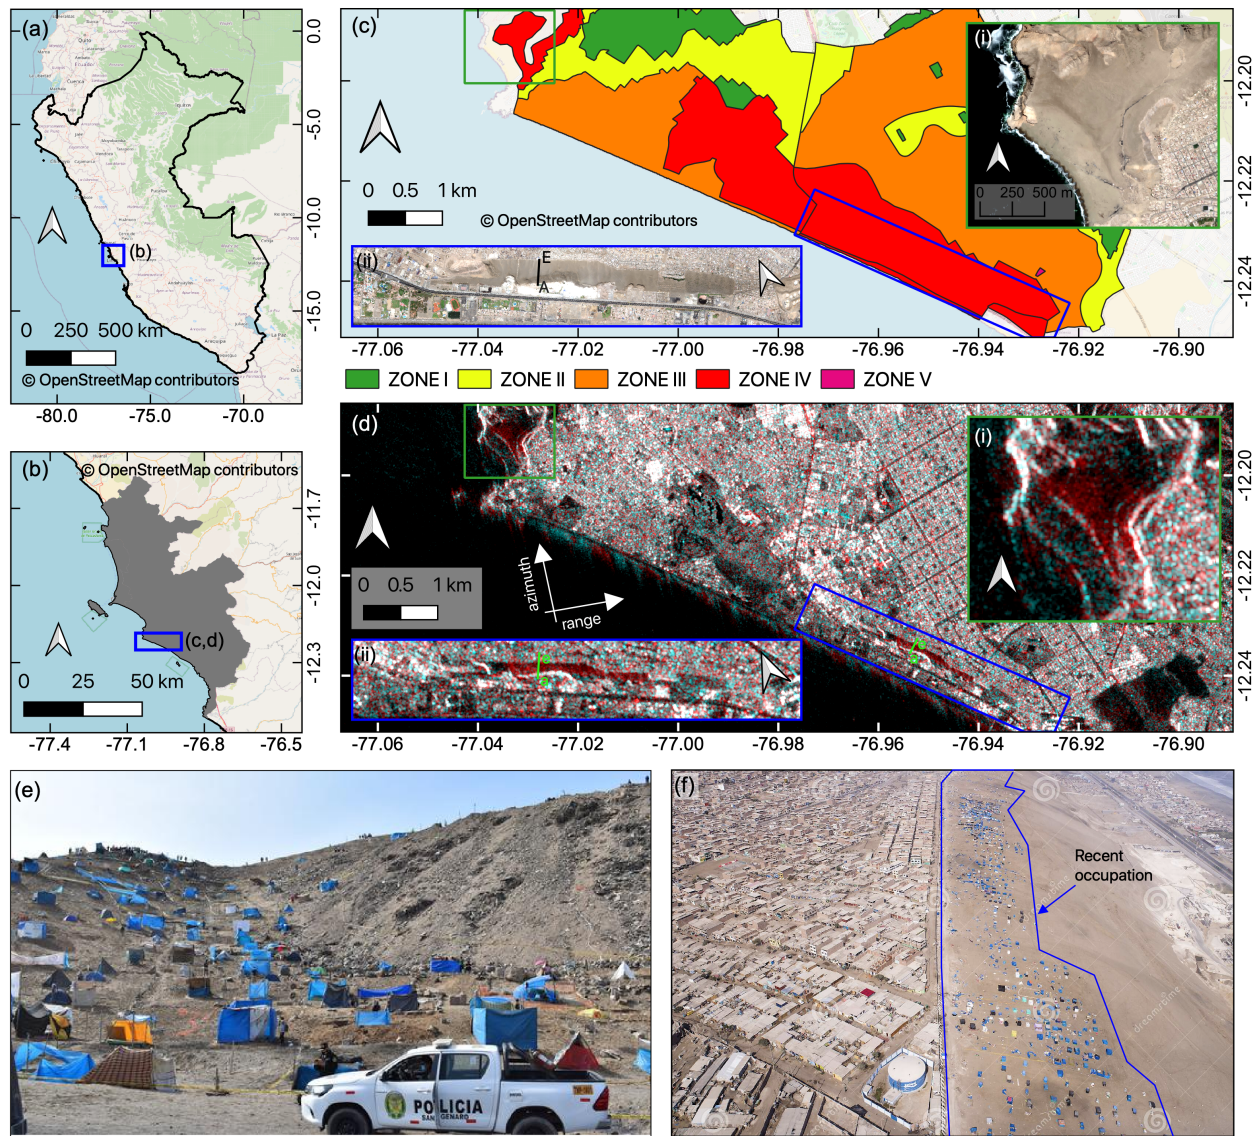
Figure 1. Location of the study area. (a) Location of Metropolitan Lima (blue rectangle) within Peru. (b) Location of the study area (blue rectangle) within Metropolitan Lima, which is partly located in the districts of Chorrillos and Villa el Salvador. (c) Seismic microzonation of the study area. The green rectangle denotes the location of inset (i), the Morro Solar. The blue rectangle denotes the location of the inset (ii), the Lomo de Corvina. Basemap of insets: MAXAR imagery. (d) Color composite of SAR backscattering intensity images. Red band: image recorded on April 14, 2021; Green and blue band: image recorded on December 03, 2020. (e) Photograph of the squatter settlement in Morro Solar recorded by Gestion (2021). (f) Photograph of the squatter settlement in Lomo de Corvina (modified from Inga (2021)).

Lima metropolitan face very frequently critical problems regarding the illegal occupation of unused land and land trafficking. The most recent occurred in April 2021, when two large areas in the outskirts of Lima were informally occupied by citizens (Figure 1). The people who participated declared to the local news that they were affected by the pandemic and cannot afford
35 their rents any longer. The Morro Solar, located in the Chorrillos district, was first occupied on April 5, 2021. Then, the Lomo de Corvina sector, located in Villa El Salvador District, was occupied on April 12, 2021. According to the local news, about 5000 and 3000 people occupied the Morro Solar and the Lomo de Corvina, respectively. During this sudden occupation, lots were delimited with chalk, and makeshift shelters were built with wooden sticks and plastic sheets (See Figures 1e and 1f). It is worth mentioning that the government declared the Morro Solar as an intangible area in 1977 and a historical monument in

particular bad soil conditions. In the case of Chorrillos district, it was divided into four zones, and the areas in Morro Solar are categorized as Zone IV mainly because of the steep slopes that might fail under the effect of strong motions (CISMID, 2010). Furthermore, Lomo de Corvina is also classified as Zone IV due to the existence of deep eolian sand deposits and the largest fundamental vibration period found in Lima city, which is slightly larger than 1 s (CISMID, 2011). Recent studies have shown that Lomo de Corvina might evidence important values of amplification factors due to the generation and interference of surface waves along the slope (Gonzales et al., 2019). It is worth mentioning that the collapse of the light makeshifts built during the recent invasions may not have represented an effective danger condition to the inhabitants. However, non-engineering masonry houses could have been constructed in the short term if the inhabitants were not removed. Note, however, that the sole action of removing shelters will exacerbate the need for residence.

Regarding the color composite SAR image shown in Figure 1c, red tones are observed in the new informal settlements, which express an increment of the backscattering in time. Such increment is originated from the double bounce scattering mechanism produced by the shelters. Figures 2b and 2c depict a scheme of the backscattering mechanism under two scenarios. When the radar pulses emitted by the satellite reach a flat area, only a small fraction of the energy is backscattered to the sensor

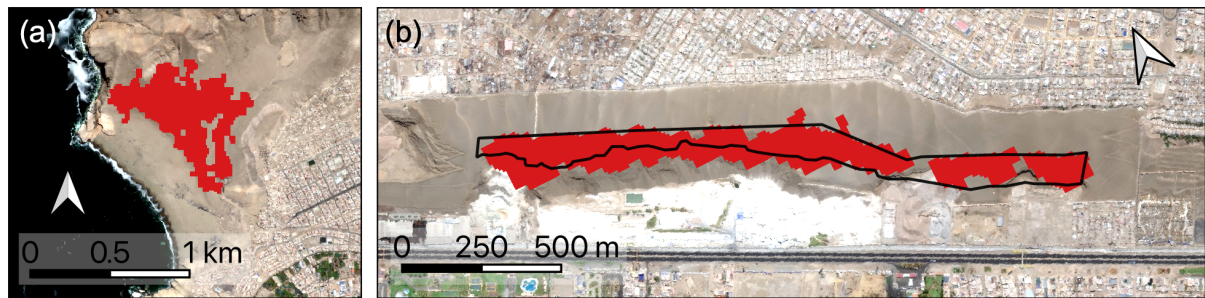
Figure 3. Sentinel-1 SAR-based map of the recent informal settlement in Morro Solar (a), and Lomo de Corvina (b). Basemaps: MAXAR imagery

After thresholding, the morphological operators *closing* and *opening* were applied using a kernel size of 3×3 . Then, pixel clusters were identified, and those with sizes lower than 200 pixels were filtered out. Figure 3 depicts the extent of the invaded areas in Morro Solar and Lomo de Corvina. The black polygon shown in Figure 3b denotes the extension of the occupied area estimated from visual inspection of images recorded by an unmanned aerial vehicle (UAV). Our results from SAR images identified 84% of the area identified by visual inspection. Furthermore, only 67% of the area identified from SAR images is contained within the black polygon. We believe that the main reason for the discrepancies between SAR images' results and that from visual inspection lies in the complex geometric distortions in the SAR images.
