Evolution of the Tazones Lighthouse slope (Cantabrian coast, N Spain). Multidisciplinary monitoring between 2018 and 2020

Abstract. The Tazones Lighthouse slope shows different active mass movements affecting an area of 70.000 m² of the Cantabrian Coast (N Spain), characterized by almost vertical rocky cliffs developed on Jurassic rocks: alternating marl, sandstone and limestone with three main stratigraphic and structural discontinuity families. Between June 2018 and May 2020, 22 monthly monitoring campaigns have been carried out to measure the displacement of 38 control points, located between 75-110 masl. The total station monitoring has been complemented by **orthophoto** analysis and detailed digital terrain models (DTM) from two drone flights. Since the beginning of the 3D monitoring, about the 50% of the markers moved more than 1 m, one of them exceeding 15 m. Detailed DTM has shown that the increased activity is controlled by the discontinuities. There is an extraordinary correlation between displacement acceleration and precipitation and soil moisture: the largest displacements have occurred after 2 periods of intense rain (January and October-November 2019, with a maximu

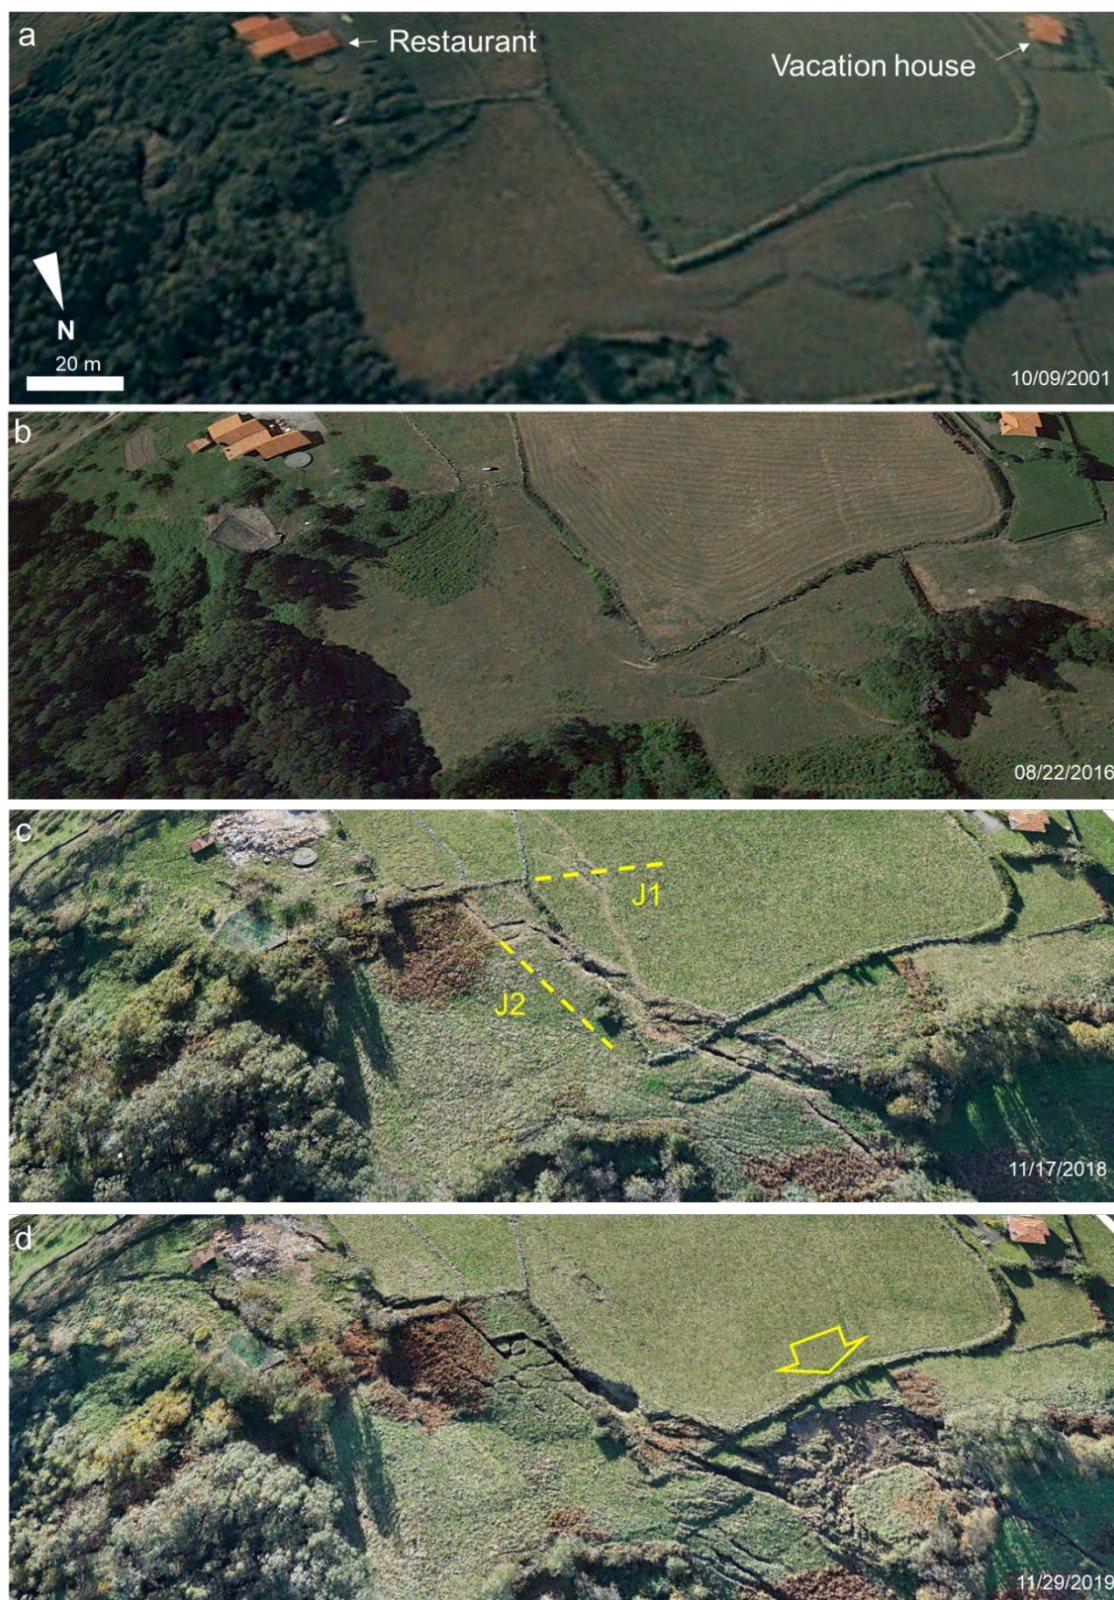
Figure 3: Tazones Lighthouse slope evolution. a. 2001. b. 2016. c. 2018. J1 and J2 family joints are indicated. d. 2019. The yellow arrow indicates a surficial planar slide. Source: a and b, © Google Earth; c and d, drone flights carried out in this research.

185 Figure 3 shows the temporal evolution of the cracks in the area. Some of them were already partially visible in the 2001 images (Fig. 3a). Even some small stretches can be intuited in old aerial photograph up to 1984 (López-Toyos et al., in press). However, although they are spatially coincident with the area of current activity, the description of jet mining galleries collapses in the area by some authors (Monte Carreño, 2004) hampers to unequivocally know the origin of these signs.

The cracks were clearly visible in 2016 (Fig. 3b), but showed a fast growing from 2018 (Fig. 3c) to 2019 (Fig. 3d), reaching a total cumulative length of about 1,000 m, a maximum width of 8 m and 10 m maximum depth. As shown by Fig. 3c, there is a close relationship between the cracks trending and the position of J1 and J2 joints families. The cracks are still presently growing, because of the activity of the slope.

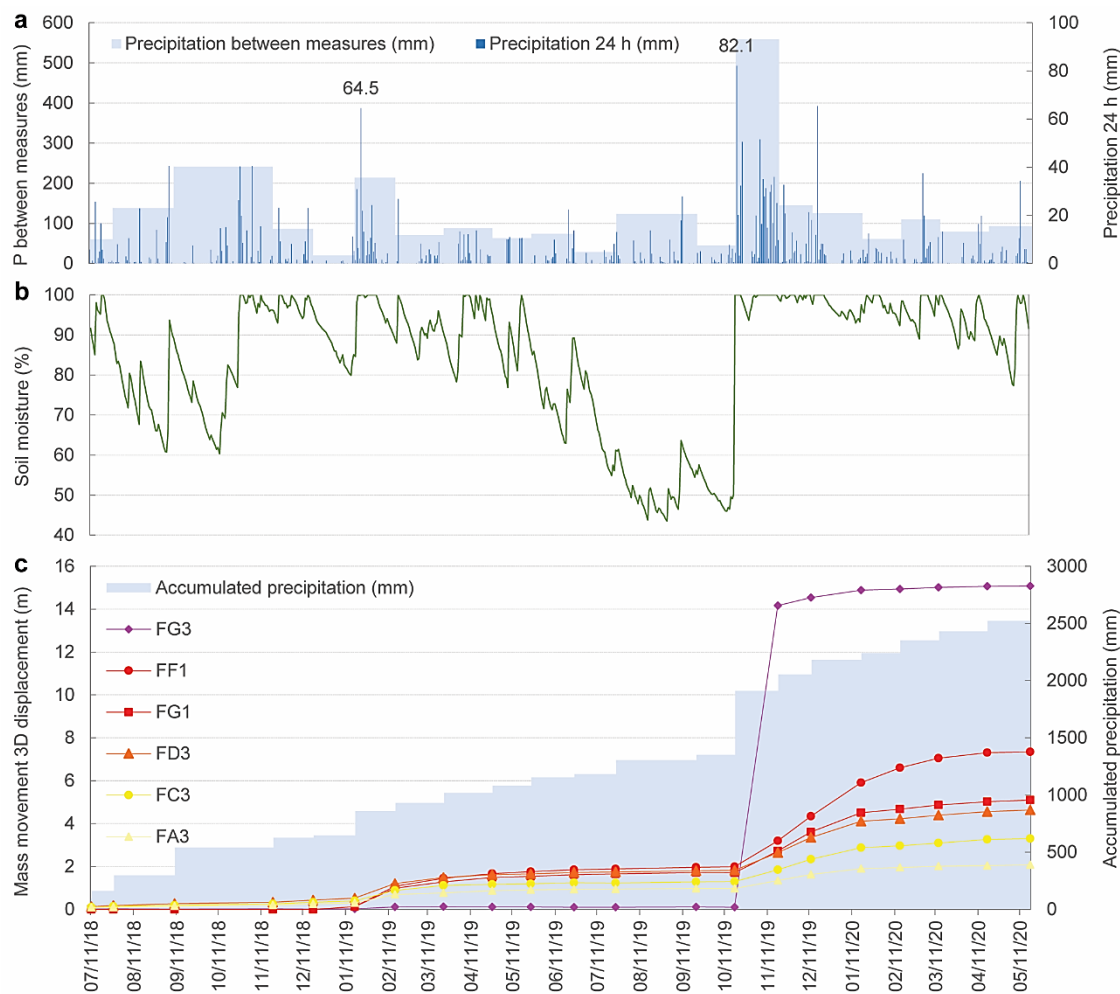
Figure 7. a. Distribution of daily rainfall vs. accumulated rainfall recorded at the Lucas-Aspo rain gauge. b. Soil moisture content evolution. c. Temporal evolution of the 3D displacement of 6 selected markers vs. accumulated rainfall.

The distribution of the precipitation registered in the AEMET Lucas-Aspo rain gauge from June 2018 to May 2020 and its relationship with the soil moisture content evolution and the displacement of six selected markers are shown in Fig. 7. Considering the variable almost monthly periodicity of the topographic control, the correlation between daily precipitation, soil moisture content and displacement cannot be addressed at a daily scale. Thus, the calculation of the precipitation between measurement campaigns (Fig. 7a) and the accumulated precipitation (Fig. 7c) has facilitated the correlation of these parameters. The periods January-February 2019 and October-November 2019 show high values of accumulated precipitation between campaigns, reaching 646 mm and 559 mm, respectively. These periods are coincident with the maxima daily rainfall values reached during the study interval: in January 22, 2019 (64.5 mm) and October 19, 2019 (82.1 mm) (Fig. 7a). Concerning the soil moisture content, this parameter shows sudden increases linked to these rainfall peaks, reaching the saturation very quickly and maintaining values above 85-90% the subsequent months (Fig. 7b). In coincidence with these periods, Fig. 7c shows two significant increases in the trend of the accumulated rainfall graph (Fig. 7c).

The comparison of the climatic series with the displacement recorded during the aforementioned periods show a good correlation between them, with a clear rise of the displacement in accordance to the rainfall and soil moisture content increases, which allows the definition of two events of acceleration of displacement (particularly in the markers FG1, FF1 or FG3). As may be seen in Fig. 7, during the periods that register the most relevant displacements, January-April 2019 and October 2019-March 2020, soil moisture content shows values above 90% most of the time.
