Evolution of the Tazones Lighthouse slope (Cantabrian coast, N Spain). Multidisciplinary monitoring between 2018 and 2020

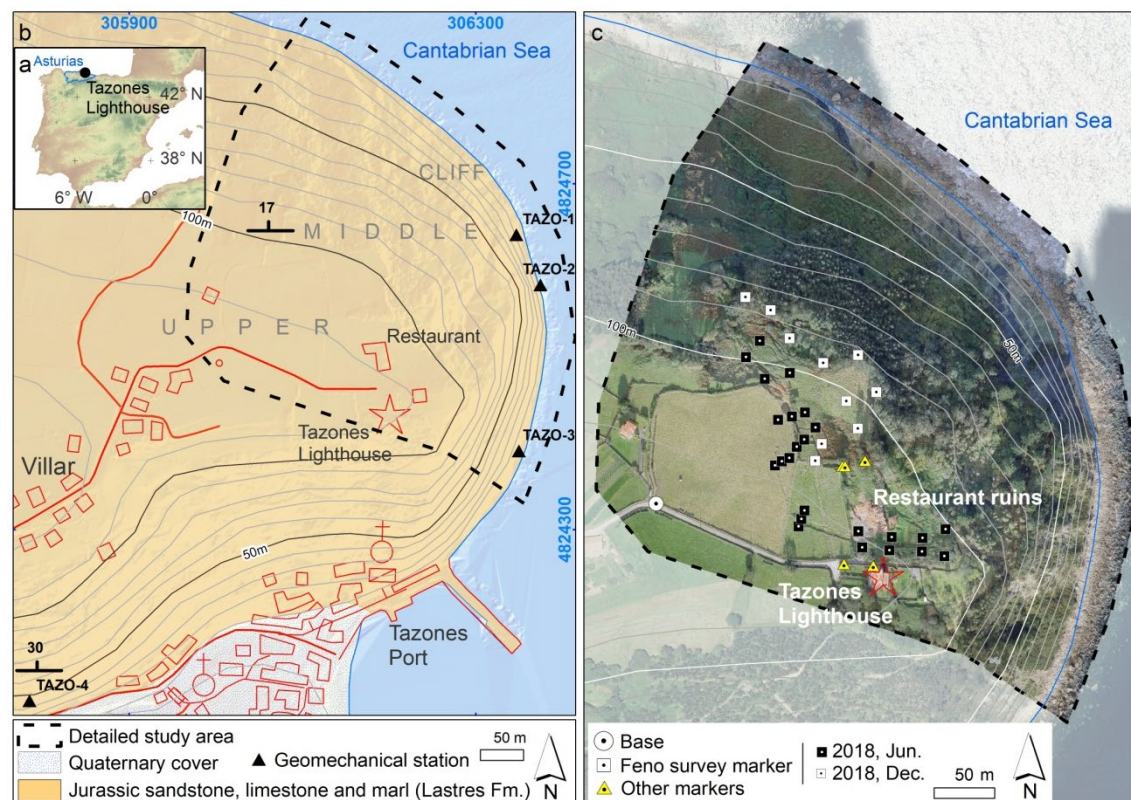
Figure 1: a. Location of the study area in the Spanish Cantabrian coast. b. Parts of the slope, geological map (Pignatelli et al. 1972) and location of the geomechanical stations. LIDAR-PNOA 2012 CC-BY 4.0 scne.es. c. Position of topographic markers. OrtoPNOA 2017 CC-BY 4.0 scne.es. UTM coordinates ETRS89 Zone 30.

The study area of the Tazones Lighthouse slope ($43^{\circ}32'54''\text{N}$, $5^{\circ}23'57''\text{W}$) includes a sector of $161,103 \text{ m}^2$ characterized by the presence of a marine terrace (rasa) located at 115 m.a.s.l. limited by almost vertical rocky cliffs developed on Jurassic rocks (Fig. 1).

The geomechanical characterization of the rock has been carried out by surveying four geomechanical stations at the foot of the cliff (Fig. 1a), which is the only accessible area where the bedrock outcrops. Moreover, an overall inspection of the cliff has been performed from a boat from the sea.

Slope displacement has been topographically monitored through 34 feno-type markers and 4 additional control points, distributed in an area of approximately 12,000 m² (Fig. 1b). Before its installation, a preliminary field reconnaissance of the area was carried out to try to ensure that their positions allowed measuring the displacement in the direction of the cracks opening. In June 2018, 24 topographic markers were installed; 10 more were added in December of that year and 2 additional ones were installed in February 2019, after the appearance of new cracks. All of them are located in the range 95-110 meters above sea level. From the first date outlined until May 2020, 22 topographic control campaigns have been carried out (the installation one, plus 21 follow-up campaigns), attempting that their periodicity was monthly, although the time intervals from one to the other range from 16 to 75 days (Table 1).

Three main areas can be distinguished according to the distribution of slopes indicated above (Fig. 1b): (i) upper area of very low slope and predominantly without movement (blue in Fig. 4a), (ii) lower area of steep slope corresponding to the cliff, also
 195 predominantly blue in Fig. 4a, except the northernmost area, and (iii) intermediate area in which forest vegetation grows and the movement of the treetops gives a false pattern of apparently generalized movement. Although herbaceous, shrub and forest

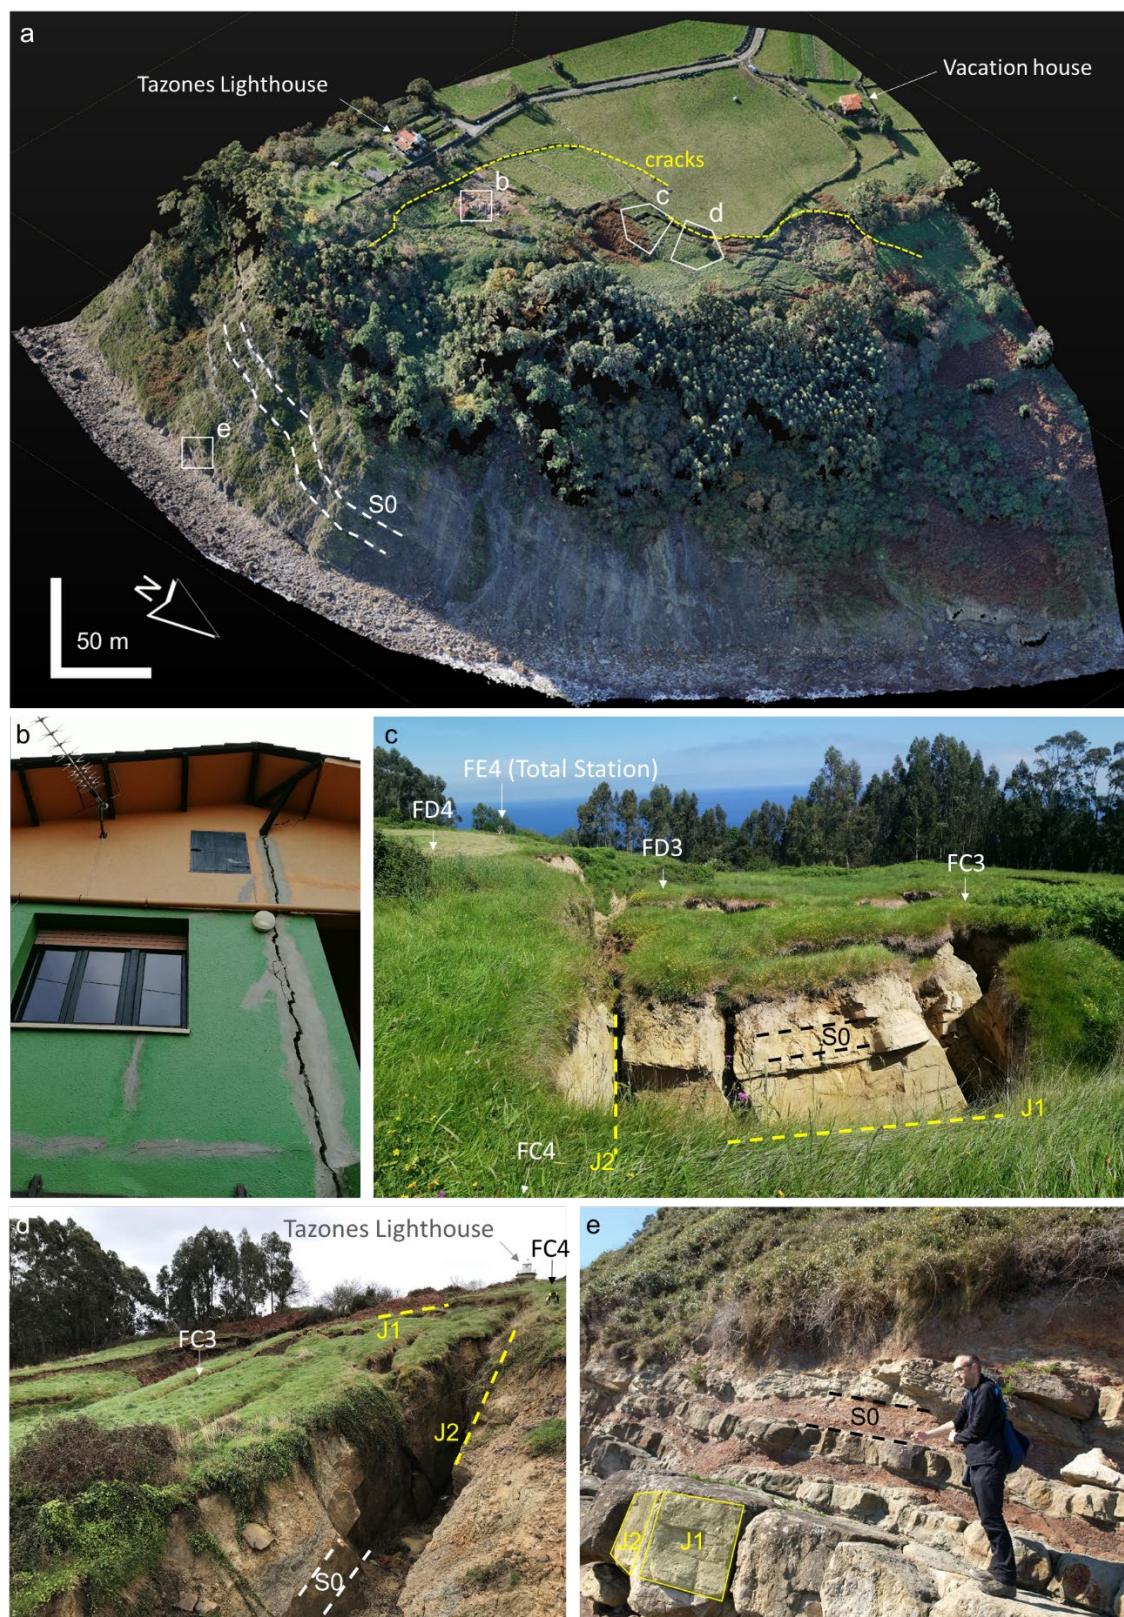
Figure 2: a. 3D view of the Tazones Lighthouse slope in the 2019 drone flight. b. Cracks in the restaurant building in 02/20/2018. The presence of cement in the wall shows the attempt to repair old cracks prior to the destructive event of February 2018. c. – d. Two views of the central part of the monitored area (FC2 - FC5 area), showing S0 and J1-J2 family joints and the position of some markers. e. Bedrock detail showing S0 and J1-J2 family joints in the bottom of the cliff.

The area is being monitored since 2018, when irreversible structural damages appeared in a restaurant building (Fig. 2a) located in the surroundings of the lighthouse because of the fast evolution of the landslide (Domínguez-Cuesta et al., 2019, 2020b; Valenzuela et al., 2019). The towns of Villar and Tazones area located in the vicinity of the study area, although outside of it. Within the studied area there were only three constructions: a vacation house, the Tazones Lighthouse and the mentioned restaurant, demolished as a result of the gravity process activity. The area is highly frequented by tourists who come to see the lighthouse and to walk a section of the Asturian coastal path that runs through the surroundings, known as the Jet Route trail-Ruta del Azabache. At the bottom of the cliff, it is also frequent the presence of fishermen or visitors who come to recognize dinosaur tracks or to take a walk.

175 In the upper part of the slope, main evidence of instability corresponds to different cracks (Fig. 2). The first evidences were recognized when the investigators came to the area, in February 2018, during the eviction of the restaurant due to the opening of the cracks that irreversibly affected the structure of the building (Fig. 2ba). It could be noticed that some of the cracks were old and other showed signs of recent activity, progressing until now. Both, the vacation house and the lighthouse are outside of the cracked area.

180 The data taken in the four geomechanical stations (Fig. 1a, Fig. 2e) have allowed geologically and geotechnically characterizing the bedrock by defining three main families of discontinuities (S0: 360/15-17; J1: 262/85; J2: 166/75), whose intersection favors the individualization of bedrock blocks. This is very evident in the central part of the monitored area, where different blocks can be recognized. Its size ranges between 3x3x6 m and 9x9x6 m, conditioned by the mentioned thickness of the Lastres Fm. layers and the spacing between the joints (Fig. 2c, d).

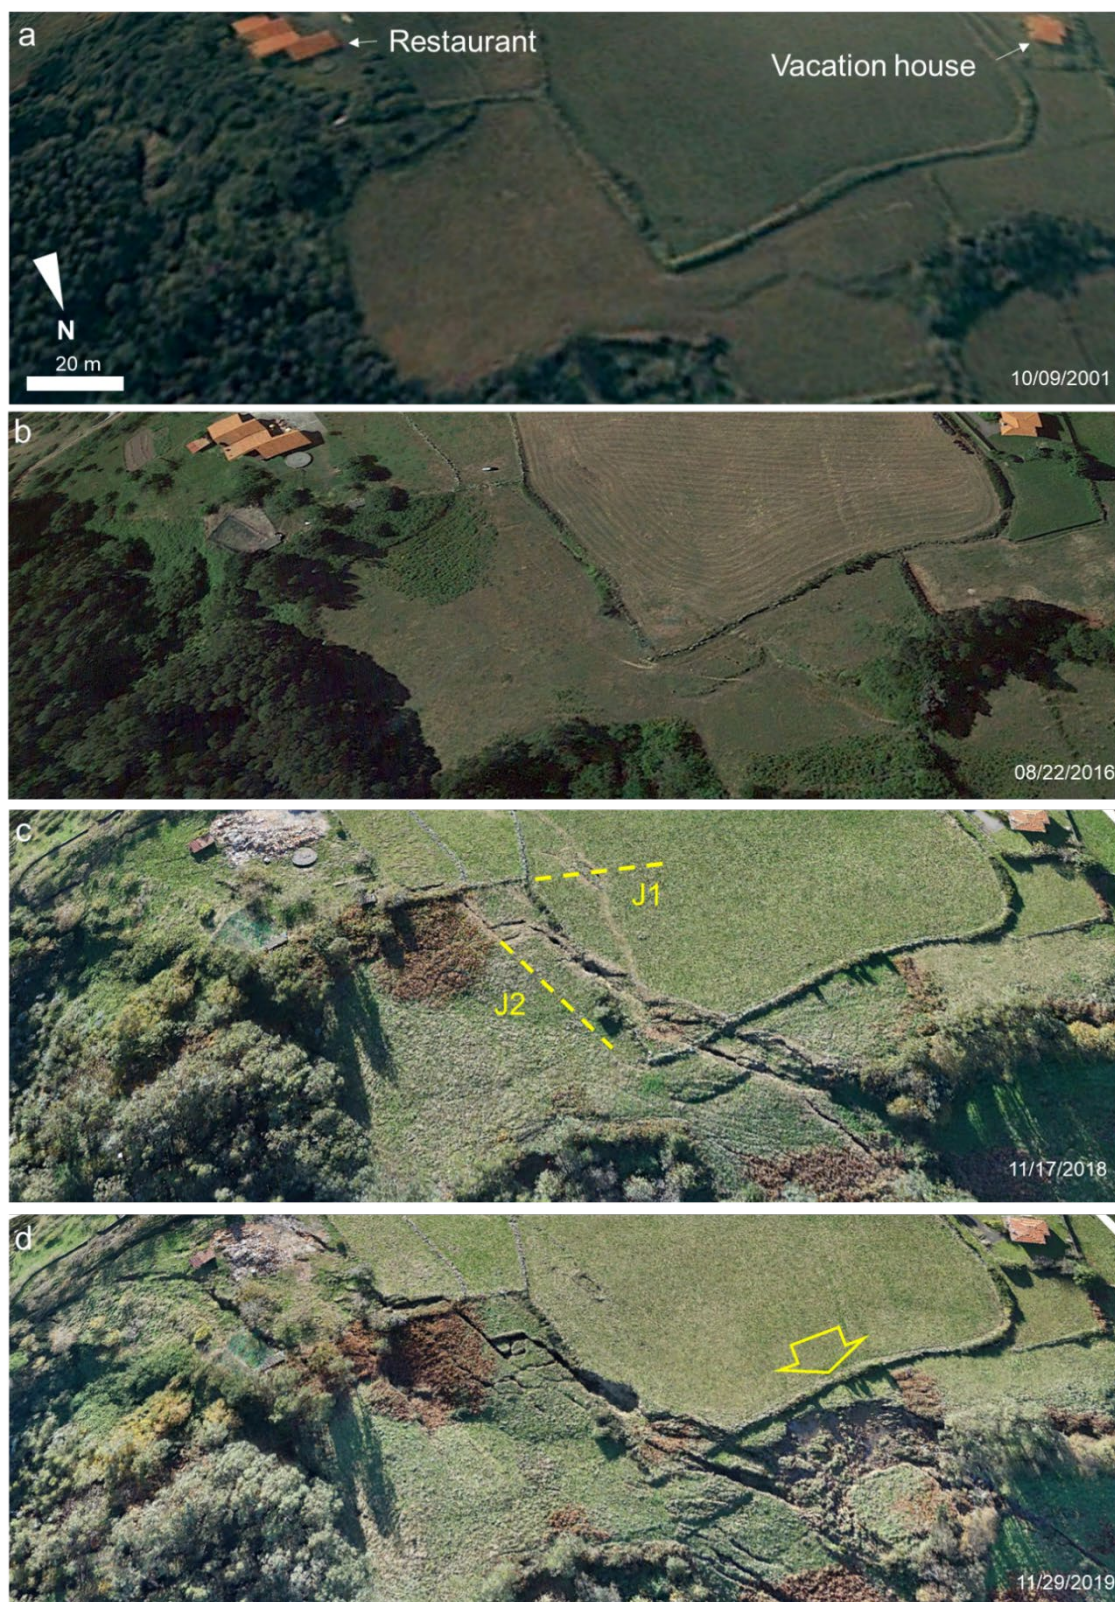
Figure 3: Tazones Lighthouse slope evolution. a. 2001. b. 2016. c. 2018. J1 and J2 family joints are indicated. d. 2019. The yellow arrow indicates a surficial planar slide. Source: a and b, © Google Earth; c and d, drone flights carried out in this research.

185 Figure 3 shows the temporal evolution of the cracks in the area. Some of them were already partially visible in the 2001 images (Fig. 3a). Even some small stretches can be intuited in old aerial photographs of up to 1984 (López-Toyos et al., in press). However, although they are spatially coincident with the area of current activity, the description of jet mining galleries collapses in the area by some authors (Monte Carreño, 2004) hampers to unequivocally know the origin of these signs.

The cracks were clearly visible in 2016 (Fig. 3b), but showed a fast growing from 2018 (Fig. 3c) to 2019 (Fig. 3d), reaching a
 190 total cumulative length of about 1,000 m, a maximum width of 8 m and 10 m maximum depth. As shown by Fig. 3c, there is a close relationship between the cracks trending and the position of J1 and J2 joints families. The cracks are still presently growing, because of the activity of the slope.

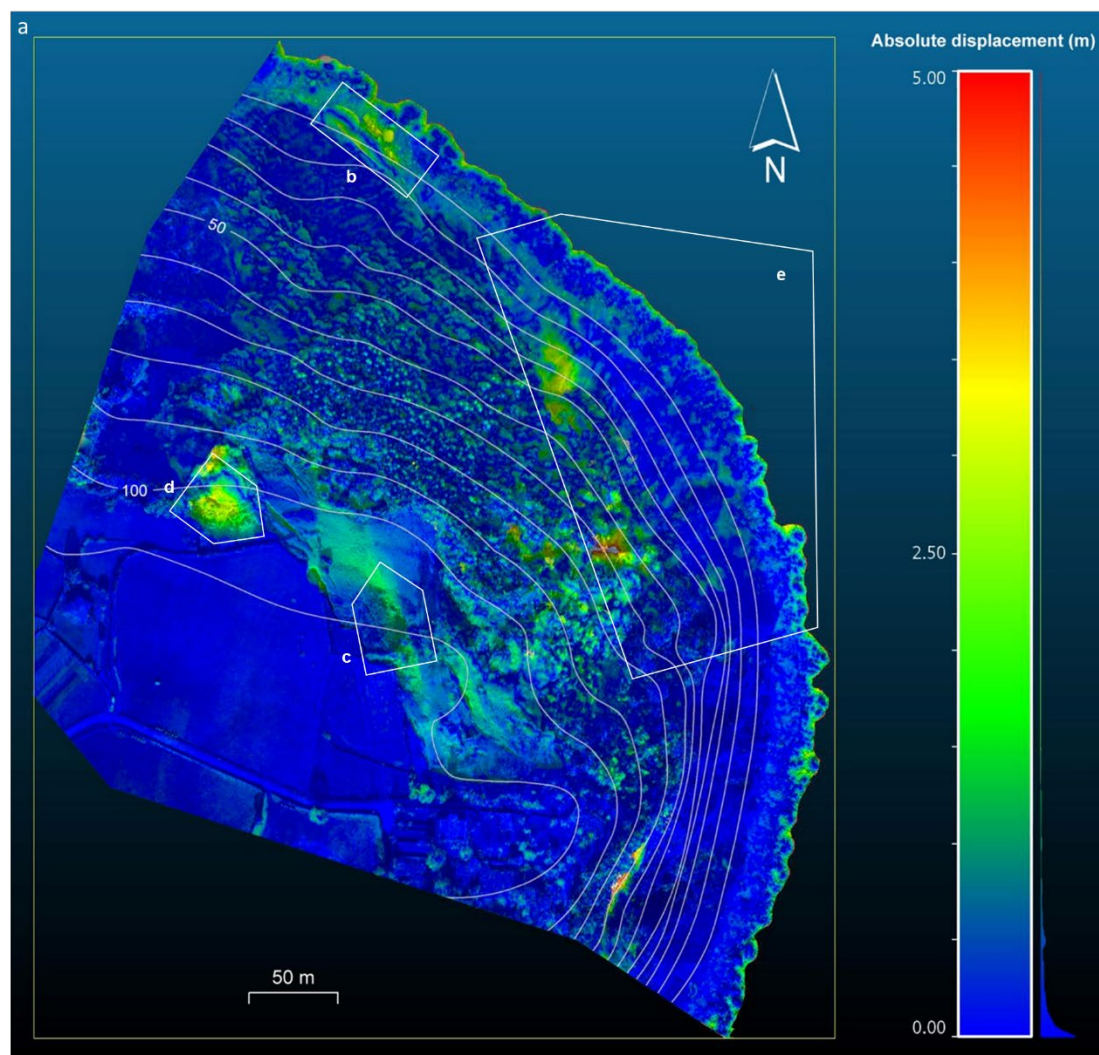
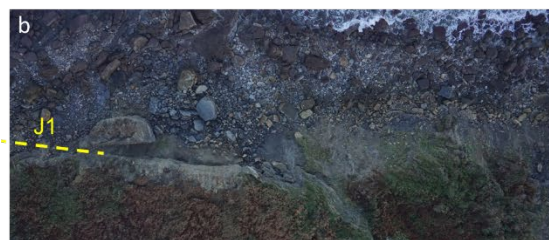
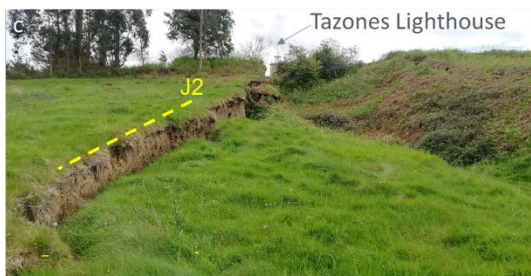
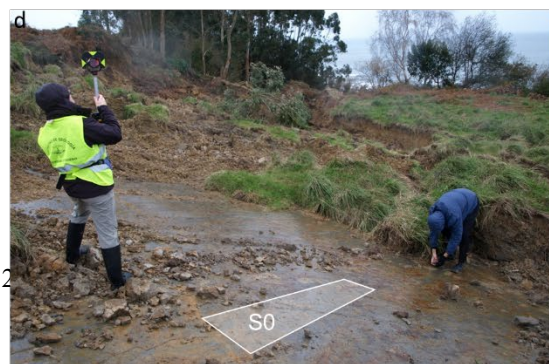
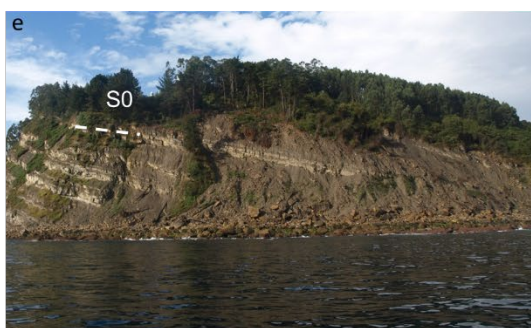
515 Figure 4: a. Surface differences between 2018 and 2019 point clouds built from Cárabo S3 aircraft drone flights. b. Detail of the foot
 of the cliff, showing an scarp that evolves by sliding and toppling. c. Surficial slide occurred in November 2019. d. Track that connects
 the Lighthouse area and the bottom of the monitored area. e. View of the cliff from the sea showing metric size block in the bottom.

vegetation, mainly eucalyptus, is profuse in this area, the field data and the comparison between the DSM carried out from the photogrammetric flights done by the Cárabo S3 aircraft in 2018 and 2019 have allowed to observe important changes occurred in some areas of the slope of the Tazones Lighthouse surroundings. Thus, the evolution of the cracks can be related to a primary planar landslide following S0 bedding and secondary movements such as flows, topples or rock fall, as has been observed in other areas of soft cliffs (Hobbs et al., 2020). Fig. 4a shows the changes in the surface of the slope and the spatial distribution of the slope instability evidence. In detail, it is possible to appreciate differences that can be attributed to the present movement of the slope, mainly in four areas: (1) the area b at the foot of the cliff, where sliding and topple processes have occurred (Fig. 4b); (2) the area c (Fig. 4c) is undergoing gradual changes since the start of monitoring, with a 100-m-long crack currently connecting the restaurant area with the lower part; (3) the westernmost part of the study area in which the presence of the sliding plane developed in November 2019 and represented in Fig. 4d, stands out; (4) the area e on the current active cliff, where evidence of sliding, rock fall and flow processes can be recognized (Fig. 4e).

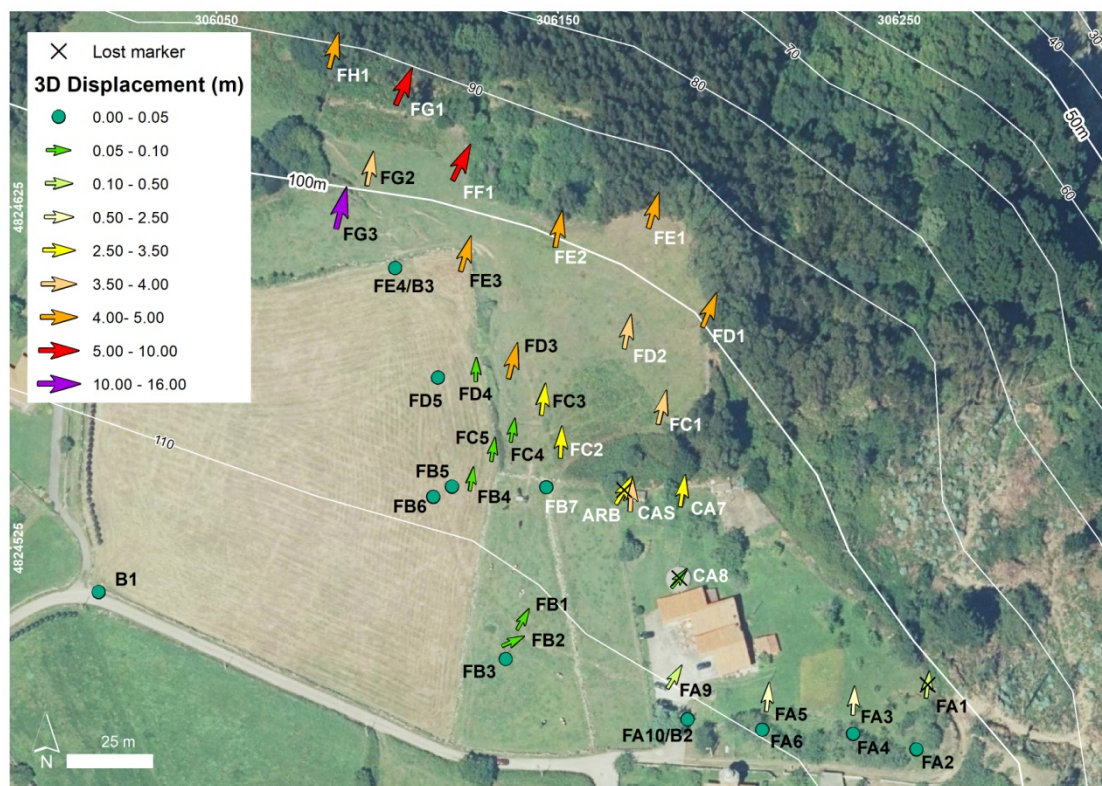
520 Figure 5: 3D displacement of the 38 markers monitored over the Tazones Lighthouse landslide from June 2018 to May 2020. White
 and black labels indicate markers of the first (June 2018) and second (December 2018) installation, respectively. OrtoPNOA 2017
 CC-BY 4.0 scene.es

245 Table 2 summarizes all data recorded regarding 3D accumulated displacement of the 38 monitored markers (Fig. 1c, Fig. 5). They are organized by ranking of the obtained displacement results and classified in 9 intervals. Some of them appear without data, as previously explained in the Methodology section. Monthly measurements in Table 2 reflect in some cases small changes (1-2 cm increment or decrement) that may be attributable to the precision of the measurement method.

The analysis of the markers displacement from June, 12 2018 to May, 18 2020 has revealed that some of them have remained
 250 almost static, while others have experienced different displacement values of 3D accumulated displacement reaching even more than 15 meters (FG3). Thus, there are 10 markers, whose 3D accumulated displacement is equal to or less than 5 cm (FA2, FA4, FA6, FA10, FB3, FB5, FB6, FB7, FD5 and FE4). These 10 markers and the areas in which they were installed are considered to have remained stable during the measurement period (Fig. 5).

The arrows in Fig. 5 show the displacement vectors together with the rank of displacement values presented in Table 2. As it can be seen, the vectors are mostly oriented to N-NNE and NE, showing the direction of the movement, which is consistent with the dip of S0 (360/15-17), described in the previous section. The evolution of the Tazones Lighthouse slope is also highly conditioned by the orientation of the coast with respect to discontinuities such as S0 and family joints, as has already been highlighted in other areas (Francioni et al., 2018). The S0 is oriented towards the coast cliff.

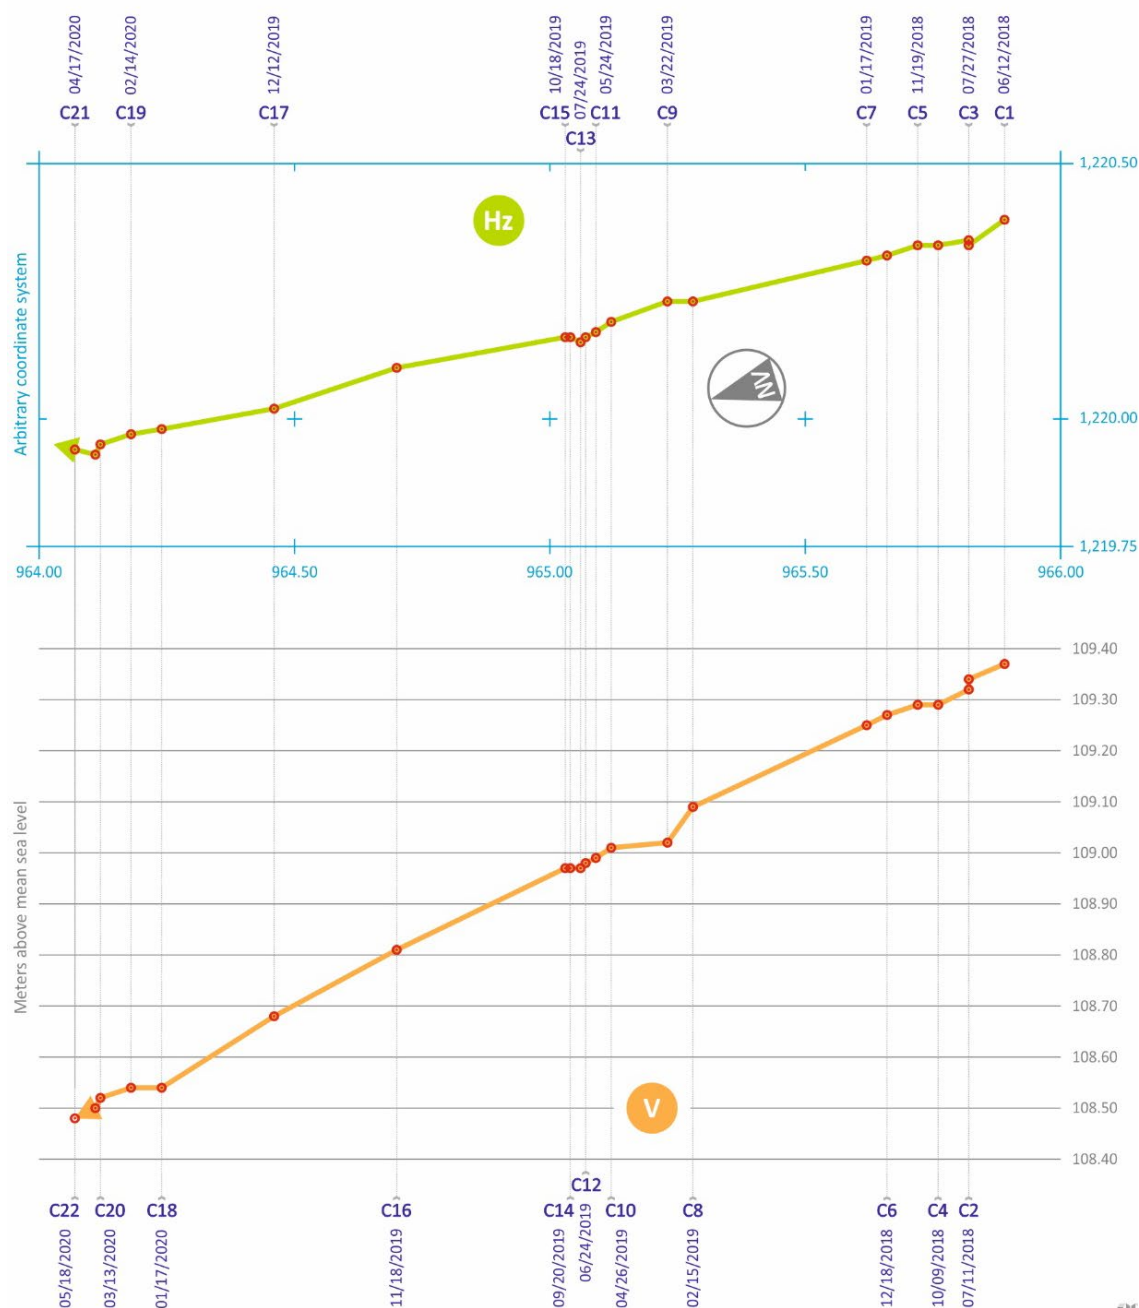
Figure 6: Time evolution of the horizontal (Hz) and vertical (V) displacement over the 22 campaigns of FA3 marker.

The temporal evolution of the displacement of one of the faster markers is presented in Fig. 6 that shows horizontal (Hz) and vertical (V) movement registered by the marker FA3. Red dots indicate the position of the marker registered in each campaign and the green/orange lines represent the inferred evolution of the movement between campaigns. The green line indicates how the movement has progressed in plan, with respect to the North; the orange one illustrates the movement with respect a horizontal plane. This marker has monthly 3D absolute displacements ranging from 1 to 38 cm, with an almost straight plan path and also a discontinuous vertical movement clearly conditioned by the S0 angle (15-17 towards the North). Thus, Fig. 6 illustrates how this marker has experienced discontinuous movement both spatially and temporally.

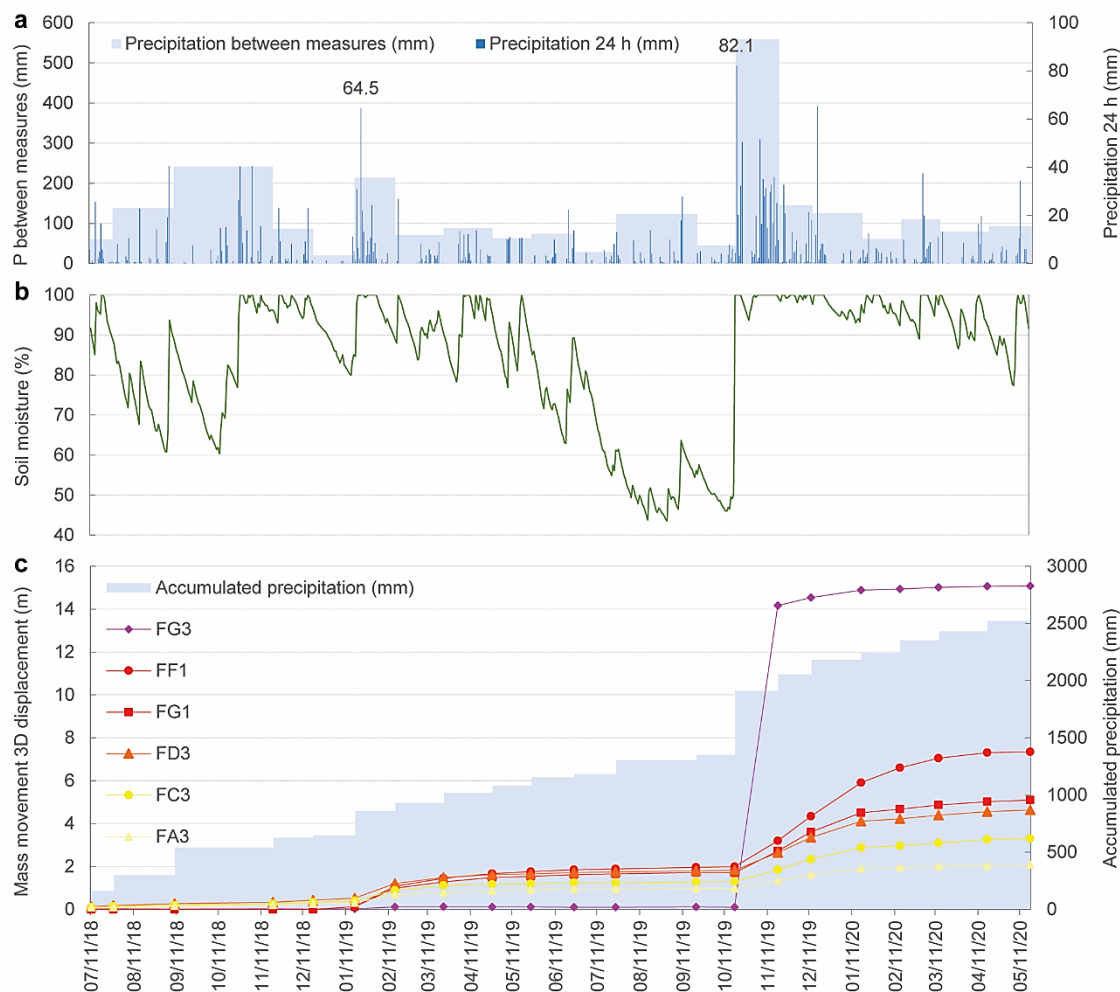
Figure 7. a. Distribution of daily rainfall vs. accumulated rainfall recorded at the Lucas-Aspo rain gauge. b. Soil moisture content evolution. c. Temporal evolution of the 3D displacement of 6 selected markers vs. accumulated rainfall.

The distribution of the precipitation registered in the AEMET Lucas-Aspo rain gauge from June 2018 to May 2020 and its relationship with the soil moisture content evolution and the displacement of six selected markers are shown in Fig. 7. Considering the variable almost monthly periodicity of the topographic control, the correlation between daily precipitation, soil moisture content and displacement cannot be addressed at a daily scale. Thus, the calculation of the precipitation between measurement campaigns (Fig. 7a) and the accumulated precipitation (Fig. 7c) has facilitated the correlation of these parameters. The periods January-February 2019 and October-November 2019 show high values of accumulated precipitation between campaigns, reaching 646 mm and 559 mm, respectively. These periods are coincident with the maxima daily rainfall values reached during the study interval: in January 22, 2019 (64.5 mm) and October 19, 2019 (82.1 mm) (Fig. 7a). Concerning the soil moisture content, this parameter shows sudden increases linked to these rainfall peaks, reaching the saturation very quickly and maintaining values above 85-90% the subsequent months (Fig. 7b). In coincidence with these periods, Fig. 7c shows two significant increases in the trend of the accumulated rainfall graph (Fig. 7c).

The comparison of the climatic series with the displacement recorded during the aforementioned periods show a good correlation between them, with a clear rise of the displacement in accordance to the rainfall and soil moisture content increases, which allows the definition of two events of acceleration of displacement (particularly in the markers FG1, FF1 or FG3). As may be seen in Fig. 7, during the periods that register the most relevant displacements, January-April 2019 and October 2019-March 2020, soil moisture content shows values above 90% most of the time.
