Deadly disasters in Southeastern South America: Flash floods and landslides of February 2022 in Petrópolis, Rio de Janeiro

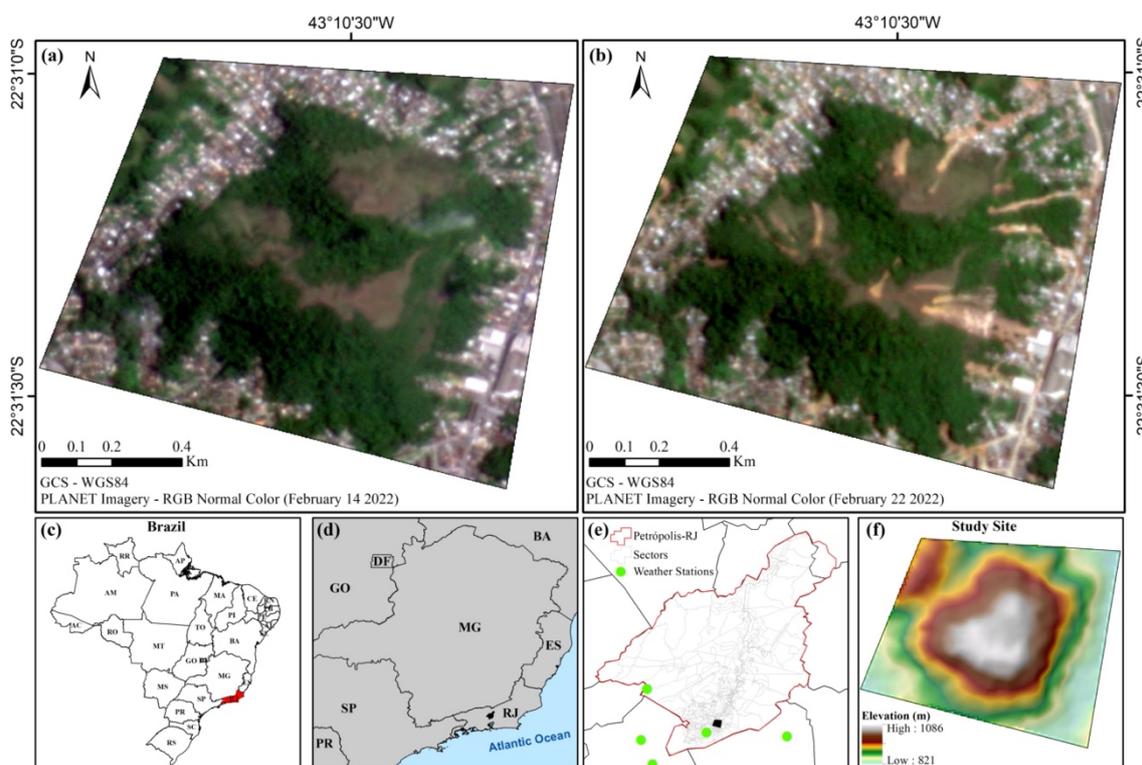
115 **Figure 1: Petrópolis and study site. (a) Planet image natural color from February 14, 2022, (b) Planet image natural color from February 22, 2022, (c) location of Rio de Janeiro State in Brazil, (d) location of study site in the Rio de Janeiro State, (e) location of study site into Petrópolis city and (f) elevation map of the study site (ALOS/PALSAR, <https://asf.alaska.edu/data-sets/sar-data-sets/alos-palsar/>). (c) – (e) were based on The Brazilian Institute of Geography and Statistics (IBGE).**

Petrópolis is located within the Atlantic Forest Biome, a biodiversity hotspot (Myers et al., 2000) (Fig 1). Only 13% of the original cover remains (Fundação SOS Mata Atlântica/INPE, 2018) due to intense deforestation and human disturbance that mostly occurred in the first half of the 19th century (Dean, 1996). Historically, land degradation in the region is associated with a combination of different geomorphic processes, deforestation overexploitation (Nehren et al., 2019), and urban expansion
110 (Guerra 1995, Rosi et al., 2019).

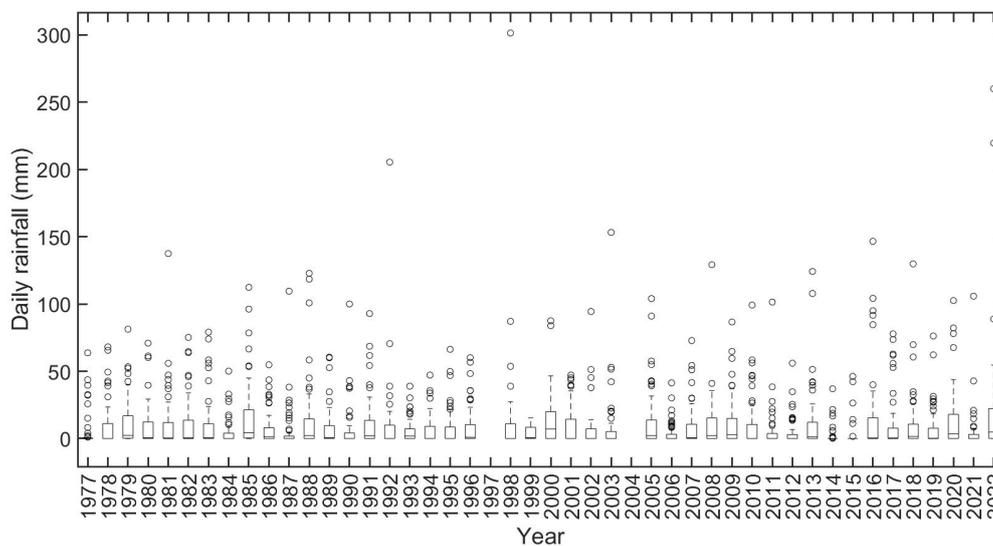
Figure 2: Boxplot of daily rainfall (mm) for the months of January and February from 1977 to 2022 (Source: Long-Term precipitation time-series from 5 weather stations, including dataset from INMET, INEA and CEMADEN).

Figure 2 shows daily rainfall distribution between January and February from 1977 to 2022. By comparing the shape of the boxplot for 2022 with the other years, the third quartile of 2022 was observed to be the biggest of the entire series (22.35mm). It indicates that in January and February 2022, 25% of the days accumulated daily precipitation large than 22.35 mm. 2022 also registered 3 outliers (circles). Compared with the other years, this number is not so expressive, but the records stand out for being abnormally large (rainfall accumulated of 88.8 mm, 219.6 mm and 260 mm in one day). In 2022, the most intense outliers also occur in greater numbers than in all other years of the series (only 4 events greater than 189.6 mm) (Figure 2). The value registered on February 15, 2022 (260 mm) is the second largest value for that month in the 46-years series.

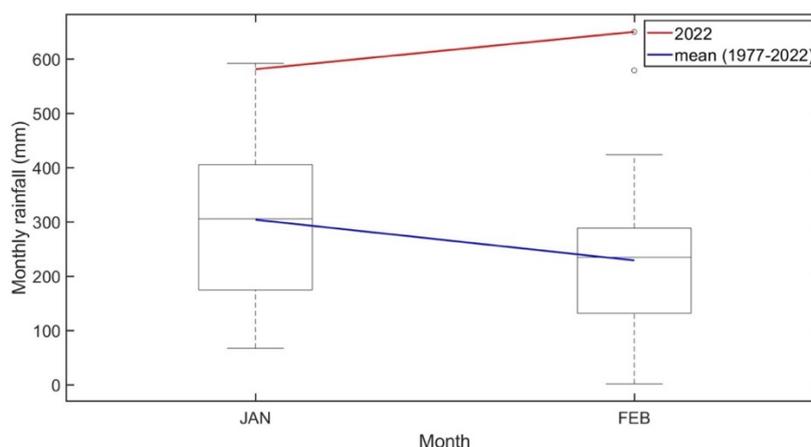
Figure 3: January and February rainfall (mm) distribution (boxplot) for 1977-2022. Blue line indicates the mean value for 1977-2022 period (for the months of January and February) and red line represents the accumulated rainfall for 2022. Circles represents outliers.

From our results, mean precipitation for the region in January is 304.19 mm while that in February is 229.28 mm (Figure 3).
 270 January 2022 registered an accumulated rainfall of 581.4mm, the second biggest value in entire series. In February, the accumulated was 650mm, the biggest value for the 46-years series and considered as outlier for the month (circle).

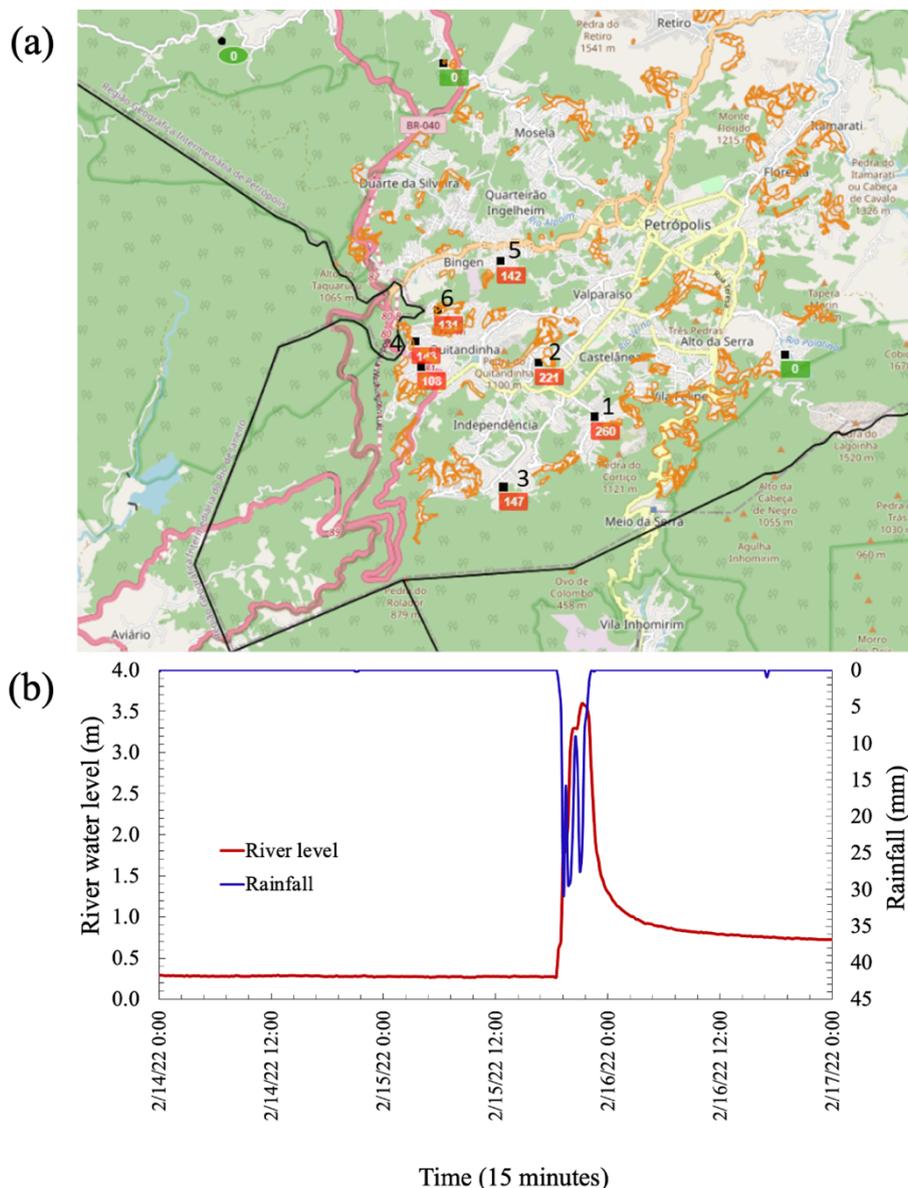
Figure 4: (a) Accumulated precipitation in 24-hours on February 15, 2022 at CEMADEN rain gauges. Orange contours correspond to areas of risk for landslides at Petrópolis. Black line indicates the municipality limit. The cartographic based was obtained from ©OpenStreetMap contributors 2022. Distributed under the Open Data Commons Open Database License (ODbL) v1.0. (b) Rainfall (blue) and river level (red) time series for February 15, 2022 time event, at Alto da Serra hydrological station (INEA).

For the February 15, 2022 event, Figure 4a depicts the spatial variability of 24-h accumulated precipitation over Petrópolis. The highest rainfall accumulation was observed at São Sebastião station (330390604G), flagged as “1” in Figure 4.

It recorded about 260 mm in 24-h and approximately 230 mm in only 3-h from 16:00 to 21:00 (local time). Another nearby
290 station Dr. Thouzet (330390603G) also registered 221 mm in 24-h (flagged as “2” in Figure 4). Station Independencia2
(330390612A), Quitandinha (330390601G), 143 mm (“4” in Figure 4), Bingen (30390605G), 142 mm (“5” in Figure 4) and
Rua Amazonas/Quitandinha (330390618A), 131 mm (“6” in Figure 4). The INEA hydrological station, Alto da Serra
(2243315) was the only one with data of this event. The peak level was 3.59 m (Figure 4b) for an accumulated rainfall of 207
mm until the peak (Total rainfall was 223 mm). The maximum peak previously registered was 2.58 m on March 18, 2013
295 (data period 2012 – 2021), for an accumulated rainfall of 186 mm. Note that heavy precipitation particularly affected the urban
part of the city where risk areas are located. Further away, over the rural part of the municipality, no rainfall was recorded.

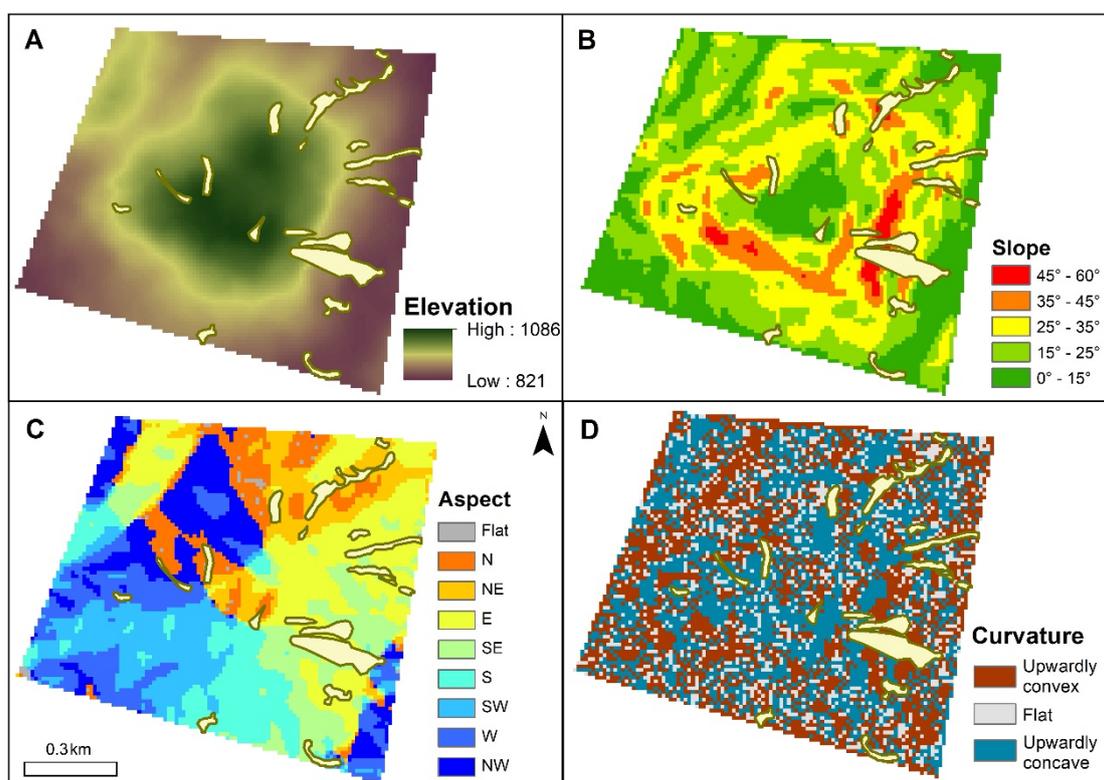
Figure 5. Distribution map of terrain attributes in the study area of Petrópolis. (A) Elevation (B) Slope (C) Aspect and (D) Curvature of Petrópolis. Light yellow polygons represent the extent of the February 2022 landslide patches.

Located in the mountainous regions, Petrópolis has a relatively high elevation. It has an average of 953.5 m elevation across
300 the study extent and ranges from 821 to 1086 m (Figure 5A).

The landslide scars were found across all elevations although most began above 950 m elevation. As for the slope morphology, the greatest slope angle recorded in this study area is approximately 60° (Figure 5B), the east-facing slopes account for the largest area (Figure 5C) and most of the slopes were either concave or convex (Figure 5D). Spatial analysis revealed that, of the 5 categories of slope angles, slope angles of 45-60° had the highest percentage of landslide occurrence with 23% (Figure 6A). There was also a distinct increasing trend in the proportion of landslide occurrences as the slope becomes steeper. This corresponds to numerous previous findings that steeper slopes increase slope instability due to greater resistance required to maintain stability (Rodríguez et al., 2008; Catani et al., 2013; Reichenbach et al., 2018). It is often one of the most important factors when assessing landslide susceptibility (Costanzo et al., 2012; Reichenbach et al., 2018). However, complementary analysis is required for the occurrence of landslides in slopes lower than 25°, as they may be associated with the execution of slopes of cuts and/or fills (Ávila et al., 2021; Mendes et al., 2018a; Mendes et al., 2018b).

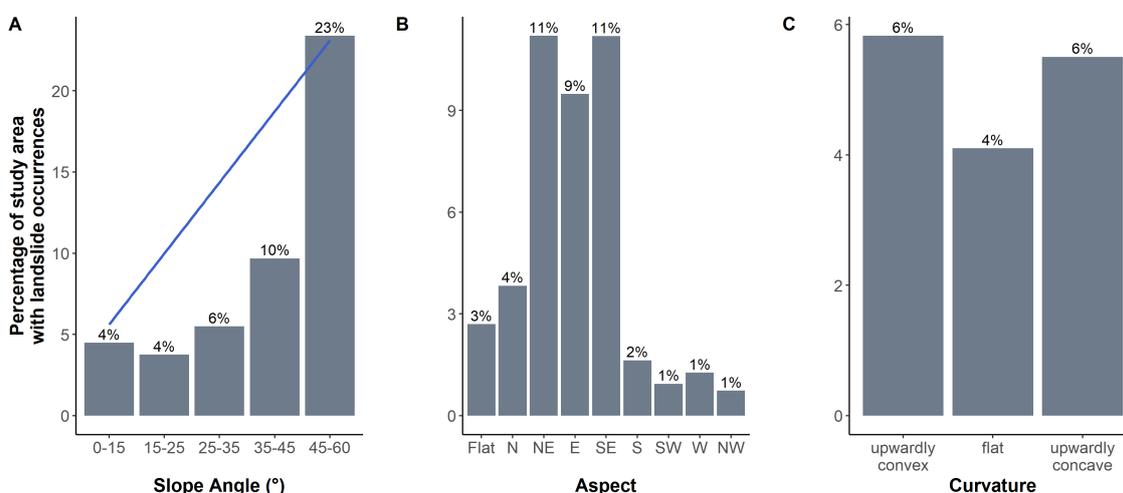
320 **Figure 6. Percentage of the landslide area in relation to the total study area, in each classification of A: Slope (blue trend line); B: Aspect, C: Curvature.**

For the aspect factor, the east-facing slopes appear to be the most conducive for landslides as they account for more than 30% of landslide occurrences (Figure 6B). Conversely, west-facing slopes had the lowest landslide occurrence with only 1% experiencing landslides. This could be attributed to multiple reasons such as the exposure of the surface to varying extent of wind and solar radiation prior to the landslide event (Guzzetti et al., 1999; Dai and Lee, 2002). This could have conditioned the soil moisture, humidity as well as vegetation growth on the slopes (Catani et al., 2013; Reichenbach et al., 2018). Vegetation growth in Petrópolis was observed to be more abundant on west-facing slopes which could have increased the slope stability

330 in that direction due to their extensive root systems. Additionally, the rainfall direction during the storm could have also favored
landslides in the eastward orientation.

In terms of slope curvature, these landslides did not appear to vary substantially between the different curvatures (Figure 6C).
While upwardly convex (negative curvature) and concave (positive curvature) slopes (6%) had a higher percentage of landslide
occurrences than flat curvatures (4%), the difference is small at about 2%. Based on the spatial analysis of the terrain
335 morphology, this Petrópolis landslide event was likely associated with the terrain morphology of the mountain even though
the trigger was induced by the intensive rainfall during the storm.

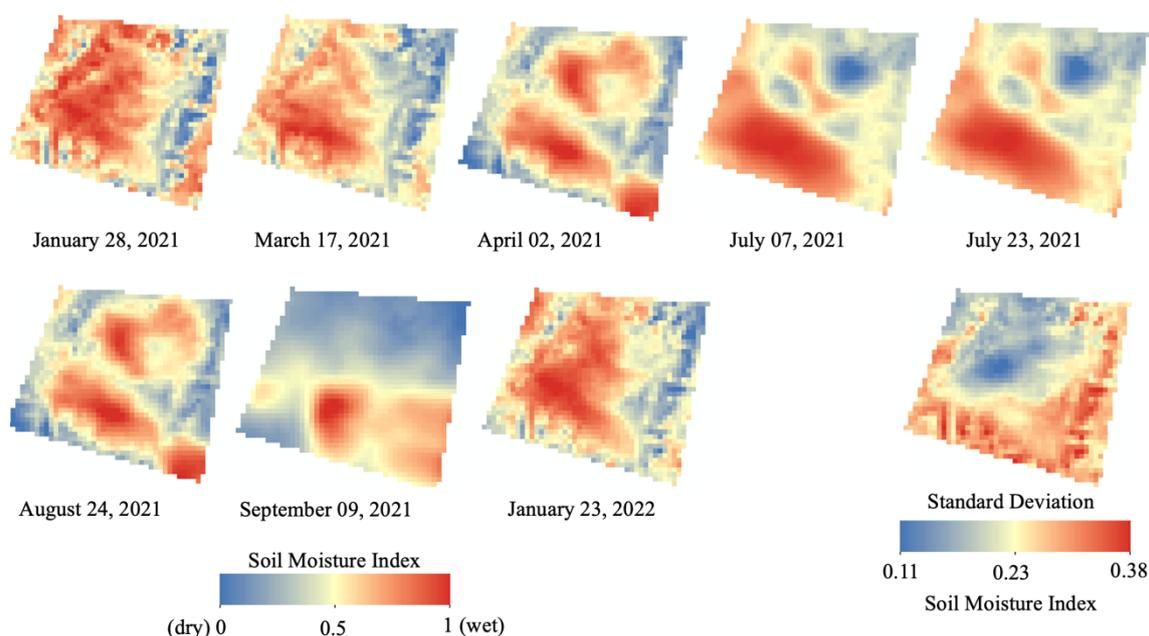
Figure 7: Soil moisture index from January 28, 2021 to January 23, 2022.

The estimation of SMI from January 2021 to January 2022 are shown in Figure 7. Values near zero represents dry soil
340 conditions and values near 1 signifies wet soil conditions. The results shows that the wet soil conditions were more frequently
in the highest altitude and dryer in the lower altitude during the summer from January 2021 to April 2021 (Compare with
Figure 5A for elevation). The soil moisture becomes higher in the south portion during the winter (July to September 2021),
mainly in the lower altitude, with one exception in August where the pattern resembles that in summer. In January 2022, the
moisture condition spread throughout the area, just like in January 2021. The spatial standard deviation image showed a higher
345 variability in lower altitude than in higher altitude. The main concentration of buildings within our study site was also found
within the region with higher moisture variability.

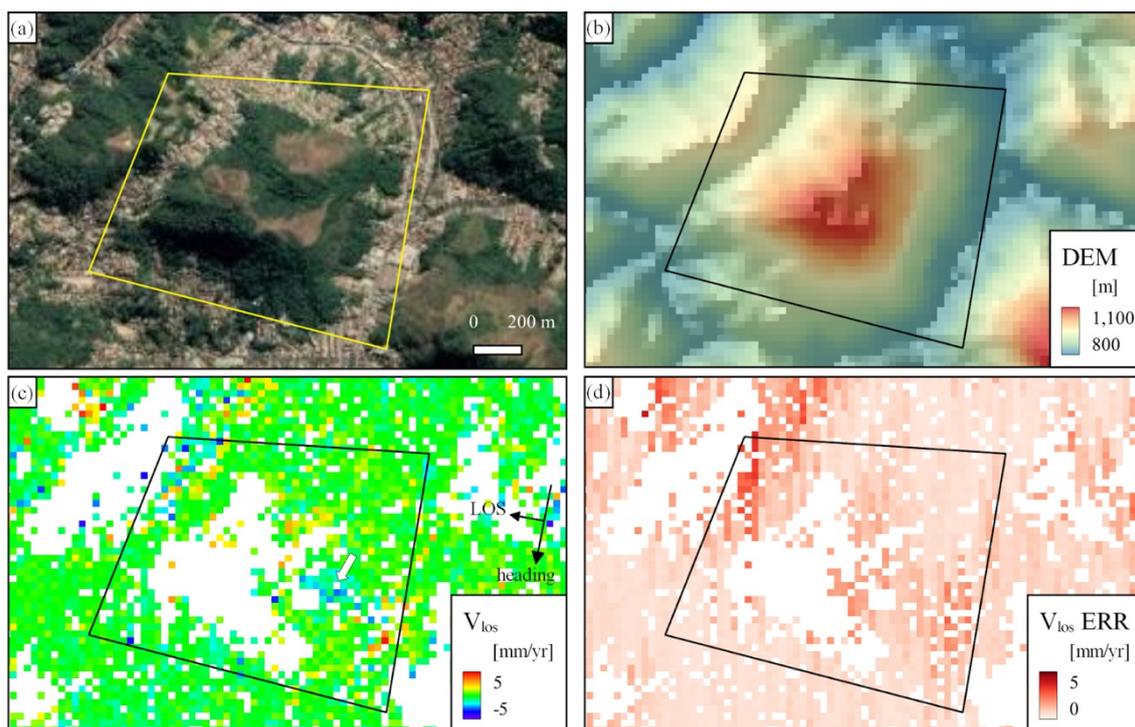
365 **Figure 8: (A) Optical image before February 2022 landslides (Image from © Google Earth Pro). (B) Digital Elevation Map (ALOS/PALSAR). (C) InSAR line-of-sight (LOS) velocity between May 8, 2015 and December 20, 2021. Note that most areas have nearly zero deformation except for the eastern slope (pointed by a white arrow). (D) Standard deviation of LOS velocity.**

InSAR time-series analysis revealed a narrow zone on the eastern slope of the study site with a continuous motion away from the satellite at a rate of 2-3 mm/yr (Fig. 8C). Given the line-of-sight (LOS) direction, the motion can be either westward or downward. Since westward motion is nearly impossible on an east-facing slope, we interpreted the motion as a continuous
355 down-slope movement with part of the downward motion (negative LOS velocity) canceled by the eastward motion (positive LOS velocity).

This interpretation means that the actual down-slope velocity needs to be larger than the LOS velocity. Considering the slope angle (about 50°-60°; see Figure 5) and the satellite angle (about 38°), the actual down-slope velocity within this zone can reach as high as 10-15 mm/yr. Other than this zone, the rest of the study site showed little ground deformation between May
360 2015 and December 2021.

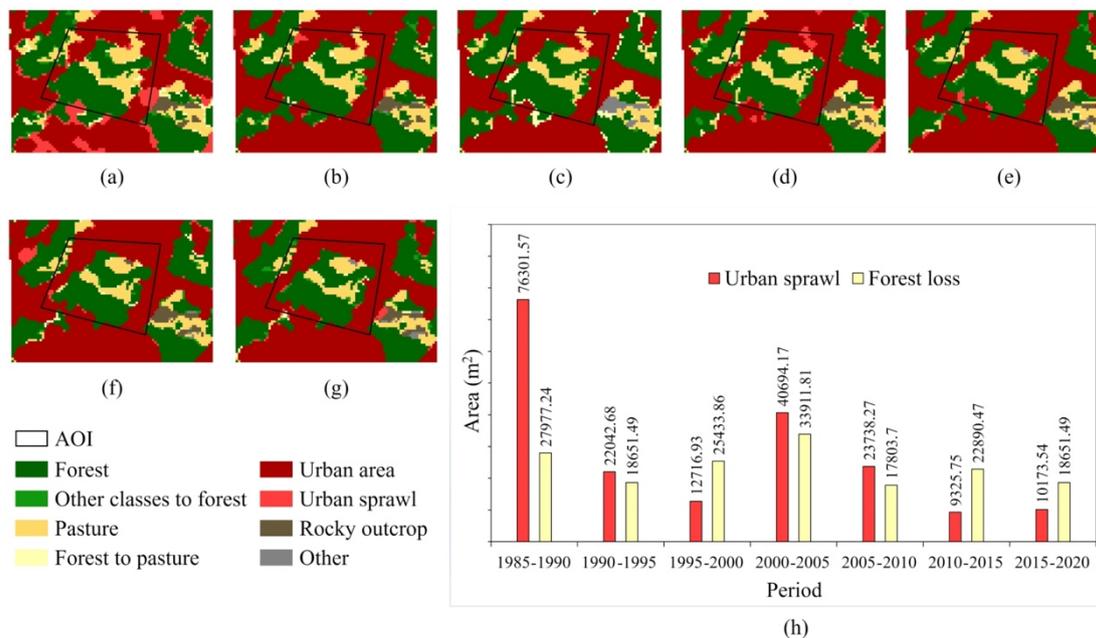
Figure 9. Transition classes for the study area: (A) 1985 – 1990, (B) 1990 – 1995, (C) 1995 – 2000, (D) 2000 – 2005, (E) 2005 – 2010, (F) 2010 – 2015, (G) 2015 – 2020 and (H) area (m²) of urban sprawl and forest loss over the analysed period.

In Petrópolis municipality, forest cover has historically been replaced mostly by pasture and agriculture (3.38%), followed by urbanization (0.77%). Looking closer to the study area, forest loss has been constant all over the study interval reaching about 16.6 ha by 2020 (Figure 9 and Table 3). When the urban expansion data for the study area is observed (Fig. 9 and Table 3), it is verified that this study area reflects the data presented for the municipality, with an increase in the urban area over the periods and a greater urban expansion for the period of 1985 to 1990. The urban sprawl can be seen in Figure 9, which presents the transition information between classes for the study area.

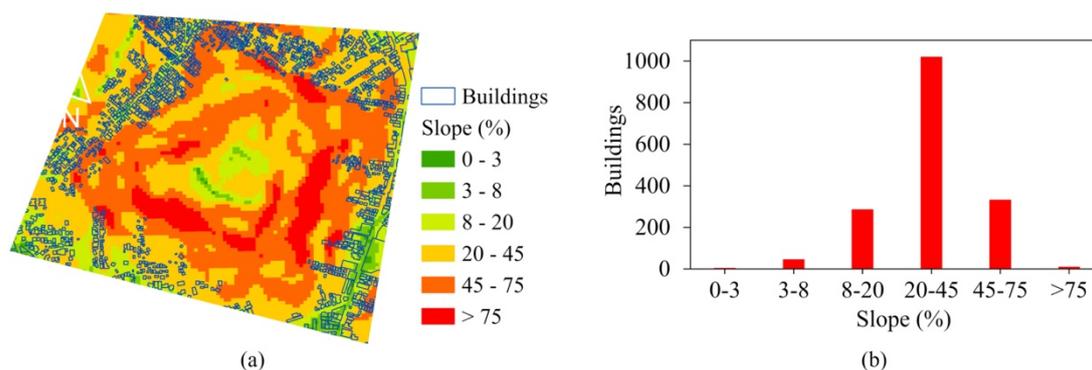
405 **Figure 10: Building footprints and slope in the area of interest (A) and (B) number of buildings per slope intervals.**

For the study area, approximately 1700 buildings that occupy the area around the hill were counted. When the buildings were confronted with landslide scars, it was found that at least 60 houses were affected by landslides. Due to the characteristics of the relief in the region, occupation on hillside areas is very common. Most of them (1021 buildings) are on the slope range of 20 to 45% (Figure 10). It was observed that 343 buildings occupy areas with slopes above 45%, which are considered
400 Permanent Preservation Areas, according to the Brazilian Environmental Legislations (Law nº 12.651/2012) (Brasil, 2012). Considering the use and occupation of the study area, further stability analysis is recommended to verify the possibility of variation in the safety factor of the slopes due to the execution of slopes of cuts and fills (Mendes et al., 2018a; Mendes et al., 2018b).

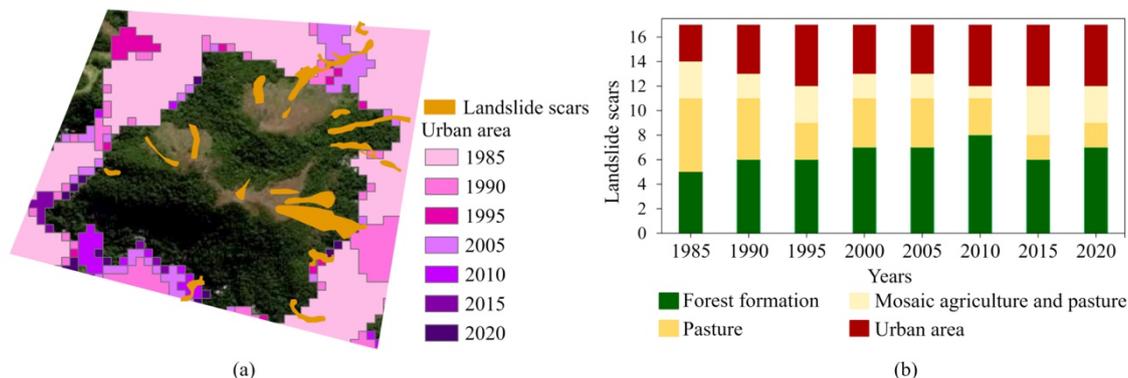
The landslide area coinciding with the urban area totalled about 17,000 square meters (Figure 11A). The scars occurred in areas of forested area, urban area, pasture and agriculture, common classes in the urban region of the municipality. From the zonal statistics considering the landslide scars of this event and the LULC class as the majority in its interior, it was verified that there were lesser landslide scars on urban areas in 1985, compared to the years after. Over the years, it was found more
410 scars with urban area predominancy, and fewer scars found on agriculture and pasture. This finding may be an indication that urban sprawl at the beginning of the analysis period (1985) is sufficient for landslides to cause destruction, material damage, and loss of life in the region. The graph in Figure 11b shows the zonal statistic result for the 17 landslide scars (2022-year event) and LULC classes for the years of analysis.
