Brief communication: Landslides on the Argentinian Santa Cruz river mega dam works revealed by PSI DInSAR

Abstract. In the dam industry, safety and environmental aspects are crucial beyond production goals. By monitoring landslides associated with the construction of a hydro-power dam in the Santa Cruz River in the Argentine Patagonia, this paper contributes to the assessment of the project safety. Ground deformation is monitored using SAR satellite data and the Persistent Scatterer Interferometry technique, and contrasted with optical imagery, geological and technical reports and fieldwork. The results include maps of accumulated deformation and deformation time series for the locations of the anchorages of the dam, providing a new and independent dataset to assess the dam work integrity.

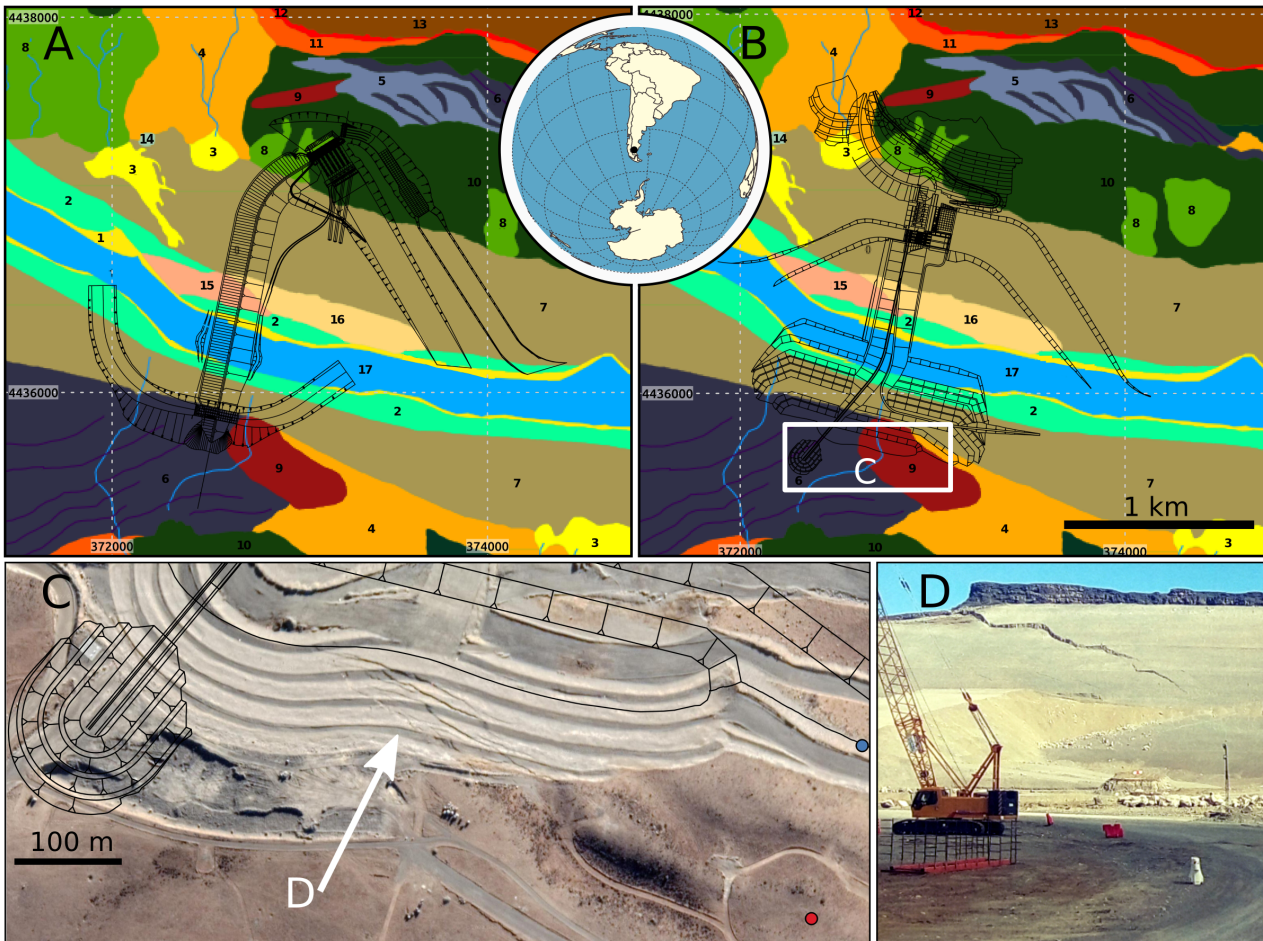
Figure 1. A dot in the very center of the planisphere (between A and B) shows the project location (50.21° South, 70.78° West). A: First design of the CC-NK dam (2015). B: Second design of the CC-NK dam after experiencing structural issues (2020). At the background, the geomorphological map with the following categories may be observed: 1, Alluvial plain. 2, Fluvial terraces. 3, Active alluvial fan. 4, Flank pediment. 5, Basal moraine. 6, Marginal moraine. 7, Glaciofluvial terrace covered by catastrophic flow deposits. 8, Rock avalanche deposits. 9, lateral spread and rotational landslides. 10, Rotational landslides. 11, Scree slope. 12, Rock fall. 13, Lava flow. 14, Seasonal lagoon. 15, Wind blowout. 16, Parabolic dune. 17, Santa Cruz river channel. Box C shows the optical satellite image where the cracks of the south bank can be seen. In D, a view from the ground of the crack on the south margin may be observed. Source: Our own elaboration based on (EBISA, 2017; IEASA, 2020), © Google Maps, www.worldmapgenerator.com [accessed August 2022] and on fieldwork.

Both dams are concrete face rockfill dam (CFRD) type. The Cóndor Cliff - Néstor Kirchner dam (CC-NK), the larger of the two dams and the one studied in this work (Fig. 1) is 68 m high from its crest to the bottom of the channel, and will store 5.3 km³ of water. The second dam, La Barrancosa - Jorge Cepernic, which is downstream from CC-NK, is 41 m high and will generate a 3.5 km³ reservoir (EBISA, 2017).

and modification of the dam. The new design keeps its productive characteristics, but with a completely different morphology (Fig. 1 A and B). Because of this situation, project deadlines and costs have substantially changed, affecting its financial viability. Large sectors of the work which had already been done until 2019 later had to be removed to readapt the project since
55 2020 onwards. The structure has been substantially modified : without moving the central sector of the dam axis, its anchors have been diverted a few hundred meters upstream, also readapting the location of other key dam elements (deviation channel, machines hall, etc.). This results in a roughly U-shaped dam very different from the original.

In none of the four curves can the arrest of surface deformations be clearly seen, so it is possible to affirm that the sliding processes were still active in April 2021 (date of the last observation). The works in general, and the movements in particular, are clearly located in areas of Quaternary sedimentation and materials resulting from paleo mass wasting processes that had already been described as potentially conflictive in the preliminary project reports (see Fig. 1 A and B), such as:

- 165
- on the north bank: basal moraine (8), lateral expansion and rotational slide (18), rotational slide (20);
 - and on the south bank: marginal moraine (9) and lateral expansion and rotational slide (18).

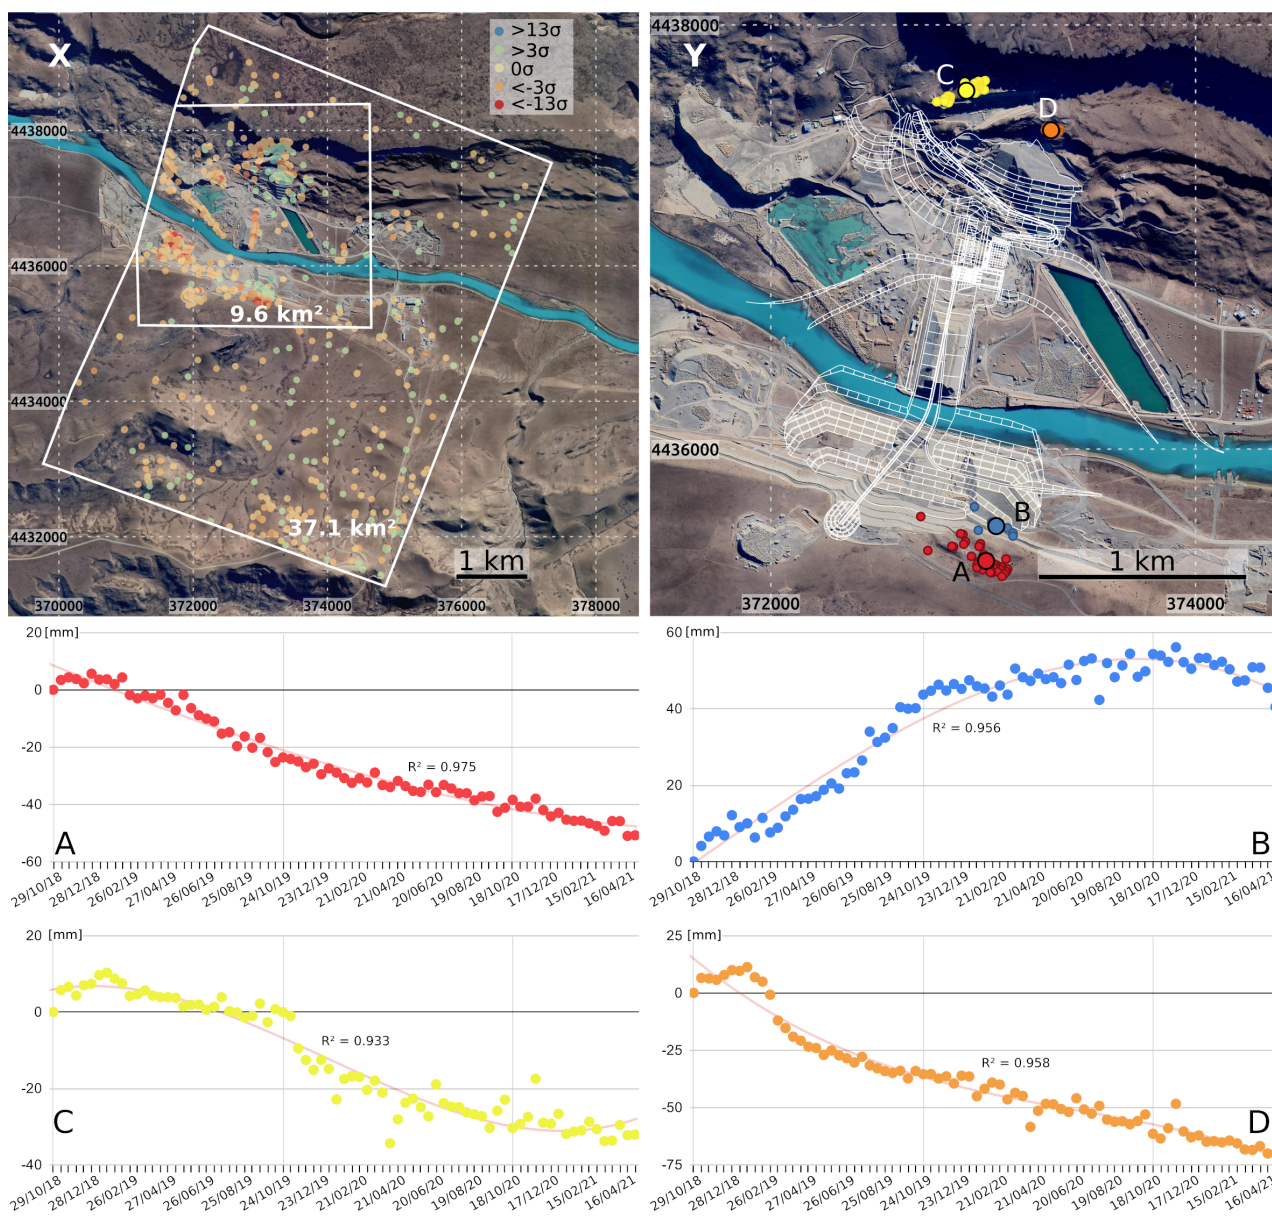
Figure 2. Top left (X). Area covered by the PSI processing. White polygons delimitate the two mentioned areas, the general starting dataset and the in detail analysed zone. The optical background image is from Google from July 2022 (© Google Maps). Coordinates are UTM zone 19S. Only reflectors $>3\sigma$ are represented, magenta negative and cyan positive deviation, scale ranges until 13σ . Top right (Y): construction site. The plan of the second dam design has been superimposed. The PSs of each landslide subgroup are represented on the southern (A, B) and northern (C, D) margins. Charts A to D correspond with the deformation time series of the calculated average for each one of the landslide areas (A to D).

The main result of this work consists of a map of accumulated ground displacement in the CC-NK dam area and surroundings
(Fig. 2 and Appendix B1 and B2) and the displacement time series from November 2018 to April 2021. All the presented
measurements are in Line of Sight (LOS).

A total of 68477 Persistent Scatterers (PSs) were obtained in a region of 37.1 km². This corresponds to a ratio of 1897
105 PSs/km², approximately one point every 527m² (see Figs. 2-X and B2). Out of these, 1018 PSs (0,7%) show a displacement
above 3 σ ($\sigma=2.69$), i.e. an accumulated deformation over 8.07 mm along the monitored period. The value of 3 σ was taken to
clearly discriminate those points with random scattered values around 0 from those with clear deformation trends (see Fig. B1-
E). Consequently, to better focus the analysis, the first group of <3 σ was discarded. Thus, only the reflectors with pronounced
deformation trends have been analysed (Fig. 2-X).

110 From this initial dataset, the sub region that includes the work of the CC-NK dam was analysed in detail (Fig. 2-Y; small
polygon on Fig. 2-X). This corresponds approximately to 9.6 km². There, 15678 PSs were obtained, that is 1742 PSs/km²,
approximately one point every 574 m², out of which 857 (5.5%) have magnitudes of >3 σ of the original dataset.

The results are presented in Fig. 2. On the south bank, two movement zones are identified, zone A with 51 (red) reflector points and zone B with 18 (blue). On the north bank the identified zones are: zone C with 33 reflecting points (yellow) and D with 15 (orange).

135 Maximum accumulated displacements between extreme values range from 40 to 80 mm. This represents 16 mm/yr for area C, and 32 mm/yr in area D. A polynomial fit line with a determination coefficient R^2 (Mirmazloumi et al., 2022) has been superimposed in the chart to show the absence of noise in the measurements. It is worth underlining that the magnitudes measured do not accurately reflect the real magnitude of the movements since:

Area A is located in a flat area, so it could be said that most of the movement is vertical, which, according to the orbit direction of the satellite, is in agreement with the negative values of the LOS measurement showing subsidence.

Area B is located on the slope, so horizontal and vertical displacements are measured. The general orientation of this area is not the optimal to be observed with the descending satellite trajectory, but the considerable magnitude of the deformation made it possible to obtain results. Presumably, deformation to the west and east of the A-B locations became invisible to the radar either by the large magnitude of the ground displacements (at west, in the crack, where data decorrelation is present, see Fig. B1-I in Appendix B) or due to the deficient orientation of the slope and the smaller magnitude of the displacements (to the east).

Observing the situation on sectors A and B (with inverse trend sign), it is possible to suggest that a rotational mass wasting is taking place, which agrees with the bibliography (Astini et al., 2015), but more information is necessary to provide a more definitive conclusion.

155 Since area C is mainly flat, it is possible to say that a vertical component in the ground deformation is relevant, but the PSI information is not enough to determine the exact direction of the deformation vector. In the chart, a step in the trend is visible in October 2019, which coincides with the start of containment works in the area as revealed by the optical sources.

Finally, as sector D is found in a steep surface, both vertical and horizontal displacements are relevant, but further measurements should be made to get a complete comprehension of the situation there. The strong slope of the curve around February 160 2019 confirms the ground instability trends described in the company reports (IEASA, 2020).

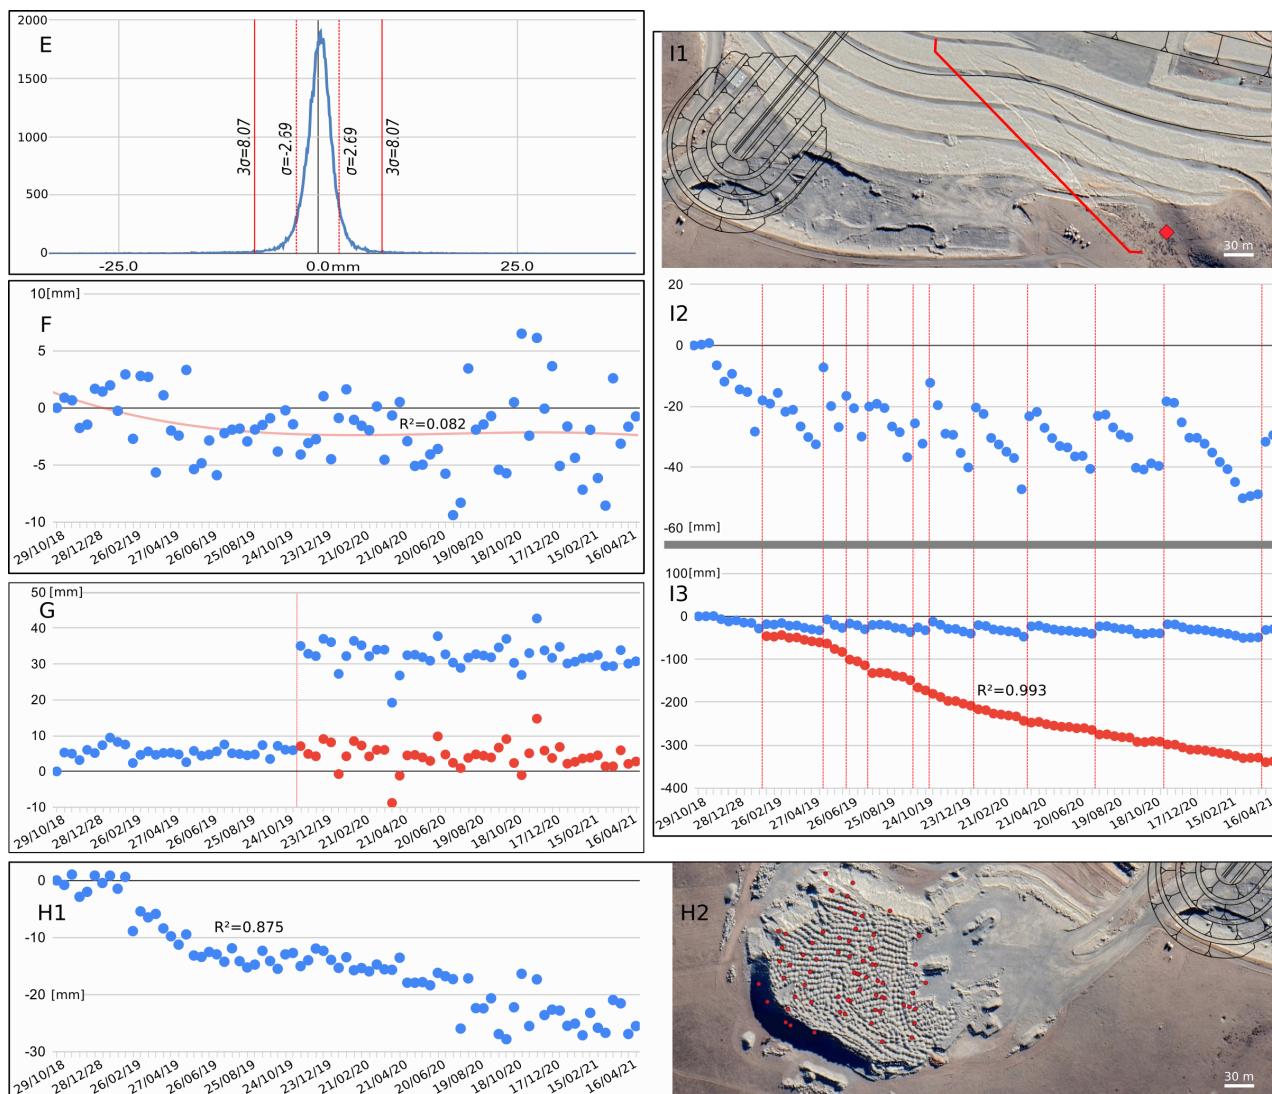
Figure B1. Examples of PSs with high σ values which, as presented in page 5 and following the same number notation, have not been studied in this work. Optical satellite images from © Google Maps

220 Figures B1 and B2 show examples of PSs with high σ values that have not been included in this work and correspond to items mentioned in page 5 and following briefly described. The letter notation is the same for both figures:

- E. Frequency distribution graph of the accumulated displacement of the PSs reflectors in the study area and the 3σ threshold.
- F. Time series of a stable PS with dispersed measurements due to random errors. Elevated σ between 2 and 3 due, $R^2=0.082$.

- 225 – G. Phase unwrapping error (PUE). 40 reflectors average. Red dots in the chart in Fig. B1 represent the series after applying a manual PUE correction jump of 28 mm (Mirmazloumi et al., 2022).

- H. Deformation trend (Fig. B1-H1) caused by construction works (B1-H2). 72 reflectors average.
- I. 11 phase unwrapping errors for a single reflector located in the root of the big crack in the southern margin (west
230 of studied sectors A and B). This is an exceptional and isolated sample which preserved the coherence along the time series despite the high deformation rate. Chart in Fig. B1-I2 indicates the deformation trend without PUE correction. I3 corresponds to the same chart after applying a manual PUE correction. A visual detail of the crack is shown in Fig. B1-I.3 and the location of that reflector in Fig. B2 as a grey diamond. Official documentation describes the occurrence of the landslide on 14th February 2019. This is clearly visible in the charts (first vertical dashed red line). At the same time, it is clear that the trend was present before (at lower rates) and after this date. Dashed red vertical lines indicate the en-

235 forcement of a PUE correction, eleven times in this case. Official reports (IEASA, 2021) describe ground displacements up to 15 mm/day (5.5 m/yr) in the main sector of this big crack, where we could not obtain PSI. Observing this chart, we cannot confirm the end of the deformation trend in April 2021.

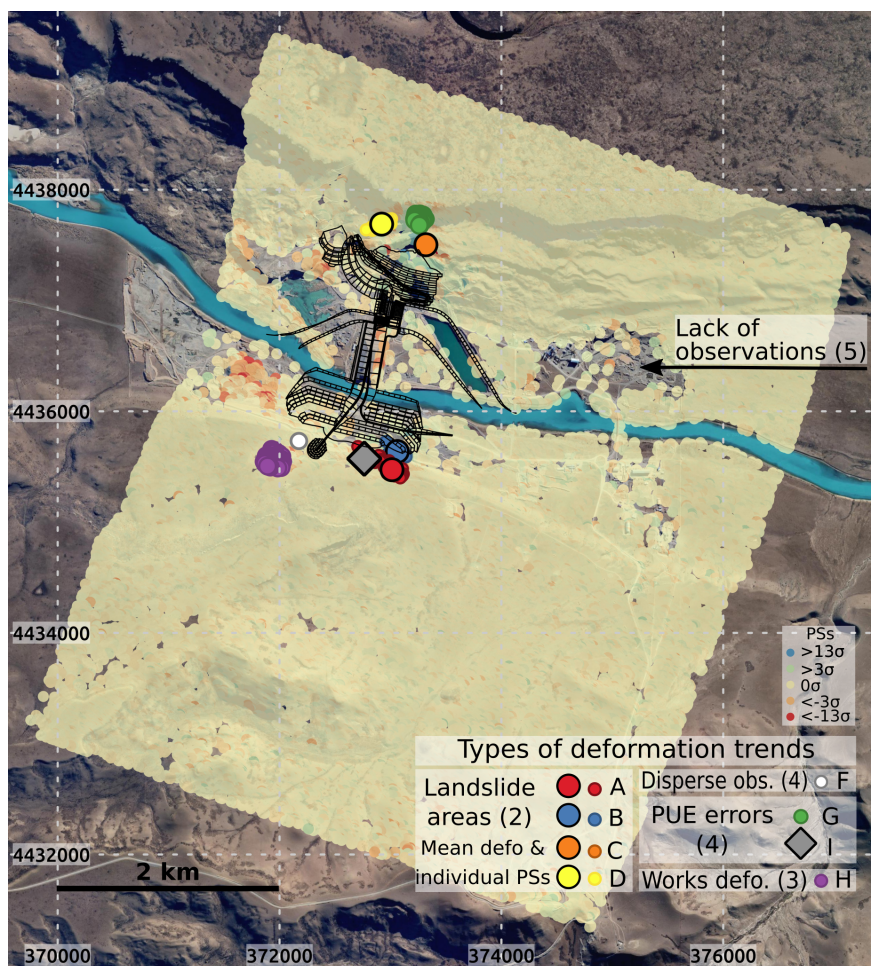
Figure B2. Map of the full PSI results and examples of the identified deformation trends, 1 to 5, as described on the items on page 5 or presented in previous B1. A to D are landslides studied in this work. F to I are the other time series trends briefly described in this Appendix. Arrow (number 5 as in page 5) is an example of the absence of observations due to the surface changes produced by the construction work. Our own elaboration. Background satellite image © Google Maps

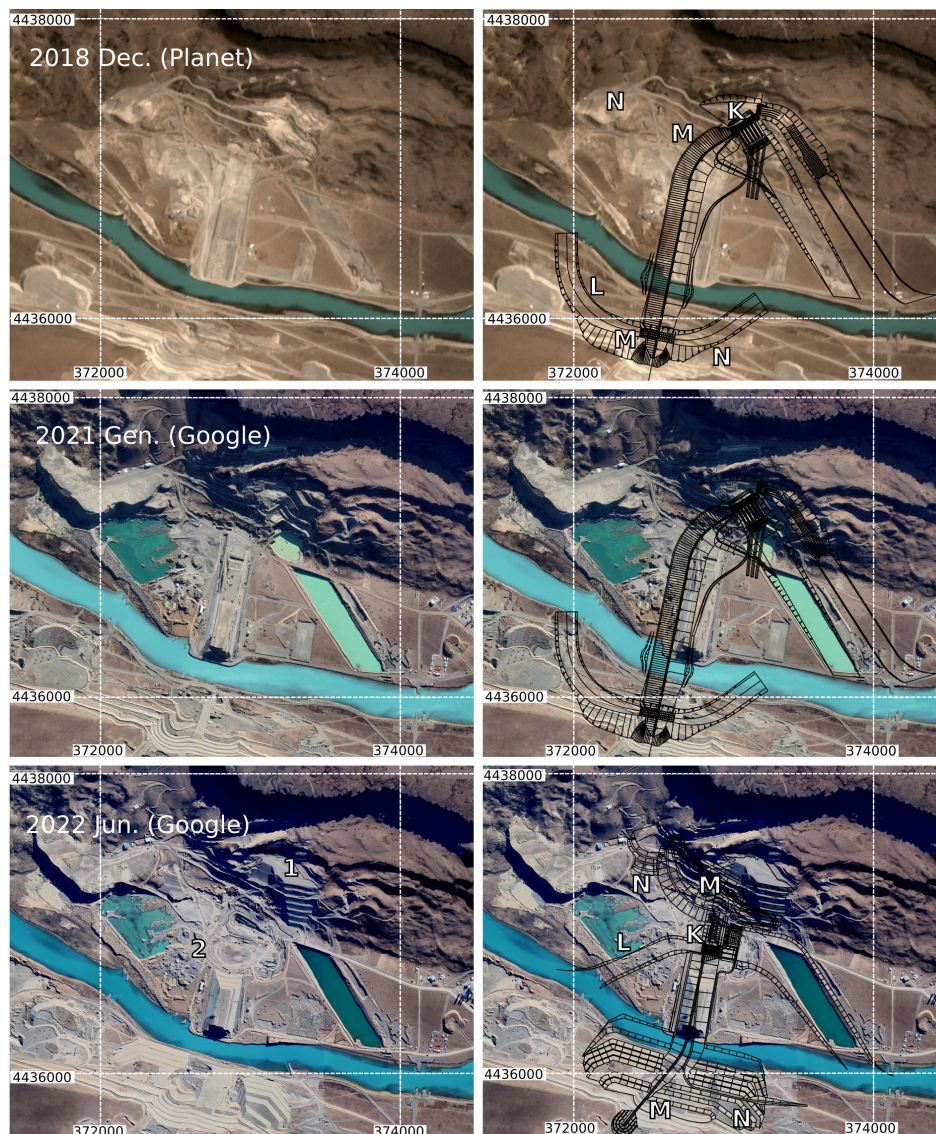
Figure B3. Three moments of the dam construction. In the left column, optical image, in the right, the dam plans have been superimposed (the third row corresponds to the new project). Letters identify main structural changes: K) machines hall, L) deviation channel, M) change of the dam wall direction, N) structural retaining walls. Numbers identify main correction works to the original project (modification of structures already built): 1) the space prepared to the main hall have been filled in again (over 1 million m^3), 2) an important part of the dam wall (which was originally planned to have 12.1 millions m^3) has been retired, and a big 10 m wide and 36 m deep exploratory well is built there to study the rock substratum. To dig the well, a volume of around 70.000 m^3 had to be previously removed at the ground level in the area which had already been filled with basement materials of the dam wall. Our own elaboration. Background images from PlanetTM and © Google Maps.

Fig. B3 presents three stages of the project evolution through optical sensors where main project changes can be seen.
