Brief communication on the NW Himalayan towns; slipping towards potential disaster

The NW Himalaya has been one of most affected terrains of Himalaya subjected to frequent disastrous landslides owing to active tectonics and multiple precipitation sources. This article aims at two towns (Joshimath and Bhatwari) of the Uttarakhand in the NW Himalaya (India), which have been witnessing subsidence for decades. In the last 1-2 weeks Until 9th Jan. 2023, Joshimath has witnessed widespread cracks in more than 500 houses that has created the a social unrest in the region. The hillslopes accommodating both the towns comprise highly jointed gneisses with schistose interlayers rockmass, subsidence in road, broken retaining wall, holes, displacing boulders, and cracks in the houses. Recently, such slope instability phenomena have increased that is leading to social movements in the region seeking government action for possible evacuation and rehabilitation. Present study has involved continuum modeling-based slope stability simulation to determine the response of these hillslopes under various loading conditions; gravity, rainfall, building load, domestic discharge, and seismic load. Results

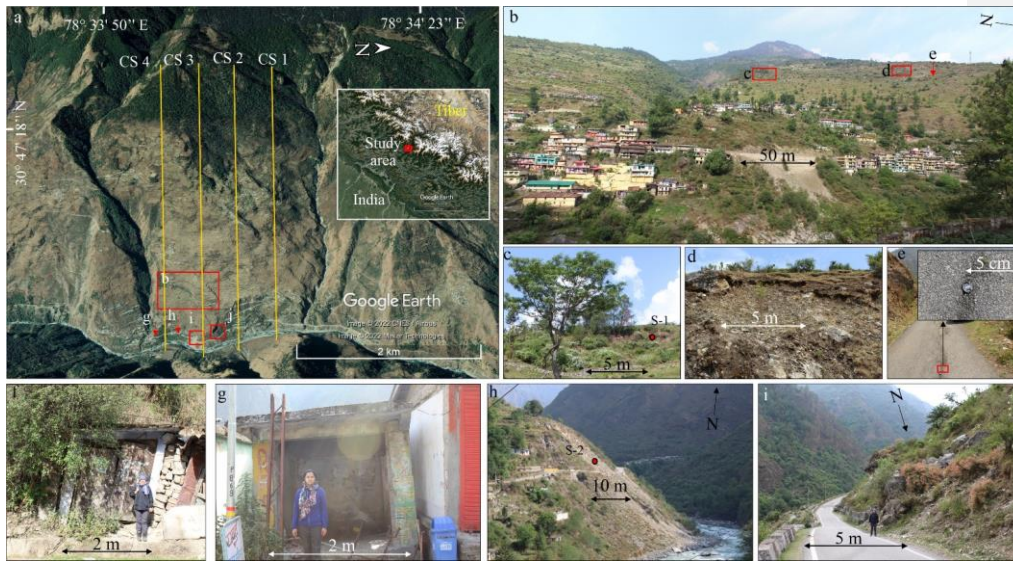
9 **Fig. 2.** Field observation of Bhatwari town. (a-b) Location of Bhatwari town with inset highlighting the
10 position in the NW Himalaya. CS 1 to CS 4 mark the position of 2D slope sections used for the slope
11 stability evaluation; (c-d) Exposed scarp. S-1 refers to soil sampling site; (e) Cracks and displacement of
12 road; (f-g) Tilting houses/shops; (h) Active slope failure at slope toe; (i) Big Gneissic boulder implying
13 paleo-landslide site.

Another town that is included in this article is Bhatwari (Fig. 2). As per ~~census (2011) of Govt. of India~~ ~~census-2011~~, it had a population of 1268 that is 1.0025 % lower than that of year 1991. Though ~~the~~ population migration from hilly terrain to plain area is becoming common phenomena in the NW Himalaya owing to socio-economic priorities, decreased human population of this town might be due to such slope instability problems also. Similar to ~~the~~ Joshimath town, Bhatwari is also situated along a narrow gorge ~~made-incised~~ by Bhagirathi River valley. The hillslope of the town comprises gneissic rockmass and the MCT-I (locally termed as Vaikrita Thrust: VT) and MCT-II (locally termed as Munsyari Thrust: MT) faults pass through the northern and southern side, respectively of this region. (Supp. Fig. 1). Two tributaries merging into Bhagirathi River bound the hillslope from northern and southern side.

1 Bhatwari town is also situated in the orographic barrier setting and hence receives ~3732
2 mm/month rainfall (Supp. Fig. 2). Field observation revealed exposed scarps in the upper part of
3 town, cracks in the road, and tilting houses (Fig. 2b-hg). Big (4-5 ft.) boulders and active slope
4 failure in the loose material at the slope toe indicate the possibility of paleo-landslide on which
5 Bhatwari town is located (Fig. 2i-jh-i). Yadav et al. (2020) have also noted the material
6 displacement in the range of 12-22 mm/yr. during the years 2006-2016 at this location. The last
7 big earthquakes (1 Sep. 1803: M_w 7.8, 20 Oct. 1991: M_w 6.8) occurred within 22 km hypocentral
8 distance from this town.
