RESPONSE TO THE REVIEW #1 OF MANUSCRIPT NUMBER: NHESS-2022-93

The article describes the collapse of a large hall with a flat roof in southern France after heavy snowfall turned into rain. The analysis of such cases is very valuable on the one hand to check the design snow loads and on the other hand to identify structural weak points of a structure. The study was carefully prepared, but unfortunately no quantitative data was available on important input parameters such as the amount of snow load at the time of the damage or the condition of the structure before its collapse. Therefore, the main statements of the article are somewhat speculative. In order to finally answer the question what was the exact cause of the collapse of the building, the collapsed structure would have to be investigated in more detail (e.g. material technology tests). In several building collapses, such as the ice rink in Bad Reichenhall, material deficiencies were partly responsible.

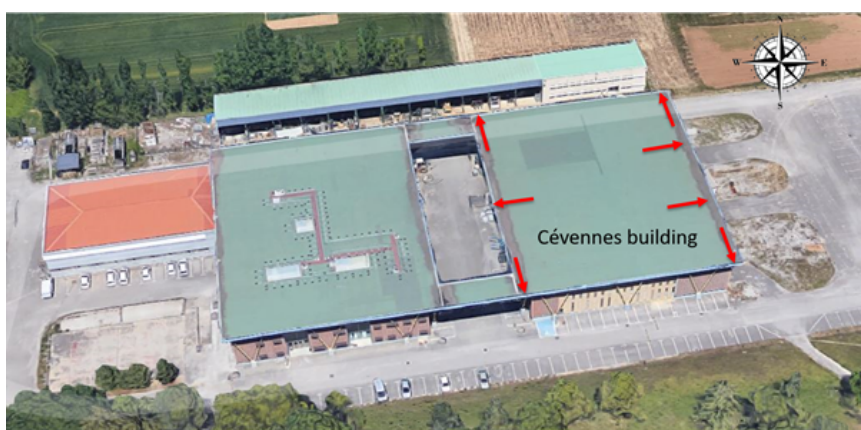
Because of the 1% slope of the roof, rainwater was flowing east or west of the building. Rainwater was supposed to flow along a small wall on the roof perimeter and to be normally evacuated thanks to seven 20 cm high outlets. Four outlets were located at the end of the north and south edges, one at the middle of the west edge and two at quarter and three-quarter of the east edge, as specified by the red arrows in the figure below. All this information about the water drainage system will be added to the revised manuscript.

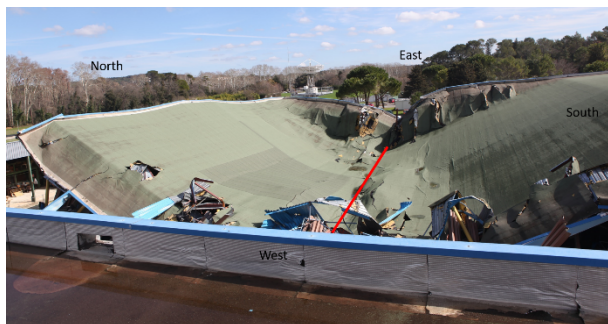
A new figure is proposed on which the part of the roof which totally collapsed is more visible and materialized by the red line on the picture.
