Back analysis of a building collapse under snow and rain loads in Mediterranean area

Abstract. At the end of February 2018 the Mediterranean area of Montpellier in France was struck by a significant snowfall that turned into an intense rain event caused by an exceptional atmospheric situation. This rain-on-snow event produced pronounced damage to many buildings of different types. In this study, we report a detailed back analysis of the roof collapse of a large building, namely the Irstea Cévennes building. Attention is paid to the dynamics of the climatic event, on the one hand, and to the mechanical response of the metal roof structure to normal loading, on the other hand. The former aspect relies on multiple sources of information that provide reliable estimates of snow heights in the area before the rain came into play and substantially modified the snow quality. The latter aspect relies on detailed finite element simulations of the mechanical behaviour of the roof structure in order to assess the pressure due to snow cover loading which could theoretically lead to failure. By combining the two approaches, it is possible to reconstruct the most probable scenario for the roof c

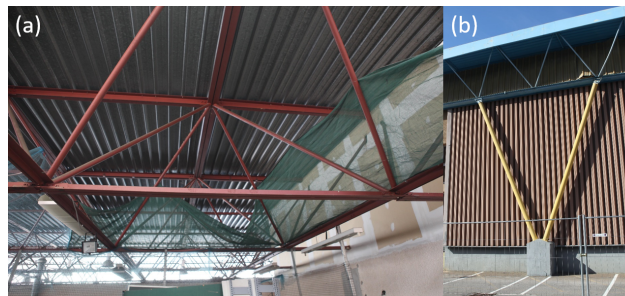
Figure 7. View of the supporting structure of the Irstea Cévennes building before its damage: (a) red-colored roof metal frame and (b) supporting tubular pylons (in yellow) along the facades.

The supporting structure of the building consisted of three-dimensional vertical metallic trusses designed to support the flat roof (see an example shown in Figure 7a) and themselves supported by metal tubular pylons that were arranged along the

facades of the building. The lattice structure, consisting of elements welded or bolted together, extends over the entire roof surface and withstands all the forces acting upon it. For the southern, western and northern facades of the building, the tubular pylons consisted of two round tubular profiles arranged in V-shape and sealed on concrete blocks anchored in the ground (see photograph on Figure 7b, and sketches on Figures 8a and 8b). For the eastern facade of the building, they consisted of rectangular tubular profiles and a Saint Andrew's cross obtained with T-profiles (see sketch on Figure 8c). It is worth noting here that no such tubular pylons had been settled inside the building in order to allow the movement of large-size vehicles, such as agricultural tractors.

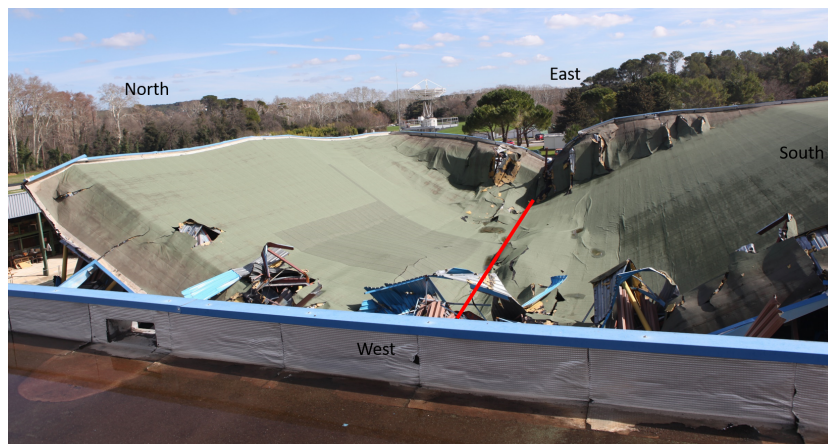
Figure 10. Overview of the damaged Irstea Cévennes building.

This section gives a brief summary of the main damage observed during a field visit on 18 March 2018. Additional details are provided in Appendix A. The snow load led to the collapse of the experimental hall of the Irstea Cévennes building in the central part of the structure, in the west-east direction, as seen by the red line in Figure 10. The western and eastern facades were heavily damaged, as seen in Figs. 11a and 11c. On the contrary, the other two facades (see Figure 11b and 11d) were much less damaged due to the presence of the inner concrete walls of the offices and of the inner metal frames of the laboratory rooms along the south and north facades, respectively.

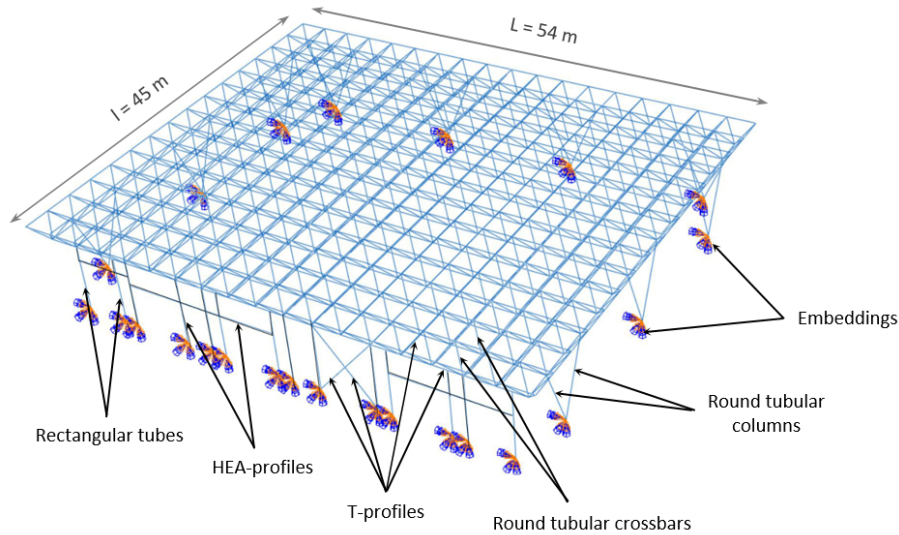
Figure 12. Overview of the metal structure of the Cévennes building modelled with the FE Abaqus software.

The structure is modelled in Abaqus by 132 778 Timoshenko beam elements of B31 (two-node linear beam element in space) type and 0.05 m long.

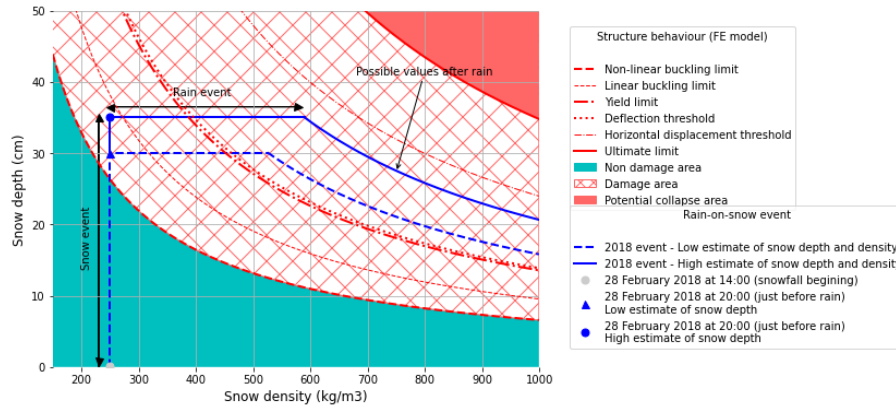
300 Figure 17 graphically summarizes the results of the quasi-static pushover and buckling FE simulations in the case of a uniform pressure distribution. Based on the hydrostatic pressure assumption (ρgh), the iso-pressure curves corresponding to the different failure criteria used (see Table 4) can be plotted in the (ρ, h) -plane and this defines the safe and unsafe zones for the structure in terms of snowpack height h and density ρ . Below the dashed red-colored line (buckling limit), the structure remains intact. Above the continuous red-colored line (ultimate criterion), the structure collapses. In between (hatched zone in Figure 17),
 305 the structure undergoes irreversible damage that is more and more significant when approaching the continuous red-colored line. The dashed-dotted, dotted, and fine dashed-dotted red-colored lines define the yield limit, curvature limit based on the deflection of the structure, and horizontal displacement limit, respectively. Additionally, the buckling load obtained via the linear buckling analysis is represented by the fine dashed red-colored line.

Figure 17. Comparison of the snow loads leading to different failure criteria of the Cévennes building, as calculated by FE model simulations, with different combinations of snow depth and density, assuming a uniform pressure field. The estimated scenario for the rain-on-snow event of 2018, as back-analyzed in Section 2, is also included in the comparison.

The corresponding two pairs of values (density ρ and height h , before rain) can be displayed in the (ρ, h) -plane of Fig-
 315 ure 17, as depicted by the blue-colored triangles and circles. These two points can be directly compared to the iso-pressure curves inferred by the FE Abaqus simulations: they remain below the limits related to linear buckling, curvature, horizontal displacement, and material properties but are above the non-linear buckling limit that takes into account initial geometric imperfections (estimated to be 645 N.m^{-2} ; see Table 4). They remain well below the load leading to the full collapse of the building, which is estimated to be 3410 N.m^{-2} , as given by the ultimate limit criterion (see Table 4). Therefore, it can be safely
 320 concluded here that the initial snowfall (before rain) was critical for potential irreversible damage (buckling) to the structure, but it is unlikely to have been the sole cause of the full collapse.

There are several sources of explanation for the fact that our analysis displayed on Figure 17 does predict irreversible damage but not a full collapse of the building. One reason is associated with the initial state of the structure which we assume as perfect with no previous damage experienced by the structure. An unknown initial damage which would have been taken into account in the FE simulations could have easily brought the horizontal blue lines in the red zone. Another reason is that pushover simulations do not account for the buckling of the structure, while post-buckling analysis fails to predict the collapse of the structure.

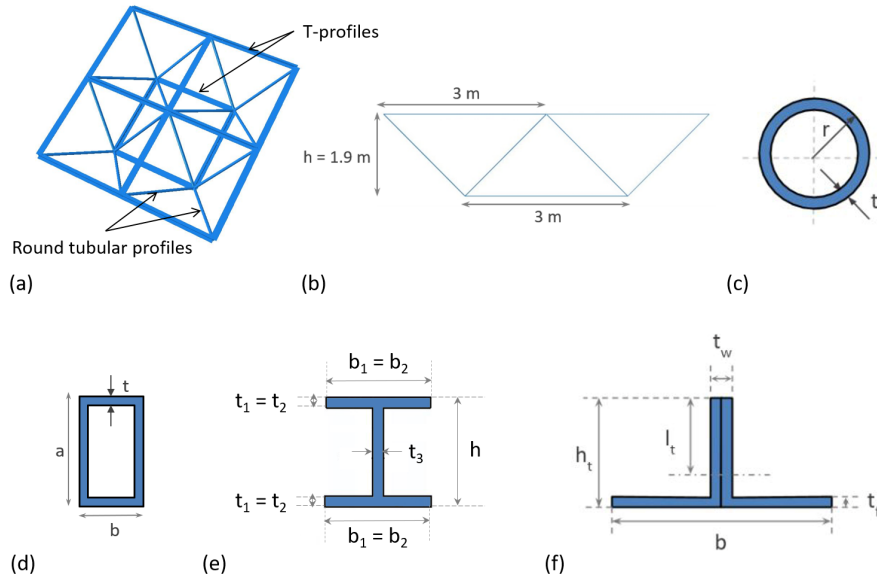
Figure A3. Details of the metal structure modelled by the FE Abaqus software: general view (a) and front view of one single roof frame element (b), round (c), and rectangular (d) tubular profiles' and HEA (e) and T- (f) profiles' features.

445 Figure A3 gives a description of the geometry of the metal structure modelled by FE Abaqus software, including the details of the geometry of each component. The numerical values given to the different geometrical properties defined in Figure A3 are given in Table A1.

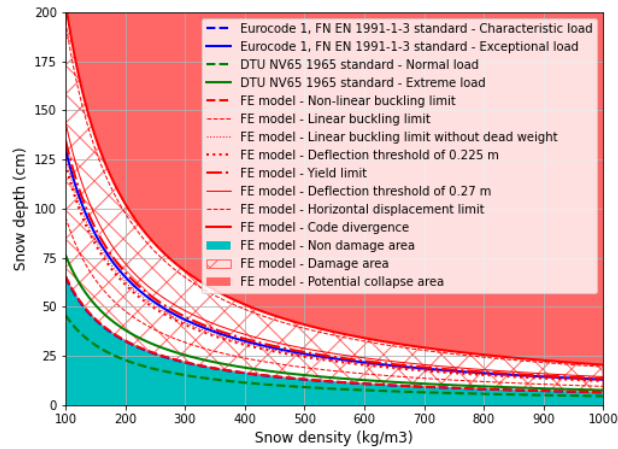
Figure B1. Comparison for different combinations of snow depth and density between the snow loads leading to the different failure criteria of the Cévennes building, as calculated by the FE model, and the snow load values recommended by Eurocode 1 and the DTU NV65 without taking into account safety factors (both in terms of loads and the steel behaviour law) in the case of a snow pressure field with a central accumulation.

So, in Figure B1, roof snow loads leading to the failure criteria of the Cévennes supporting structure according to the FE model simulations in the most critical case of pressure field with a central accumulation (in the range $645 - 1915 \text{ N.m}^{-2}$ for criteria other than the ultimate limit) are compared to values (without safety factors) recommended by the French DTU NV65 standard, valid at the moment of the building construction in 1982 (450 and 750 N.m^{-2} for normal and extreme design loads) and the NF EN 1991-1-3 standard, adopted in application of Eurocode 1 ($0.8 * 550 + 200 = 640$ and $0.8 * 1350 + 200 = 1280 \text{ N.m}^{-2}$ for characteristic and exceptional design loads, respectively).
