Back analysis of a building collapse under snow and rain loads in Mediterranean area

Abstract. At the end of February 2018 the Mediterranean area of Montpellier in France was struck by a significant snowfall that turned into an intense rain event caused by an exceptional atmospheric situation. This rain-on-snow event produced pronounced damages to many buildings of different types. In this study, we report a detailed back analysis of the roof collapse of a large building, namely the Irstea Cévennes building. Attention is paid to the dynamics of the climatic event, on the one hand, and to the mechanical response of the metal roof structure to normal loading, on the other hand. The former aspect relies on multiple sources of information that provide reliable estimates of snow heights in the area before the rain came into play and substantially modified the snow quality. The latter aspect relies on detailed finite element simulations of the mechanical behaviour of the roof structure in order to assess the pressure due to snow cover loading which could theoretically lead to failure. By combining the two approaches, it is possible to reconstruct the most probable scenario for the roof

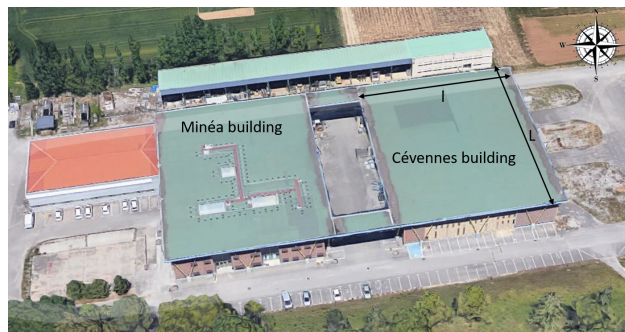
Figure 6. Overview of the Irstea Cévennes building before damage (Photo credit: ©Google Earth 2014, adapted by I. Ousset).

The Cévennes building was an experimental hall built in 1982 and situated at Lavalette domain in Montpellier (see Figure A1
140 in Appendix A). At the time of its failure, it sheltered a wind tunnel and a mezzanine built in 2014 along the northern facade,
as well as offices on two levels along the southern facade. Figure 6 gives an overview of the Cévennes building before damage.
Its dimensions on the ground were 40.5 m in the east-west direction and 49 m in the north-south direction (area of almost 2000
m²) and 10 m high.

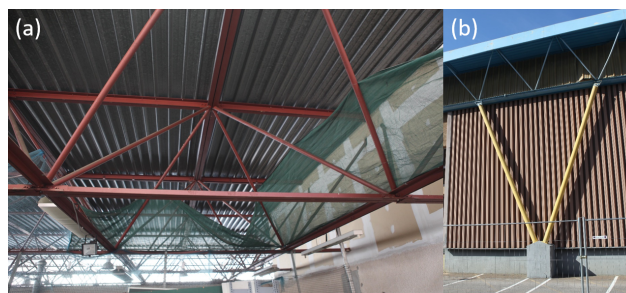
The supporting structure of the building consisted of three-dimensional vertical metallic trusses designed to support the
145 (nearly) flat roof (see an example shown in Figure 7a) and themselves supported by metal tubular pylons that were arranged

Figure 7. View of the supporting structure of the Irstea Cévennes building before its damage: (a) red-colored roof metal frame and (b) supporting tubular pylons (in yellow) along the facades.

along the facades of the building. For the southern, western and northern facades of the building, these tubular pylons consisted of two round tubular profiles arranged in V-shape and sealed on concrete blocks anchored in the ground (see photograph on Figure 7b, and sketches on Figures 8a and 8b). For the eastern facade of the building, they consisted of rectangular tubular profiles and a Saint Andrew's cross obtained with T-profiles (see sketch on Figure 8c). It is worth noting here that no such tubular pylons had been settled inside the building in order to allow the movement of large-size vehicles, such as agricultural tractors.

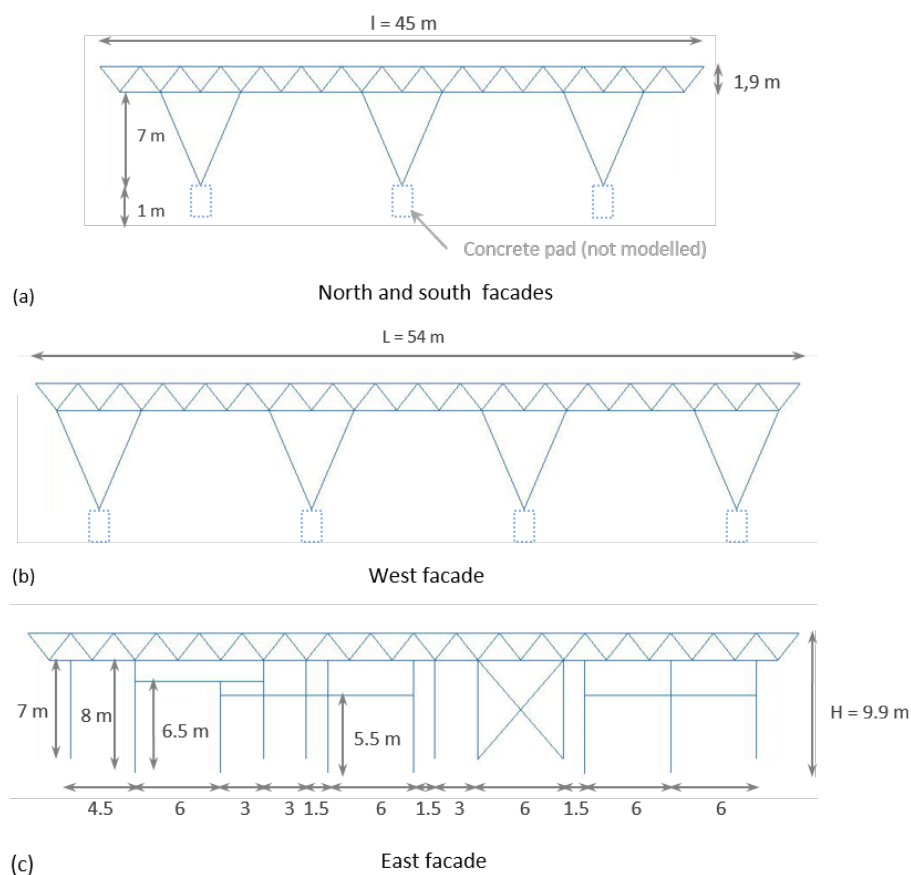
Figure 8. Sketches showing the geometrical details (size and shape) of the metallic structure of every facade of the Irstea Cévennes building.

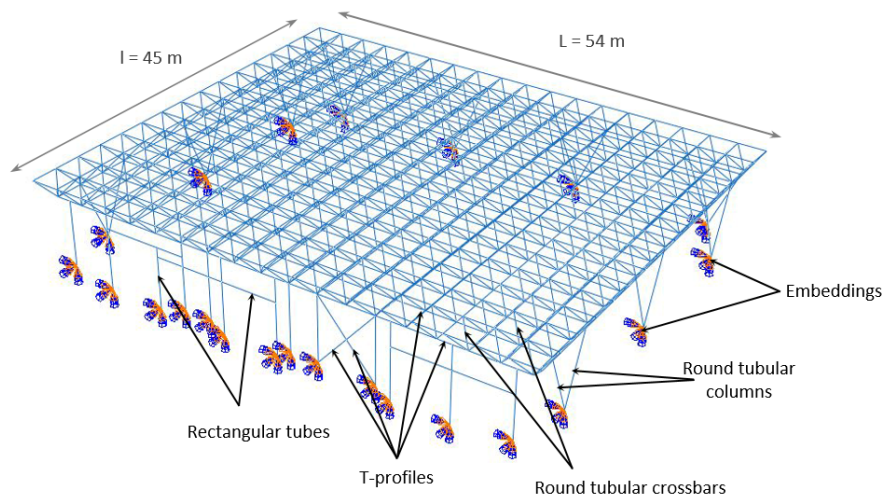
Figure 11. Overview of the metal structure of the Cévennes building modelled with the FE Abaqus software.

the structure failure during the rain-on-snow event. Figure 11 shows an overall sketch of the modelled structure with respect to the description of the building provided in the previous subsection. The details of the roof metal frame which was fully modelled by the FE Abaqus are shown in Figure A3. The dimensions of the structure and of all its components are given in Table A1.

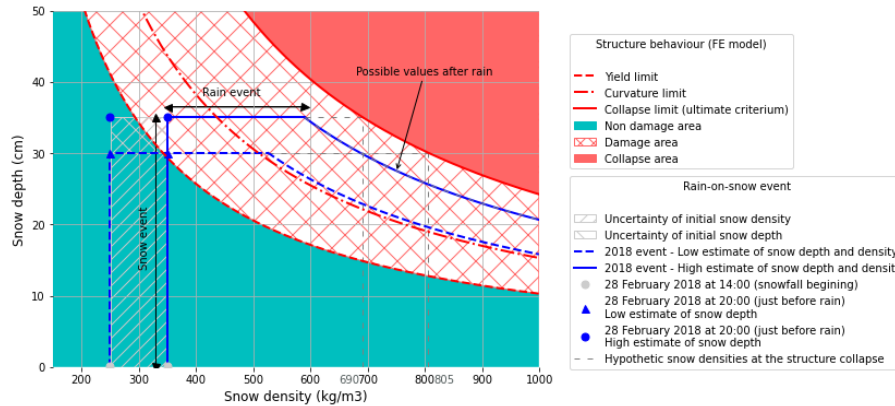
Figure 13 summarizes the results of the quasi-static pushover FE simulations graphically. Based on the hydrostatic pressure assumption (ρgh), the iso-pressure curves corresponding to the different failure criteria used (see Table 3) can be plotted in the (ρ, h) -plane and this defines the safe and unsafe zones for the structure in terms of snowpack height h and density ρ . Below the dashed red-colored line (yield limit), the structure remains intact. Above, the continuous red-colored line (collapse limit or ultimate criterion), the structure collapses. In between (hatched zone in Figure 13), the structure undergoes irreversible damages that are more and more significant when approaching the continuous red-colored line. The dashed-dotted red-colored line defines the curvature limit based on the deflection of the structure.

The analysis of the chronicle of the climatic event described in Section 2 led to an initial snow depth on the ground (before rain) that certainly ranged from 30 to 35 cm and an initial snow density likely to be in the range $250 - 350 \text{ kg.m}^{-3}$. The corresponding two pairs of values (density ρ and height h , before rain) can be displayed in the (ρ, h) -plane of Figure 13, as depicted by the blue-colored triangles and circles. These four points can be directly compared to the iso-pressure curves inferred by the FE Abaqus simulations: they define a rectangular area which mostly remains just below the yield limit, thus in the safe zone for the structure. However, a small portion of that rectangle already enters the hatched unsafe zone where plastic deformations of the structure can occur. This indicates that some height and density combinations that might have occurred lead to a snow loading which is greater than the failure pressure given by the yield limit criterion (estimated to be 1000 N.m^{-2} ; see Table 3). Such combinations with the highest heights and densities at the same time are however more uncertain. This rectangular area remains well below the load leading to the full collapse of the building estimated to be 2375 N.m^{-2} given by the ultimate limit criterion (see Table 3). This is also below the critical load leading to the deflection limit estimated to 1275 N.m^{-2} (see Table 3). As such, it can be safely concluded here that the initial snowfall (before rain) was critical for potential irreversible damages (plastic deformations) to the structure, but not for its full collapse.

As analysed in Section 2, the snowfall was followed by rain: during that rainfall, the snow cover density may have increased up to around 600 kg.m^{-3} due to partial saturation of the snowpack with water available. Predicting the evolution of the snowpack after rain and its interaction with the deforming structure is difficult and we may expect some complicated dynamics that potentially produced a non-uniform pressure field during the rain event. In want of any monitoring or any full modeling of the snowpack evolution over time during the rain-on-snow event of 2018 and its interaction with the structure, we consider here one (simplified) scenario with no settling ($h = cste$) but a gradual increase of density due to water. This scenario is represented by the blue-colored horizontal lines drawn in Figure 13. Depending on the initial snow height and the ultimate limit reached for the density of the very wet snowpack after rain, this defines (ultimate) points that remain in the intermediate hatched zone

Figure 13. Comparison for different combinations of snow depth and density between the snow load leading to the failure of the Cévennes building, as calculated by the FE model simulations, and the estimated scenario for the rain-on-snow event of 2018, as back analysed in Section 2.

for which the structure undergoes plastic deformation. For the highest initial height of 35 cm (continuous blue line), the red zone corresponding to full collapse of the building becomes close but is not reached. As such, it can be concluded that the rain added to the snow cover initially in place certainly led to severe irreversible damages to the structure.

There are several sources of explanation for the fact that our analysis displayed on Figure 13 does predict irreversible
260 damages but not a full collapse of the building. One reason is associated with the initial state of the structure which we assume as perfect with no previous damages experienced by the structure. An unknown initial damage which would have been taken into account in the FE simulations could have easily brought the horizontal blue lines in the red zone. Another reason is associated with the assumption made that the pressure field imparted to the structure remains uniform during the pushover FE simulations. The real interaction of the quickly evolving snowpack during rain and the deforming structure is not modelled
265 in detail. In want of any available numerical tool to model this strong coupling between the snow cover dynamics and the behaviour of the structure, a solution would be to impart non-uniform pressure fields to the structure during the pushover simulations. Such scenarios are uncertain and would have required ad-hoc assumptions but some of them would certainly move the iso-pressure curves (yield limit and collapse limit) below the curves currently shown in Figure 13, thus leading to full collapse of the building.

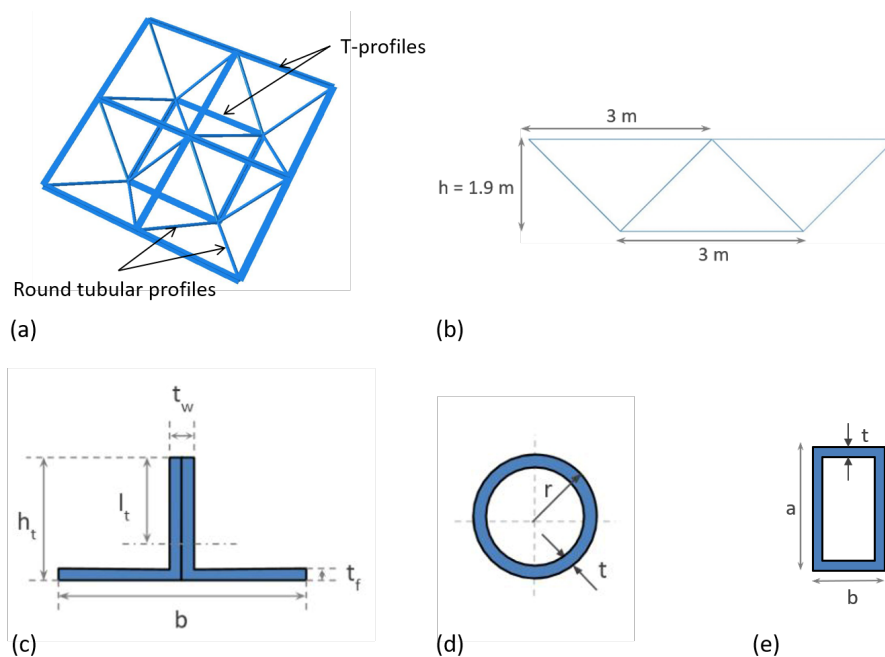
Figure A3. Details of the metal structure modelled by the FE Abaqus software: general view (a) and front view of one single roof frame element (b), T-profiles (c), round (d) and rectangular (e) tubular profiles' features.

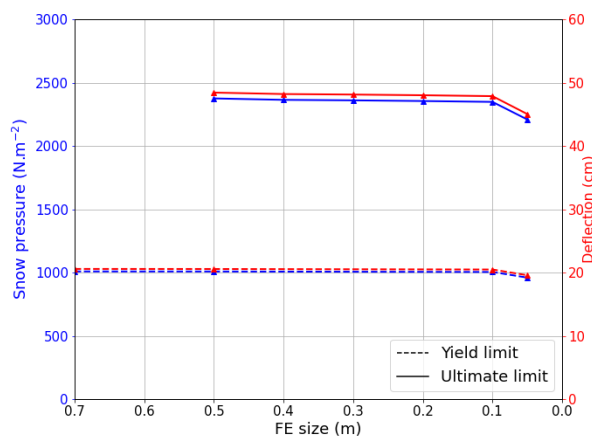
Figure A4. Study of the mesh sensitivity of the FE model, in the case of the actual model of the structure. Snow pressures (left-hand side y -axis; blue-colored lines) and deflection (right-hand y -axis; red-colored lines) leading to failure versus the FE mesh size, considering both the yield limit (dashed lines) and ultimate limit (continuous lines).

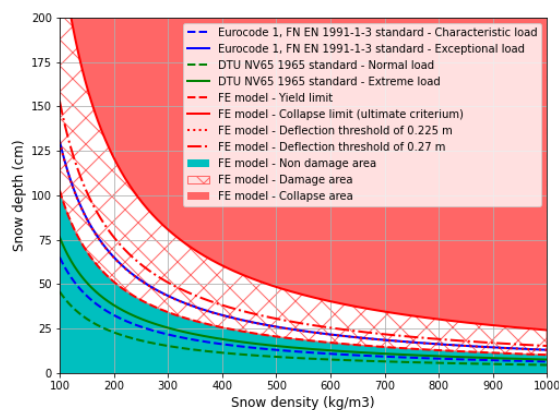
In Figure B1, roof snow loads leading to the collapse of the Cévennes supporting structure according to the FE model
 simulations (in the range $1000 - 2375 \text{ N.m}^{-2}$) are compared to values (without safety factors) recommended by the French
 DTU NV65 standard, valid at the moment of the building construction in 1982 (450 and 750 N.m^{-2} for permanent and
 accidental design loads) and the NF EN 1991-1-3 standard, adopted in application of Eurocode 1 (640 and 1280 N.m^{-2} for
 390 permanent and accidental design loads, respectively).

The results show that the structure begins to yield for a snow load largely above the normal and extreme loads recommended
 by the DTU NV65.

Figure B1. Comparison for different combinations of snow depth and density between the snow load leading to the failure of the Cévennes building, as calculated by the FE model, and the snow load values recommended by Eurocode 1 and the DTU NV65 without taking into account safety factors (both in terms of loads and the steel behaviour law).

Under current regulations, yield occurs for a load less than the exceptional load recommended by Eurocode but the building fails serviceability (excessive deflection) for snow load largely above the permanent project situation and slightly above the accidental project situation recommended by Eurocode.
