1 **Analysis of landslide and mudflow scenarios in loess and clay soils that caused tragic**  
2 **incidents in Uzbekistan**

11 **Abstract.** The article describes real landslides occurred in Uzbekistan, divided into two  
12 groups. The first group is about landslides that caused accidents, where the separation zone, the  
13 form of movement, blockages and the nature of the destruction of residential buildings are  
14 considered. These are landslides of a one-time separation, rectilinearly directed and covering  
15 residential buildings; liquefaction landslides that demolish or overwhelm buildings located in the  
16 lower part of the slope; mud streams moving along the channel of the brook, transferring to the  
17 opposite side and flooding the buildings located in the floodplain of the brook. The second group  
18 is about landslides that block the riverbeds and form blockages of transverse and longitudinal  
19 shape. Scenarios for the formation and erosion of blockages, the height of blockages in loess and  
20 clayey rocks, the parameters of dammed lakes, and the places of debris erosion are considered.

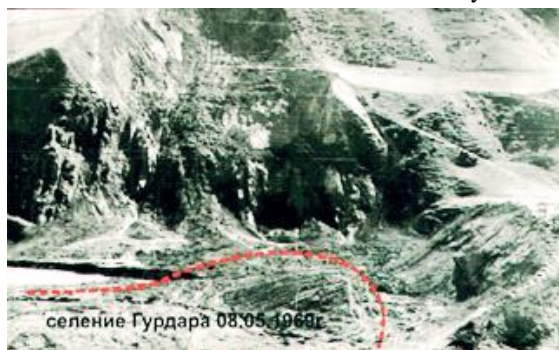
**Fig. 1.** Gurdara Landslide (1969)

1 crack measuring 70-80 m in length and up to 20 cm in width. A few days before the disaster, it  
2 subsided as a block by 1.0-1.5 m (Fig. 1).

3 On May 8, 1969, at 4:00 local time, a sliding landslide occurred with a depth of engagement  
4 of 10-12 m and a volume of 0.12-0.14 million m<sup>3</sup>. The landslide moved down from a height of 120  
5 m, burying the settlement of Gurdara, which had a population of 300 people (Niyazov et al, 1991).

6 The detachment zone had distinct characteristics. The width of the landslide cirque in the  
7 lower zone was 1.3-1.4 times greater than in the upper zone, measuring 130-140 m. The interior  
8 of the landslide cirque was completely cleared of displaced rock masses. The upper boundary of  
9 the detachment wall was smooth without any undulations, while the lateral boundaries of the

the detachment wall were slightly lower in height than the main detachment wall. All these features indicate a unified and simultaneous displacement of the rock masses. The Gurdara landslide is located in the Buldzhuan area on the right bank of the Palkhaksay River, 1.2 km from its confluence with the Kyzylsu River. The landslide slope, with a height of 100-120 m and a convex shape, has a steepness ranging from 40 to 450 m. It consists of a layer of loess deposits with a thickness of 10-15 m, resting on weakly cemented

23 Neogene sandstones. In the upper part of the slope, near the watershed, there was an old landslide  
24 crack measuring 70-80 m in length and up to 20 cm in width. A few days before the disaster, it  
25 subsided as a block by 1.0-1.5 m (Fig. 1).

26 On May 8, 1969, at 4:00 local time, a sliding landslide occurred with a depth of engagement  
27 of 10-12 m and a volume of 0.12-0.14 million cubic meters. The landslide moved down from a  
28 height of 120 m, burying the settlement of Gurdara, which had a population of 300 people.

29 The detachment zone had distinct characteristics. The width of the landslide cirque in the  
30 lower zone was 1.3-1.4 times greater than in the upper zone, measuring 130-140 m. The interior  
31 of the landslide cirque was completely cleared of displaced rock masses. The upper boundary of  
32 the detachment wall was smooth without any undulations, while the lateral boundaries of the  
33 detachment wall were slightly lower in height than the main detachment wall. All these features  
34 indicate a unified and simultaneous displacement of the rock masses.

35 **Debris Avalanche:** The displaced mass of loess deposits from the right bank of the slope  
36 cascaded onto the left bank along a gentle terrace. The displaced mass was in a moist and highly  
37 fragmented state, but the soils were not in a fluid state. The avalanche engulfed the settlement  
38 in a uniform strip, extending approximately 150-170 m in length and 100-120 m in width, with a  
39 consistent thickness of 3-4 m. The formation of the avalanche likely occurred through the  
40 overlapping and simultaneous horizontal spreading of the landslide masses upon each other within  
41 the floodplain. The displacement and spreading of the collapsed rocks occurred instantaneously,  
42 resulting in the loss of all human lives in the affected area.

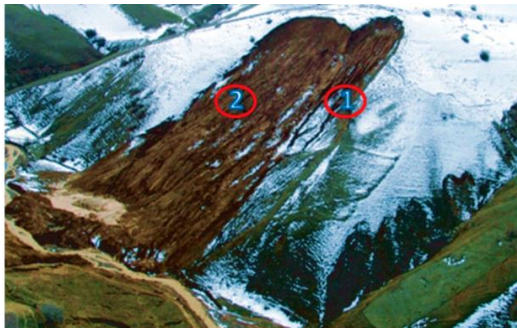
Fig. 3. Tokberdy landslide (1994)

33 **Tokberdy-1 landslide** (April 18, 1994). On a straight slope with a height of 170 m and a  
34 gradient of 35-40° along the watershed line, a large crack measuring up to 400 m in length and  
35 0.3-0.5 m in amplitude was observed. In March 1994, the crack began to lengthen, and lateral shear  
36 cracks appeared, dividing the landslide mass into two parts (Fig. 3).

Three hours before the landslide occurred, the daily rate of crack widening reached up to 2-18 mm per day. The landslide, with a volume of 0.16 million m<sup>3</sup>, covered the riverbed and partially buried houses. People were warned, and two individuals who were dismantling their house lost their lives. Ten years later, on April 25, 2004, the right side of the Tokberdy landslide, with a volume of 0.2 million m<sup>3</sup>, moved at a speed of 5 m/s, shifted 140 m, blocking the riverbed and the area where residential structures had

1 Thus, the detachment zone was located in the upper, gentle part of the watershed at an  
2 elevation of 160-170 m above the riverbed. The average depth of displacement was approximately  
3 10 m. The length of the detachment zone and its width ranged from 80 to 110 m, and the gradient  
4 of the detachment zone was very steep, ranging from 35 to 400. The rock displacement occurred  
5 in a single cycle.

6 Deposition area: As a result of the landslide displacement, the Gushsay riverbed was temporarily  
7 blocked by a deposition spanning approximately 40-50 m in length, over 200 meters in width, and  
8 with a thickness of 2.0-2.5 m, forming a small lake. Within 3-4 hours, the deposition was washed  
9 away. The loess materials in the deposition were heavily fragmented and moistened. A second  
10 deposition occurred after the second landslide in 2004, which spread to the opposite slope over a  
11 distance of 160-170 m with a thickness of 2-4 m. The loess materials in this deposition were in a  
12 fragmented and loosened state. Tokberdy-1 landslide (April 18, 1994). Here, on a straight slope  
13 with a height of 170 m and a gradient of 35-400 along the watershed line, a large crack measuring  
14 up to 400 m in length and 0.3-0.5 m in amplitude was observed. In March 1994, the crack began  
15 to lengthen, and lateral shear cracks appeared, dividing the landslide mass into two parts (Fig. 2).

16 Three hours before the landslide occurred, the daily rate of crack widening reached up to  
17 2-18 mm per day. The landslide, with a volume of 0.16 million m<sup>3</sup>, covered the riverbed and  
18 partially buried houses. People were warned, and two individuals who were dismantling their  
19 house lost their lives. Ten years later, on April 25, 2004, the right side of the Tokberdy landslide,  
20 with a volume of 0.2 million m<sup>3</sup>, moved at a speed of 5 m/s, shifted 140 m, blocking the riverbed  
21 and the area where residential structures had previously been located. Two individuals who were  
22 herding cows and sheep in the morning perished.

23 Thus, the detachment zone was located in the upper, gentle part of the watershed at an  
24 elevation of 160-170 m above the riverbed. The average depth of displacement was approximately  
25 10 m. The length of the detachment zone and its width ranged from 80 to 110 m, and the gradient  
26 of the detachment zone was very steep, ranging from 35 to 400. The rock displacement occurred  
27 in a single cycle.

28 Deposition area: As a result of the landslide displacement, the Gushsay riverbed was  
29 temporarily blocked by a deposition spanning approximately 40-50 m in length, over 200 m in  
30 width, and with a thickness of 2.0-2.5 m, forming a small lake. Within 3-4 hours, the deposition  
31 was washed away. The loess materials in the deposition were heavily fragmented and moistened.  
32 A second deposition occurred after the second landslide in 2004, which spread to the opposite  
33 slope over a distance of 160-170 m with a thickness of 2-4 m. The loess materials in this deposition  
34 were in a fragmented and loosened state (Niyazov et al, 2012).

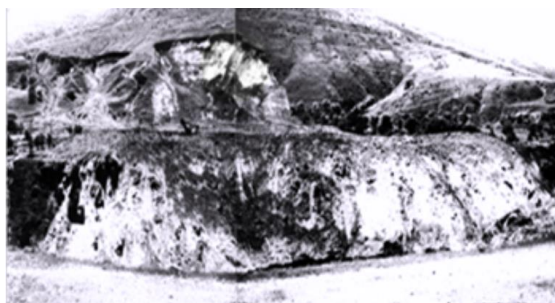
18  
19  
20  
**Fig. 4.** Photo of Khojikent landslides  
(1961 and 1969)

1 100 m along the edge of the scarp and a displacement depth of 20 m. The volume is estimated at  
2 0.4 million m<sup>3</sup> (Fig. 4).

3 The detachment zone of the landslide has a curved shape in plan, widening in the lower  
4 part to 120-130 m. The height of the detachment wall ranges from 25 to 30 m, with a steepness of  
5 80-85°. A spring with a discharge of 0.2 liters per second emerges between the middle and lower  
6 parts. The upper lateral boundary of the landslide is close to the height of the detachment wall,  
7 measuring 18-20 m and decreases in the lower part following the slope inclination. The upper edge

of the detachment wall has a smooth and straight form, indicating a single detachment event. The detachment wall was formed due to extension rather than shear displacement.

Spread zone: The displaced mass of loess deposits moved as a muddy flow along the flat surface of the terrace, covering a distance of up to 400 m and descending into the Chirchik River, forming a mudflow with a thickness of 2.5-3 m and a width of up to 200 m. The area of displacement was 19,000 m<sup>2</sup>,

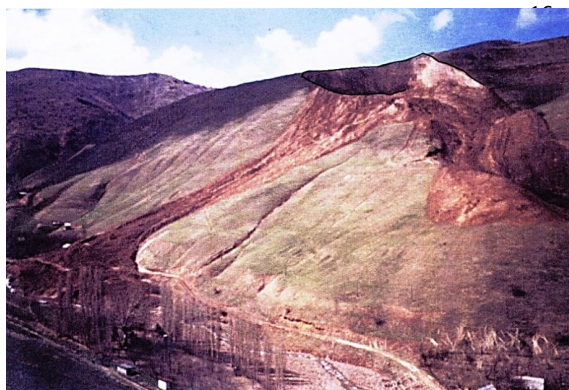
Fig. 5. Kashkasai mudflow (1994)

6 The detachment zone of the landslide is located along the line of the unusually steep  
7 watershed surface, with a length and width of 200 m and a depth of 15 m. The surface of the  
8 detachment zone's boundaries is flat, indicating a simultaneous and unified detachment. The  
9 simultaneous displacement of the entire mass of the 0.6 million m<sup>3</sup> landslide resulted in movement  
10 in two directions (Fig. 5).

11 The main portion, with a volume of 0.4 million m<sup>3</sup>, advanced along a lateral tributary for  
12 over 800 m and covered the floodplain of the river for a distance of 350 m. The second part of the  
13 landslide, with a volume of 0.2 million m<sup>3</sup>, moved towards the left side of the slope, with a flow  
14 width of 18-25 m, and also descended towards the Kashkasay riverbed for a distance of 350-400  
15 m, causing damage to one residential building and auxiliary structures.

Thus, there was no collapse or landslide dam formation. The entire mass of the landslide dispersed and remained on the slope with a thickness ranging from 1.0 to 2.5 m. The loess materials were in a loosened state but not in a liquid condition.

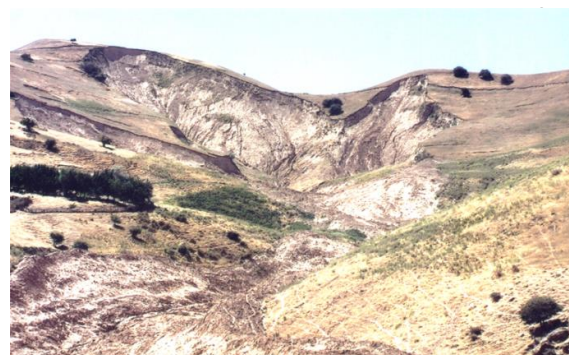
Fig. 6. Karakishlak mudflow (1994)

31 of 300. The landslide mass, originating from a height of 300 meters and with a slope inclination  
32 of 170, rapidly moved along a winding channel, covering a distance of 1.2 km while changing its  
33 direction four times. Upon entering the Gushsay Valley, the mass of debris struck the right bank,  
34 causing it to rotate by 800 and follow a curved path for a distance of 200 m. It then ascended the  
35 right bank to a height of 30 m, resulting in the destruction of a property on the opposite bank  
36 (Fig.6).

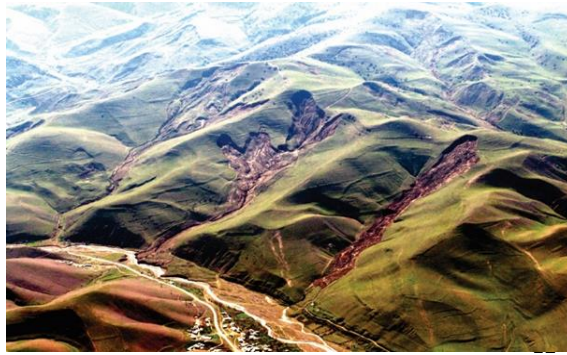
Fig. 7. Mudflows in Gushsay-Guldarama (1994)

The second landslide occurred on the right bank of the lateral stream on April 16 at 3 a.m. The landslide mass, with a volume of 800,000 m<sup>3</sup>, moved from the same height along this stream and also changed direction four times. Upon reaching the Gushsay Valley, the mass of debris struck the left bank at an angle of 35-40 degrees and continued to move upstream, ascending to a height of 60 m on the opposite bank. As a result, a road was blocked for a distance of 140 m, and nine properties were destroyed. However, people were alerted and

51 evacuated in time (Fig. 7).

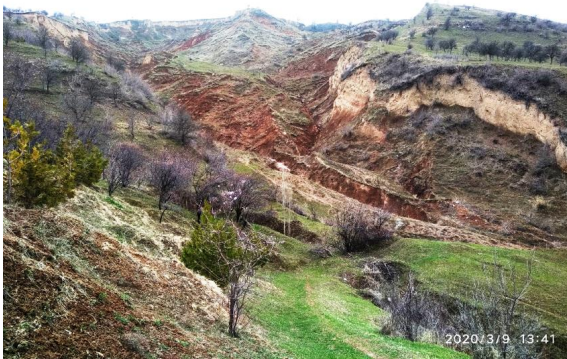
Fig. 8. Djauz mudflow (1993)

Due to the unpredictability of the direction and extent of the landslide masses, a catastrophe occurred in the village of Djauz on July 11, 1993. At 10:40 p.m., a landslide-flow with a volume of 700,000 m<sup>3</sup> occurred, advancing over a distance of more than 500 m. It developed in two stages (Fig. 8).

30 of soil crossed over to the opposite slope at a height of 60-70 m, rebounded off it, changed direction  
31 by 25-300 degrees, and caused the collapse of a residential structure (Niyazov et al, 2013).  
32

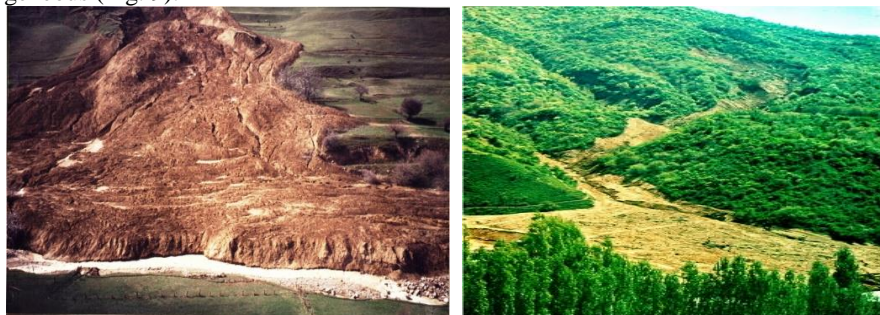
24 **“Crystal” landslides** were recorded with the following volumes: 120000 m<sup>3</sup> in 1961,  
25 30000 and 70000 m<sup>3</sup> in 1969, 160000 m<sup>3</sup> in 1979, and 600000 m<sup>3</sup> in 1994. In May 1979, for the  
26 first time, a cone-shaped flow with a width of up to 200 m and a thickness of 2.5-3.2 m obstructed  
27 the channel of Ugam River. The elevation difference between the detachment wall and the water  
28 level in the river was 250 m. The detachment zone had a length of 195 m, and the transit zone  
29 extended for 500 m, resulting in a total length of 1100 m. The river channel had several bends,  
30 where the landslide mass collided with the banks, fragmented, mixed and became more  
31 homogeneous (Fig. 9).

32 **Fig. 9.** Crystal landslide (1994). Mudflow and washout section of 200 m long, 40-45 m  
33 wide and 3 m thick.  
34

35 During its movement along the channel, the landslide left traces on the outer side of the  
36 bend, approximately 4-6 m higher than on the inner side, indicating a high velocity of movement.  
37 A secondary landslide-flow event occurred in this zone on May 9, 1994, with a volume of 600000  
38 m<sup>3</sup>. It traveled along the channel for a distance of 1100 meters and completely obstructed the Ugam  
39 River, which was 40-45 m wide, 200 m long and had a thickness of up to 3 m. After 20 minutes,  
40 instead of the dam, the erosion began on the left bank of the river channel. With a discharge of 97  
41 m<sup>3</sup>/s and strong current, the river eroded a narrow passage with a width of 4 m within one hour.

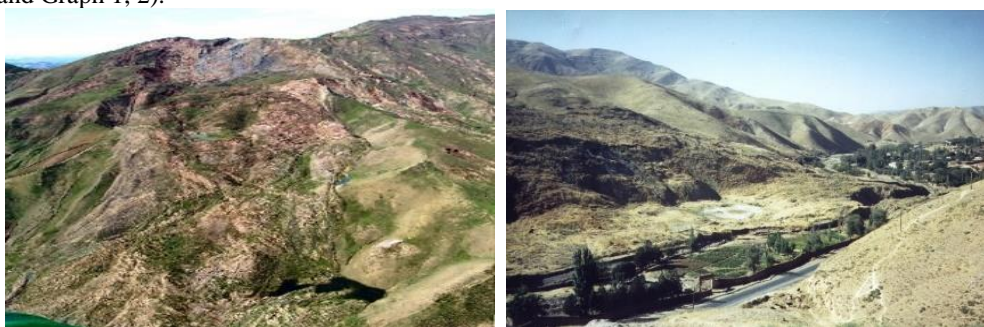
1 Subsequently, the water started widening the channel, eroding the left bank bypassing the cone-  
 2 shaped obstruction, thus forming a new floodplain. As a result, no mud or debris flow was formed.  
 3 **The Langar landslide**, located on the left bank of the Langar River, occurred on May 12,  
 4 1998, with a volume of 10.5 million m<sup>3</sup>. The detachment zone is associated with the watershed.  
 5 On a slope with a height of 420 m, a detachment scarp was formed, measuring 600 m in width and  
 6 800 m in length, with a depth of 20-25 m of clayey rock displacement. The development of the  
 7 landslide occurred through consecutive and rapid displacements, ranging from 50 to 80 meters per  
 8 day, additionally involving the underlying sandy-clay deposits with a thickness of 8-10 m (Fig. 10  
 9 and Graph 1, 2).

10  
 11 **Fig. 10.** The upper zone of the Liangar landslide failure and the lower zone, where the overlap of  
 12 the river bed and the formation of the dam occurs (1998).  
 13

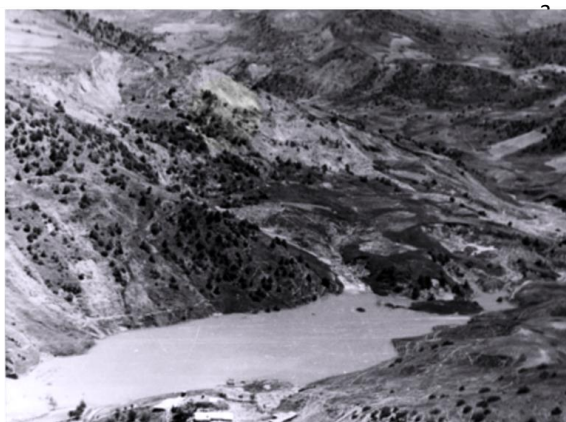
1           **The "Kattakishlok" landslide**, which occurred on March 10, 1969, is located on the right  
2 bank of the Uradari River. It consists of clayey layers with a thickness of 3-4 m, underlain by

17  
18  
19  
20  
**Fig. 11.** A landslide rockfall and a lake in the village  
of Kattakishlok in the Uradarya river basin,  
March 10, 1969.

sandstones and aleurolites with interlayers of clay from the Cretaceous period. The sandstone and aleurolite layers, with a thickness of 15-20 m, shifted along the clayey layers of the Cretaceous formation, resulting in a displacement of 0.7 million m<sup>3</sup> of material. The landslide mass extended over a length of 600 m, with a width of 150 m at the upper part and 200 m at the lower part. The circular-shaped scarp had a height of 35 m.

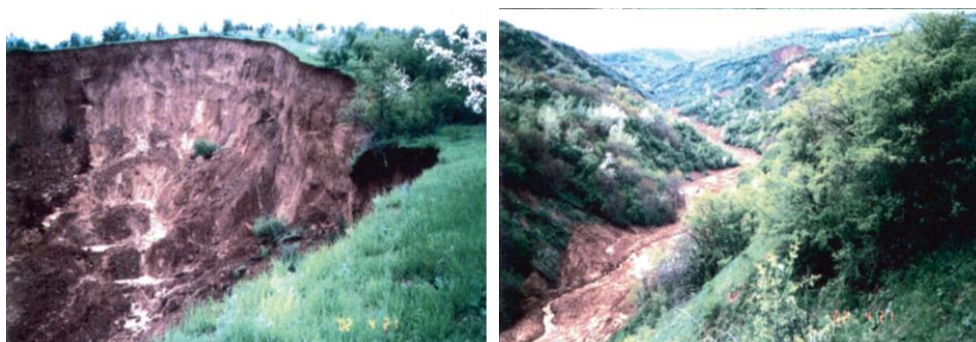
Fig. 12. Breakaway wall and mud flow along the Sharkilamasai (2002).

42           At the base of the slope, a debris accumulation formed, measuring 40 m in width, 50 m in  
43 length and 8-10 m in height. A debris lake was formed, and it underwent erosion, resulting in a  
44 mudflow. The volume of water in the lake, which formed over a few hours, amounted to 840 m<sup>3</sup>  
45 (60x20x7), as the water discharge in Sharkilamassai was approximately 100 m<sup>3</sup>/hour.

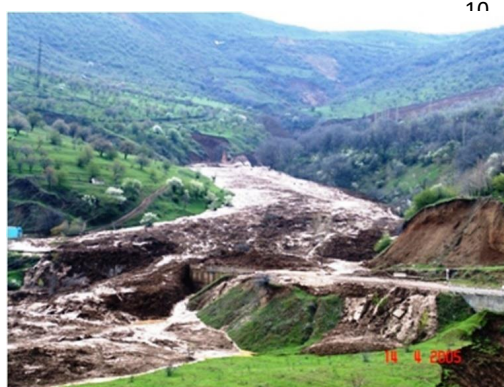
Fig. 13. Baibaksay landslide

3 **The Baibaksay landslide** formed on April 7, 2005, in an area where cirques and landslide  
4 cracks from 1969 were present. The displacement occurred on a slope with a height of 250 m and  
5 a gradient of 30°, consisting of loess deposits. The mudflow, with a volume of 1.4 million m<sup>3</sup>,  
6 formed in a zone with a length of 350 m and a width of 200 m. In the first day, it advanced 700 m  
7 with a depth of 6-8 m and a width of up to 60 m. Four springs with a total discharge of 4-5 liters  
8 per second emerged from the wall of the detachment area. Three days later, during the night of  
9 April 10th to 11th, the mudflow progressed an additional 200 m and began to cover an overland

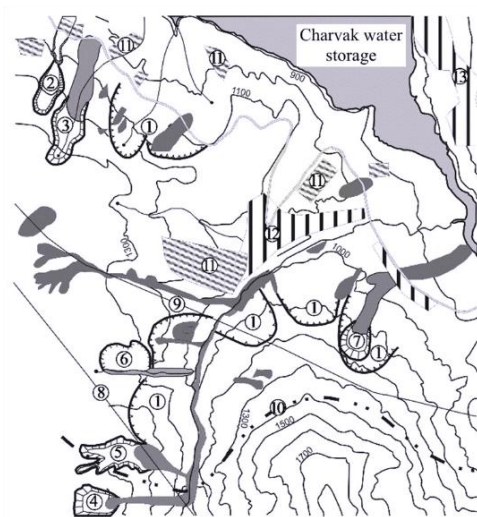
Fig. 14. Overview of Mazarsay mudflows

44 wide channel, the displaced mass turned 90° to the north and merged with Mazar-Say, reaching  
45 the Chatkal River within 10 hours, forming a mudflow with a length of 3.1 km and a depth of  
46 0.5-1.5 m (Fig. 14).
