Optimization strategy for flexible barrier structures: Investigation and back analysis of a rockfall disaster case in southwestern China

Abstract. Field investigations and back analyses were conducted on a rockfall hazard. The flexible barrier protection system constructed along the roadside was damaged by the rockfall impact and lost its ability to mitigate. Vital physical characteristics like rockfall trajectory and kinetic energy were presumed based on the data from the aerial survey and the slope digital model. A numerical model, including slope, rockfalls, and flexible barrier, was created, so the impacting process was reproduced. It demonstrates that the rockfall's impact kinetic energy is only around 40% of its design protection energy. The improper connections of members are the leading causes of damage, which prevent the flexible barrier from producing significant deformation and reduce its capacity to absorb impact force. The damage can be avoided by changing the members' connections to improve the nets' and ropes' ability to slide and deform. **The calculation results indicate that the optimized model's performance in terms of complete protection impact resistance is th

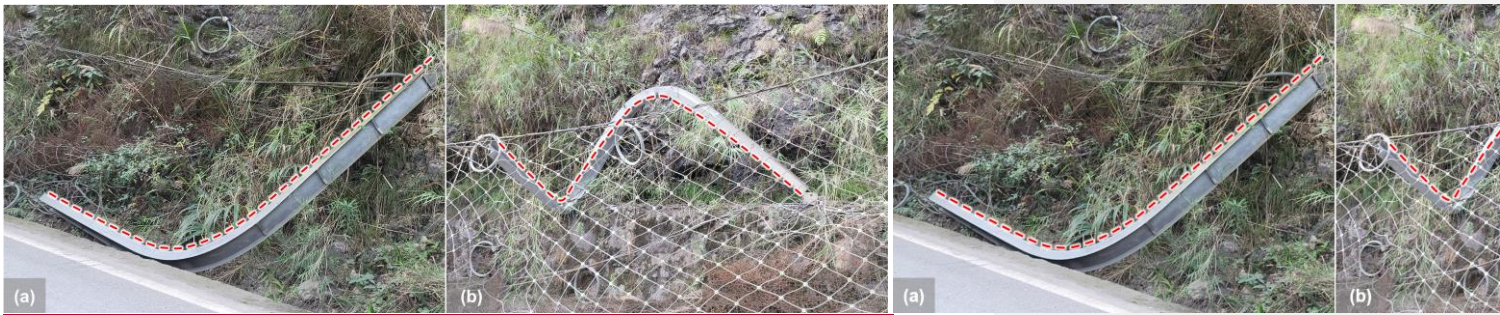
Figure 2: Steel column buckling forms of the other two flexible rockfall barrier projects: (a) "C"-shaped compression buckling and (b) "S"-shaped bending and torsion buckling.

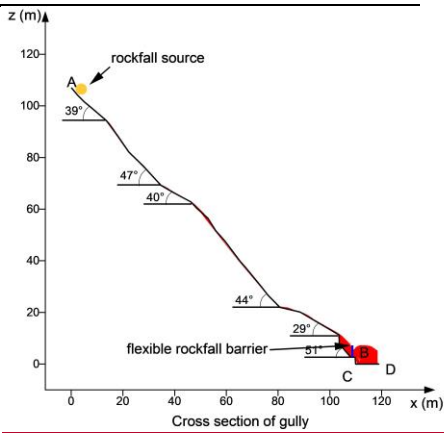
Figure 7: Rock mobility analysis Rockfall movement analysis: (a) Trajectory of rockfall and (b) Probability distribution of kinetic energy of falling rocks at the flexible barrier.

The number of falling rocks/rockfalls that reached the net (n_{fall}) after 10,000 calculations was 3433. Fig. 7b depicts the distribution of the kinetic energy of rockfalls that impact the flexible barrier (E_{impact} , $E_{impactor}$). The impact energy ranges from 73.64 kJ to 220.6 kJ, with a maximum value lower than the project's design protection energy level. The final determination of the impact energy of the falling stone impacted on the system was 100 kJ in the finite element calculation simulation (Section

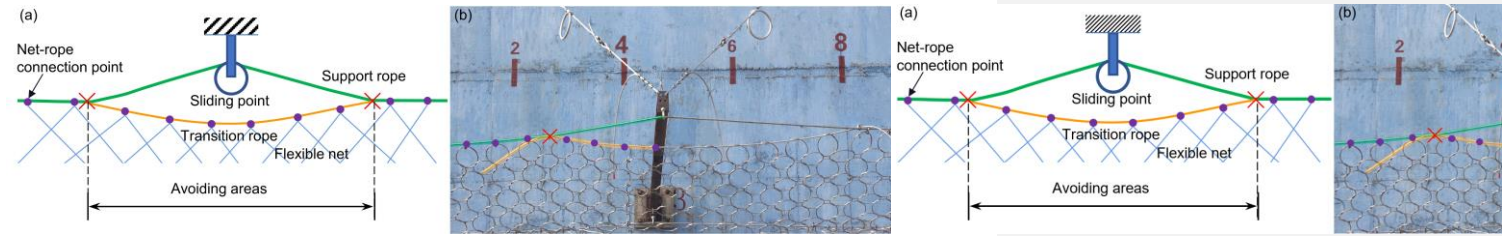
Figure 15: The transition rope applied between column ends and support ropes: (a) Structure schematic and (b) project photo.

between the steel column end, the support rope, and the flexible net. The transition rope should be used in most cases where the design protective energy is 1000kJ or less and the support rope does not slide a significant distance along the end of the column (Yu et al., 2018b). The transition rope can prevent the lateral force at the column end and a sharp rise in the axial force of the steel column generated by the net jamming, both of which cause the column to buckle (Fig. 15).
