Optimization strategy for flexible barrier structures: Investigation and back analysis of a rockfall disaster case in southwestern China

Abstract. Field investigations and back analyses were conducted on a rockfall hazard. The flexible barrier protection system constructed along the roadside got damaged by the rockfall impact and lost its ability to mitigate. Vital physical characteristics like rockfall trajectory and kinetic energy were presumed based on the data from an aerial survey and the slope digital model. A numerical model, including slope, rockfalls, and flexible barrier, was created, so the impacting process was reproduced. It demonstrates that the rockfall's impact kinetic energy is only around 40% of its design protection energy. The improper connections of members are the leading causes of damage, which prevent the flexible barrier from producing significant deformation and reduce its capacity to absorb impact force. The damage can be avoided by changing the members' connections to improve the nets' and ropes' ability to slide and deform. The calculation results indicate that the optimized model's performance in terms of complete protection is three times better than

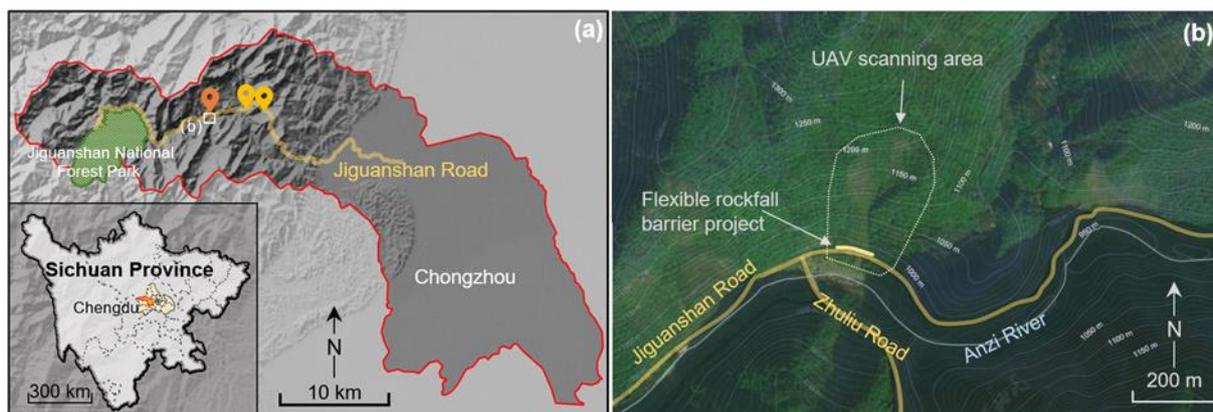
75
Figure 1: Geological map of the rockfall disasters: (a) Regional terrain and the location of the three disaster sites. Map data: <https://mywis.cn/> and ©Aliyun 2022; (b) Regional aerial image of the case focused in this paper. Image: www.tianditu.gov.cn.

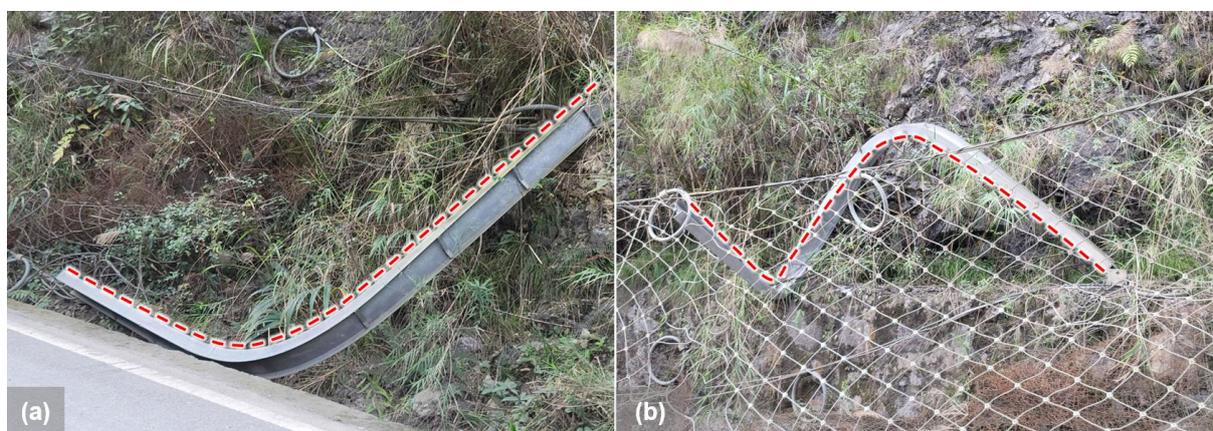
buckling steel columns, with the most common buckling forms being "C"-shaped compression buckling and "S"-shaped
bending and torsion buckling (Fig. 2). This paper provides a detailed investigation and analysis of a disaster site where rockfalls
had not been cleared at that time (Fig. 1b).

80
Figure 2: Steel column buckling forms of the other two flexible rockfall barrier projects: (a) "C"-shaped compression buckling and
(b) "S"-shaped bending and torsion buckling.

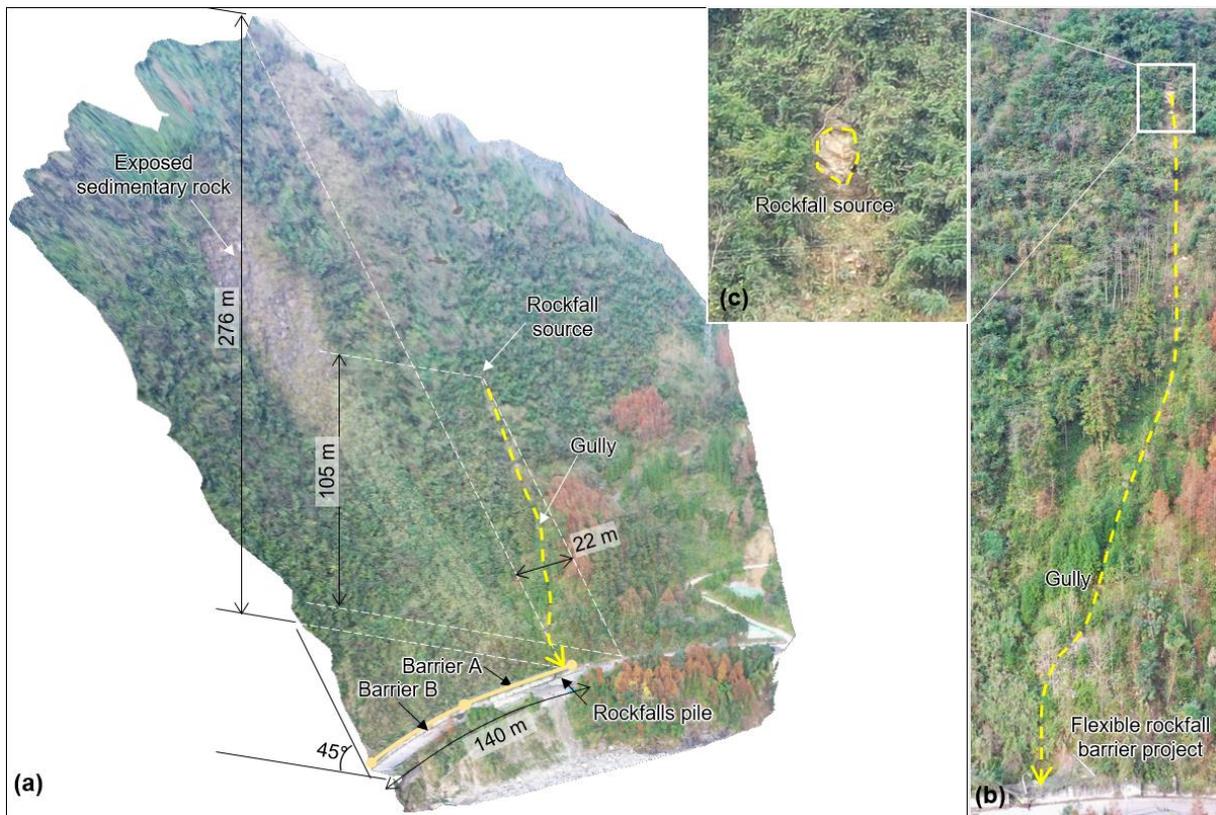
Based on the slope inclination photography information obtained by the UAV, a 3D digital model of the terrain was constructed with the help of ContextCapture software (Bentley, 2021), with a reduction accuracy of centimeter level. The 3D model of the scanned slope is depicted in Fig. 3a; it is roughly 276 meters high and slopes at a 45° angle, with a steep top and a gentle bottom. The hill was primarily covered by medium-high shrubs and bushes. Its foot was predominantly covered by plants like ferns, bamboo, and reed-like herbs, typical in southern and southwestern China. Sedimentary rock formations were exposed in the concave cavity area in the middle of the slope, and numerous hazardous rocks were created by the prolonged penetrating joints and fissures that divided the rock into broken blocks or pieces of various sizes. The area on the slope where new rock layers were exposed after rock spalling was presumed to be the source of rockfalls. The rockfall source was located 105 meters above the stopping point at the bottom of the hill and was 22 meters lateral along the road. A small amount of gravel and debris was scattered in the gully, and the vegetation along the front section of the gully was severely destroyed. About 2 meters wide, the gully had a minor quantity of rubble and garbage spread throughout it, and the vegetation along the front half of the gully had been severely devastated (Fig. 3). Rockfalls had been stopped by the retaining walls and the flexible rockfall barrier built at the foot of the slope.

Figure 3: Investigation results of the rockfall source area and trajectory. (a) The digital model of the slope; (b) Rockfall impact gully; (c) Rockfall source.

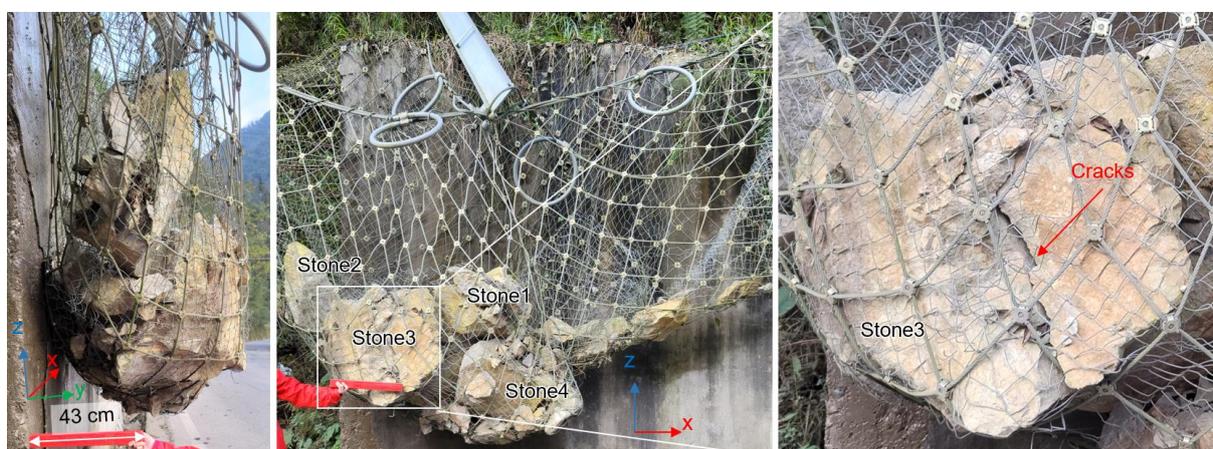
100 Many intercepted rockfalls, mostly tuff and muddy, were pocketed inside the nets of the protection system, as depicted in Fig. 4, with sharp angles and disparate blocks. The four largest blocks of these stones could be approximated as four cubes: Stone 1 was $0.5\text{m} \times 0.5\text{m} \times 0.5\text{m}$, Stone 2 was $0.3\text{m} \times 0.3\text{m} \times 0.7\text{m}$, Stone 3 was $0.8\text{m} \times 0.9\text{m} \times 0.7\text{m}$ and Stone 4 was $0.4\text{m} \times 0.4\text{m} \times 0.4\text{m}$. Stone 3 with cracks was thought to have been broken after hitting the barrier, while the remaining stones seem to be crushed in the movement. The remaining debris has a diameter of about 0.05 m to 0.1 m.

Figure 4: Rockfalls piled up in the net.

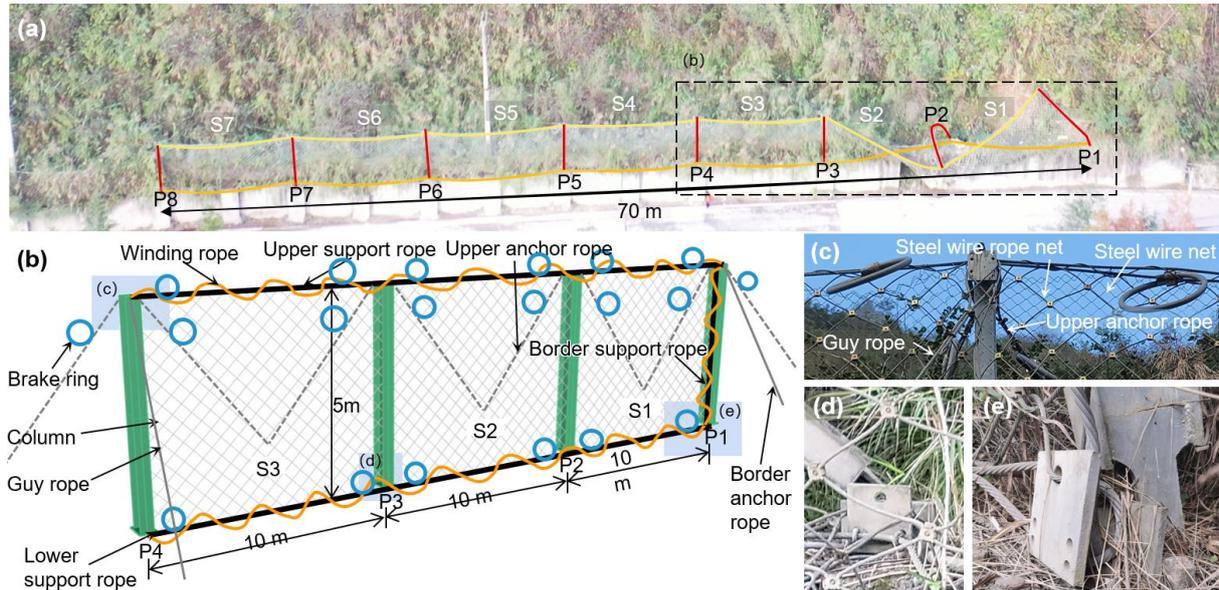
110 Barrier A, impacted by rockfalls, was the subject of a thorough investigation in this research (Fig. 5a). Eight support posts divided Barriers into seven spans, each 10 meters wide. Two of the seven spans, S1 and S2, were damaged by rockfalls and collapsed. The eight 5 meters high steel columns served as the support posts, numbered P1 – P8, and were bolted to the base with a specific swing space in both the longitudinal and transverse directions (Fig. 5b & 4e). Bolted to the top of the retaining wall were the bases. To guarantee the stability of the steel columns, the upper anchor ropes, border anchor ropes, and guy ropes were snapped to their top (Fig. 5c). The ends of steel columns P1 and P8 were fixed with support ropes (including upper, lower, and border support ropes) by rope buckles (Fig. 5e), the upper support rope of the middle spans was lapped to the top of the support posts (Fig. 5c), and the lower support rope of the middle spans passed through the rings on the column bases (Fig. 5d). As energy-consuming devices, brake rings were used to connect the upper anchor rope, and upper and lower support cables near each column ends (Fig. 5b & 4c). Steel wire rope net and steel wire net made up the interception unit (Fig. 5c).

120 The steel wire net was connected to the steel wire rope net and support ropes by steel wire. Steel wire rope net was woven by winding ropes to the support ropes and hooking to the end of the column. All the steel's anti-rust and corrosion plating remained

Figure 5: Structure composition of the flexible barrier. (a) Overall photo of the project; (b) Components connection relationship; (c) Column upper end; (d) Base and foot of column in the middle spans; (e) Base and foot of border column.

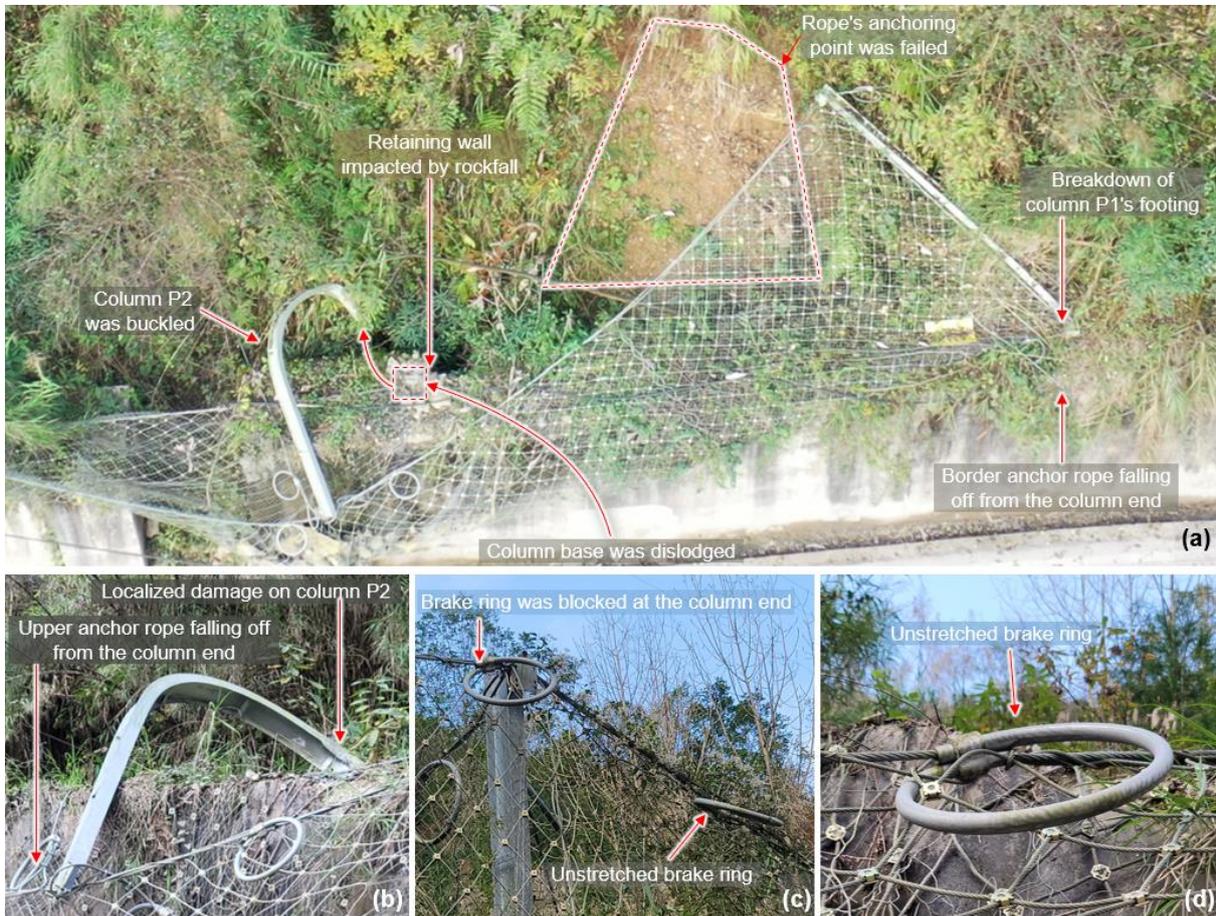
- 135 (1) Steel column was buckled and destabilized. Due to extreme buckling instability, column P2 could not withstand further pressure (Fig. 6a & 5b).

- (2) Column base was dislodged. The base of steel column P2 detached from the column base on top of the concrete retaining wall (Fig. 6a);
- (3) Rope's anchoring point failed. Due to the anchoring end falling off, the upper anchor ropes connecting steel columns P1 and P2 were not properly functioning (Fig. 6a).

- 140 (4) Steel column was falling. Due to the steel column P1's footing breakdown and the border anchor rope falling off from the column end, the steel column P1 ultimately toppled. Coupled with the instability of steel column P2 and the upper anchor rope breaking off, the interception spans S1 and S2 overturned (Fig. 6a).

- (5) Energy consumption of the brake ring was insufficient. None of the brake rings deployed on this flexible rockfall barrier showed any discernible activity. The brake rings were blocked at the end of the column because them being set on the support ropes in the middle spans. The support ropes were almost impossible to slide (Fig. 6c). The brake rings on the support ropes were directly prevented from being activated by the steel wire rope net and the winding rope since the support ropes were connected to the net by the winding rope (Fig. 6d)

150 **Figure 6: Damage phenomena of the flexible barrier. (a) The damaged two-span structure; (b) Column P2; (c) Column P3; (d) The connection relationship between the brake ring and the support rope and the steel wire rope net.**

The impact energy of rockfalls on the system is estimated to be minimal because the brake rings lack an evident working phenomenon, the wire rope connecting it is unbroken, and the steel wire rope net is intact.

- (1) Unreasonable installation of the flexible net: The wire rope net and the support rope was connected by winding rope; as a result, when the barrier gets impacted, the winding rope would tighten, and the wire rope net could not fully move along the support rope. And the steel column then instantaneously entered the pressure-bending state due to the wire rope net being hooked on the end of the column, which directed the impact force acting on the net to the end of the column.

- (2) Insufficient buffer space for the support rope to the columns: Since the support ropes were fixed to the border column ends, lateral tension would cause the border columns to tilt sideways when the barrier was impacted.

- (3) Unreasonable placement of the brake ring: The brake ring, which should be the component with the highest percentage of energy consumption, only dissipated 17.7 kJ of impact energy, approximately 11.2% of the total energy consumed. This is because the brake ring cannot be fully stretched due to the intertwining of the support rope, winding rope, wire rope net, and brake rings.

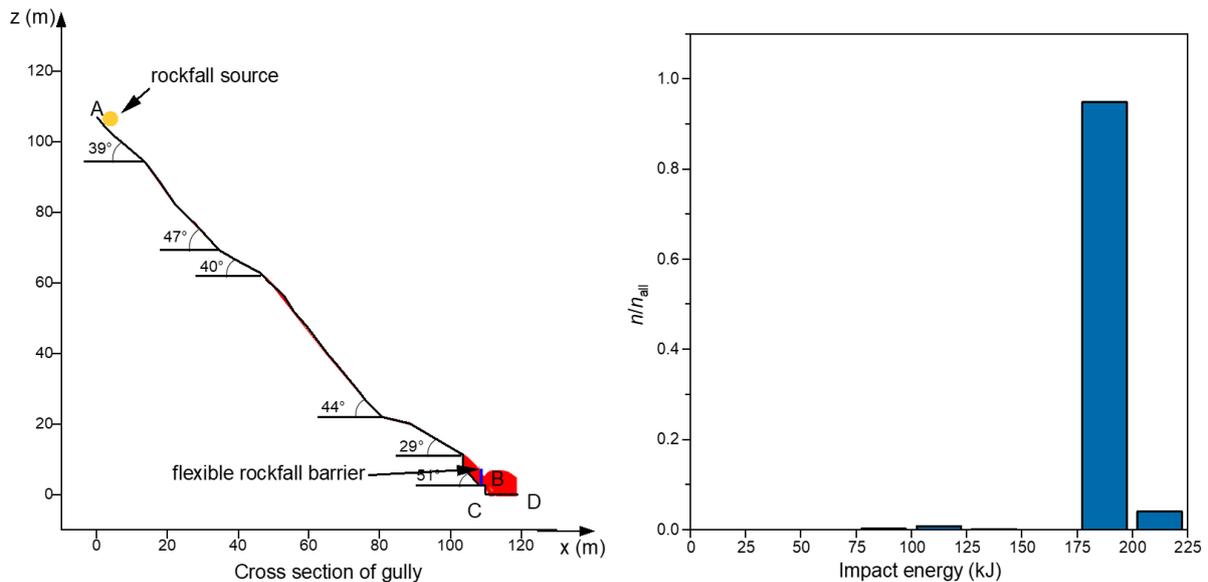
Figure 7: Rockfall movement analysis: (a) Trajectory of rockfall and (b) Probability distribution of kinetic energy of falling rocks at the flexible barrier.

The number of falling rocks that reached the net (n_{all}) after 10,000 calculations was 3433. Fig. 7b depicts the distribution of the kinetic energy of rockfalls that impact the flexible barrier (E_{impact}). E_{impact} ranges from 73.64 kJ to 220.6 kJ, with a maximum value lower than the project's design protection energy level. The final determination of the impact energy of the falling stone on the system was 100kJ in the finite element calculation (Section 3.2), under seven trial calculations with the impact energy were 75, 100, 125, 150, 175, 200, and 225 (unit: kJ). This settled energy is outside the range analyzed to be the most likely, 175kJ to 200kJ. It is assumed that this is because Rocscience Rocfall primarily reflects the macroscopic scenario of rockfall movement on the slope, and less is depicted about the specifics of the rockfall movement process. Fig. 6a indicates that rockfall hit the retaining wall before hitting the passive net; this impact probably considerably reduced the energy of rockfall hitting the flexible barrier.

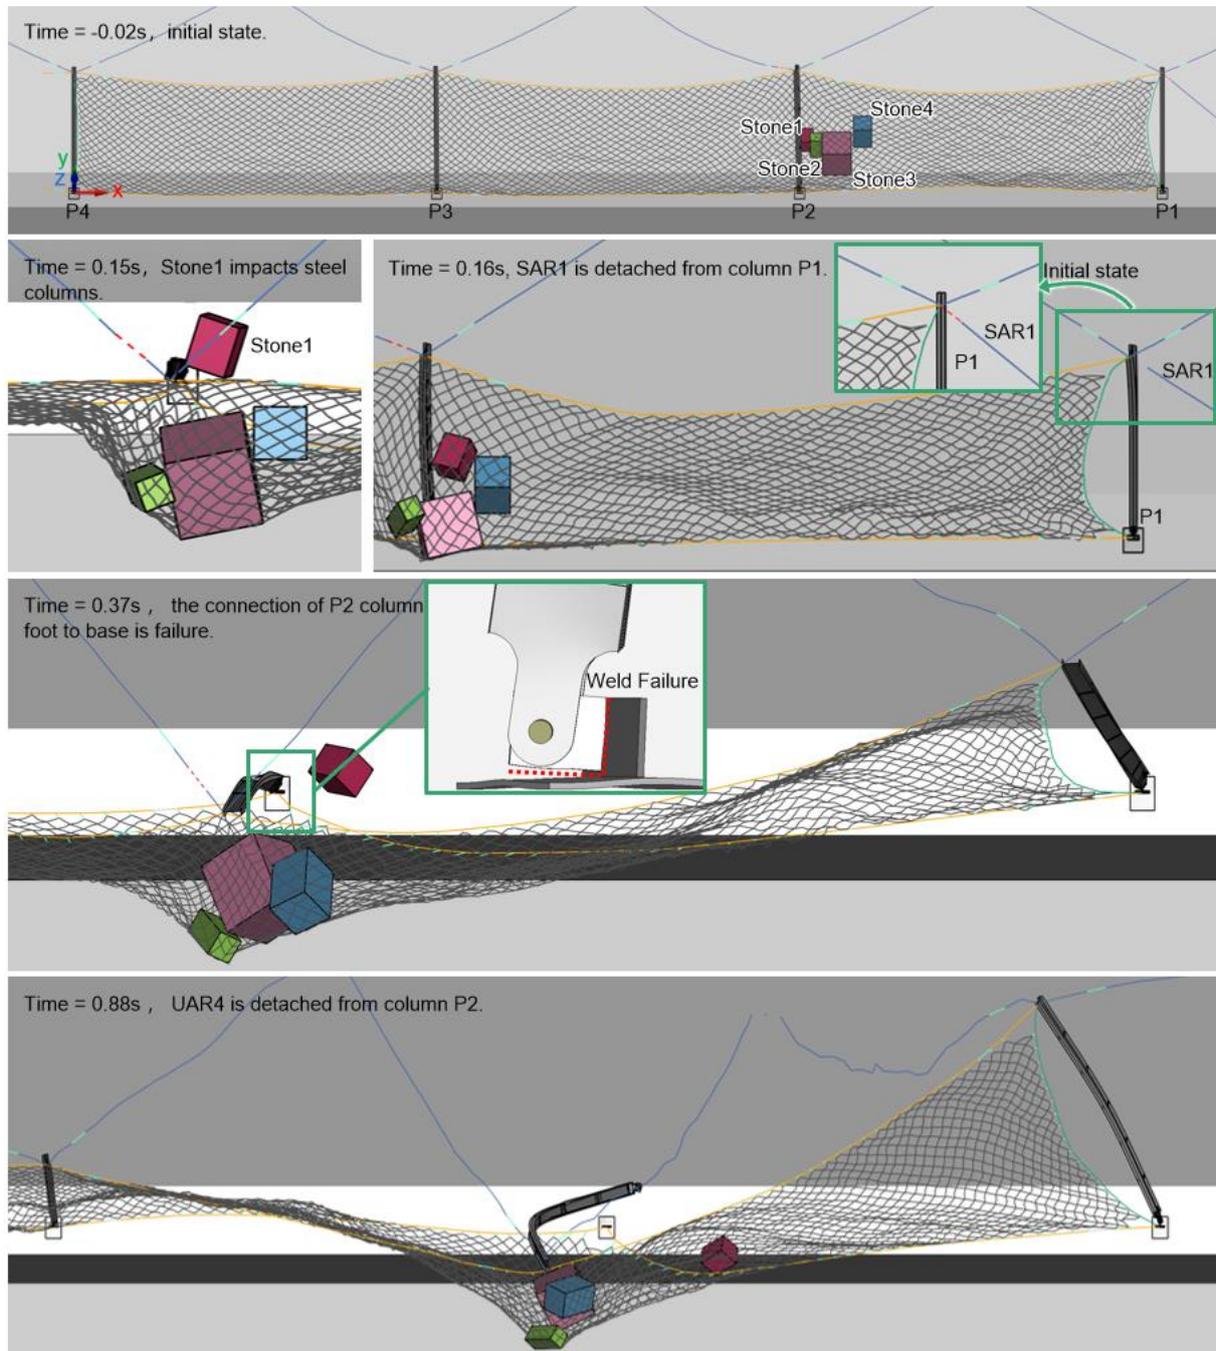
230 The process of rockfall impacting the flexible rockfall barrier is depicted in Fig. 10 as calculated by Act_BA, restoring critical
phenomena like anchor rope shedding, rope anchorage point failure, and base connection plates of column failure. Finally, the
entire protection system was destroyed, and the rockfalls were piled up to the right of the net near the end of column P2,
essentially in the same state as the actual project.

Figure 8: Keyframes of the impact process (the 0 instant occurs when Stone3 touches the wire rope net).

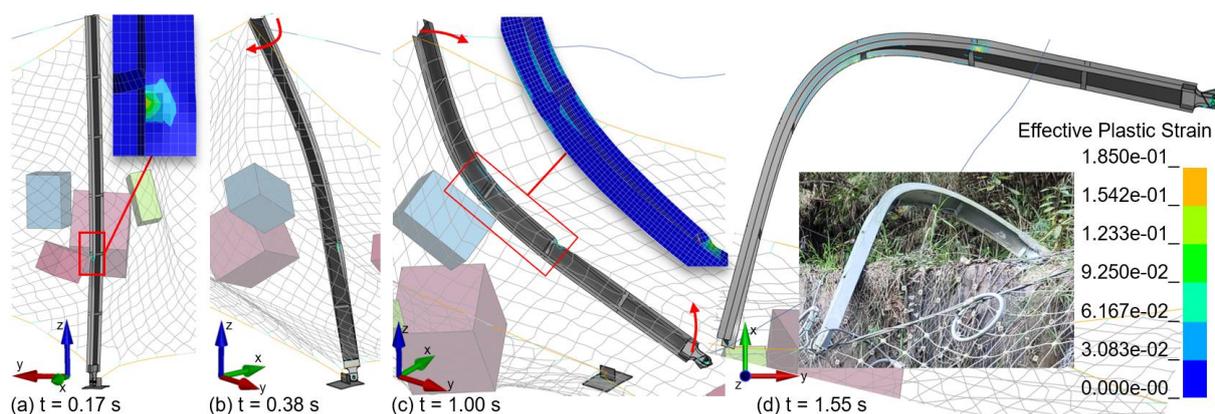
Like the actual project, the steel column P2 suffered substantial buckling damage, and the flange also sustained localized damage. And border column P1's foot damage caused the column to be dumped entirely. Fig. 11 depicts the buckling progression of steel column P2 in Act_BA: At 0.15 s, Stone1 impacted steel column P2, causing localized damage at the impact point; at 0.25 s, the stress on both sides of the end of the steel column P2 was out of balance after the failure of the anchorage point connected to the ropes UAR2 and UAR3, while the column foot was restrained and the column P2 was twisted; at 0.37 s, the base connection plate of the column P2 welded failed as a result of the column foot twisting, releasing the column P2 from the torsional restraint and turning it into a compression-bending member; at 0.98 s, the column P2 was impacted by the rebounding stone; finally, a C-shaped buckling state was created by constantly compressing and stressing the steel column P2.

245 **Figure 9: Column P2 deformation development in Act_BA.**

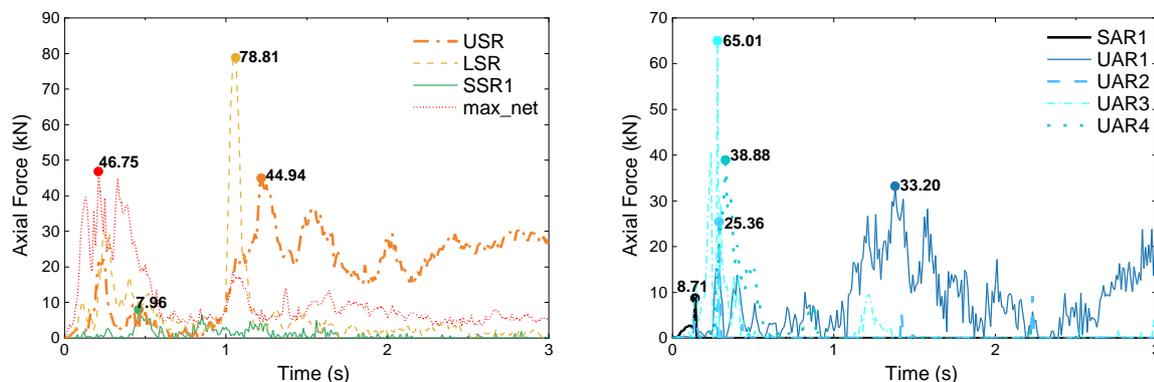
The numerical simulation reproduced the phenomena of rope failure, such as the failure of the rope anchorage point connected to upper anchor ropes UAR2 and UAR3 and the disengagement of the side anchor rope SAR1 and upper anchor rope UAR4 from column P1's end. Fig. 12 shows the temporal evolutions of wire ropes' internal force, where all the wire ropes' axial force extreme is below the breaking strength of the corresponding specification wire rope. However, considerable tension pulses were seen in LSR and UAR3 because of the confined member slide deformation. Additionally, each wire rope in the wire rope net had an axial force that was consistently less than the breaking force.

Figure 10: Axial force of the Wire ropes in Act_BA

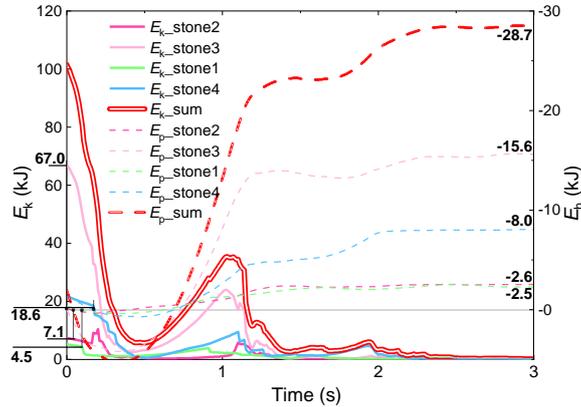
An energy analysis of the protection process was carried out based on the simulation results to assess the protection system's contribution to the interception of rockfalls. The initial moment of impact kinetic energy and falling stone potential energy were taken from the moment the first rock, Stone3, touched the barrier in this paper, even though there were differences in the times at which each rockfall impacts the barrier. The temporal evolution of kinetic energy and potential energy of rockfalls shows that the total impact kinetic energy was 101.4 kJ, which is 40.1% of the design protection energy of the flexible rockfall barrier (Fig. 13). During the protection process, the gravitational potential energy of rockfalls and flexible barrier decreased by 26.5 kJ and by 29.9 kJ, respectively. Therefore, the energy consumed in the protection process (E_{all}) was 157.8 kJ. Table 4 displays the energy distribution during the protection process: The three paths of energy consumption are material elastic-plastic deformation energy consumption, component contact friction energy consumption (including winding rope energy consumption), and system/air damping consumption, with energy consumption of 56.9kJ, 93.9kJ, and 7.0kJ, accounting for 36.06%, 59.51%, and 4.44% of the total energy consumption, respectively. Noteworthy, the steel column consumes 34.7kJ, about 60.83% of the energy consumed by material elastic-plastic deformation.

Figure 11: Temporal evolution of kinetic energy and potential energy of rockfalls.

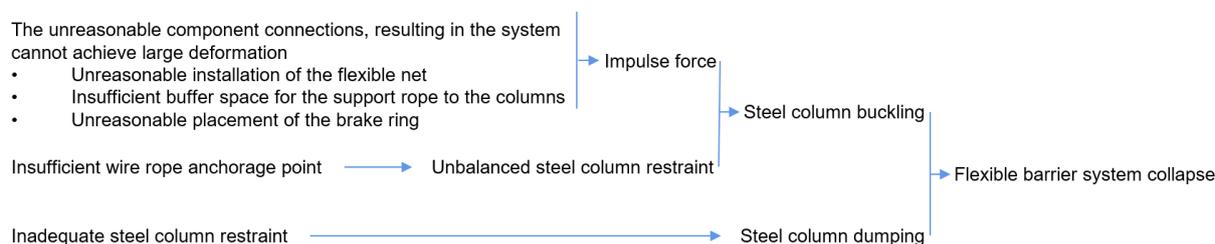
Combining the information from the field investigation and the back analysis, the reasons for the failure of the flexible rockfall barrier are analyzed as follows:

Model Ctrl_BA strengthens the connections as well as the wire rope anchorage points. The result of Ctrl_BA shows that column P1 was always in the normal working condition, column P2 did not enter the torsional force state, but column P2 still entered the C-shaped compression bending flexure state as in the Act_BA working condition. Moreover, no damage to the members due to low material configuration was found in the field survey results, model Act_BA or model Ctrl_BA. This means that the three unreasonable connections—unreasonable flexible net installation, insufficient buffer space for the support rope to the columns, and unreasonable placement of the brake ring—are the primary causes of this mitigation project's inability to withstand the rockfall impact. Due to the unreasonable component connection form, a sliding system could not be formed, and the flexible rockfall barrier's buffering mechanism also could not be developed. This resulted in an impulse force at the column end, which eventually caused the steel column to buckle and the system to collapse. Therefore, achieving substantial system deformation requires adequate relative sliding motion between the components, especially the sliding ability of the support rope at the column end (Fig. 14).

310 **Figure 12: Analysis of the system damage mechanism of Act_BA.**

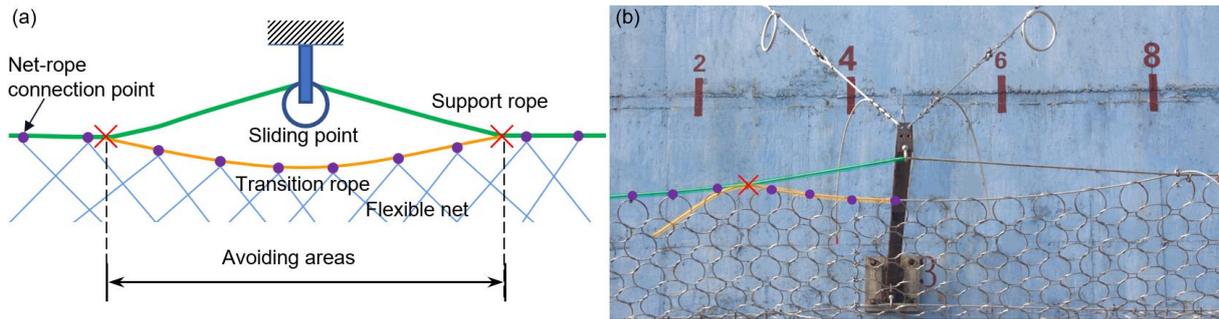
Figure 13: The transition rope applied between column ends and support ropes: (a) Structure schematic and (b) project photo.

Whether the support rope allows for sliding at the end of the steel column depends on the connection mechanism employed between the steel column end, the support rope, and the flexible net. The transition rope should be used in most cases where

315 the design protective energy is 1000kJ or less and the support rope does not slide a significant distance along the end of the column (Yu et al., 2018b). The transition rope can prevent the lateral force at the column end and a sharp rise in the axial force of the steel column generated by the net jamming, both of which cause the column to buckle (Fig. 15).

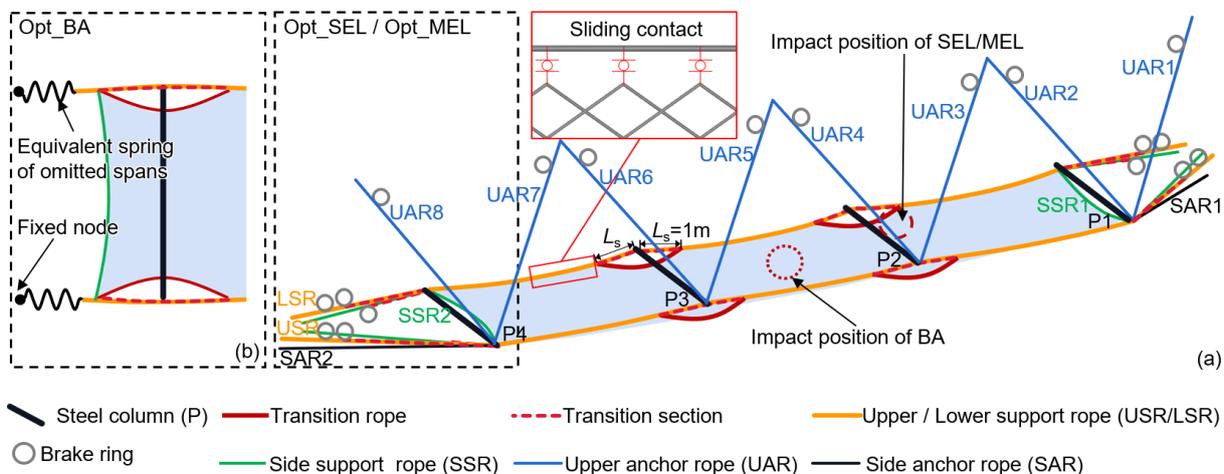
330 **Figure 14: Structure representation of the model Opt_. (a) Simulation models Opt_SEL and Opt_MEL. (b) Simulation model Opt_BA.**

320 The control model (Ctrl_) is optimized based on the analysis in Section 3.4, while leaving the specifications of the system components unaltered, and the optimized model is denoted as Opt_ (Fig. 16). The optimization measures are: (1) removing the brake rings from the flexible net connection portion and replacing them with a single brake ring attached to the support rope and all brake rings positioned at the wire rope's anchor end; (2) changing the connection between the column end and the support rope to a transition rope whose length of the transition section L_s set to 1 m, the maximum elongation of the linked
 325 brake ring; (3) extending the support rope from the end of the border column to the slope, and the support rope is in sliding relationship with the border column end; (4) using shackles to link the support ropes to the net or threading the support ropes through the net's holes to ensure that the relative sliding properties between the net and the support ropes; (5) setting an initial x-axis angle of 10° for the barrier to reduce the chance of it being reverse-tipped after impact.

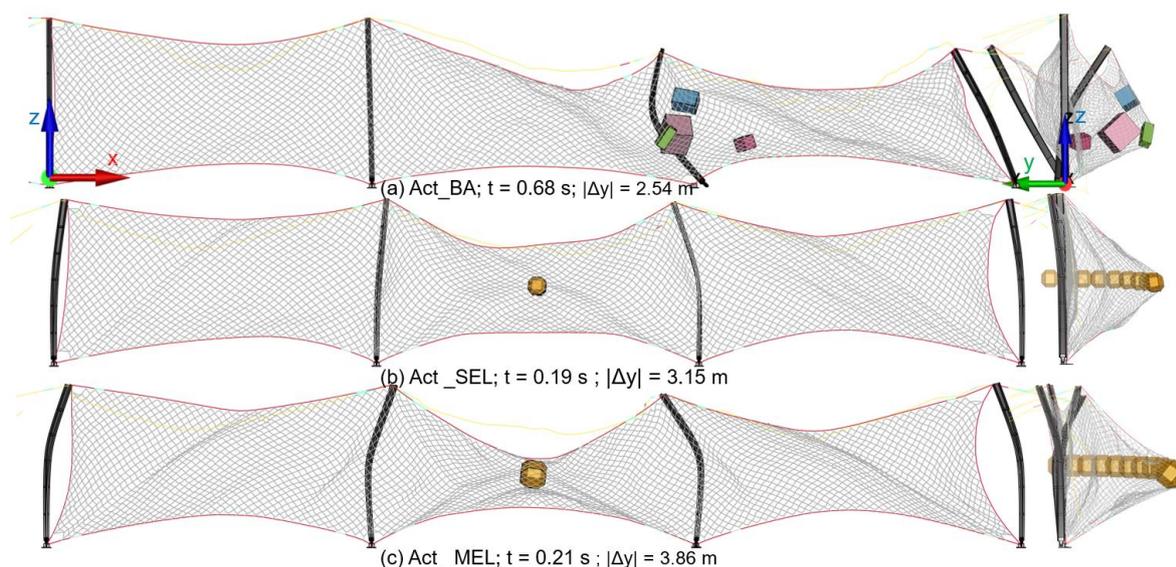
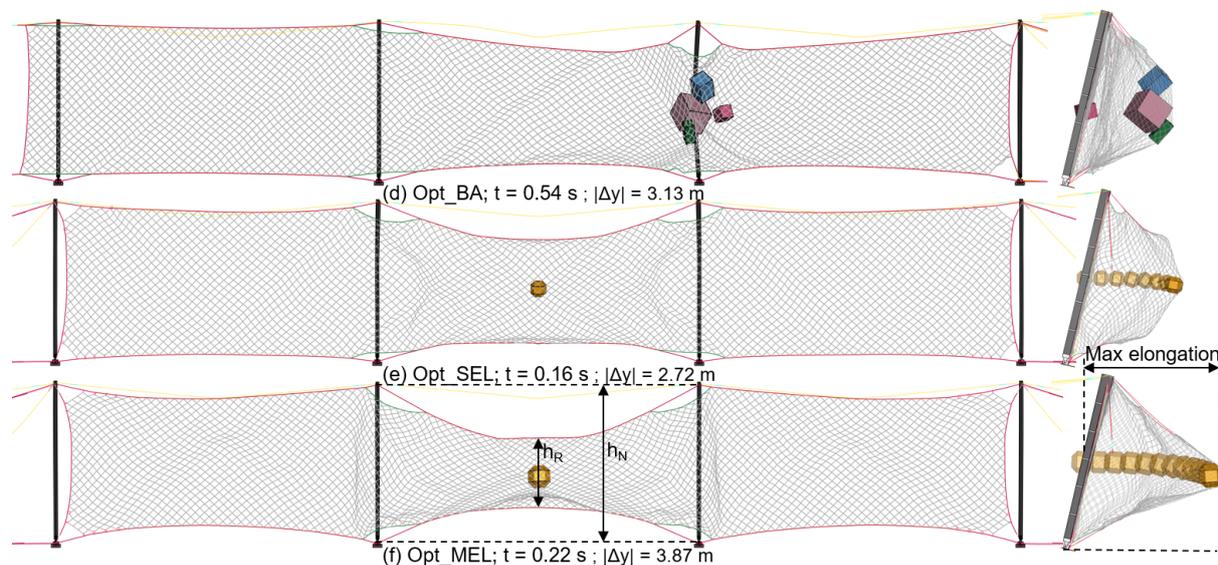
340 Fig. 17 and Table 5 display the six working conditions' outcomes and structure states. The rockfalls were stopped in all simulation conditions. Still, the model Act_ showed buckling of the steel columns in all impact conditions, significantly weakening the ability of the protection system to continue protecting. If this model had been used for the project, it would have required component replacement and structural repairs before it could continue for protection employment. In the three impact conditions of model Opt_, the entire system maintained structural integrity following impact with no buckling column.

345 In Opt_SEL and Opt_MEL, the barrier successfully intercepted rockfalls, and the barriers were not broken. After completing the interception, the structure of Opt_MEL is described below: as shown in Fig. 17f, the maximum elongation L_{max} is 3.35 meters—the guidelines require L_{max} to be less than 5 meters, and the residual height of the net h_R is 2.85 meters—the guidelines require h_R to be larger than 50% of the nominal height of the kit h_N , which meaning h_R needs to be larger than 2.5 meters. Therefore, the model Opt_ complies with standards for class A flexible rockfall barriers with 250kJ of energy in JT/T

Figure 15: System forms at the moment of maximum y-directional deformation.

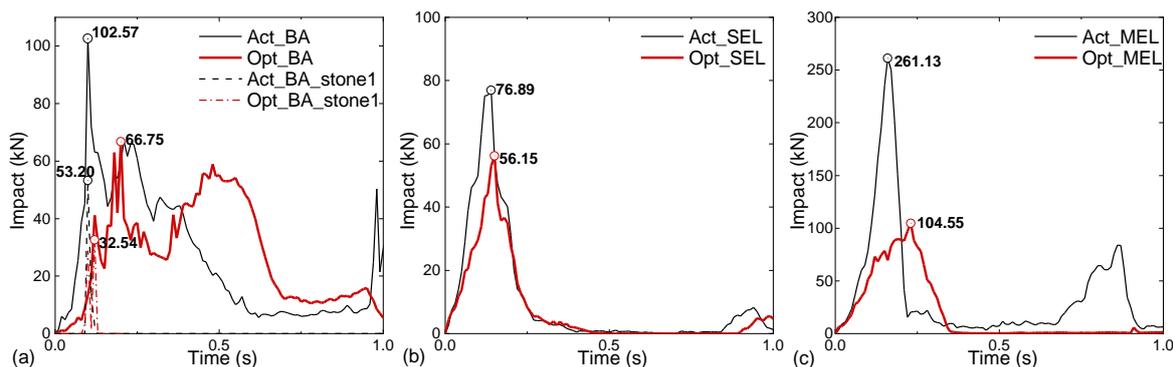
365 **Figure 16: Temporal evolution of the impact of rockfalls and barriers**

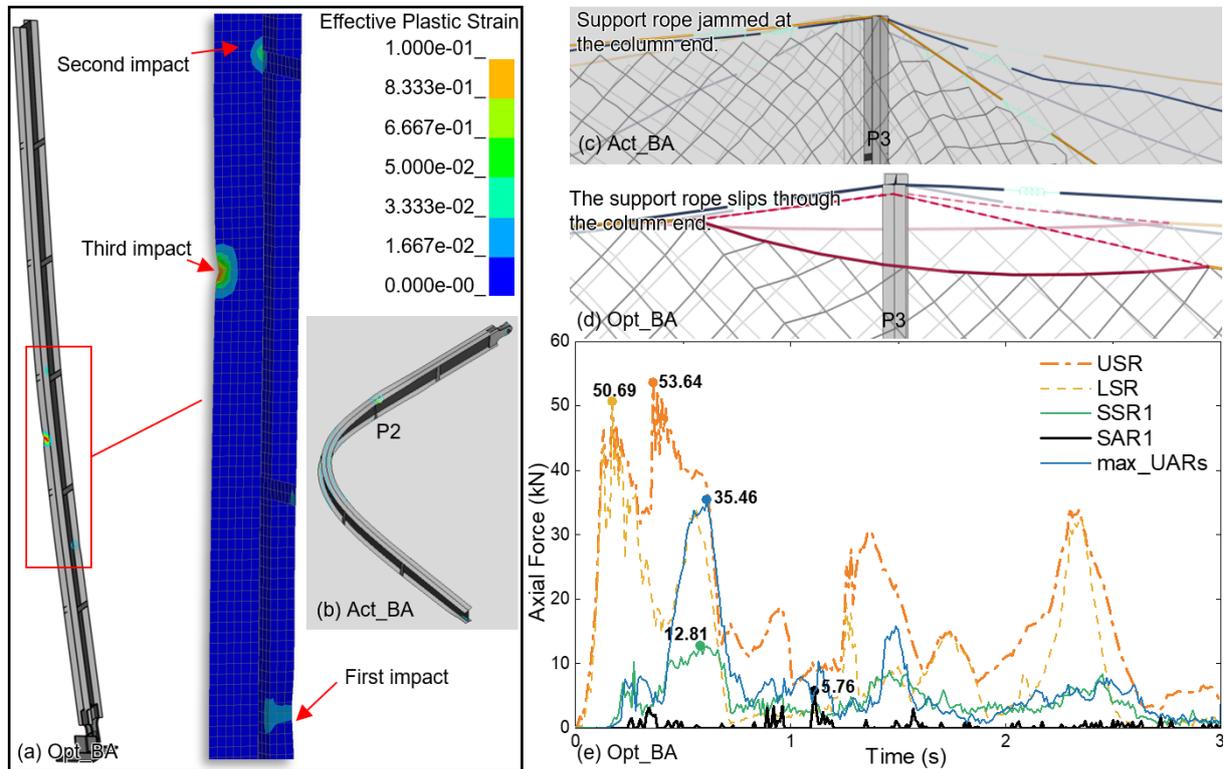
Stone1 impacted the steel column P2 in Opt_BA just as it did in the case. Still, due to the different system stiffness, the impact force was almost 39% lower in Opt_BA than it was in Act_BA (Fig. 18a). Although Opt_BA's steel column P2 suffered numerous impacts, none of them seriously damaged it (Fig. 19a). The steel column P2 experienced overall bending at the moment of the most significant system deformation (Fig. 17g). After the impact passed, the steel column recovered, and the entire structure remained stable eventually (Fig. 19a), preventing the system from overthrowing due to the buckling of the steel columns in the Act_BA (Fig. 19b).

In Opt_BA, the transition ropes prevented the net from jamming at the column end and lessened the deflection of the column caused by the tugging of the support ropes (Fig. 19c & Fig. 19d). Due to the system's improved deformation capacity, the internal force of the wire rope increased more gradually (Fig. 19e), and the phenomenon of the pulse force of the wire rope as it in Act_BA did not occur (Fig. 12).

380 **Figure 17: Opt_BA calculation result: (a) The column P2 in Opt_BA got local damages after several hits. (b) The column P2 in Act_BA was buckling. (c) and (d) are the support rope sliding performance on the end of column P3 in Act_BA and Opt_BA, respectively, where semi-transparent for pre-impact and saturated color for post-impact. (e) The internal force of part of the wire ropes in Opt_BA.**
