Early warning system for ice collapses and river blockages in the Sedongpu Valley, southeastern Tibetan Plateau

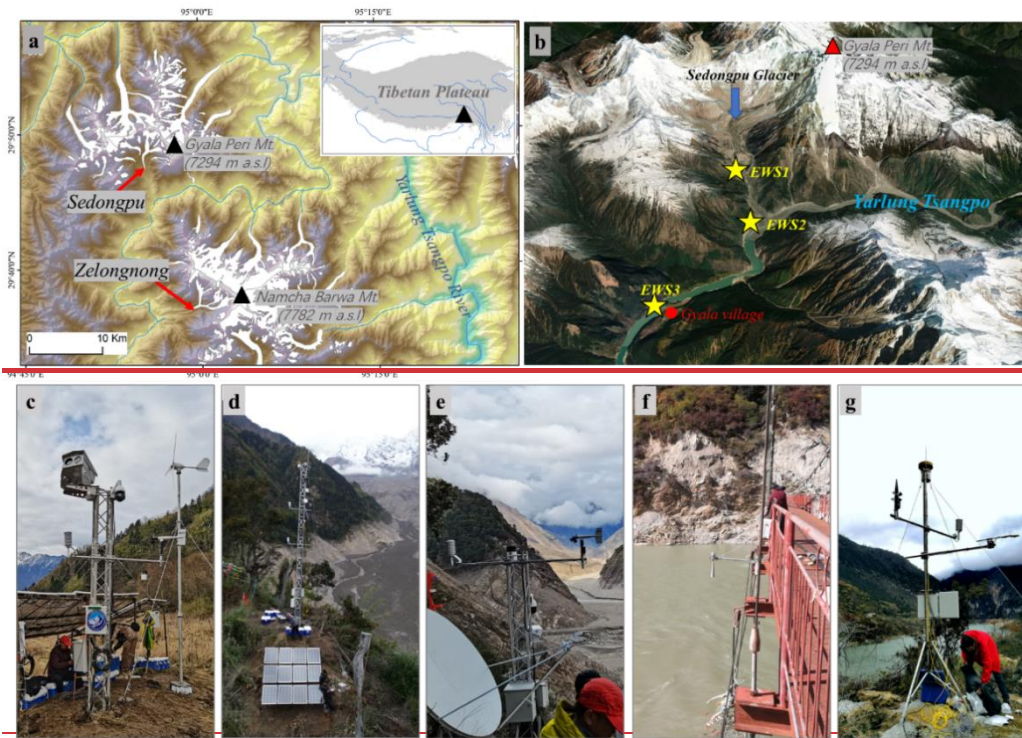
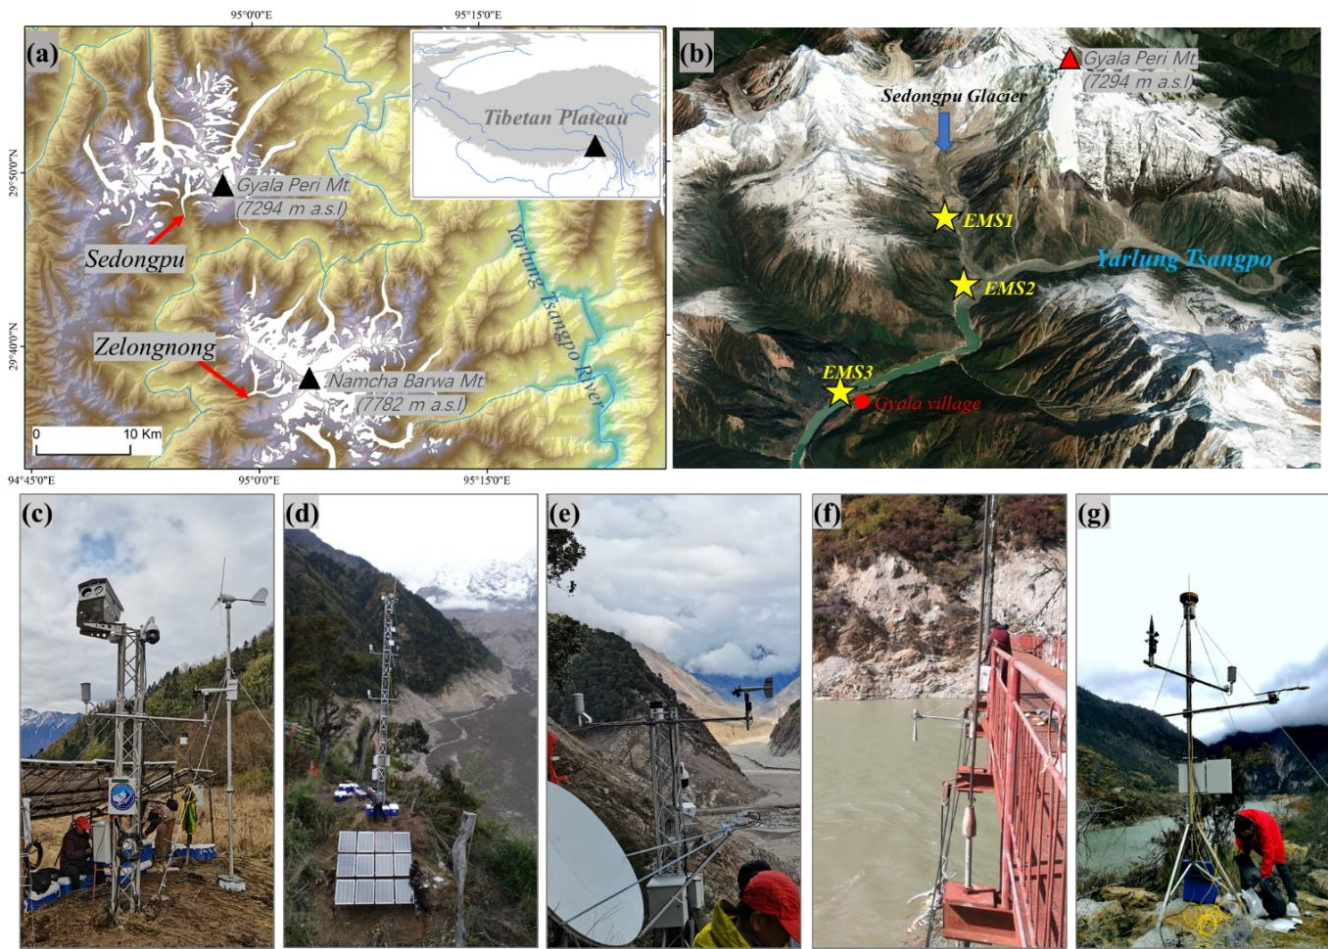
Figure 1. Study region and early warning systems. (a) Glacier distribution around the Mt. Namcha Barwa and the Mt. Gyala Peri in the southeastern Tibetan Plateau with the Sedongpu Glacier and Zelongnong Glacier; (b) @Goolge Earth image showing the 3D topography of the Sedongpu Valley and the locations of three early warning systems: EWS1-3 (yellow stars); (c) the EWS1 inside the Sedongpu Valley for ice collapse observations; (d) the EWS2 of the 10 m observation tower, which was installed near the Sedongpu Valley outlet but was destroyed by the massive ice-rock collapse on 22 March 2022; (e) the rebuilt EWS2 near the Sedongpu Valley outlet to warn the blockage of the Yarlung Tsangpo River; (f, g) the EWS3 of the radar water level sensor and the automatic weather station (AWS) with pressure water level sensor near the Gyala village.

Since 2019, the EWSs have been progressively built ~~around~~-along the Sedongpu Valley. The EWSs consist of three parts (EWS 1-3) with different monitoring instruments and scientific functions (Fig. 1c-g and Table 1).

In May 2022, a 4 m observation tower with various monitoring sensors was constructed on the right bank of the glacial terraces at 3308 m asl in the Sedongpu Valley (Fig. 1b and c). Owing to logistical inaccessibility, all instruments were transported by helicopters. The objective of EWS1 is to monitor the location, magnitude and process of the ice-rock collapse inside the Sedongpu Valley. The overall monitoring system consists of the following five parts:

- v) Data transmission and power supply. All datasets were transmitted via the Asia-Pacific satellite (Asiasat 7). Owing to the heavy monsoon cloud cover and less efficient solar power generation in this region, power is supplied by both solar panels and wind (Fig. 1c).

In May 2021, the EWS2 ~~in the upstream region~~ was re-established in the upstream region to avoid possible destruction by debris flows of similar magnitude as in March 2021 (Fig. 1e). Similar to the monitoring equipment at EWS1, EWS2 was equipped with optical and thermal cameras to monitor the status of the Sedongpu Valley outlet, a three-component SmartSolo geophone with a transmission threshold of 10 to indicate the power of debris flows and various meteorological sensors (Table. 1). The video was stored locally on the hard disk, and hourly photos were transmitted to the service via satellite.

The main objective of EWS3 was to provide real-time early warning information of river blockage through changes in the water level at Gyala village, which is located ~6 km upstream of the Sedongpu Basin. The water level will soon rise when the Yarlung Tsangpo River is partially or completely blocked by debris flow from the Sedongpu Valley. Therefore, the water level is a very important early warning indicator. Two different types of water level sensors were used to provide sufficient redundancy and to avoid possible sensor failures. A Campbell CS477 radar water-level sensor (10-minute interval) and a Campbell CS451 pressure transducer (5-minute interval) were installed separately in October 2019 and May 2021 to provide real-time records of the water level in case of river blockages (Fig. 1f).

Considering the relatively open topography near Gyala village, an automatic weather station was also installed (Fig. 1g) for long-term monitoring of the regional background of climate change by measuring air temperature, relative humidity, wind speed/direction, precipitation, and four components of radiation including incoming shortwave radiation (S_{in}), reflected shortwave radiation (S_{out}), incoming longwave radiation (L_{in}), outgoing longwave radiation (L_{out}) using a CNR4 net radiometer, and air pressure using a Vaisala PTB110 barometer (Table. 1).

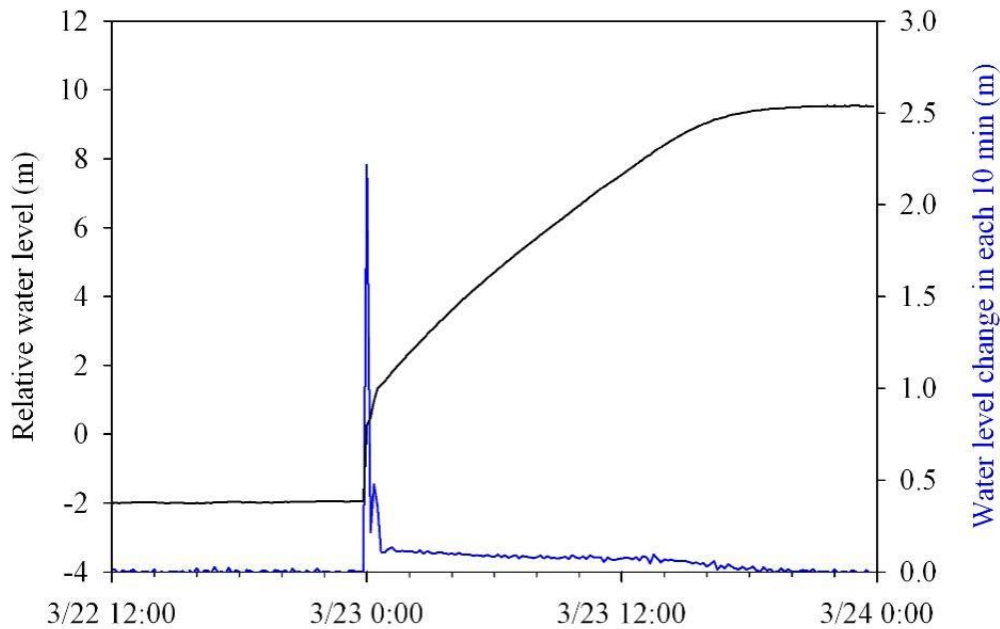
Figure 2:- A total water level rise of 11 m (black line) caused by the damming of the Yarlung Tsangpo River on 22 March 2021, with the rate of water level rise every 10 minutes (blue line)

On 22 March 2021, a massive ice-rock collapse occurred from the northern ridge of Mt. Gyala Peri, and the resulting mass flow temporarily dammed the Yarlung Tsangpo River. Based on a comparison of pre- and post-event DEMs, the total collapse volume was estimated to be $\sim 50 \text{ Mm}^3$ (Zhao et al., 2022). The water level sensor at EWS3 sent an automatic warning message due to a sudden 2.2 m rise in the river level between 23:50 on 22 March and 00:00 on 23 March (Fig. 2). The water level continued to rise at a rate of 0.6 - 0.8 m/hour, rising by a total of 11 m before stabilising at approximately 18:00 on 23 March 2021. This collapse turned into a highly mobile mass flow which ~~completely destroyed~~destroyed the EWS2 installed near the Sedongpu Valley outlet (Fig. 1d). Unfortunately, the ~~video process~~ of this chain ~~catastrophe~~disaster was not recorded.

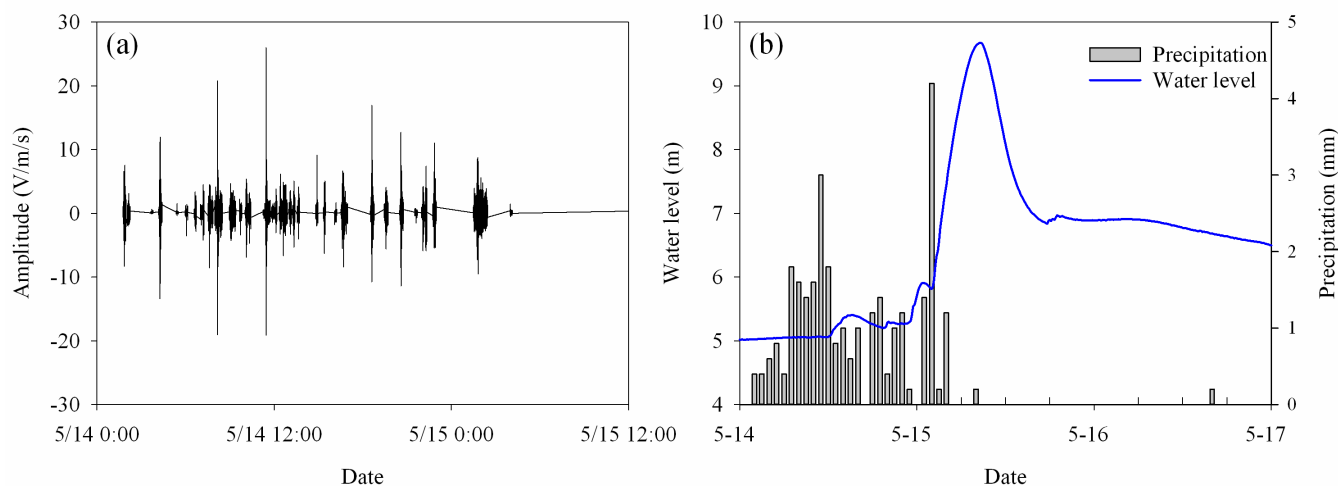
Figure 3- The recorded geophone waveform at EWS1 due to frequent ice-rock collapses on 14 May 2022 (a), and the rising water level of the Yarlung Tsangpo River due to the blockage on 15 May 2022 along with the hourly precipitation (b)

On 14 May 2022, the geophone at EWS1 warned that repeated collapses occurred in the Sedongpu Valley (Fig. 3a). The most pronounced shaking occurred at approximately 10:00 and 12:00, with both waveform amplitudes exceeding 20. However, both EWS2 near the Sedongpu Valley outlet and EWS3 near Gyala village did not ~~send a warning message~~ show river blockage and water level rising before midnight on 14 May 2022. Between 23:50 on 14 May and 00:00 on 15 May, the water level sensor at EWS3 sent a warning message, and the water level rose by a total of 4 m before stabilising at around 20:00 on 15 May 2022 (Fig. 3b). Infrared imagery at EWS2 showed that the Yarlung Tsangpo River was temporarily completely dammed and then released, consistent with the rapid rise and fall in the water level (Fig. 4ab). The AWS at EWS1 recorded a total rainfall of 31.6 mm ~~on during the period from~~ 14 May to 17 May with intensive rainfall (7 mm) occurring between 01:00 and 04:00 on 15 May (Fig. 3b). Overall, the ice-rock collapse and intensive rainfall provided ~~favorable~~ favourable conditions for the formation of a diluted debris flow, resulting in the temporary blockage of the Yarlung Tsangpo River (Fig. 4a, b).

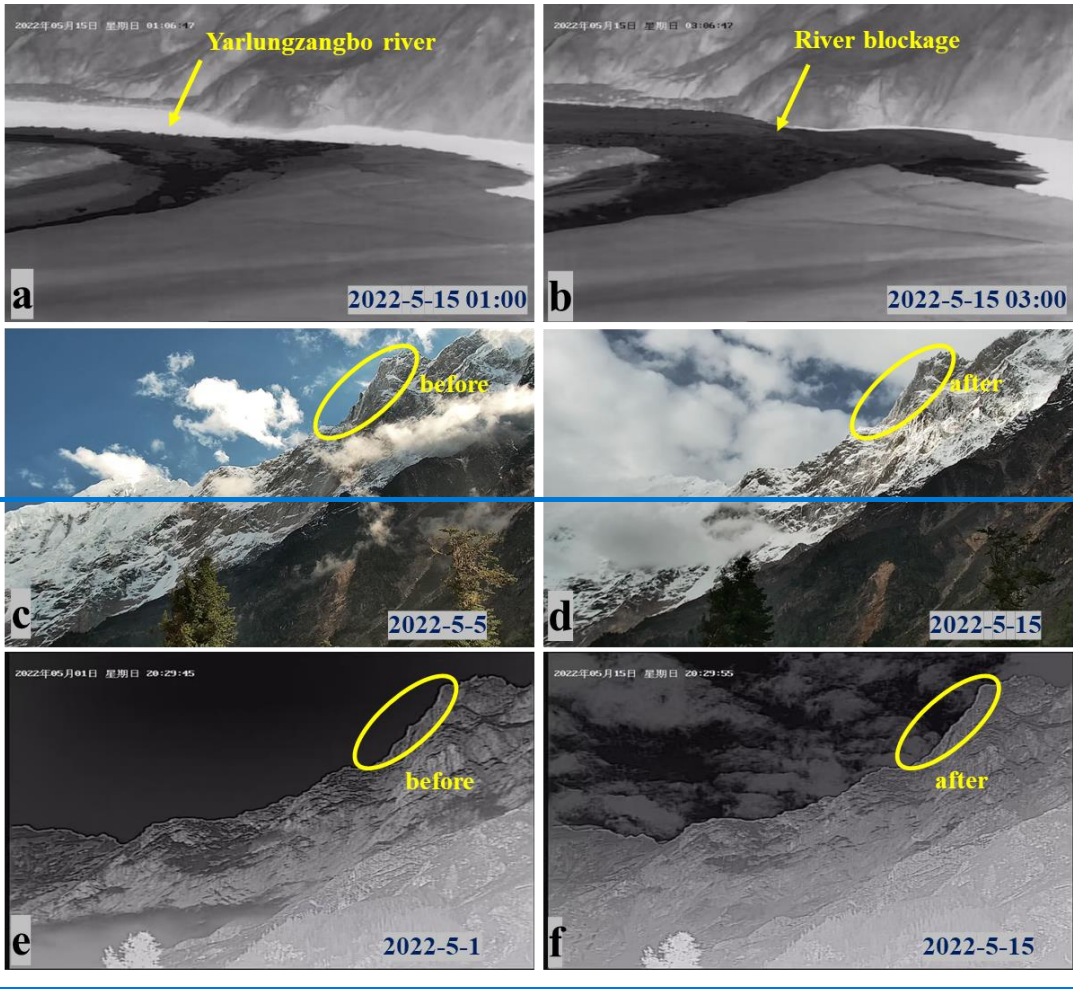
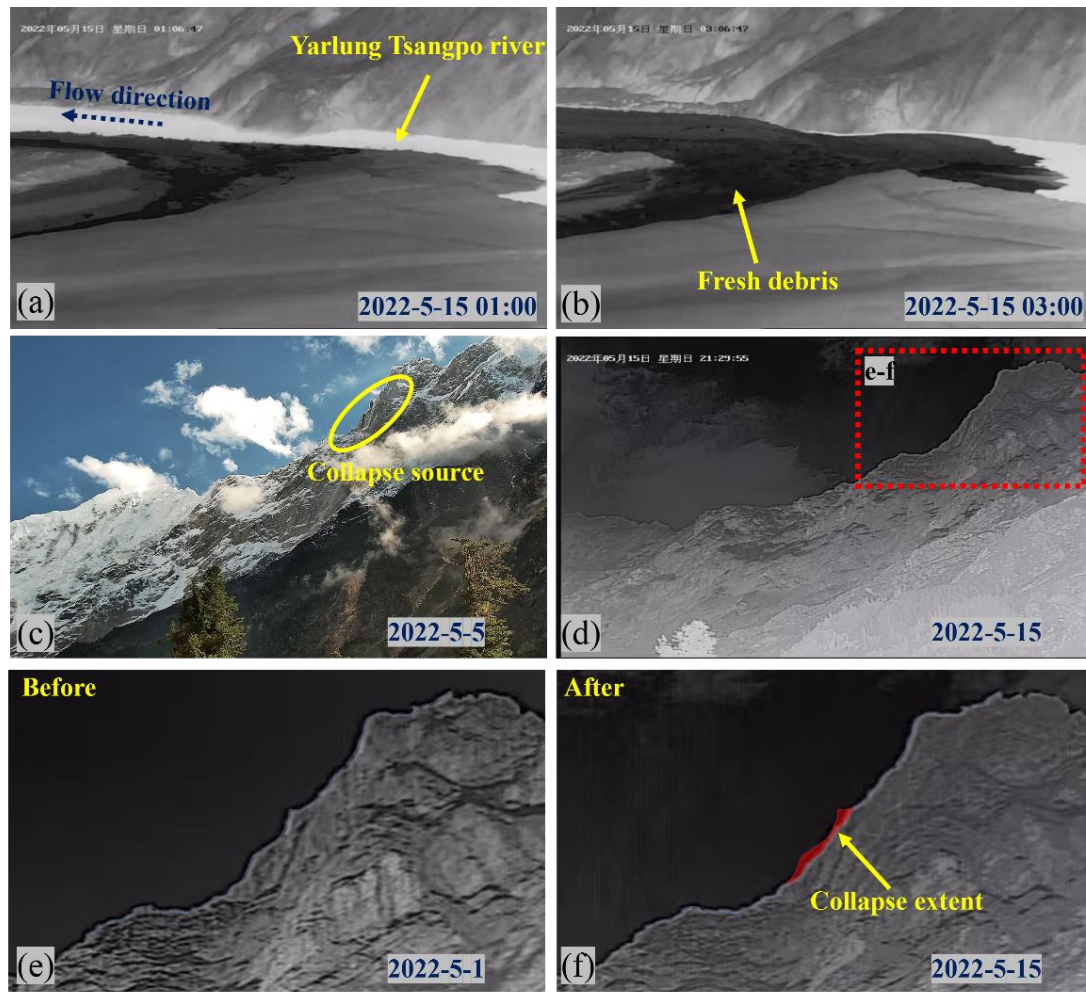
250 **Figure 4-** The debris-induced blockage of the Yarlung Tsangpo River (a, b) and the optical and thermal images showing
 the topographic conditions at the targeted monitoring of the collapsed area (c, d) with the zoomed region (red dashed
 rectangle) shown in e-f, and the change of ridgeline before and after the repeated ice-rock collapses on 14 May 2022 and the
 extent of the collapse source are outlined in transparent red. The debris-induced blockage of the Yarlung Tsangpo River (a, b)
 and the optical (a, b) and thermal (c, d) images showing the topographic changes before and after the repeated ice rock
 255 collapses on 14 May 2022.

A comparison of both optical and infrared photographs before and after the ice-rock collapse showed that repeated collapses occurred on the northern ridge of Mt Gyala Peri (Fig. 4c-f), which is close to the locations of previous massive ice-rock collapses in 2017 (Kääb et al., 2021) and 2021 (Zhao et al., 2022). In fact, the ridge was heavily glaciated, so these repeated events were mixed ice-rock collapses. The delayed formation of debris flows after ice-rock collapses (about 20 hours later than the first collapse) suggests that it takes some time for the collapsed ice to melt, which agrees well with the delay between the observed ice collapse in October 2019 and its delayed debris flow (Zhao et al., 2022).

As shown in Figures 4c-f and Figure 6e-f, the selected cloud-free photos were taken several days before and after the collapse, delaying the real-time assessment of the collapses. Therefore, new weather-independent monitoring instruments

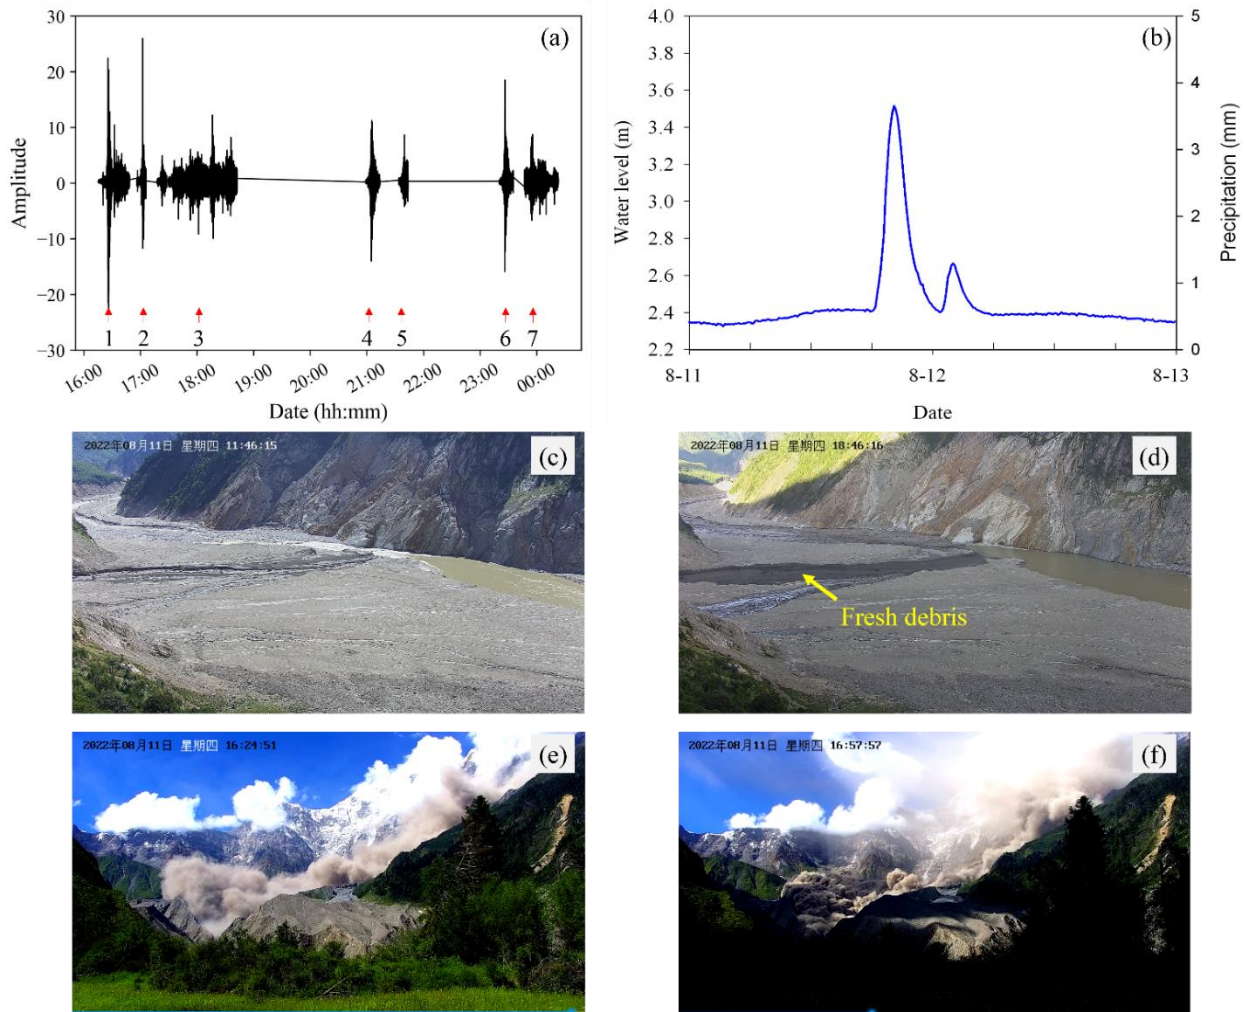
265 Figure 5: ~~The recorded waveform of seven collapses on 11 August 2022 (a) and the [small scale fresh debris flow into the Yarlung Tsangpo River and the corresponding water level rise by small-scale debris flow and precipitation condition \(b\), and the photos taken before and after the occurrence of fresh debris flow into the Yarlung Tsangpo River \(c,d\), and video screenshots of two rock collapses at 16:24 and 16:57 on 11 August 2022.](#)~~

On 11 August 2022, the geophone at EWS1 ~~again~~ warned of repeated collapses in the Sedongpu Valley (Fig. 5a). The first collapse occurred at 16:26, with a waveform amplitude greater than 20, and lasted approximately 5-7 minutes. The following six repeated collapses occurred within the next eight hours. Among these seven repeated collapses, the waveform

260 showed that the greatest energy was released by the ~~second~~^{first} collapse, with a maximum amplitude greater than ~~2825~~, and the longest collapse process lasted approximately 84 mins during the third event (Fig. 5a).

Photographs of EWS2 also show that small-scale fresh debris flowed into the Yarlung Tsangpo River, causing partial
river blockage (Fig. 5bc and 5d). ~~The warning system at EWS3 indicated that the water level began to rise at around 18:30
and rose by 1.1 m at around 20:00, and then started to fall back rapidly (Fig. 5b).~~ Comparison between the post- and pre-
event optical and infrared imagery at EWS1 showed that the collapsed sources were different from previous ice-rock
285 collapses (Fig. 4Fig. S1 in the Supplement). Two ~~visible~~ collapsed regions are mainly concentrated a few hundred meters
below the mountain ridge, with a few glacier distributions (Fig. 6e-f). This evidence suggests that lower ice content within
collapsed materials prevent the formation of highly mobile debris flows and thus limit the magnitude of river blockage.

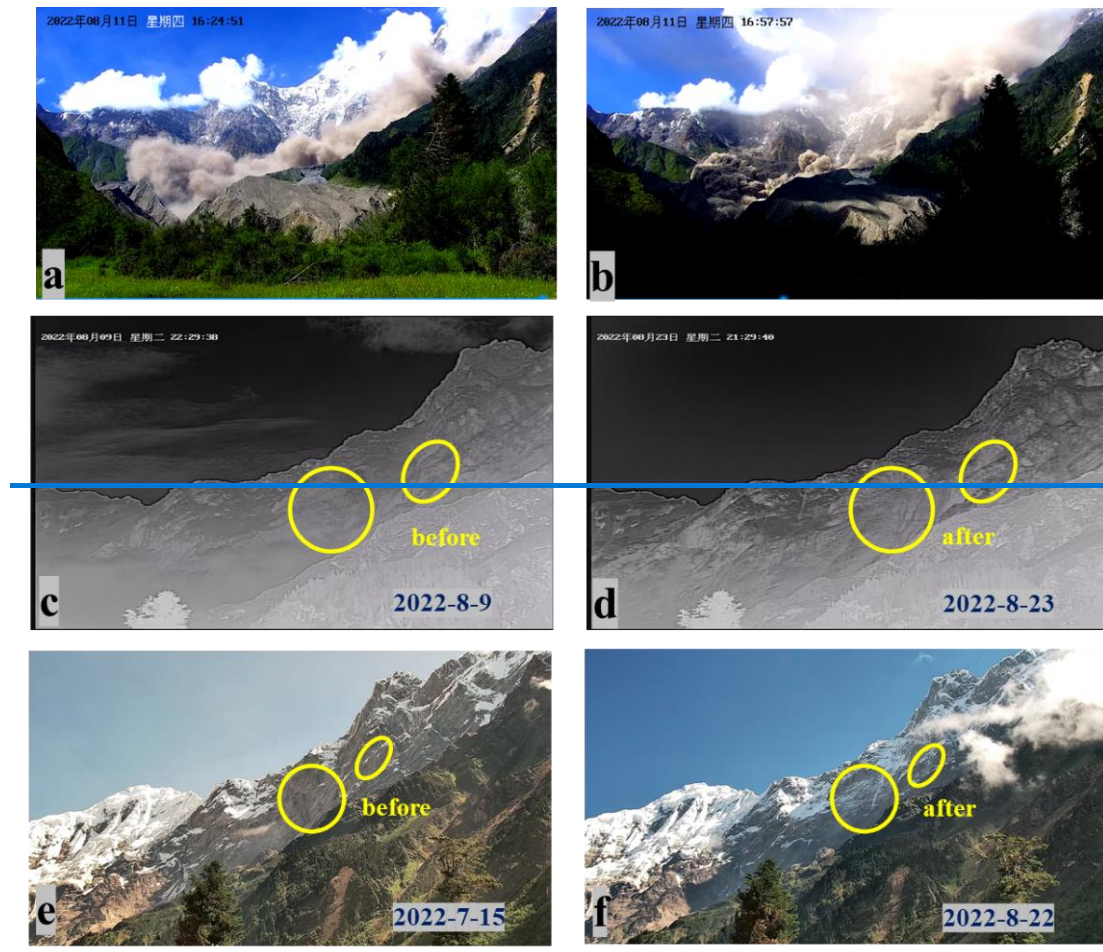
Figure 6: Video screenshots of two rock collapses at 16:24 and 16:57 on 11 August 2022 (a, b), and the thermal (c, d) and optical (e, f) photos before and after the collapses showing the collapsed sources.

Owing to the sunny weather conditions, the optical video system at EWS1 successfully captured the entire process of
the two collapses that occurred during the daytime (Fig. 5e and 5f, Supplementary videos). Both videos of the two collapses
290 showed that the highly mobile collapsed material resulted in dark yellow dust in the Sedongpu Valley. The colours of both
collapses differed from the observed ice collapse recorded in October 2019 (Zhao et al., 2022). This indicates that the
majority of the collapsed material on 11 August 2022 was composed of rock. Second, the combination of the video and
geophone waveform showed that the size of the collapses was impressive when the amplitude of the geophone waveform at
EWS1 was greater than 20. In addition, the onset and duration of the collapse recorded by the geophone were in agreement
295 with the video recordings. These matches demonstrate that the geophone waveform at EWS1 can be used to reflect the onset

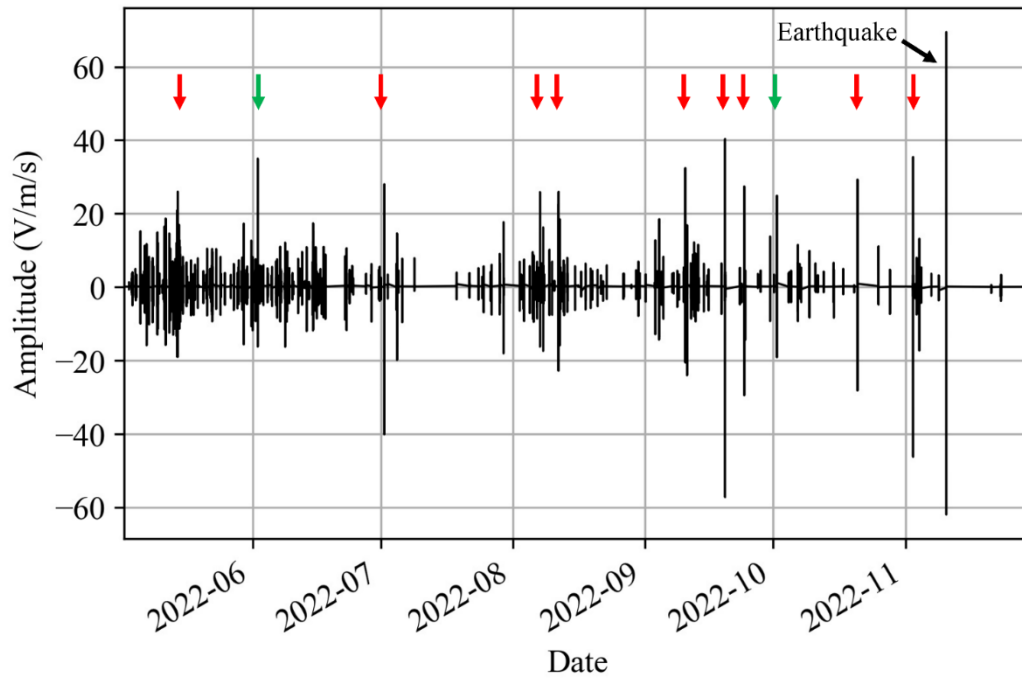
325 **Figure 76** Geophone waveform inside the Sedongpu Valley during the period from May to December with 12 events of
waveform amplitude greater than 20. The red arrow indicates the confirmed collapses and induced debris flows, the black
arrow indicates the Mw 5.6 earthquake on 10 November 2022, and the green arrow indicates two abnormal waveforms.

geophone waveform can be effectively used to warn against the occurrence and magnitude of ice-rock collapses. When the
310 ~~X-axis~~ amplitude of the geophone waveform at EWS1 was approximately 20, the magnitude of the ice-rock collapse was
similar to that of the 11 August 2022 event (Fig. ~~6a-5e~~ and ~~6f~~). The geophone records at EWS1 show that there are a total of
12 events with waveform amplitudes greater than 20 from May 2022 to December 2022 (Fig. 6). Combined with the infrared
and optical photographs at the Sedongpu Valley outlet, nine of the twelve events were confirmed to correspond to the
occurrence of debris flows that arrived at the Sedongpu Valley outlet but did not significantly block the river (Fig. 7 and Figs.
315 ~~S2-8 in the Supplement~~). Only three events, including the Mw 5.6 earthquake centred at ~~MedogMedog~~ on 10 November
2022, did not correspond to the debris flow near the valley outlet. Therefore, when the geophone amplitude exceeds 20 in

EWS1, there is a high probability that collapse-induced debris flow will occur in the Sedongpu Valley. ~~The geophone
amplitude of 20 was selected as the first-level warning threshold. Due to no catastrophic events occurred in 2022, the EWS
defined temporally two times (40) and three times (60) of the first-level threshold as the second and third-level warning
320 thresholds, which would be optimized by further observations. In practice, the EWS in this study provides a three level
warning system by selecting thresholds of 20, 40 and 60, respectively.~~

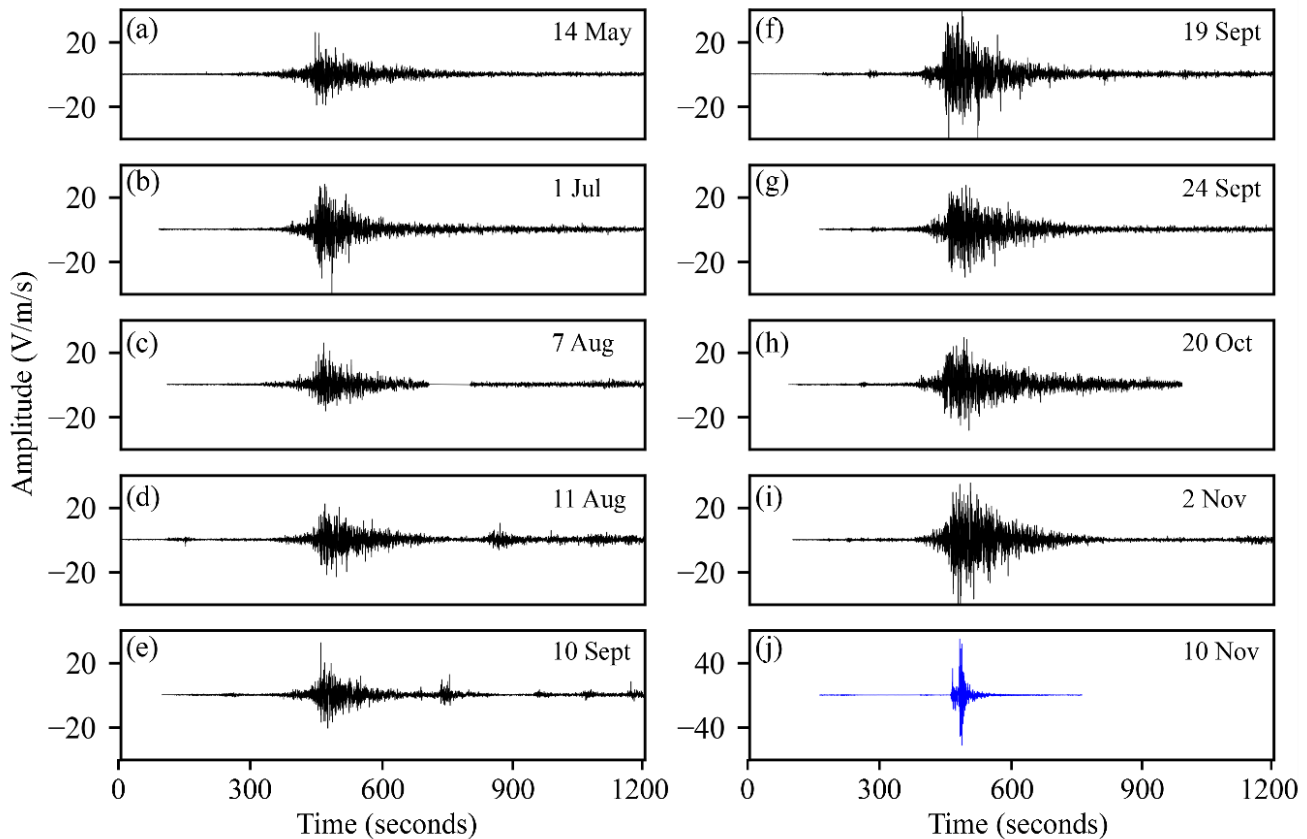
Figure 87.: Comparison of the waveforms generated by [the a series of ice-rock collapses occurred on May 14 \(a\), July 1 \(b\), August 7 \(c\), August 11 \(d\), September 10 \(e\), September 19 \(f\), September 24 \(g\), October 20 \(h\), November 2 \(a-i\) on 11 August 2022](#) and [the seismic waveforms](#) by the earthquake on 10 November 2022 (j). Note the different y-axis limits.

The study region is located in an active crustal zone that experiences frequent earthquakes (Li et al., [2022b](#)[2022a](#)). A
330 mixed waveform of collapses and earthquakes may result in false warning signals. In fact, the waveforms of ice collapses
and earthquakes differ because of different physical processes. Figure [8-7](#) shows a comparison of the [nine](#) waveforms
triggered by [a-the confirmed](#) rock collapses [recorded on 10 August 2022](#) and the Mw 5.6 earthquake on 10 November 2022.
The collapse typically lasted for several minutes and produced a continuous waveform ([Fig. 7 a-i](#)). In contrast, the waveform
from an earthquake is usually short-lived owing to the rapid release of rupture energy, *e.g.*, approximately one minute for a
335 Mw 5.6 earthquake (Fig. [8b7j](#)). [In addition, for the two false warnings \(maximum amplitude greater than 20\) that occurred](#)
[on 2 June and 1 October \(Fig. 6\), the detailed waveform analysis can easily exclude such false warnings by assessing their](#)

[waveform duration and characteristics \(Fig. S9 in the Supplement\). These two waveforms are abnormally short and different](#)
[from the typical collapse-induced waveform, indicating the possible noise.](#) Therefore, in addition to the threshold of the
maximum amplitude, the duration [and characteristics](#) of the waveform [would be re-examined by the experts at STPSER and](#)
340 [thus was also used adopted](#) as additional information for the ice-rock collapse warning in the Sedongpu Valley.

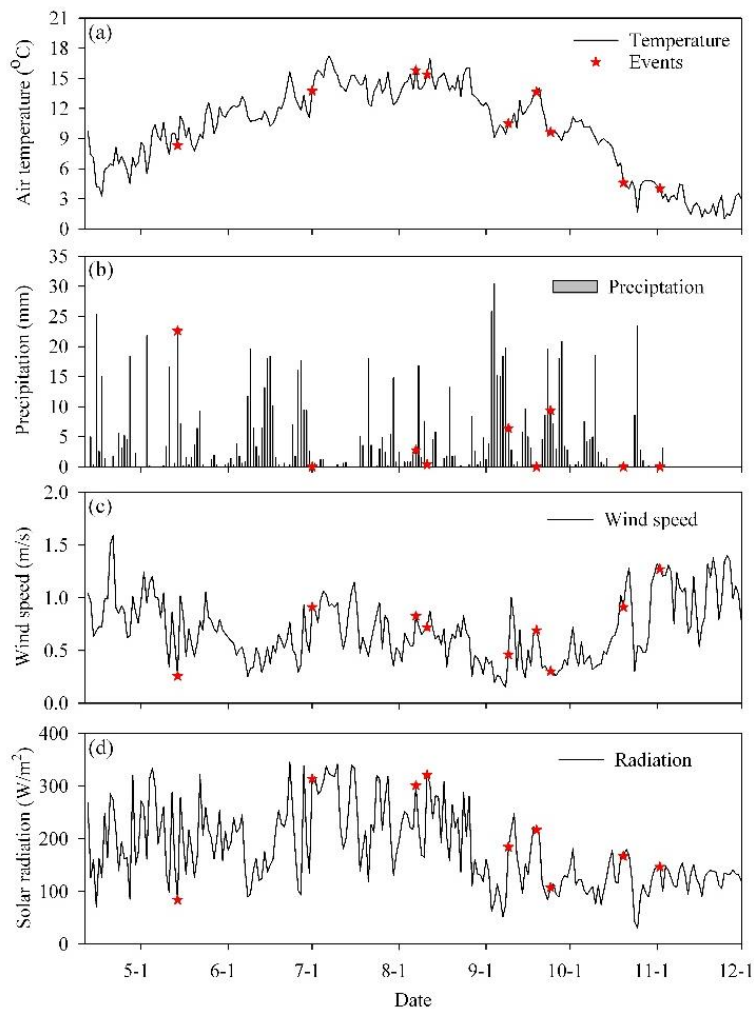
Figure 8. The occurrence of repeated ice-rock collapses (red stars) and the time-series of meteorological factors including air temperature (a), rainfall (b), wind speed (c) from EWS1 and the incoming shortwave radiation from EWS3 (d).

[The EWS showed that at least nine ice-rock collapse-debris flows were found during the period from April to December 2022 in the Sedongpu Valley. Previous studies show that some catastrophic rockslide-debris flows were triggered by heavy rainfall \(e.g. Anderson and Sitar, 1995; Yin et al., 2016\). The in-situ AWS measurements in/near the Sedongpu Valley provided an opportunity to investigate the relationship between the occurrence of ice-rock collapses and the possible meteorological triggers. Figure 8 shows the variation of meteorological factors such as air temperature, rainfall, wind speed and incoming shortwave radiation and their relevant values in the corresponding ice-rock collapse events \(red stars\). It is](#)

355 clear that the ice-rock collapses at the Sedongpu Valley could occur under different meteorological combinations (Table S1
in the Supplement). For example, the weather condition of the ice-rock collapse on 14 May 2022 was characterized by
relatively colder weather (8.3 °C), heavy rainfall (22.6 mm), weaker wind speed (0.3 m/s) and lower solar radiation (83.9
W/m²). In contrast, the weather conditions of the ice-rock collapse on 11 August 2022 were warmer (15.4 °C), less
precipitation (0.4 mm), moderate wind speed (0.7 m/s) and sunny weather (321.1 W/m²). In addition, it is clear that no
360 weather anomalies (e.g. extremely high air temperature or heavy rainfall) prior to the ice-rock events. This suggests that
there were no immediate meteorological triggers for these small-scale ice-rock collapses and the associated debris flows in
2022 at the Sedongpu Valley. However, it should be noted that climate change can trigger complex delayed feedbacks in

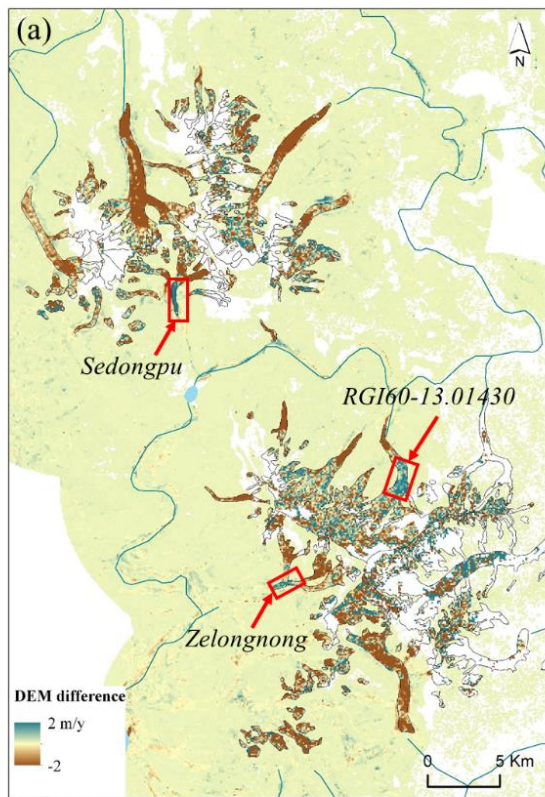
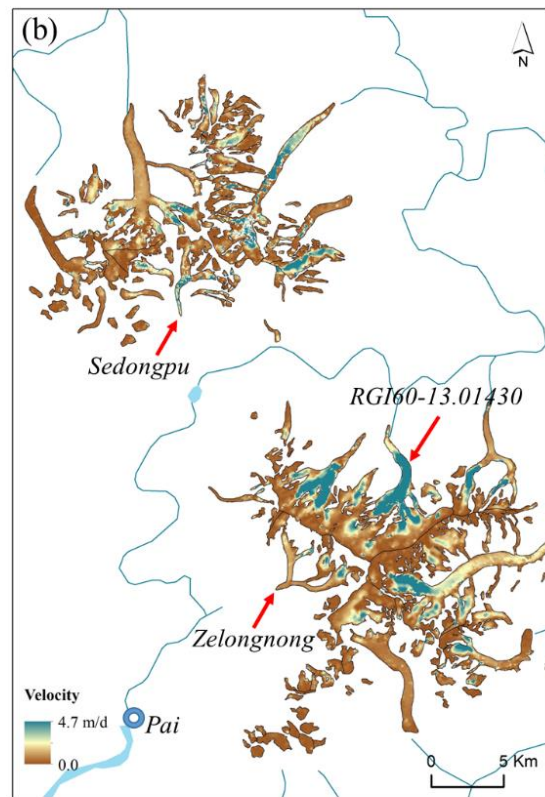
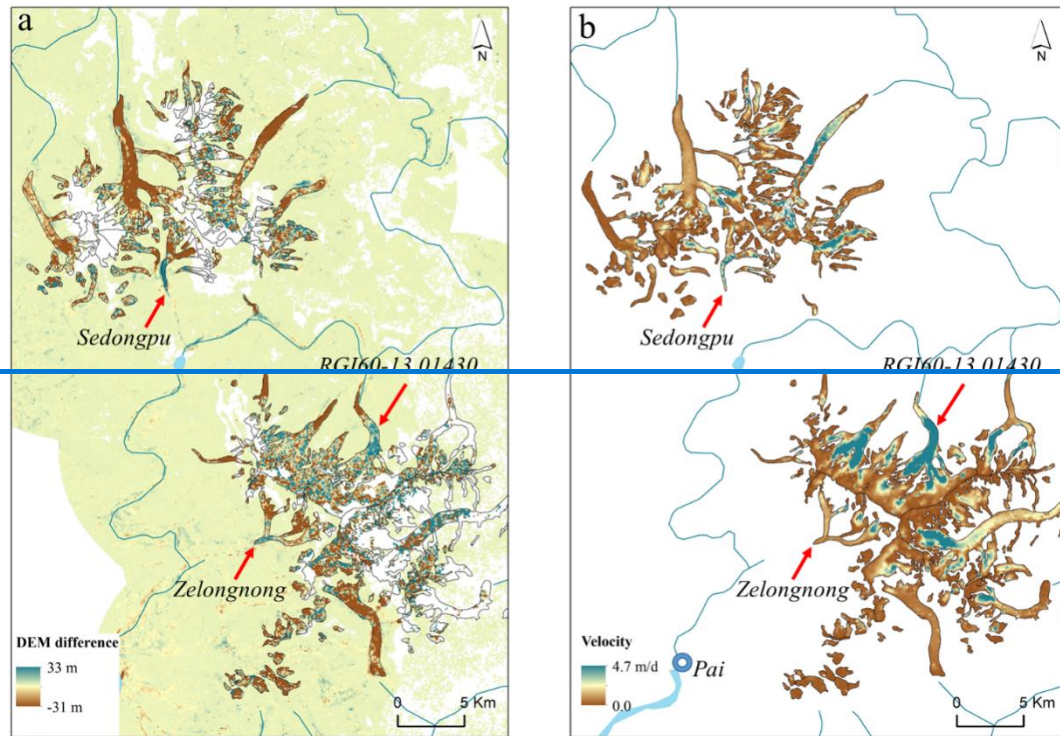
Figure 99— Spatial distribution of mean surface elevation change (m/y) during 2010-2020 (Hugonnet et al., 2021) and annual surface velocity (m/day) in 2017 (Millan et al., 2022), and the locations of the three glaciers with abnormal surface thickening (the red rectangles) and the tower of Pai. Spatial distribution of mean surface elevation change (m) during 2010-2020 and annual surface velocity (m/day) in 2017, and the locations of the two glaciers with possible collapse risks and the tower of Pai.

380 Based on the published datasets, including glacier elevation change during the period 2010–2020 (Hugonnet et al., 2021) and glacier surface velocity during the period 2017–2018 (Millan et al., 2022), it was found that apart from the detached Sedongpu Glacier, there are still two glaciers (Zelongnong Glacier and the glacier numbered RGI60-13.01430) with possible collapse risks in the study region (Fig. 99). As shown in Figure 9a9a, the ablation zone of the Sedongpu Glacier has experienced an anomalous glacier thickening ($\sim \pm 2.0$ m/yr) over the past decade, which facilitated massive low-angle glacier detachment in October 2018 (Kääb et al., 2021). A similar anomalous ice thickening near the ablation zone (the red rectangles in Figure 8a) was also found at the Zelongnong Glacier ($\sim +0.35$ m/yr) and RGI60-13.01430 Glacier ($\sim +0.37$ m/yr). In addition, the spatial distribution of the surface velocity also indicated a high glacier displacement in the ablation zone with possible sliding risks on these glaciers (Fig. 9b9b).
