Early warning system for ice collapses and river blockages in the Sedongpu Valley, southeastern Tibetan Plateau

Abstract: The Tibetan Plateau and its surroundings have recently experienced several catastrophic glacier-related disasters. It is of great scientific and practical significance to establish ground-based early warning systems (EWS) to understand the processes and mechanisms of glacial disasters and warn against potential threats to downstream settlements and infrastructure. However, there are few sophisticated EWSs on the Tibetan Plateau. With the support of the Second Tibetan Plateau Scientific Expedition and Research Program (STPSER), an EWS was developed and implemented in the Sedongpu Valley, southeastern Tibetan Plateau, where repeated river blockages have occurred due to ice/rock collapse debris flow. The EWS collected datasets of optical/thermal videos/photos, geophone waveforms, water levels, and meteorological variables in this sparsely populated zone. It has successfully warned against three ice-rock collapse - debris flow - river blockage chain events, and seven small-scale ice-rock collapse- debris flow events. Meanwhile, it was found that the low-cost geopho

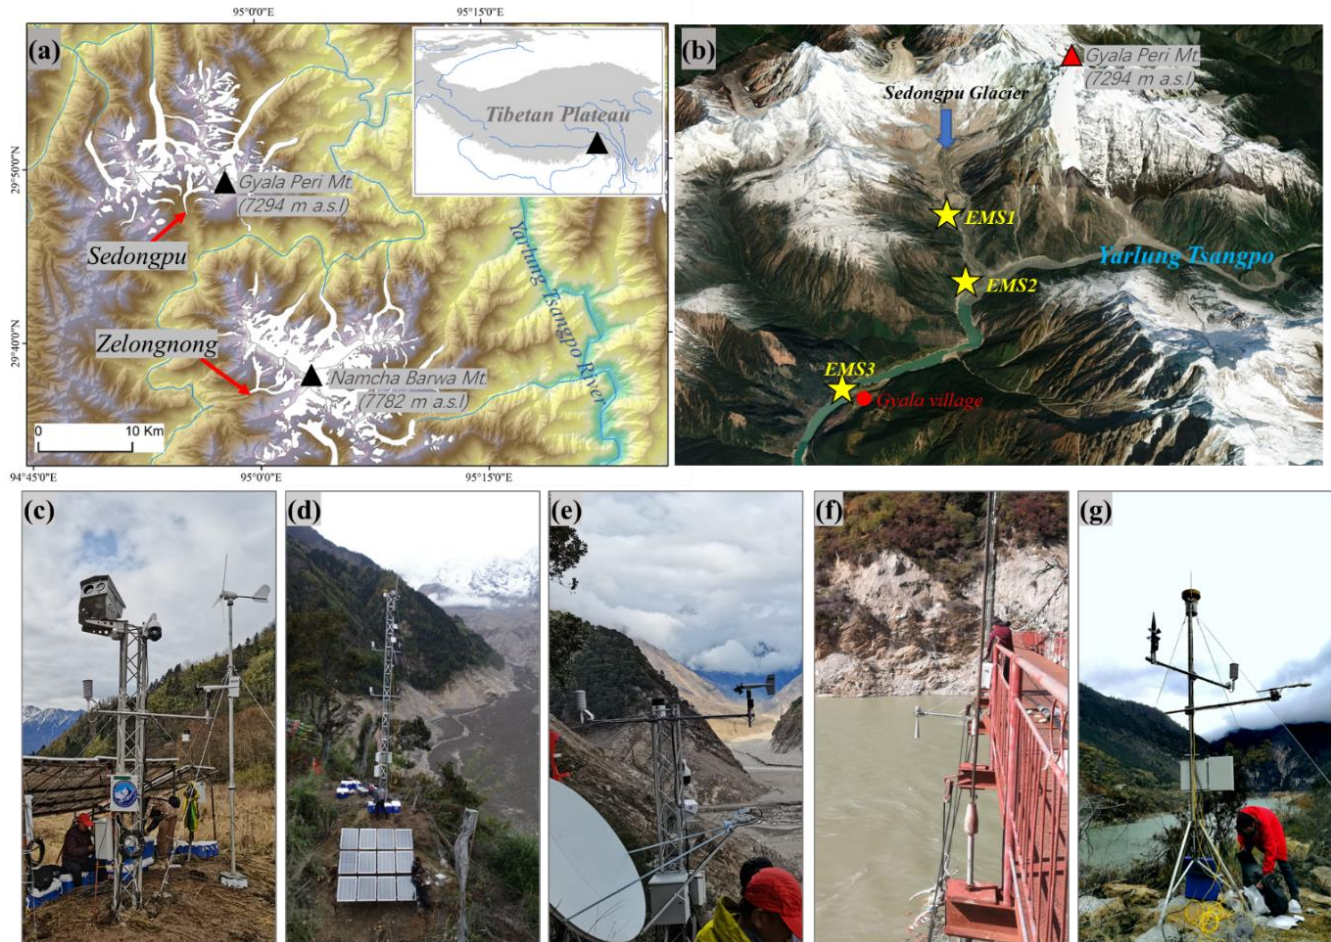
Figure 1. Study region and early warning systems. (a) Glacier distribution around the Mt. Namcha Barwa and the Mt. Gyala Peri in the southeastern Tibetan Plateau with the Sedongpu Glacier and Zelongnong Glacier; (b) @Google Earth image showing the 3D topography of the Sedongpu Valley and the locations of three early warning systems: EWS1-3 (yellow stars); (c) the EWS1 inside the Sedongpu Valley for ice collapse observations; (d) the EWS2 of the 10 m observation tower, which was installed near the Sedongpu Valley outlet but was destroyed by the massive ice-rock collapse on 22 March 2022; (e) the rebuilt EWS2 near the Sedongpu Valley outlet to warn the blockage of the Yarlung Tsangpo River; (f, g) the EWS3 of the radar water level sensor and the automatic weather station (AWS) with pressure water level sensor near the Gyala village.

Since 2019, the EWSs have been progressively built along the Sedongpu Valley. The EWSs consist of three parts (EWS 1-3) with different monitoring instruments and scientific functions (Fig. 1c-g and Table 1).

In May 2022, a 4 m observation tower with various monitoring sensors was constructed on the right bank of the glacial terraces at 3308 m asl in the Sedongpu Valley (Fig. 1b and c). Owing to logistical inaccessibility, all instruments were transported by helicopters. The objective of EWS1 is to monitor the location, magnitude and process of the ice-rock collapse inside the Sedongpu Valley. The overall monitoring system consists of the following five parts:

v) Data transmission and power supply. All datasets were transmitted via the Asia-Pacific satellite (Asiasat 7). Owing to the heavy monsoon cloud cover and less efficient solar power generation in this region, power is supplied by both solar panels and wind (Fig. 1c).

In May 2021, the EWS2 was re-established in the upstream region to avoid possible destruction by debris flows of similar magnitude as in March 2021 (Fig. 1e). Similar to the monitoring equipment at EWS1, EWS2 was equipped with optical and thermal cameras to monitor the status of the Sedongpu Valley outlet, a three-component SmartSolo geophone with a transmission threshold of 10 to indicate the power of debris flows and various meteorological sensors (Table. 1). The video was stored locally on the hard disk, and hourly photos were transmitted to the service via satellite.

The main objective of EWS3 was to provide real-time early warning information of river blockage through changes in the water level at Gyala village, which is located ~6 km upstream of the Sedongpu Basin. The water level will soon rise when the Yarlung Tsangpo River is partially or completely blocked by debris flow from the Sedongpu Valley. Therefore, the water level is a very important early warning indicator. Two different types of water level sensors were used to provide sufficient redundancy and to avoid possible sensor failures. A Campbell CS477 radar water-level sensor (10-minute interval) and a Campbell CS451 pressure transducer (5-minute interval) were installed separately in October 2019 and May 2021 to provide real-time records of the water level in case of river blockages (Fig. 1f).

Considering the relatively open topography near Gyala village, an automatic weather station was also installed (Fig. 1g) for long-term monitoring of the regional background of climate change by measuring air temperature, relative humidity, wind

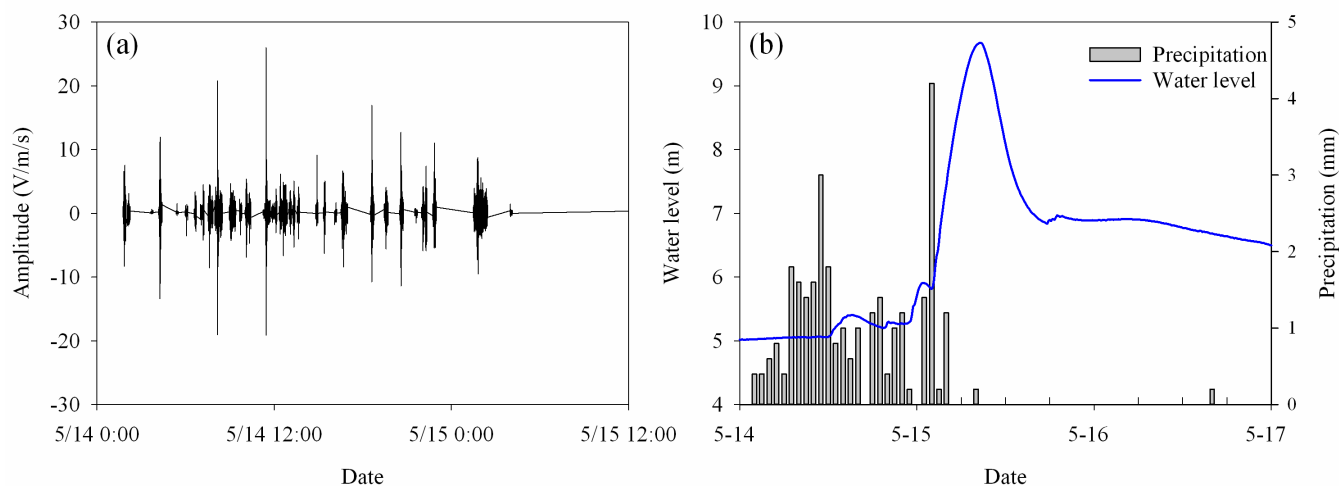
Figure 3. The recorded geophone waveform at EWS1 due to frequent ice-rock collapses on 14 May 2022 (a), and the rising water level of the Yarlung Tsangpo River due to the blockage on 15 May 2022 along with the hourly precipitation (b)

On 14 May 2022, the geophone at EWS1 warned that repeated collapses occurred in the Sedongpu Valley (Fig. 3a). The most pronounced shaking occurred at approximately 10:00 and 12:00, with both waveform amplitudes exceeding 20. However, both EWS2 near the Sedongpu Valley outlet and EWS3 near Gyala village did not show river blockage and water level rising before midnight on 14 May 2022. Between 23:50 on 14 May and 00:00 on 15 May, the water level sensor at EWS3 sent a warning message, and the water level rose by a total of 4 m before stabilising at around 20:00 on 15 May 2022 (Fig. 3b). Infrared imagery at EWS2 showed that the Yarlung Tsangpo River was temporarily completely dammed and then released, consistent with the rapid rise and fall in the water level (Fig. 4ab). The AWS at EWS1 recorded a total rainfall of 31.6 mm during the period from 14 May to 17 May with intensive rainfall (7 mm) occurring between 01:00 and 04:00 on 15 May (Fig. 3b). Overall, the ice-rock collapse and intensive rainfall provided favourable conditions for the formation of a diluted debris flow, resulting in the temporary blockage of the Yarlung Tsangpo River (Fig. 4a, b).

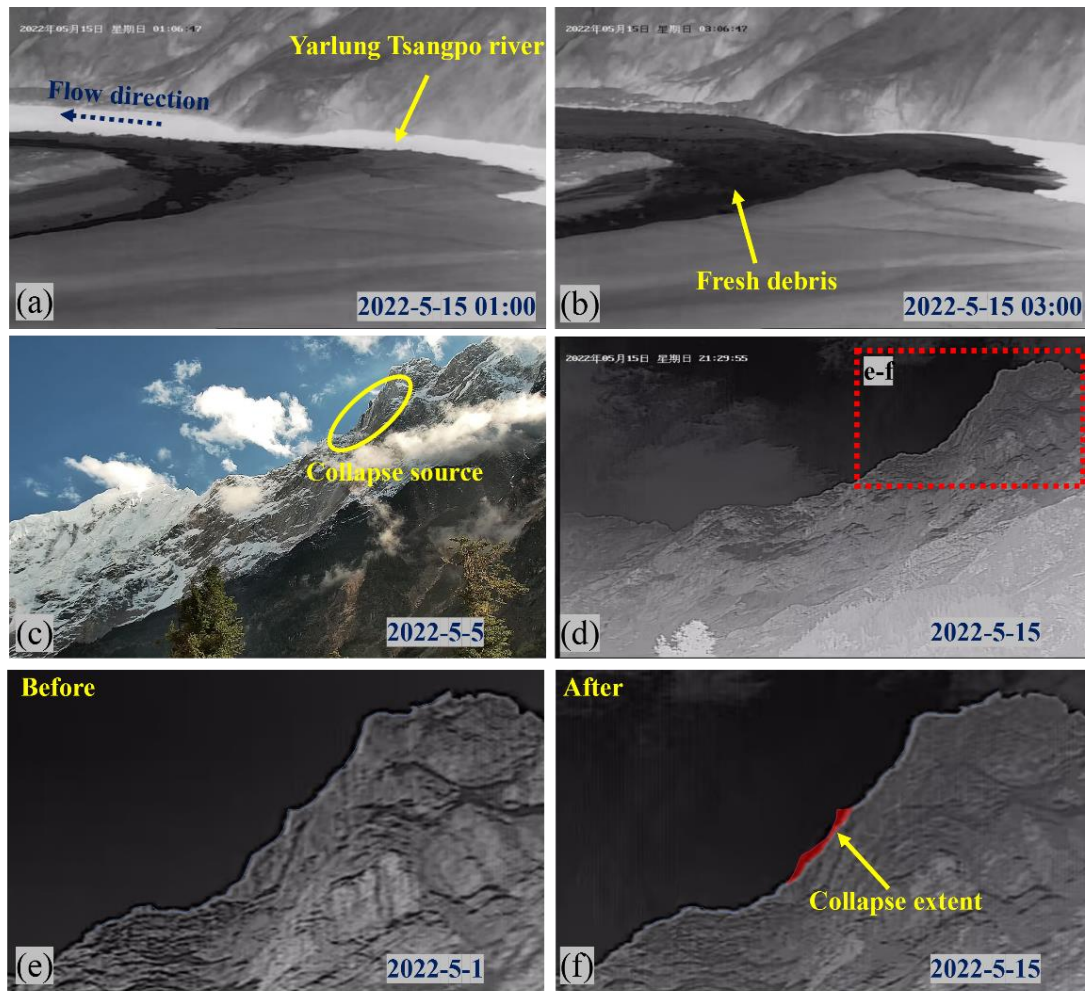
235 **Figure 4.** The debris-induced blockage of the Yarlung Tsangpo River (a, b) and the optical and thermal images showing the topographic conditions at the targeted monitoring of the collapsed area (c, d) with the zoomed region (red dashed rectangle) shown in e-f, and the change of ridgeline before and after the repeated ice-rock collapses on 14 May 2022 and the extent of the collapse source are outlined in transparent red.

A comparison of both optical and infrared photographs before and after the ice-rock collapse showed that repeated collapses occurred on the northern ridge of Mt Gyala Peri (Fig. 4c-f), which is close to the locations of previous massive ice-rock collapses in 2017 (Kääb et al., 2021) and 2021 (Zhao et al., 2022). In fact, the ridge was heavily glaciated, so these repeated events were mixed ice-rock collapses. The delayed formation of debris flows after ice-rock collapses (about 20 hours later than the first collapse) suggests that it takes some time for the collapsed ice to melt, which agrees well with the delay between the observed ice collapse in October 2019 and its delayed debris flow (Zhao et al., 2022).

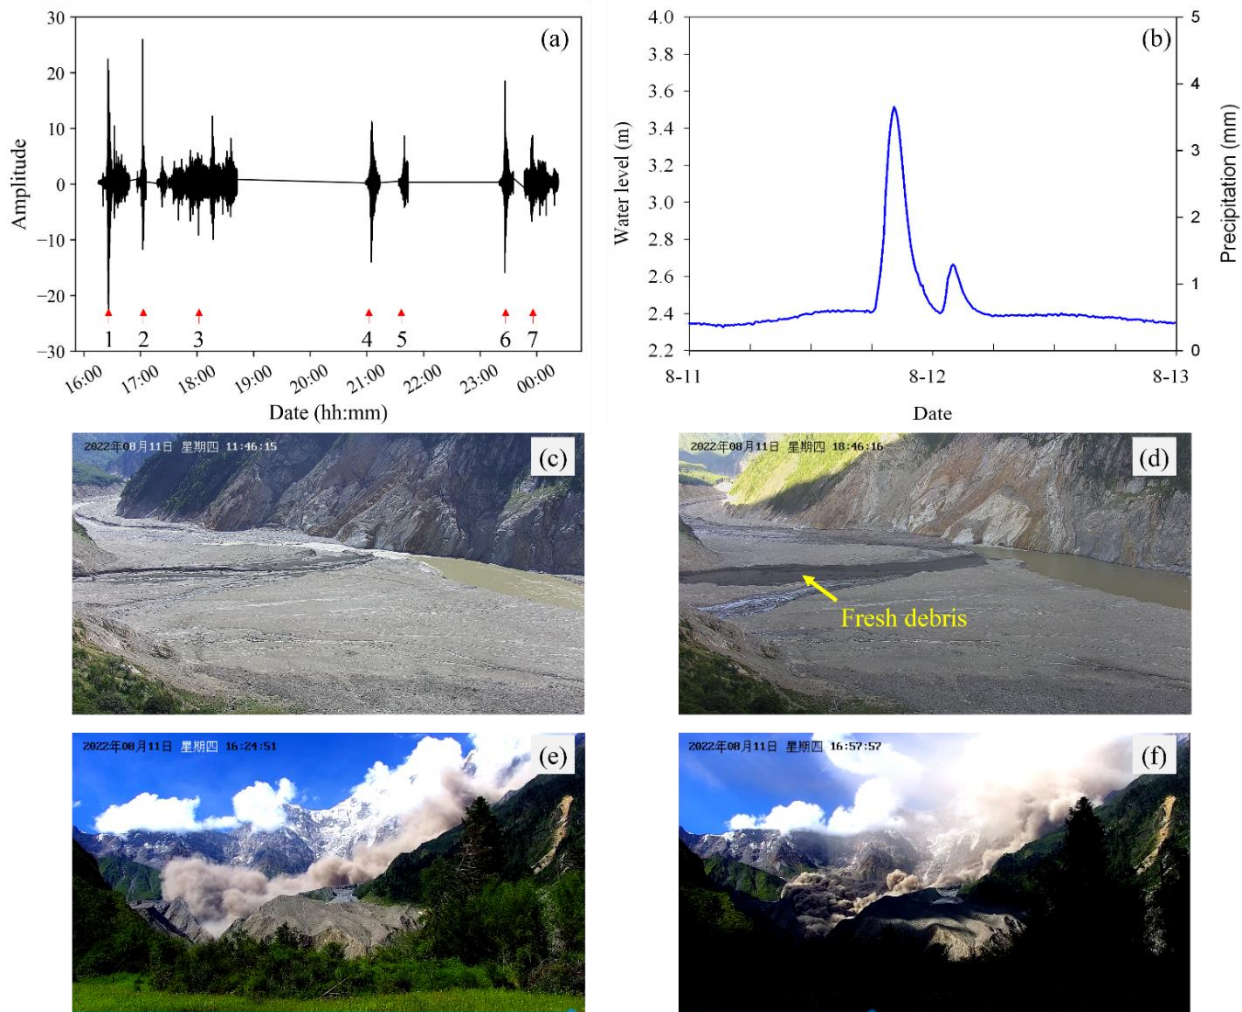
245 **Figure 5. The recorded waveform of seven collapses on 11 August 2022 (a) and the water level rise by small-scale debris flow and precipitation condition (b), and the photos taken before and after the occurrence of fresh debris flow into the Yarlung Tsangpo River (c,d), and video screenshots of two rock collapses at 16:24 and 16:57 on 11 August 2022.**

240 On 11 August 2022, the geophone at EWS1 warned of repeated collapses in the Sedongpu Valley (Fig. 5a). The first collapse occurred at 16:26, with a waveform amplitude greater than 20, and lasted approximately 5-7 minutes. The following six repeated collapses occurred within the next eight hours. Among these seven repeated collapses, the waveform showed that the greatest energy was released by the first collapse, with a maximum amplitude greater than 25, and the longest collapse process lasted approximately 84 mins during the third event (Fig. 5a).

The warning system at EWS3 indicated that the water level began to rise at around 18:30 and rose by 1.1 m at around
 250 20:00, and then started to fall back rapidly (Fig. 5b). Photographs of EWS2 also show that small-scale fresh debris flowed into the Yarlung Tsangpo River, causing partial river blockage (Fig. 5c and 5d). Comparison between the post- and pre-event optical and infrared imagery at EWS1 showed that the collapsed sources were different from previous ice-rock collapses (Fig. S1 in the Supplement). Two collapsed regions are mainly concentrated a few hundred meters below the mountain ridge, with

Owing to the sunny weather conditions, the optical video system at EWS1 successfully captured the entire process of the two collapses that occurred during the daytime (Fig. 5e and 5f, Supplementary videos). Both videos of the two collapses showed that the highly mobile collapsed material resulted in dark yellow dust in the Sedongpu Valley. The colours of both collapses differed from the observed ice collapse recorded in October 2019 (Zhao et al., 2022). This indicates that the majority of the collapsed material on 11 August 2022 was composed of rock. Second, the combination of the video and geophone waveform showed that the size of the collapses was impressive when the amplitude of the geophone waveform at EWS1 was greater than 20. In addition, the onset and duration of the collapse recorded by the geophone were in agreement with the video recordings. These matches demonstrate that the geophone waveform at EWS1 can be used to reflect the onset and magnitude of repeated collapses in the Sedongpu Valley.

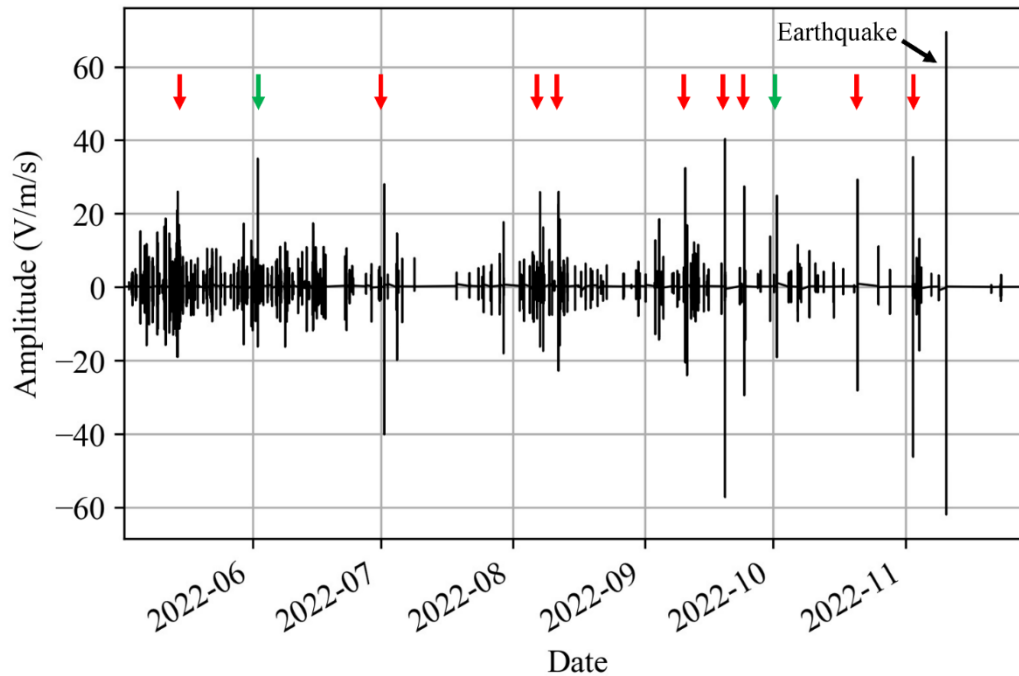
Figure 6. Geophone waveform inside the Sedongpu Valley during the period from May to December with 12 events of waveform amplitude greater than 20. The red arrow indicates the confirmed collapses and induced debris flows, the black arrow indicates the Mw 5.6 earthquake on 10 November 2022, and the green arrow indicates two abnormal waveforms.

Previous retrospective studies have shown that seismic observations are helpful in reconstructing the processes of both glacial lake outburst floods (Cook et al., 2018; Maurer et al., 2020) and ice-rock collapses (Bai et al., 2023; Cook et al., 2022; Tiwari et al., 2022). The above-mentioned ice-rock collapses in the Sedongpu Valley further demonstrated that the *in-situ* geophone waveform can be effectively used to warn against the occurrence and magnitude of ice-rock collapses. When the X-axe amplitude of the geophone waveform at EWS1 was approximately 20, the magnitude of the ice-rock collapse was similar to that of the 11 August 2022 event (Fig. 5e and f). The geophone records at EWS1 show that there are a total of 12 events with waveform amplitudes greater than 20 from May 2022 to December 2022 (Fig. 6). Combined with the infrared and optical photographs at the Sedongpu Valley outlet, nine of the twelve events were confirmed to correspond to the occurrence of debris flows that arrived at the Sedongpu Valley outlet but did not significantly block the river (Figs. S2-8 in the Supplement). Only three events, including the Mw 5.6 earthquake centred at Medog on 10 November 2022, did not correspond to the debris flow near the valley outlet. Therefore, when the geophone amplitude exceeds 20 in EWS1, there is a high probability that collapse-induced debris flow will occur in the Sedongpu Valley. The geophone amplitude of 20 was selected as the first-level warning threshold. Due to no catastrophic events occurred in 2022, the EWS defined temporally two times (40) and three times (60) of the first-level threshold as the second and third-level warning thresholds, which would be optimized by further observations.

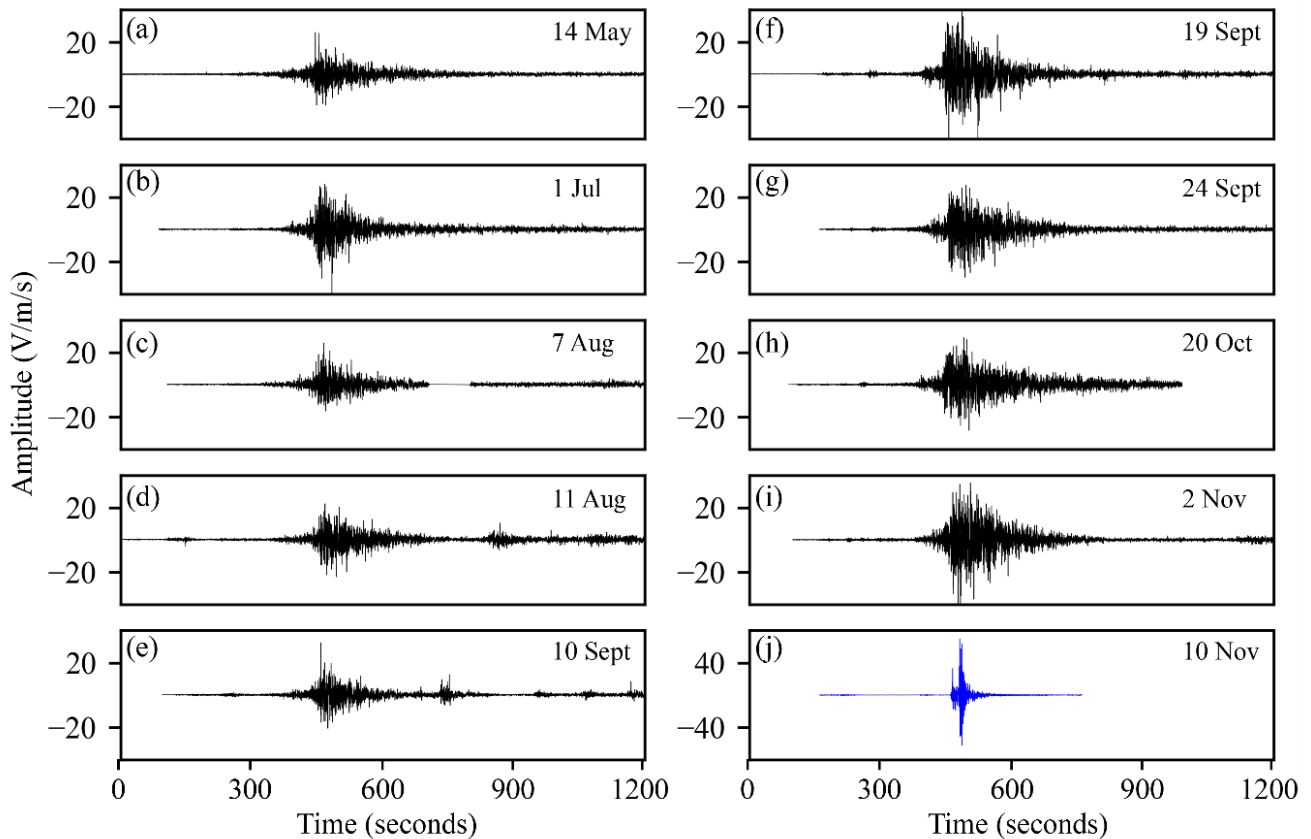
305 **Figure 7.** Comparison of the waveforms generated by ice-rock collapses (a-i) and by the earthquake on 10 November 2022 (j).
 Note the different y-axis limits.

The study region is located in an active crustal zone that experiences frequent earthquakes (Li et al., 2022a). A mixed waveform of collapses and earthquakes may result in false warning signals. In fact, the waveforms of ice collapses and earthquakes differ because of different physical processes. Figure 7 shows a comparison of the nine waveforms triggered by the confirmed rock collapses and the Mw 5.6 earthquake on 10 November 2022. The collapse typically lasted for several minutes and produced a continuous waveform (Fig.7 a-i). In contrast, the waveform from an earthquake is usually short-lived owing to the rapid release of rupture energy, *e.g.*, approximately one minute for a Mw 5.6 earthquake (Fig. 7j). In addition, for the two false warnings (maximum amplitude greater than 20) that occurred on 2 June and 1 October (Fig. 6), the detailed waveform analysis can easily exclude such false warnings by assessing their waveform duration and characteristics (Fig. S9 in the Supplement). These two waveforms are abnormally short and different from the typical collapse-induced waveform, indicating the possible noise. Therefore, in addition to the threshold of the maximum amplitude, the duration and characteristics of the waveform would be re-examined by the experts at STPSER and thus adopted as additional information for the ice-rock collapse warning in the Sedongpu Valley.

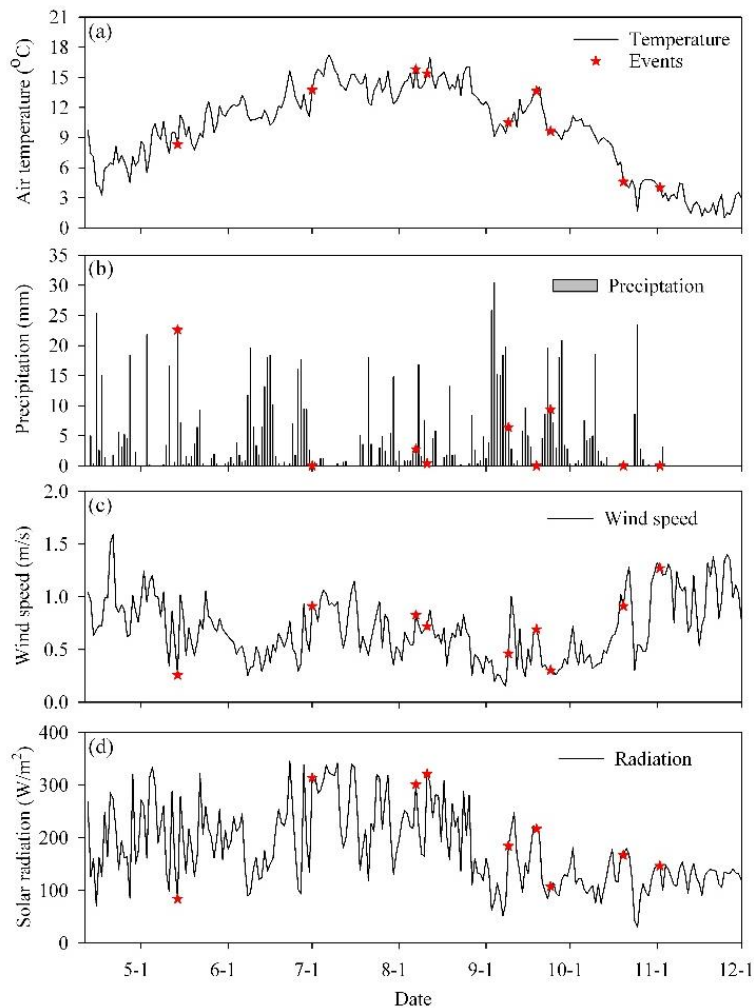
Figure 8. The occurrence of repeated ice-rock collapses (red stars) and the time-series of meteorological factors including air temperature (a), rainfall (b), wind speed (c) from EWS1 and the incoming shortwave radiation from EWS3 (d).

310 The EWS showed that at least nine ice-rock collapse-debris flows were found during the period from April to December
 2022 in the Sedongpu Valley. Previous studies show that some catastrophic rockslide-debris flows were triggered by heavy
 rainfall (e.g. Anderson and Sitar, 1995; Yin et al., 2016). The in-situ AWS measurements in/near the Sedongpu Valley provided
 an opportunity to investigate the relationship between the occurrence of ice-rock collapses and the possible meteorological
 triggers. Figure 8 shows the variation of meteorological factors such as air temperature, rainfall, wind speed and incoming
 315 shortwave radiation and their relevant values in the corresponding ice-rock collapse events (red stars). It is clear that the ice-
 rock collapses at the Sedongpu Valley could occur under different meteorological combinations (Table S1 in the Supplement).

For example, the weather condition of the ice-rock collapse on 14 May 2022 was characterized by relatively colder weather (8.3 °C), heavy rainfall (22.6 mm), weaker wind speed (0.3 m/s) and lower solar radiation (83.9 W/m²). In contrast, the weather conditions of the ice-rock collapse on 11 August 2022 were warmer (15.4 °C), less precipitation (0.4 mm), moderate wind speed (0.7 m/s) and sunny weather (321.1 W/m²). In addition, it is clear that no weather anomalies (*e.g.* extremely high air temperature or heavy rainfall) prior to the ice-rock events. This suggests that there were no immediate meteorological triggers for these small-scale ice-rock collapses and the associated debris flows in 2022 at the Sedongpu Valley. However, it should be noted that climate change can trigger complex delayed feedbacks in high-mountain regions. Previous studies have shown that the massive ice-rock collapses and glacier detachments occurred concurrently with, or shortly after, positive seasonal air temperature anomalies (Zhao et al., 2022; Bondesan and Francese, 2023). The possible triggers of ice-rock collapse therefore merit further investigation from a variety of perspectives, including the dynamic conditions of temperate glaciers, pre-event seismic activity, and the cumulative role of climate change.

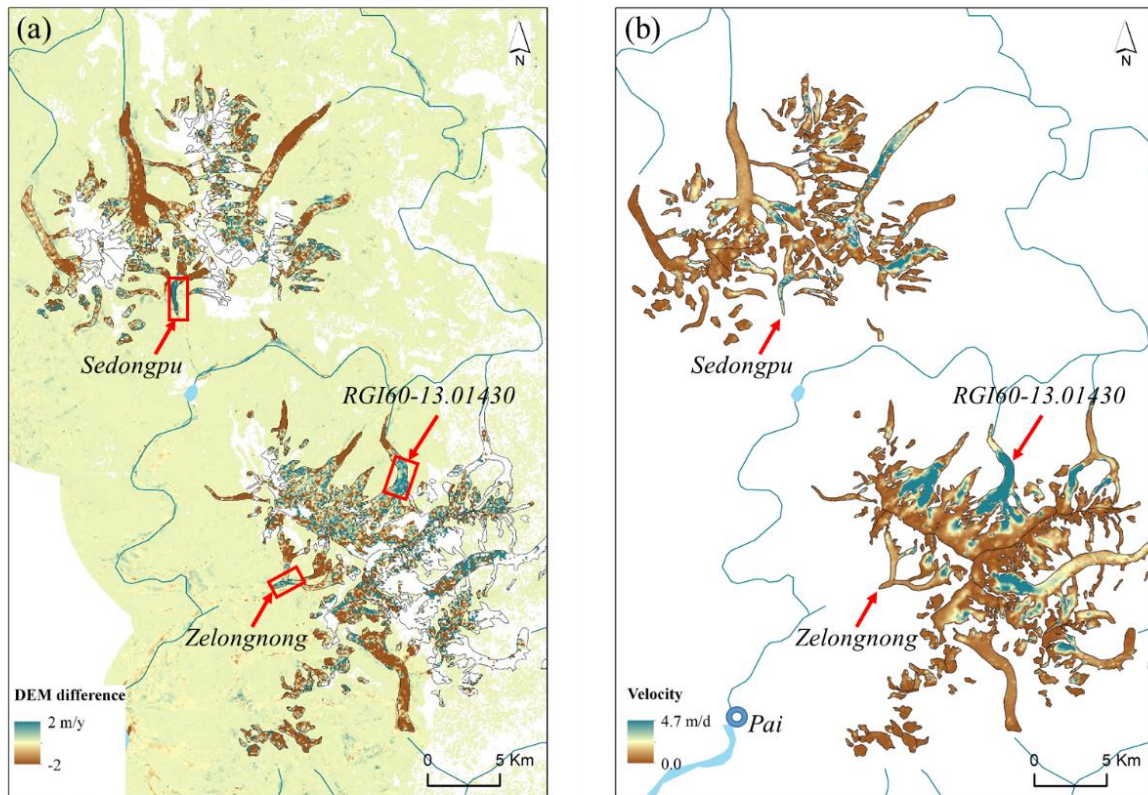
370 **Figure 9.** Spatial distribution of mean surface elevation change (m/y) during 2010-2020 (Hugonnet et al., 2021) and annual surface velocity (m/day) in 2017 (Millan et al., 2022), and the locations of the three glaciers with abnormal surface thickening (the red rectangles) and the tower of Pai.

Based on the published datasets, including glacier elevation change during the period 2010-2020 (Hugonnet et al., 2021) and glacier surface velocity during the period 2017–2018 (Millan et al., 2022), it was found that apart from the detached Sedongpu Glacier, there are still two glaciers (Zelongnong Glacier and the glacier numbered RGI60-13.01430) with possible collapse risks in the study region (Fig. 9). As shown in Figure 9a, the ablation zone of the Sedongpu Glacier has experienced an anomalous glacier thickening ($\sim+2.0$ m/yr) over the past decade, which facilitated massive low-angle glacier detachment in October 2018 (Kääh et al., 2021). A similar anomalous ice thickening near the ablation zone (the red rectangles in Figure 8a) was also found at the Zelongnong Glacier ($\sim+0.35$ m/yr) and RGI60-13.01430 Glacier ($\sim+0.37$ m/yr). In addition, the spatial distribution of the surface velocity also indicated a high glacier displacement in the ablation zone with possible sliding risks on these glaciers (Fig. 9b).
