2 **Early warning system for ice collapses and river blockages in the** 3 **Sedongpu Valley, southeastern Tibetan Plateau**

13 The following figures show the comparing optical/thermal photography and geophone
14 waveform of the seven small-scale ice/rock collapse-debris flow events (1 July, 7 August, 9
15 September, 19 September, 24 September, 20 October, 2 November), which debris flows arrived at
16 the Sedongpu Valley outlet but did not significantly block the Yarlung Tsangpo River.

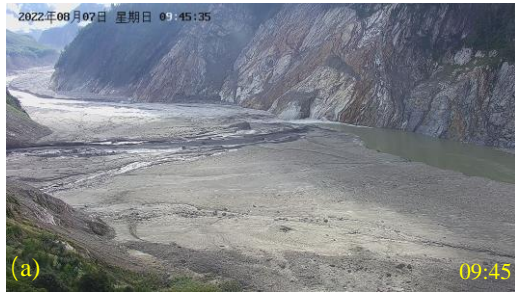
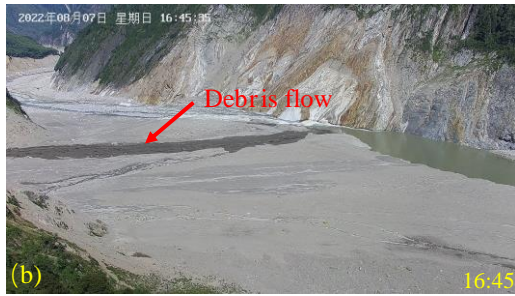
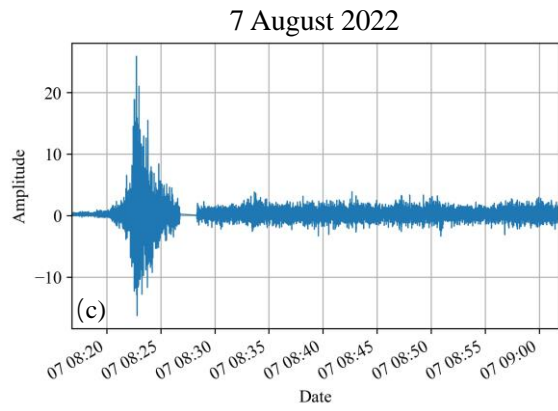
Figure S2. Similar to the above figure but on 7 August 2022.

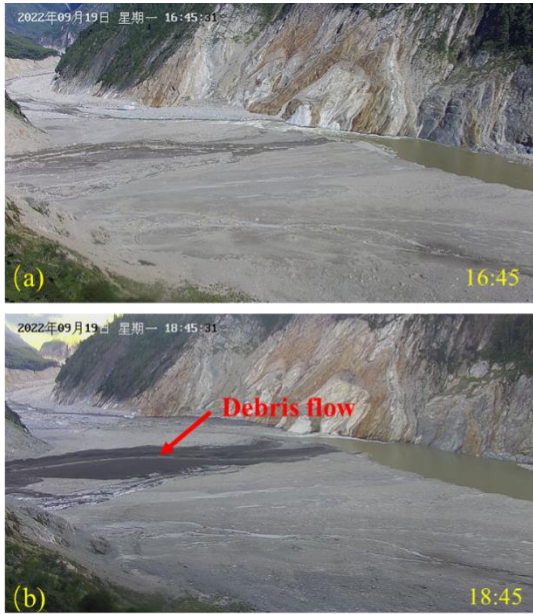
Figure S4. Similar to the above figure but on 19 September 2022.

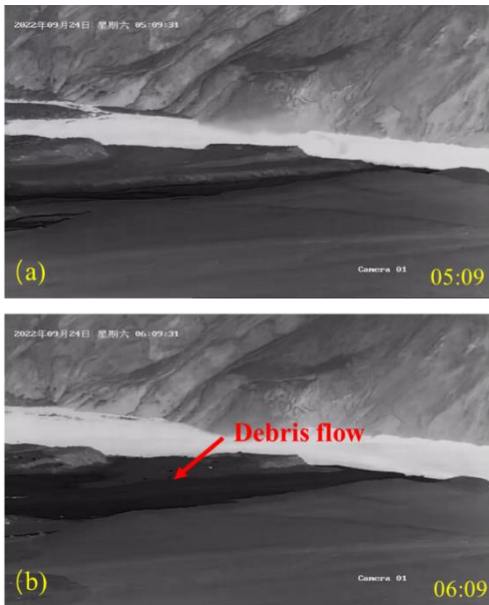
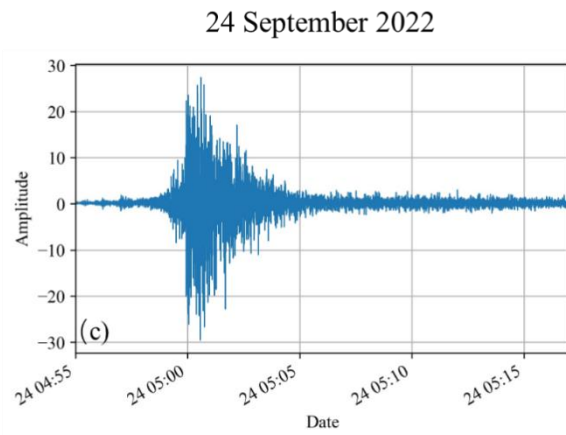
Figure S5. Similar to the above figure but on 24 September 2022.

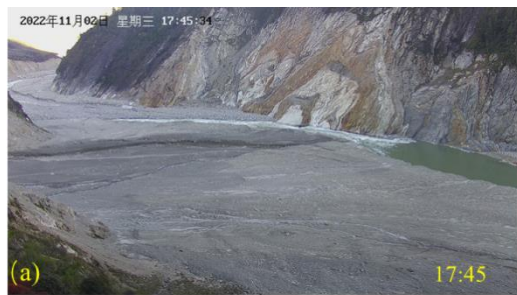
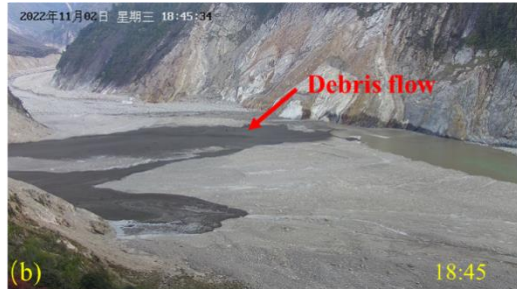
Figure S7. Similar to the above figure but on 2 November 2022.
