We sincerely thank reviewer 2 for their comments and for the time taken to review the manuscript. We have addressed all comments and provide our response below. Reviewer comments are in black, our responses are in green, and excerpts from the revised manuscript are in blue.

4. Application of the full damage assessment pipeline: Assessing tephra fall building damage in Owia

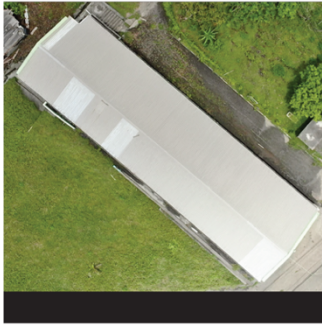
No damage to
minor damage

Figure 2. Example of the three damage states used in this work: No damage to minor damage, Moderate damage and, Major damage.
