Automating tephra fall building damage assessment using deep learning

Eleanor Tennant ¹, Susanna F. Jenkins ², Victoria Miller ³, Richard Robertson ⁴, Bihan Wen ⁵, Sang-Ho Yun ², Benoit Taisne ²

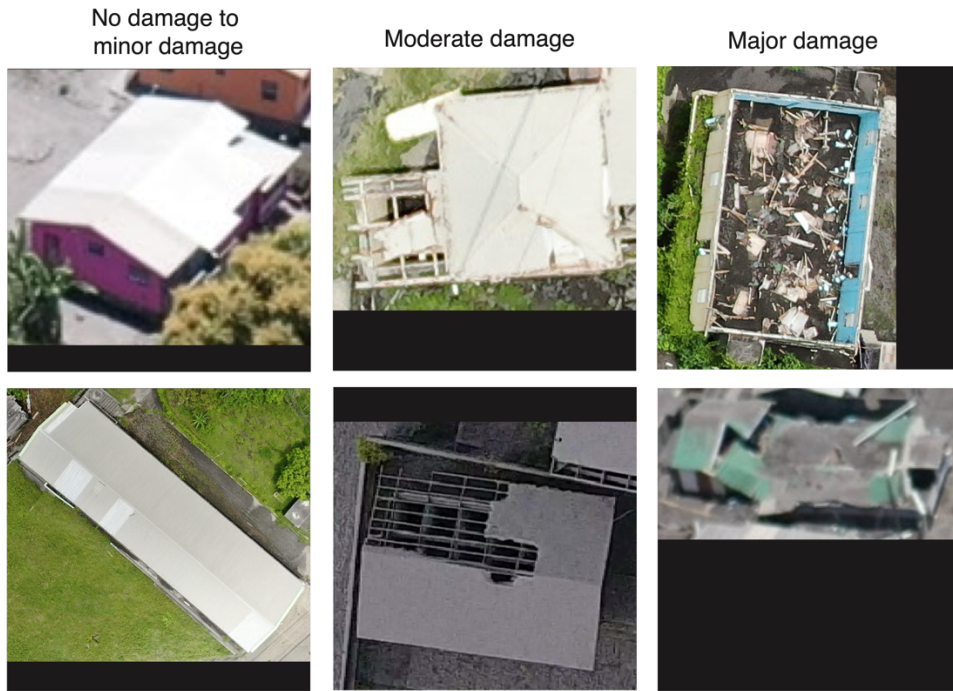
287 *Figure 2. Example of the three damage states used in this work: No damage to minor damage,*
 288 *Moderate damage and, Major damage.*

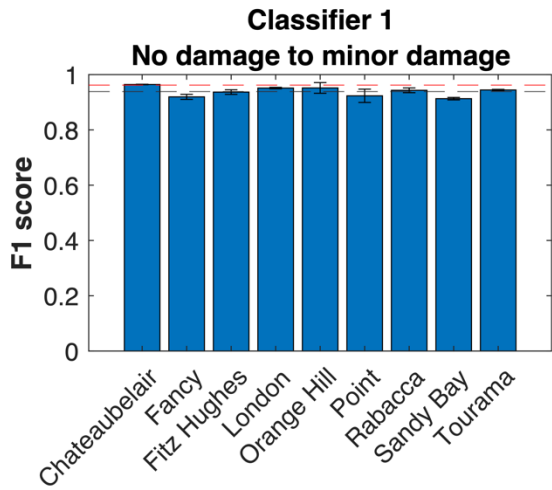
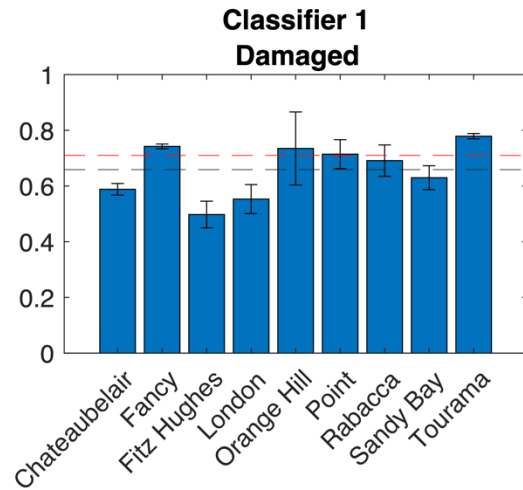
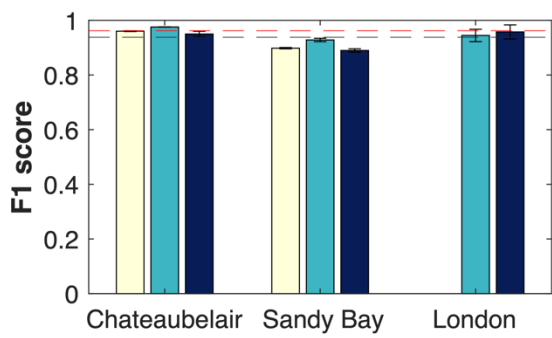
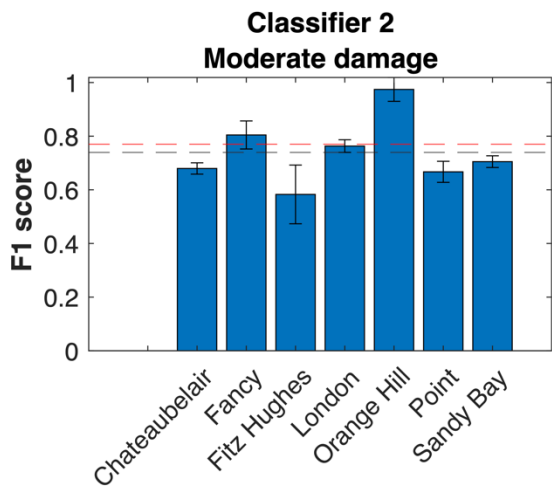
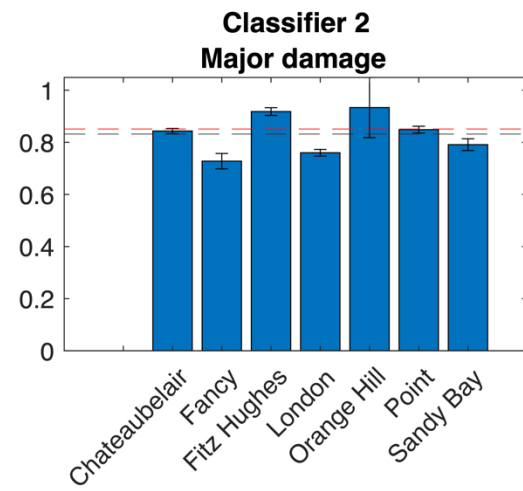
555 *Figure 6. Cross validation for Classifiers 1 and 2. For rows 1 and 3 the best experimental setup was*
556 *retrained on all the data from locations in the combined training and validation data and*
557 *evaluated on the location shown. For rows 2 and 4 the best experimental setup was retrained on*
558 *all the data from the location shown and evaluated on each dataset (UWI-TV/GOV/SRC)*
559 *separately. Each training was conducted three times, the value plotted is the mean, and the error*
560 *bars show the standard deviation. Black dashed lines show the mean F1 score across all cross*
561 *validation trained models, red dashed lines show the best F1 score for each class from the*
562 *experiments (Table 6).*

564 The performance of Classifier 1 for the No damage to minor damage class is consistent across
565 the distinct locations and datasets used for evaluation with mean F1 scores between 0.913-
566 0.983 for locations and 0.898-0.976 for datasets (Fig. 6). For the Damaged class there is more
567 variety in the performance across the locations and datasets used for evaluation. The mean F1
568 scores for the separate locations range from 0.588 (Fitz Hughes) to 0.779 (Tourama) while for
569 the different datasets the range is 0.393 (London-SRC) to 0.745 (Sandy Bay-SRC).

571 For Classifier 2, the Moderate damage class is more sensitive to the choice of location and
572 dataset used for the evaluation than the Major damage class (Fig. 6). For the different locations
573 the mean F1 score ranged from 0.583-0.974. Similarly to Classifier 1, the location with the
574 lowest mean F1 score is Fitz Hughes, whereas the highest score was produced for Orange Hill.
575 For the different datasets the range for the Moderate damage class is between 0.522-0.746.

576 For the Major damage class F1 scores for the distinct locations are between 0.728-0.933 while
577 for the different datasets the range is between 0.711-0.867.
