Natural Hazards
and Earth System
Sciences

The vulnerability of buildings to a large-scale debris flow and outburst flood hazard cascade that occurred on 30 August 2020 in Ganluo, southwest China

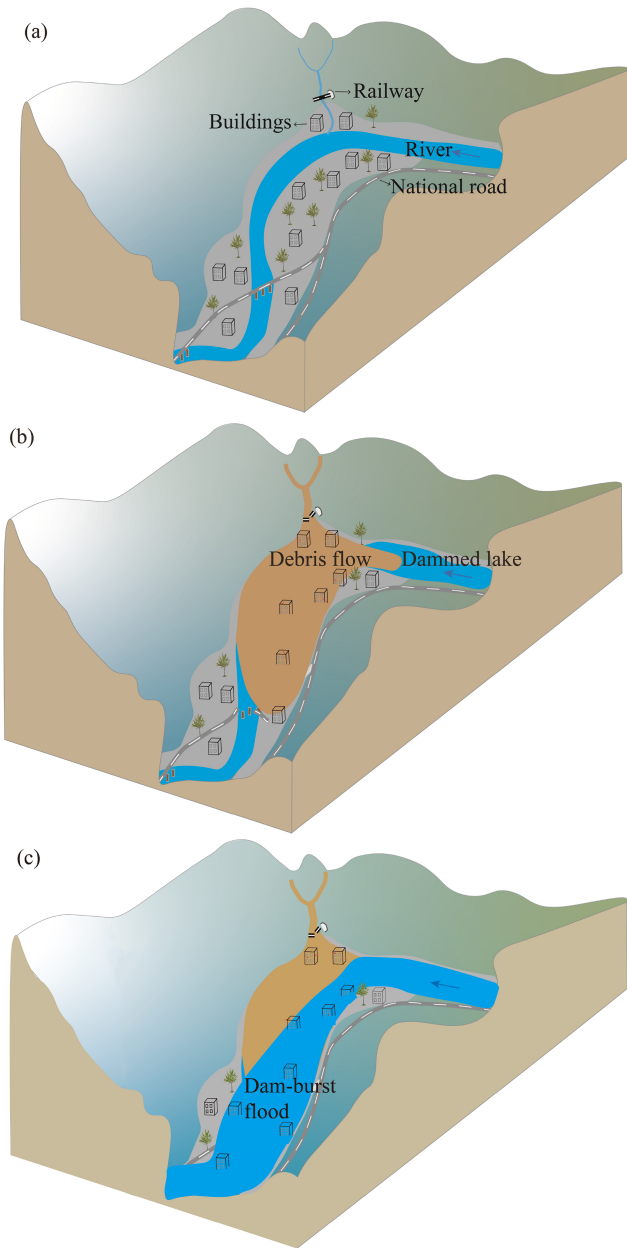
The debris flows firstly transported approximately 1 050 000 m^3 of sediment to the Niri River, forming a temporary debris dam. The debris flow swept away the railway bridge that crossed the gully mouth and impacted the national road across the river. It also destroyed the buildings close to the gully mouth and those on the opposite bank of the main river. Approximately 40 min later, the debris flow dam was breached, triggering a high-magnitude flash flood that damaged the national road and buildings near the altered flooding path (Fig. 3).

Figure 3. Illustration of the hazard cascade process: **(a)** the normal flow of river flow before the occurrence of debris flow; **(b)** debris flow blocks the river, creating a dammed lake that destroys the railway, roads, and buildings; **(c)** the dammed lake bursts, causing a flood that damaged and the road and buildings.

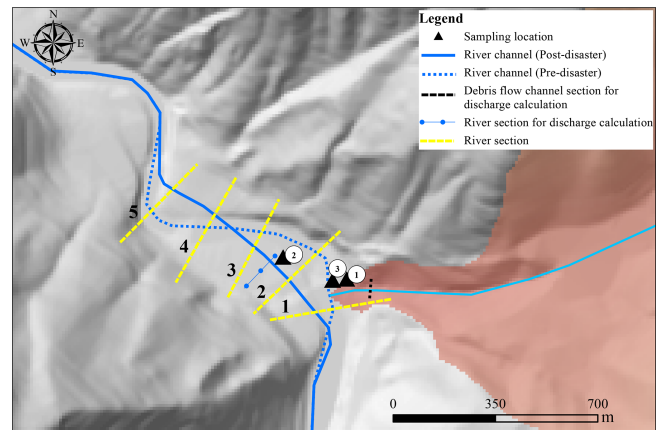
Samples of debris particles smaller than 10 cm were taken from three locations (see Fig. 4). The particle size distribution of the debris flow samples is presented in Fig. 5. The calculated bulk density of the debris flow is 1.825 g cm^{-3}, which indicates a viscous debris flow (Kang et al., 2004).

Figure 4. Distribution of river and debris flow channel sections and debris flow sampling locations.

strongly eroded by the flood, leading to the collapse and demolition of buildings. Five river sections (sections 1 to 5) were selected to analyze the terrain changes (see Fig. 4). From sections 1 to 3, the main channel varied from the right bank to the left bank, with a distance between 40 and 100 m; the average width of the new river channel was 50 m; and the vertical distance between the new riverbed and floodplain was 11.23 m. In section 5, the channel migrated from the left bank to the right bank due to the severe erosion of the original river terrace and had a maximum depth of 10 m (Fig. 10). The channel width increased to approximately 100 m, and the channel depth decreased to less than 5 m.

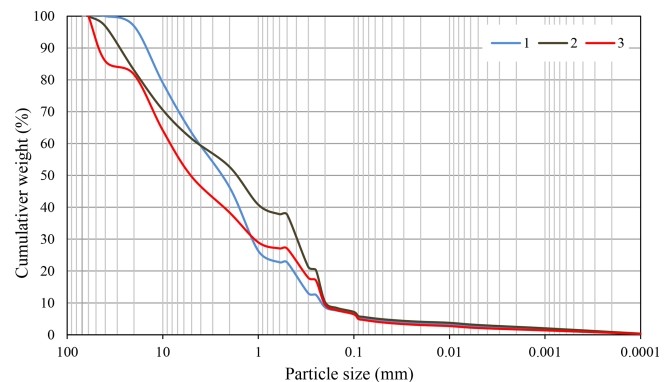
Figure 5. Particle size distribution of debris flow samples.

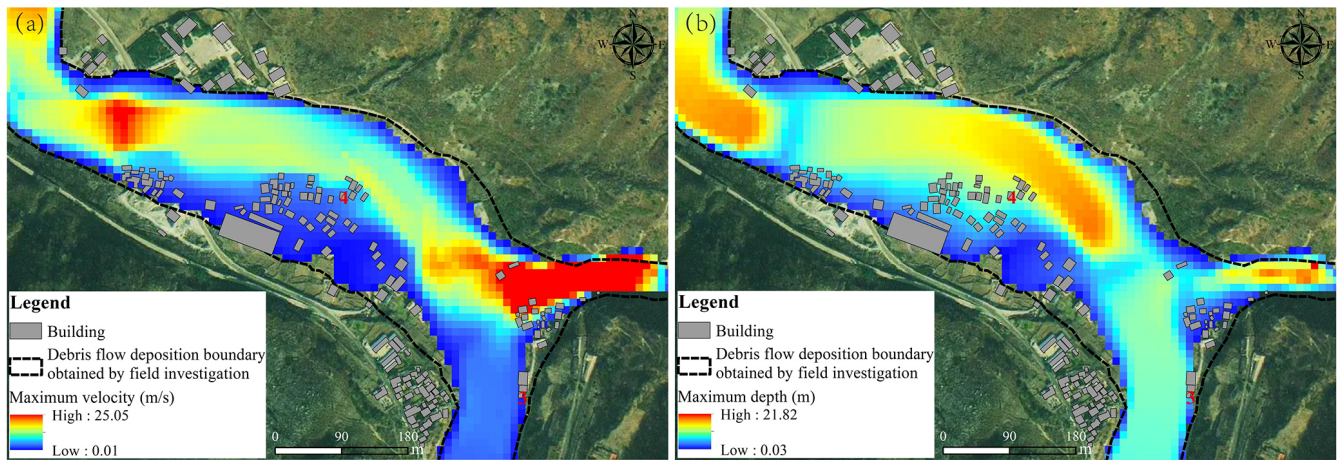
The temporal distributions of the maximum depth and velocity of the debris flow are presented in Fig. 6. The majority of buildings close to the river channel and debris flow channel were buried by the debris flow. The debris flow lasted approximately 40 min and transported a great volume of sediment downstream. The deposition zone extended from the gully mouth to the floodplain of the Niri River, covering a length of 320 m. The deposition area obtained from the simulation is $0.15\,\mathrm{km^2}$, which is close to the area measured from the UAV image, approximately $0.16\,\mathrm{km^2}$. The thickness of the sediment deposits ranged from 5 to 15 m, with an average value of 7 m. Figure 7 shows that the debris flow buried one floor of building 3 and nearly two floors of building 4 (locations indicated in Fig. 6). The simulated maximum depths at buildings 3 and 4 are 3.2 and 5.5 m, respectively, close to the actual deposition heights. The debris flow flushed into the main river and blocked the Niri River. The river channel was filled with sediment, which led to the formation of a dammed lake that raised the water level by 7–8 m. After 40 min, the unstable dammed lake breached, which resulted in a massive flash flood.

Figure 6. Distribution of maximum depth and velocity of the debris flow. (Satellite image obtained from https://www.jl1mall.com, last access: 27 November 2024.)

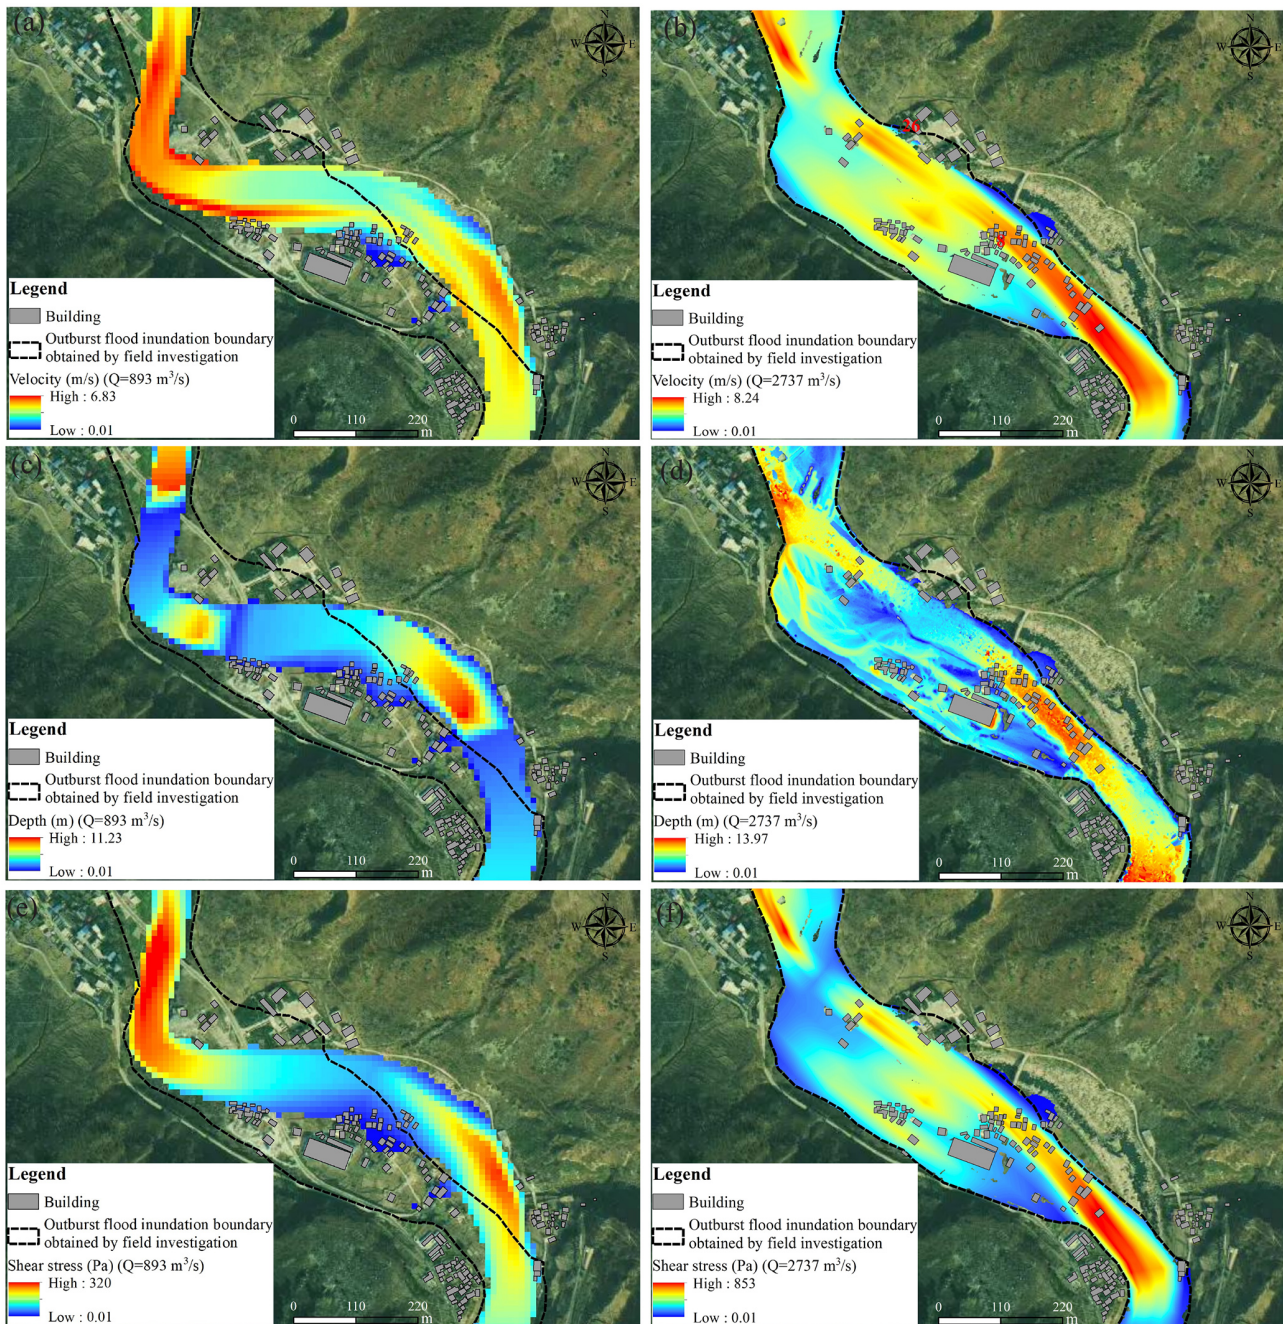
sented in Fig. 8. The simulated inundation area of the outburst floor is 0.18 km^2, which is consistent with the field investigation result with an error of 1.1 %. The flood completely submerged all buildings on the left bank near the middle of the river channel, and the buildings on the river terrace on the right bank were strongly eroded. The maximum water depth and velocity of the dam-burst flood were 13.96 m and 8.24 m s^{-1}, respectively, which were 1.24 and 1.31 times higher than those of the ordinary flood, respectively. The maximum depth of the dam-burst flood at locations of buildings 8 and 26 were 6.4 and 3.7 m, respectively (Fig. 9) (building locations indicated in Fig. 8), which are close to the result obtained by field investigation. The maximum shear stress of the flood in the main channel increased sharply from 320 to 853 Pa, indicating a 2.67-fold increase compared to the ordinary flood. For the ordinary flood scenario, the water depth and velocity were high in the channel and decreased in the floodplain. In contrast, the high velocity

and shear stress zones that resulted from the dam-burst flood were mainly distributed in the main channel and along the left bank, indicating that the material deposited by the debris flow and the original riverbank are highly susceptible to erosion.

Figure 8. Distribution of depth, velocity, and shear stress of ordinary flood and dam-burst flood: **(a)** maximum velocity distribution of ordinary flood; **(b)** maximum velocity distribution of dam-burst flood; **(c)** maximum depth distribution of ordinary flood; **(d)** maximum depth distribution of dam-burst flood; **(e)** maximum shear stress distribution of ordinary flood; **(f)** maximum shear stress distribution of dam-burst flood. (Satellite image obtained from https://www.jl1mall.com, last access: 27 November 2024.)

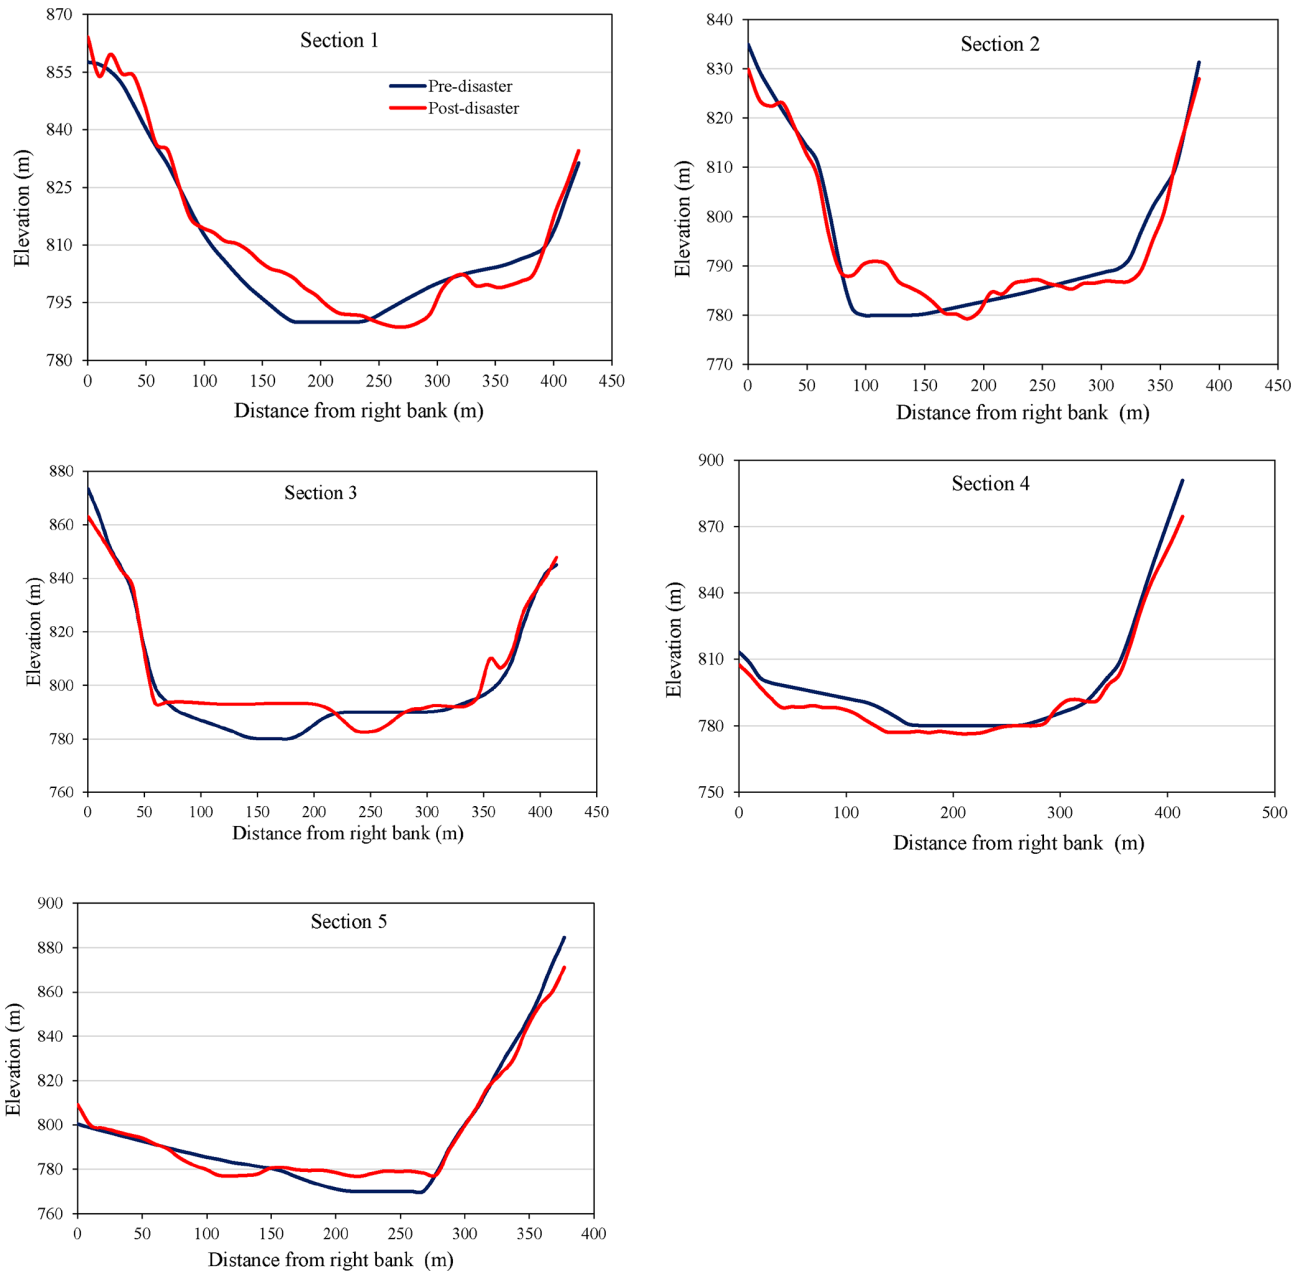
nel, raising the bed of the Niri River by 1–17 m and burying buildings up to 1 km downstream of Heixiluo Gully. The channel length shortened from 1010 to 842 m, and the channel gradient increased from 1.71 % to 2.72 %. The change in the river channel led to an inundation area that deflected to the left. Buildings built on the original left riverbank were first impacted by debris flow and subsequently destroyed by the flood. The river terrace on the original right bank was

**Figure 10.** Cross-section profile before and after the disaster.

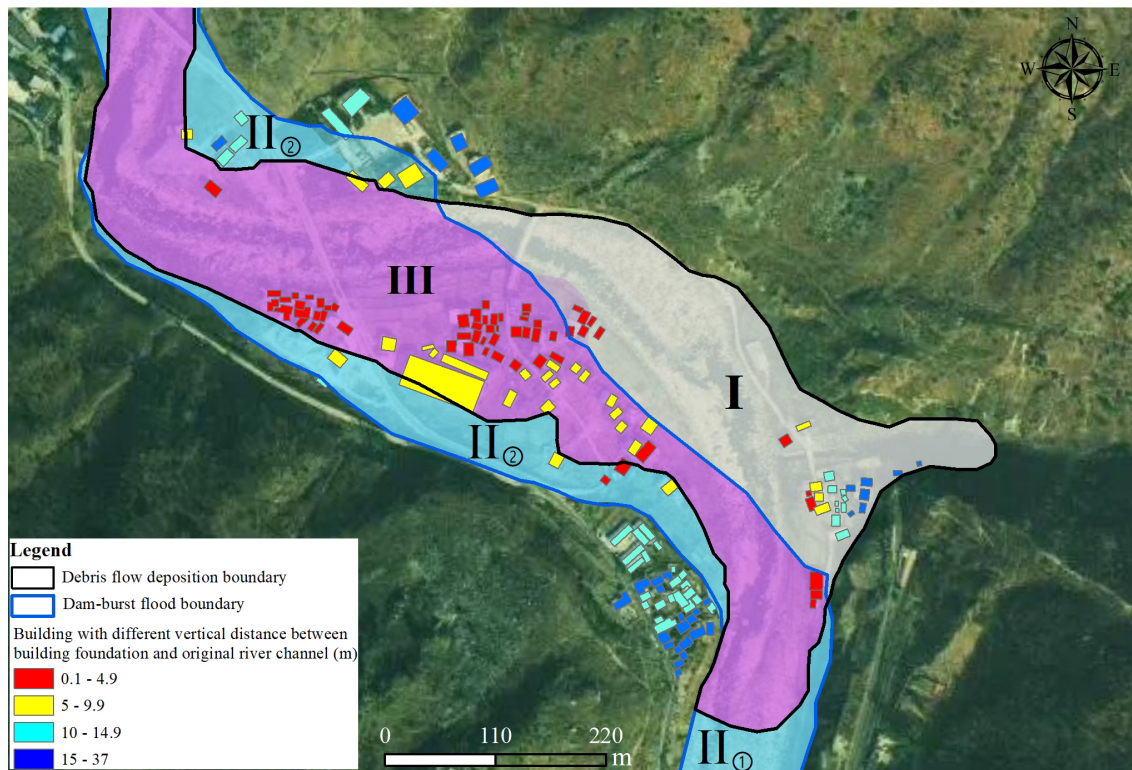
Figure 11 illustrates the boundary of debris flow deposition and dam-burst flood inundation. The debris flow deposition boundary was determined by the simulation. Flooding boundary was obtained by combining the results of the HEC-RAS simulation with field survey data. The confluence area was heavily impacted by the debris flow, resulting in the transportation of a significant amount of solid materials over an area of $0.189\,\mathrm{km^2}$. As a result, the majority of the village's buildings were inundated by the debris flow. The dam-burst flood caused serious damage to buildings by flushing a large volume of debris flow sediment and riverbank material downstream.

Figs. 11 and 12. The damage patterns of buildings in the different hazard zones can be classified into three categories, namely (I) buildings only buried by debris flow, (II) buildings only inundated by dam-burst flood, and (III) buildings sequentially buried by debris flow and inundated by dam-burst flood. Zone (I) is situated near the Heixiluo Gully mouth, where the debris flow transported a large volume of sediment and seriously eroded the sidewall and bed of the channel, expanding the channel's width from 10 to 40 m. All buildings were inundated by sediment to a depth of over 6 m.

Figure 11. Inundation boundary of debris flow and dam-burst flood and spatial division of the hazard zone based on building damage patterns: (I) buried by debris flow; (II) inundated by dam-burst flood; (III) buried by debris flow and then inundated by dam-burst flood. (Satellite image obtained from https://www.jl1mall.com, last access: 27 November 2024.)

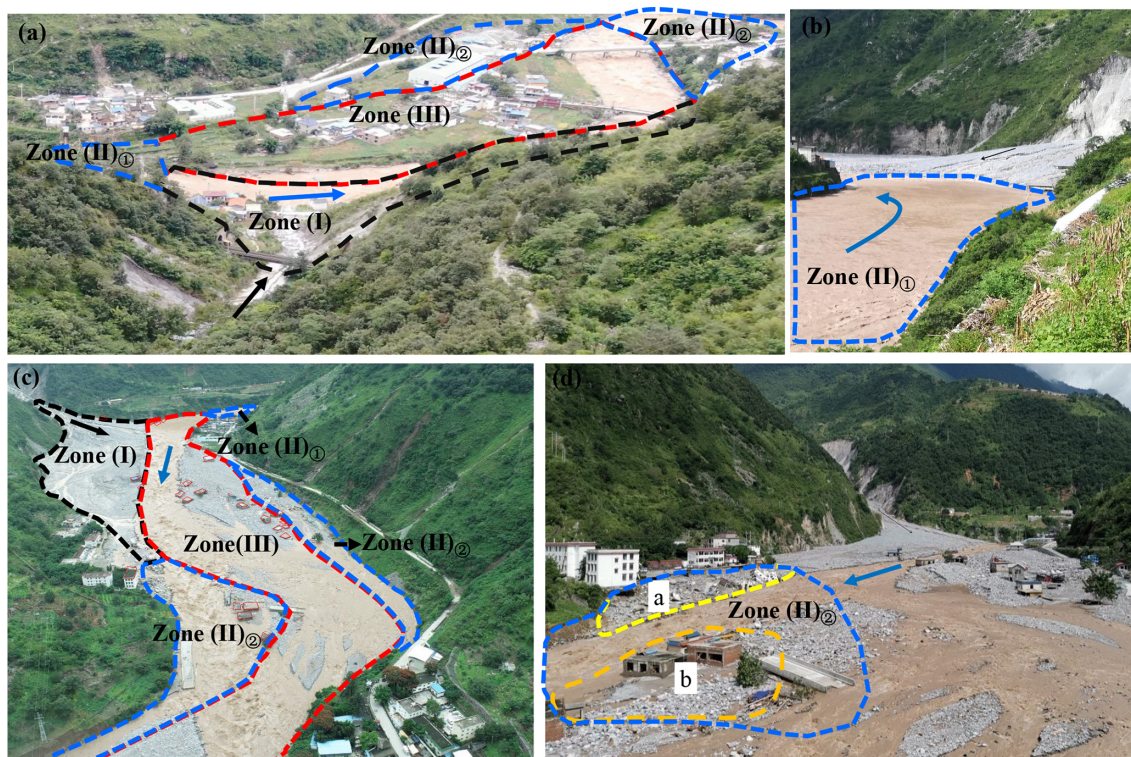
Zone (II) is subdivided into two subzones, Zone (II) ① and Zone (II) ②, based on the spatial location. Zone (II) ① is situated in the upstream reach of the Niri River, near the debris flow dam, and is mainly inundated by the static water of the dammed lake (Fig. 12b). Zone (II) ② lies on the right bank of the downstream reach of the Niri River, outside the debris flow fan. The original right riverbank in Zone (II) ② was a terrace 10 m high that was severely scoured by the highly energetic flood with a shear stress greater than 450 Pa. The entire terrace was cut off, and a new channel was formed

across the middle area (Fig. 12c). The erosion area on the river terrace measures approximately 1800 m², with a length of 300 m and a width of 60 m. Two buildings situated on the upper part of the river terrace collapsed and disintegrated due to the impact of the flood (part (a) in Fig. 12d). A three-story building was partially destroyed due to foundation erosion.

Figure 12. Spatial distribution of the three hazard zones before and after the disaster: **(a)** before the disaster; **(b–d)** after the disaster.

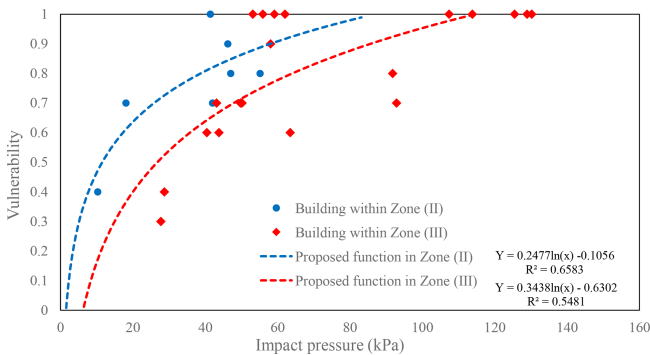
The vulnerability curve in Zone (II) and Zone (III) was developed by summing up the damage caused by the multiple hazards and impact pressure (Fig. 14). Logistic functions were proposed separately for the two hazard zones, and the corresponding determination coefficient (R^2) and root mean square error (RMSE) were also obtained. The determination coefficients of the two regression curves in Zone (III) have a higher R^2. The RMSEs of the curves in Zone (II) and Zone (III) are 0.66 and 0.55, respectively. The correlation between vulnerability and inundation depth in the two zones is shown in Fig. 15, with an R^2 lower than impact pressure: $R^2 = 0.55$ for Zone (II) and $R^2 = 0.45$ for Zone (III). Building vulnerability increases with increasing hazard intensity, and the trend is similar in the two zones. The impact pressure thresholds for Zones (II) and (III), where vulnerability

Figure 14. Proposed vulnerability functions based on the impact pressure in Zone (II) and Zone (III).

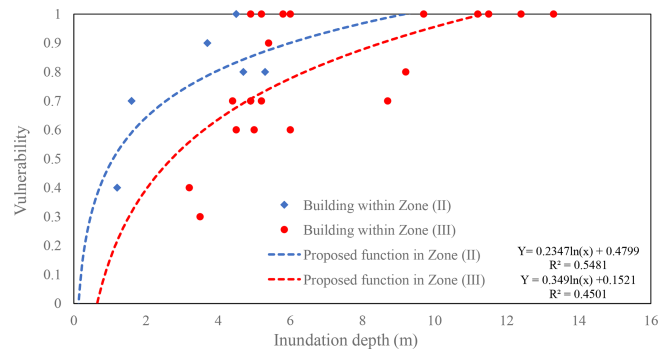
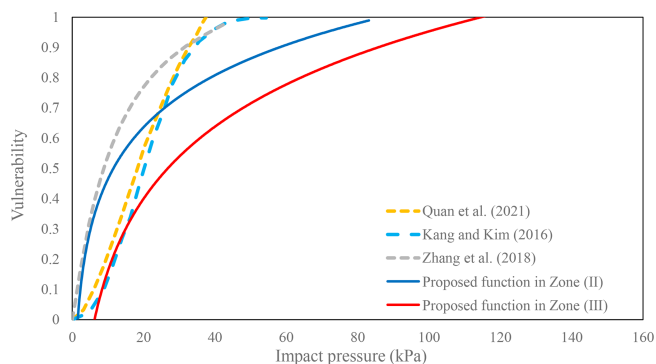
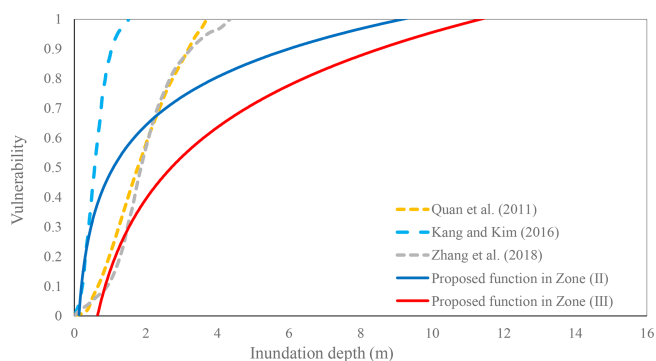
Figure 15. Proposed vulnerability functions based on the impact pressure in Zone (II) and Zone (III).

when the impact pressure is greater than 20 kPa, the slope of the two proposed vulnerability curves is much smaller than those of the three curves. For the curves based on inundation depth, when the depth is less than 1.5 m, the slope is steeper than that of Quan et al. (2011) and Zhang et al. (2018) and slower than that of Kang and Kim (2016). When the depth is greater than 2 m, the damage increases more slowly than the

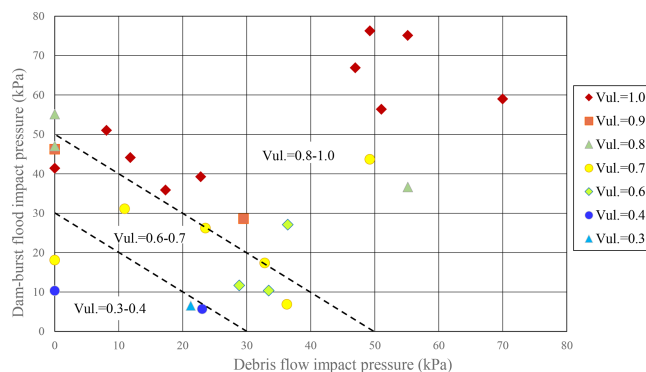
The building damage distribution chart shows building damage plotted as a function of debris flow and flood impact pressure (see Fig. 18). The figure includes aggregated damage to buildings impacted by the sequentially occurring hazards in Zone (III) and damage caused by a single hazard in Zone (II). Damage is divided into three categories based on the threshold impact pressure: slight damage (0.3–0.4), moderate damage (0.6–0.7), and heavy and complete damage (0.8–1.0). Heavy and complete damage mainly occurs at impact pressures greater than 50 kPa, while slight damage occurs below 30 kPa. Moderate damage mainly occurs at impact pressures between 30 and 50 kPa. The threshold impact pressure is compared with that proposed by Hu et al.(2012) and Zanchetta et al. (2004), which were derived from a single debris flow disaster in China and Italy, respectively. Although the detailed definition of the damage scales differs, the threshold of the impact pressure for buildings at

Figure 18. Accumulation of building damage due to debris flow and dam-burst flood. The damage distribution is based on the debris flow and flood impact pressure (Vul. refers to vulnerability).

the slight, heavy, and complete damage scales is generally larger than that for the brick–concrete structures presented in Hu et al. (2012) and smaller than that for the reinforced concrete frames also presented in Hu et al. (2012) and the masonry structures with basements presented in Zanchetta et al. (2004). A similar trend for the threshold of the impact pressure for buildings with a moderate damage scale can be observed.

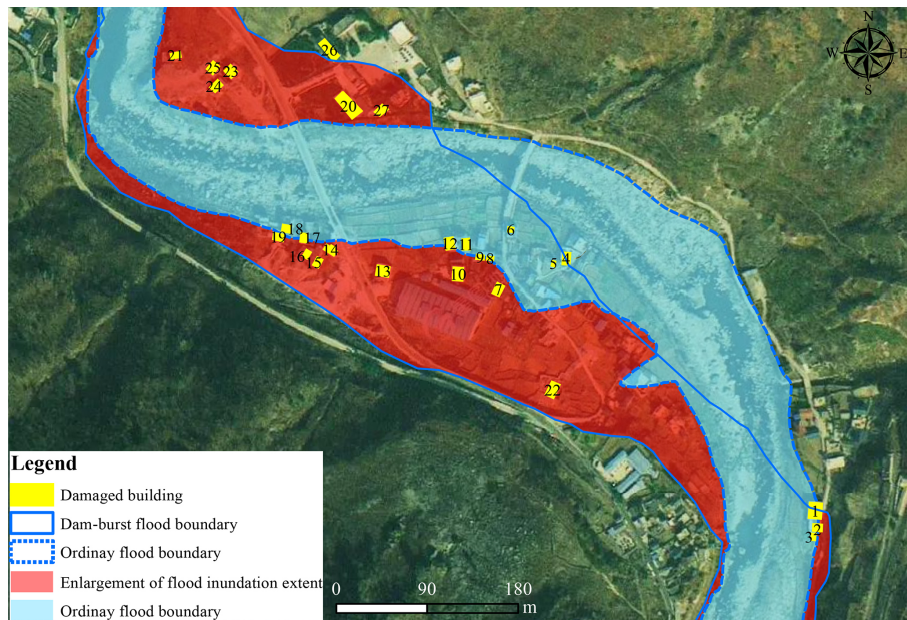
creates a new straight channel when the river channel becomes completely blocked. This channel translocation leads to a larger flooded area and causes more severe damage to buildings on the floodplain. The flood inundation zones in the village expanded to $110^5\,\mathrm{m}^2$, which is up to 4 times the area of an ordinary flood due to flood amplification (Fig. 19). In the expanded inundation zone, 41 buildings, a traffic road spanning 410 m, and farmland with an area of $10 \times 10^4\,\mathrm{m}^2$ were submerged. The buildings located in the middle of the inundation zones suffered the most severe damage due to the floodwater's high scouring capability and sediment transport capacity. Many buildings near the flow collapsed, and most structures were carried away by the water current.

Figure 19. The inundation extent of ordinary floods and dam-burst floods. (Satellite image obtained from https://www.jl1mall.com, last access: 27 November 2024.)
