Natural Hazards
and Earth System
Sciences

Tangible and intangible ex post assessment of flood-induced damage to cultural heritage

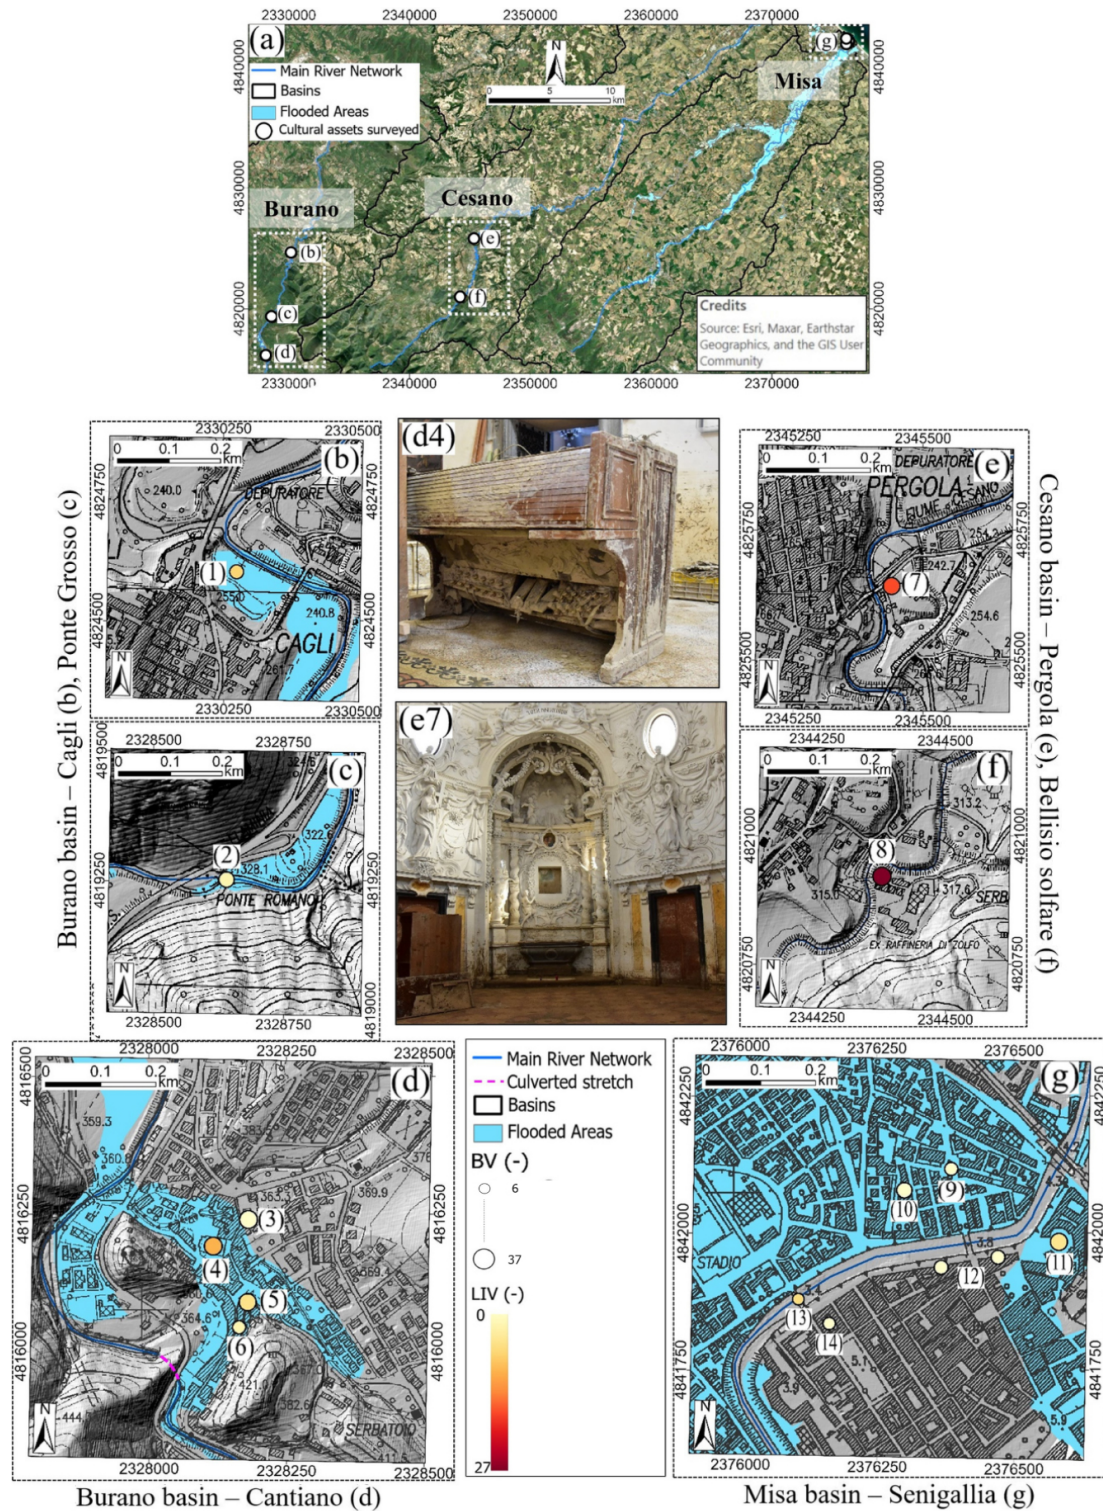
Ponte Garibaldi (Fig. 3g, label 13), namely the damaged bridge in Senigallia (Misa basin), has the lowest intangible value (BV = 6) for its limited historical value (it dates to the early 20th century), as well as for its limited aesthetic value. Indeed, even if it is an example of the typical early-20th-century architectural style, it is not a valuable structure. On the other hand, the other damaged bridge in the Burano basin, Ponte Grosso in Cantiano (Fig. 3c, label 2), is characterized by a higher intangible value (BV = 23). In this case, even if its aesthetic value is limited, both the historical and evidential values are high, because it is a rare example of infrastructure of the ancient Roman Empire.

It is worth noting that the Bellisio Solfare refinery asset (Fig. 3f, label 8), despite being mostly unknown among the most important tourist attractions and with a poor state of conservation, is characterized by high intangible value (BV = 27). Indeed, it represented an important proof of the past industrial activity of the Pergola municipality area (Bu-

Figure 3. (a) General view of the CH assets surveyed for each basin and **(b–g)** the panels including numbered labels (1–12) representing the CH asset points showing the BV (bubble size range represents $6 \leq \text{BV} \leq 37$) and LIV (scale colours) scores of the assets. Burano basin: **(b)** Sant'Emidio Oratory in Cagli (1), **(c)** Ponte Grosso in Cantiano (2), and **(d)** the assets in Cantiano (3–6). Cesano basin: **(e)** Santa Maria delle Tinte Church (7) and **(f)** Bellisio Solfare (8). Misa basin: **(g)** the assets in Senigallia (9–14). Panels **(d4)** and **(e7)** report post-event photos of San Giovanni Battista Collegiate and Santa Maria delle Tinte Church, where damage as a result of mud deposition inside the buildings is visible. The shaded relief basemap of panels **(b)**–**(g)** was obtained from the DTM lidar of the Ministero dell'Ambiente e della Sicurezza Energetica (MASE, 2024). The numerical technical map of panels **(b)**–**(g)** is from the Marche region (REGIONE MARCHE, 2023). Both maps are distributed under the CC BY 4.0 license. Coordinate system: WGS 1984 UTM zone 33N.

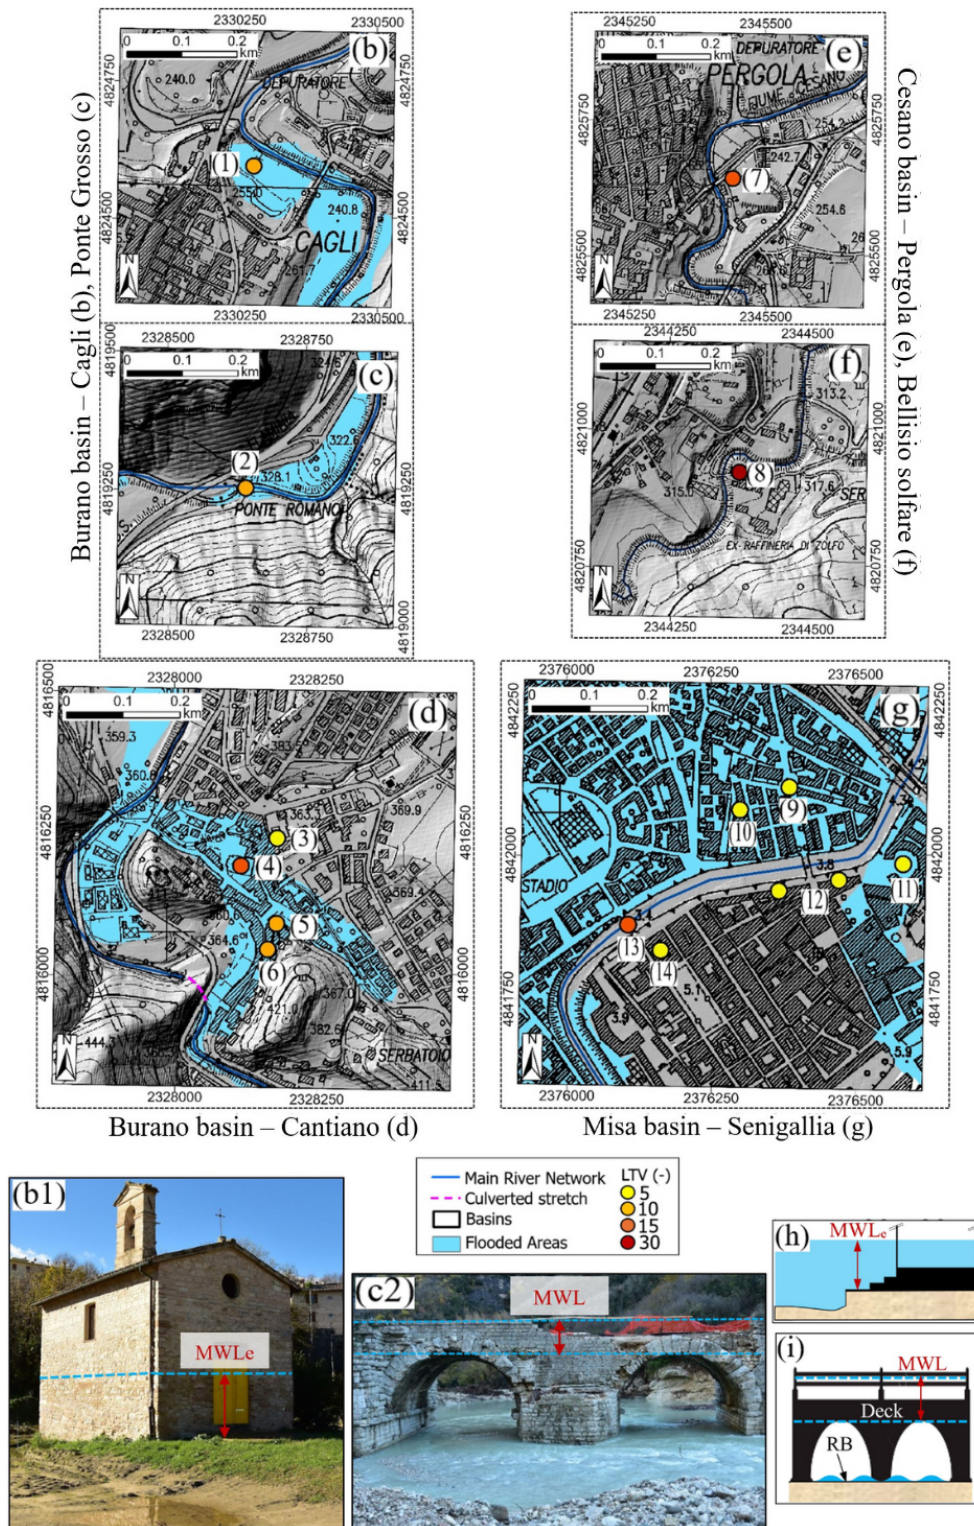
Figure 4. (b–i) The panels of the LTV scores of the assets (labels 1–12). Panels **(b1)** and **(c2)** display the post-event field survey photos depicting the damage to the Sant'Emidio Oratory and Ponte Grosso, respectively. Panels **(h)** and **(i)** report the schematic view of the MWL estimation in the case of a generic building and a bridge, respectively (RB is the riverbed). The shaded relief basemap of panels **(b)**–**(g)** was obtained from the DTM lidar of the Ministero dell'Ambiente e della Sicurezza Energetica (MASE, 2024). The numerical technical map of panels **(b)**–**(g)** is from the Marche region (REGIONE MARCHE, 2023). Both maps are distributed under the CC BY 4.0 license. Coordinate system: WGS 1984 UTM zone 33N.

In Fig. 4–g showing the spatial distribution of the LTV scores of each asset are reported. Concerning the Bellisio Solfare refinery (Fig. 4f, label 8), the highest LIV and LTV were assigned as the flood completely destroyed the building, and during the survey, only ruins were observed (LIV = 27 and LTV = 30). The historic Santa Maria delle Tinte Church (Fig. 4e, label 7) sustained considerable damage caused by the flood, both in terms of damage to intangible and tangible

value (LIV = 20 and LTV = 15). The inundation resulted in harm to the electricity system and the emergence of mould on both the floor and wall paintings. Additionally, the force of the floodwater partially wrecked the door and destroyed the 18th-century pews. As a result, the aesthetic value of the church was deemed lost. Moreover, its extended closure period led to a significant impact on its communal value. Even the San Giovanni Battista Collegiate (Fig. 4d, label 4) experienced severe damage (LIV = 13 and LTV = 15). In addition to the effects already observed for the other assets, floor tiles were broken, the wooden choir and altars were swollen due to the floodwater, and the 16th-century liturgical supply was covered by mud. In the case of San Nicolò Church (Fig. 4d, label 5), part of the floor collapsed, and the external stone and metal balustrade were swept away by the flowing water (LIV = 5.1 and LTV = 10). Similar loss scores were observed for the Sant'Emidio Oratory (Fig. 4b, label 1), in which, however, a significant loss was due to the wooden door, as it was swept away.

Overall, a high level of losses was observed for most of the affected religious structures, where closure due to extensive damage contributed to a decrease in communal value. Conversely, the Sant'Agostino (Fig. 4d, label 3), Porta Lambertina, Santa Maria del Porto, Portici Ercolani, and Filanda Serica assets (Fig. 4g, labels 9, 10, 12, and 14) incurred the lowest losses, both in intangible and tangible aspects (LIV = 0 and LTV = 5). Specifically, the two churches were not damaged as they are over-elevated from the ground floor. For all these assets, only mud marks dirtied the external walls.

The two affected bridges were significantly damaged as the maximum level reached by the water during the flood exceeded the height of the deck. Portions of the arch stones of the Ponte Grosso (Fig. 4c, label 2) collapsed, leading to a moderate decrease in tangible value (LTV = 10). However, the historical and evidential aspects remained unscathed, resulting in a relatively low decline in intangible value (LIV = 2.1). Conversely, Ponte Garibaldi (Fig. 4g, label 13) sustained severe structural damage (LTV = 15). Indeed, some months after the field survey, it ultimately had to be demolished (ANSA, 2023), resulting in the loss of aesthetic and historical significance (LIV = 6).

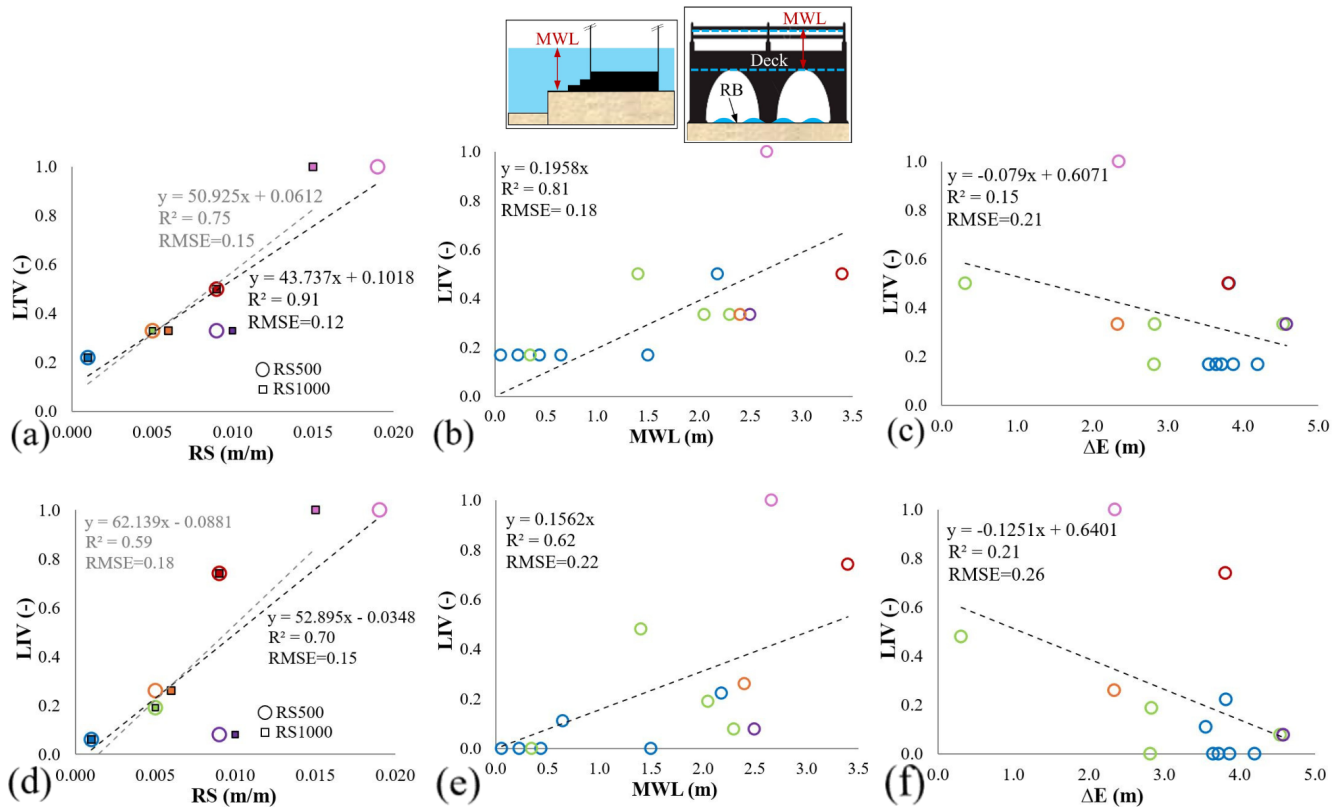
The factors RS and LTV (Fig. 5a), considering the 500 m stretch upstream of the single asset of a group of assets (RS500), exhibit both a higher correlation and a lower dispersion ($R^2 = 0.91$, RMSE = 0.12). Also considering the 1000 m stretch upstream from the CH (RS1000), the LTV–RS relationship is clear, although it results in a lower correlation and greater dispersion ($R^2 = 0.75$, RMSE = 0.15) than considering the RS500 factor. These results show that an increase in RS corresponds to an increase in LTV. Both 500 and 1000 m were considered as there are no clear recommendations in the literature on whether the flow of a river adapts to the slope of the riverbed. Nevertheless, considering these distances, it is reasonable to assume that the slope of the riverbed affects the energy of the flowing water and thus can be used as a valid proxy for current velocity. As observed, the dynamics of the flood event were different throughout the basins (Sect. 3.2). In the case of the river Misa in Senigallia (RS500, $1000 = 0.001 \, \mathrm{m \, m^{-1}}$), the flooding that occurred was mainly caused by the overtopping of the two bridges present, which in turn caused a progressive and slow rise in water levels throughout the city. This scenario resulted in damage to CH primarily attributable to water stagnation and the accumulation of fine sediments (ranging from clays to sands), rather than the direct impact of hydrodynamic forces from flowing water. Indeed, for all the CH assets, the minimum LTV (5) was observed (Table 4). The only exception is the Garibaldi Bridge, which was more severely damaged (LTV = 15) as it was obstructed due to the passage of woody debris and the related pressure exerted on it. On the other hand, for the sites in the Burano and Cesano basins, a steeper slope caused greater damage due to the hydrodynamic force of the water impacting the CH assets. This is evidenced by some videos recorded at Cantiano (as described in Sect. 3.2) but especially by the destruction of the Bellisio Solfare refinery (LTV = 30). In this case, the slope of the river Cesano was sufficient to transport and deposit large amounts of floating and coarse debris, including wood, gravel, and boulders, which contributed to the destruction of the site. However, it

Figure 5. Relations between normalized LTV **(a–c)** and LIV **(d–f)** with influencing contributing factors: **(a, d)** RS, considering distances of 500 m (black line and circles) and 1000 m (grey line and boxes) upstream of the single asset or group of assets; **(b, e)** MWL measured as the height of the maximum water/mud mark level with respect to the outside ground floor of each asset; **(c, f)** ΔE, the elevation difference between the asset and the riverbed.

is also worth noting that this site was in a poor state of conservation, which possibly reduced structural resistance.

As concerns the correlation between LTV and MWL, Fig. 5b highlights a clear relationship. Namely, the higher the flood depth, the greater the damage is, as generally found in the literature for stage–damage functions. However, a lower correlation is observed than the LTV–RS500 relationship as well as a higher dispersion ($R^2 = 0.81$, RMSE $= 0.18$). A higher RMSE value can be justified by the Bellisio Solfare site, which represents an outlier. Indeed, the maximum assigned LTV value due to its destruction is not solely linked to the MWL but rather to the energy of the flow, as demonstrated above. The lowest correlation and the highest dispersion ($R^2 = 0.15$, RMSE $= 0.21$) correspond to the LTV–ΔE relationship (Fig. 5c).
