Nat. Hazards Earth Syst. Sci. Discuss., 3, 3967–3981, 2015
www.nat-hazards-earth-syst-sci-discuss.net/3/3967/2015/
doi:10.5194/nhessd-3-3967-2015

Railway deformation detected by DInSAR over active sinkholes in the Ebro Valley evaporite karst, Spain

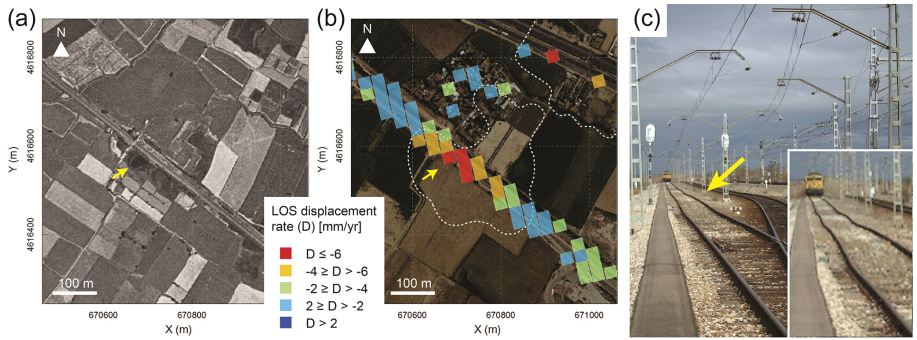
The high density of measurement points derived from the ALOS data along the Castejón–Zaragoza railway provides valuable information on the state of activity of three previously inventoried sinkholes traversed by the infrastructure. A clear subsidence zone, with negative LOS displacement rates as high as $-9.7\,\mathrm{mm\,yr^{-1}}$, coincides with a sinkhole about 300 m across previously classified as active (Figs. 2 and 3, Profile 2). Here, ground motion values show a consistent pattern with increasing subsidence rates towards the center of the sinkhole (Fig. 2). The LOS displacement values measured in the other two sinkholes, previously described as inactive (Galve et al., 2009), suggest ground stability or very slow subsidence ($< 2\,\mathrm{mm\,yr^{-1}}$).

Figure 2. Section of the Castejón–Zaragoza railway built on a buried sinkhole and affected by active karst subsidence. **(a)** Aerial photograph taken in 1956. Arrow points to a ponded sector within the large subsidence depression. **(b)** Orthoimage from 2009 with ALOS-derived displacement rates on PSs. **(c)** Photographs of the location indicated with arrows in **(a)** and **(b)**, showing obvious deformation in the railways.

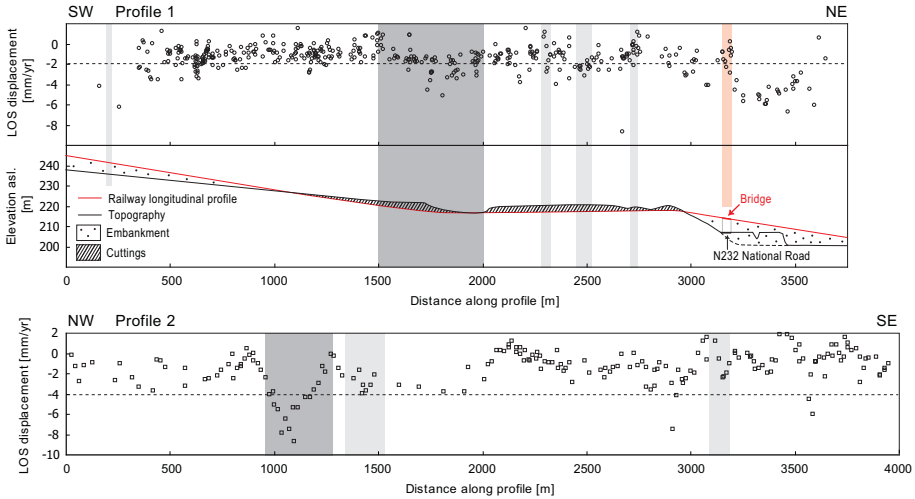
The displacement rates measured in the SW and NE portions of the analyzed Madrid–Zaragoza railway section, as high as $-6.6\,\mathrm{mm\,yr^{-1}}$, may be related to compaction of the embankments, as suggest the direct correlation between subsidence rates and embankment height (Fig. 3, Profile 1). LOS displacement rates indicate rapid settlement ($>4\,\mathrm{mm\,yr^{-1}}$) in the NE sector of the analysed stretch, coinciding with the location of a buried depression of unknown origin, filled a few decades ago and identified with aerial photographs. Here, subsidence is most probably related to compaction of anthropogenic deposits, which may exceed 10 m including the embankment. However, further investigations would be required to rule out the potential contribution of dissolution-induced subsidence (e.g. trenching, geophysics, vertical extensometers).

The negative LOS displacement values measured in the sector where the right-of-way of the railway has been excavated in Quaternary alluvium can be attributed to dissolution-induced subsidence. Between 1500 and 2700 m in profile 1, there is a significant number of points with LOS displacement rates below $-2\,\mathrm{mm\,yr^{-1}}$. In this sector, the railways run across subdued sinkholes recognized in old aerial photographs and expressed in the cuttings as deformed Quaternary alluvium (Simón et al., 1998, 2003; Galve et al., 2009). The sinkhole cluster comprises a large diffuse-edged depression and several smaller subcircular sinkholes (Galve et al., 2009) (Fig. 4). In addition to the DInSAR deformation data, several lines of evidence consistently indicate active subsidence in some sectors of the sinkhole cluster: enclosed depressions, severe cracking on buildings, conspicuous sags and wide fissures on roads and small collapse sinkholes, including the 2003 event. An excavation carried out at the SW edge of the large

Figure 3. Profiles with DInSAR-derived LOS deformation data obtained along the analyzed railway sections. Data from the Madrid–Barcelona railway corridor is represented alongside a topographic profile showing the stretches built on embankment and excavated trenches. Dark grey and light grey zones indicate sections built on sinkholes classified as active and inactive, respectively. See location of profiles in Fig. 1.

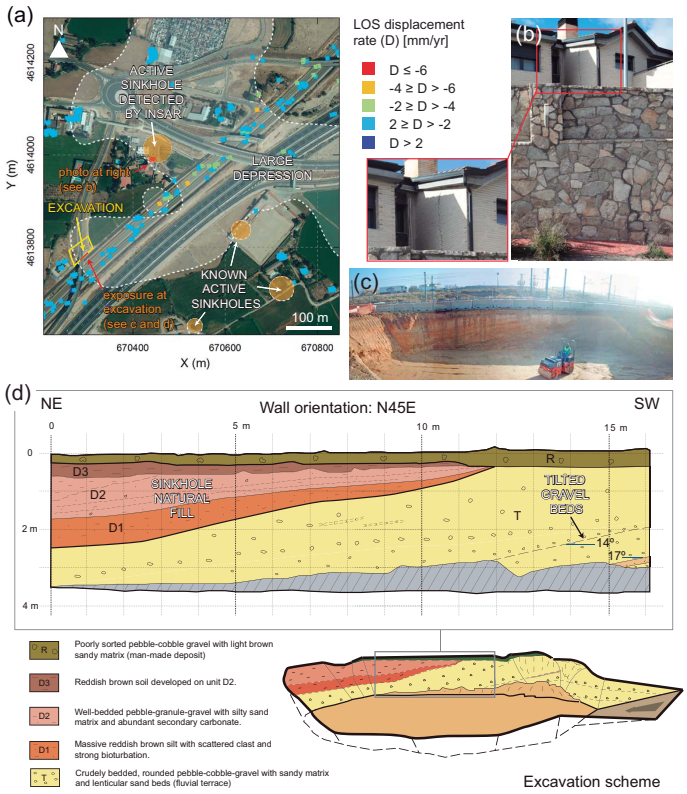
depression for the foundation of a bridge exposed tilted Quaternary deposits dipping toward the depression center (Fig. 4). Two sedimentary packages were differentiated. The lower one corresponds to pre-sinkhole terrace gravel deposits with an apparent NE dip of 14–17°. The upper one is a natural sinkhole fill deposits that pinches out towards the SW (sinkhole edge). The dip of these sediments progressively attenuates upwards (cumulative wedge-out) suggesting synsedimenary subsidence.

Figure 4. Evidence of karst subsidence associated with the track of the Madrid–Zaragoza high-speed railway. **(a)** Orthoimage of 2009 with ENVISAT DInSAR PS data indicating the main sinkholes and large karst depressions. **(b)** Cracks on a house where ENVISAT DInSAR map indicate subsidence. **(c)** General view of the excavation indicated in **(a)**. **(d)** Log and scheme of the walls of the excavation. Note the wedging-out of the sinkhole fill and the tilted terrace gravel beds.
