A forensic re-analysis of one of the deadliest tornadoes in European history

Alois M. Holzer[1], Thomas M. E. Schreiner[1,2] and Tomáš Púčik[1]

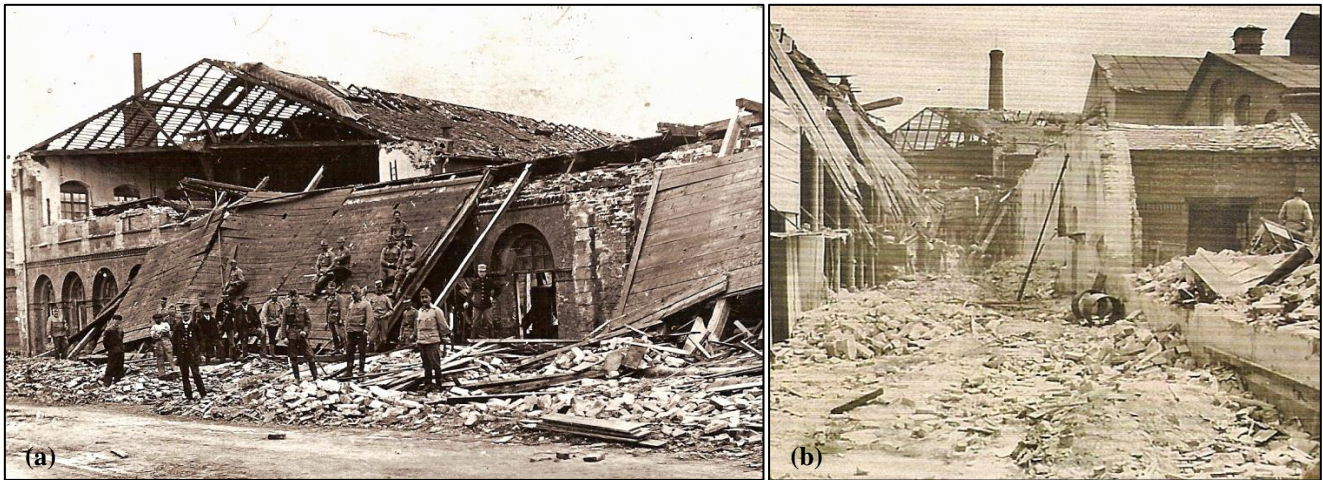
Fig. 3: Details of the old locomotive factory. Left (a): inner ceiling flipped outside, in foreground whole upper floor with

20   massive brick walls collapsed (similar as the building parts that are still visible in the background). Right (b): Former indoor part of the same building with destruction of up to 1 m thick walls down to the ground level. Source of photos: Industrieviertelmuseum Wiener Neustadt.

An example for a DI-DoD pair from the region of highest interest is the old locomotive factory, located at 47.82861 N, 16.251412 E (Fig. 3b): The photographer documented in the foreground the (pre-event) indoor part of the factory. Remaining foundations of a largely destroyed massive brick wall are visible on the right side. The remaining building parts on the left can also be seen in Fig. 3a, with a viewing angle from further left. The chosen DI for this building was "E"

30 ("strong brick structure"), while the determined DoD was "f3" ("walls partly collapsed") for the left section and "f4" ("largely blown down") for the right section. A DoD "f3" leads to F4-, whereas a DoD "f4" leads to F5 category. Because of the unknown preservation stage, the final combined rating for this building leans towards the lower F4 rating (Building "z"
