Damages induced by the 25 April 2015 Nepal earthquake in the Tibetan border region of China and increased post-seismic hazards

Abstract: The seismic effects in Nyalam, Gyirong, Tingri and Dinggye counties along the southern border of Tibet were investigated during 2-8 May, 2015, a week after the great Nepal earthquake along the Main Himalaya Thrust. The intensity was VIII in the region and reached IX at two towns on the Nepal border; resulting in the destruction of 2,700 buildings, seriously damaging over 40,000 others, while killing 27 people and injuring 856 in this sparsely populated region. The main geologic effects in this steep rugged region are collapses, landslides, rockfalls, and ground fissures; many of which are reactivations of older land slips. These did great damage to the buildings, roads and bridges in the region. Most of the effects are along four incised valleys which are controlled by N-trending rifts and contain rivers that pass through the Himalaya Mountains and flow into Nepal; at least two of the larger aftershocks occurred along the normal faults. And, the damages are not related to the faulting of N-trending rifts but distributed along the intensity of Nep

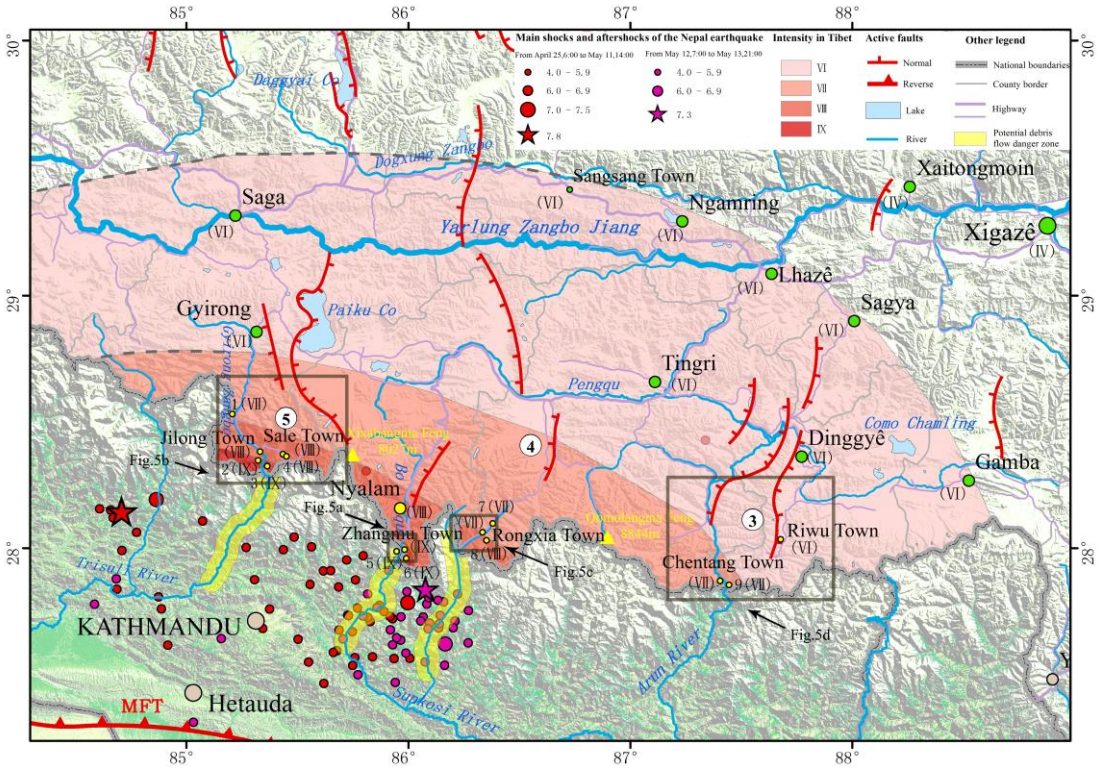
north of the mountains (for their seismic intensities, see Table 1). The main effects and economic losses are concentrated in Nyalam, Tingri, and Gyirong Counties (Fig. 2) where about 80% of the houses were completely destroyed or damaged to a large extent (Figs. 3, 4). The damage is heaviest in the towns of Zhangmu in Nyalam County; Jilong and Sale in Gyirong County, and Rongxia in Gyirong County (Fig. 5). Moreover, the highways and communications to the towns of Zhangmu, Tingri, and Resuo Bridge as well as connections to Zhangmu, Tingri, Chentang and others in Nyalam County were greatly damaged and broken.

The E-W elongation of the intensity pattern (Fig. 2, Table 1) shows at least twice the rate of attenuation northward towards the Himalaya Mountains than in an E or W direction. This can be attributed to the absorption of the seismic energy by the E-W-trending fault structure and lithologic units of the great Himalaya Mountain block,

Fig. 2 Principal active faults and the distribution of seismic intensity of the 2015 Nepal earthquake in the southern Tibet region. Epicentral data from the USGS and seismic intensity from the China Earthquake Administration. The numbers and names of the principal S-N trending rifts in southern Tibet are same as on Fig. 1. The green landmarks show the sites which intensity are from China Earthquake Administration, and yellow landmarks show the spots which intensity is resulted from our field investigation. The survey spots: 1, Rema Villiage; 2, Jifu villiage; 3, Chongse Villiage; 4, Guoba Villiage; 5, Kodari Town of Nepal; 6, Lixin Viliage; 7, Bangse Villiage; 8, Zhuobude Villiage; 9, Natang Villiage.

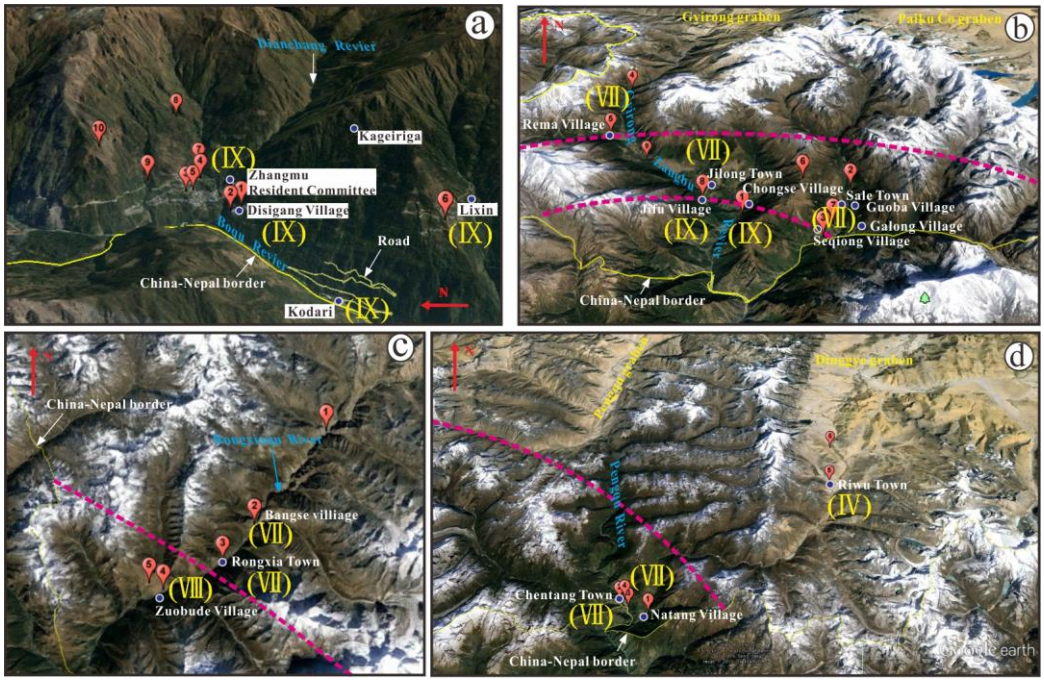
Remotely-sensed images issued by Google Earth after the earthquake show that the Gyirong Zangbo and the Buqu River valleys contain the maximum density and scale of collapses and landslides (Figs. 5a, 5b, and 6a-6h).

The Sale Village landslide, which resulted from the earthquake, on the slope along the highway from Sale Village to Seqiong Village (Fig. 5b). It is nearly 600,000 m^3 in volume and its fall blocked the road. Large tension fissures at its upper edge indicate a danger of further slippage (Fig. 8c).

Natang Village near Chentang is located at the front, lower edge of an old landslide, which is about 420 m long and 230 m wide, and consists of about 1,200,000 m^3 (Figs. 5d and 8e). The steep wall at its upper edge appears as two large dangerous rock blocks which are about 60,000 m^3 in volume and a 1.7 m wide preexisted crack occurs between the unstable rock blocks and the bedrock (Fig. 8f). The earthquake caused a partial rockfall and demonstrates the dangerous instability of the mass that might come down easily.

Fig. 5 Main surveyed sites of seismic effects after the Nepal earthquake, see Fig. 2 for the locations (image source Google Earth). Explanation: Roman numerals in brackets, seismic intensity values of the corresponding location; pink dotted lines, boundaries between different intensity zones. a, Zhangmu Town and vicinity; b, Jilong Town and environs; c, Rongxia Town and vicinity; d, Riwu Town to Chentang Town. Explanation: numbered balloons, sites of particular effects; red dashed lines, isoseismal boundaries.

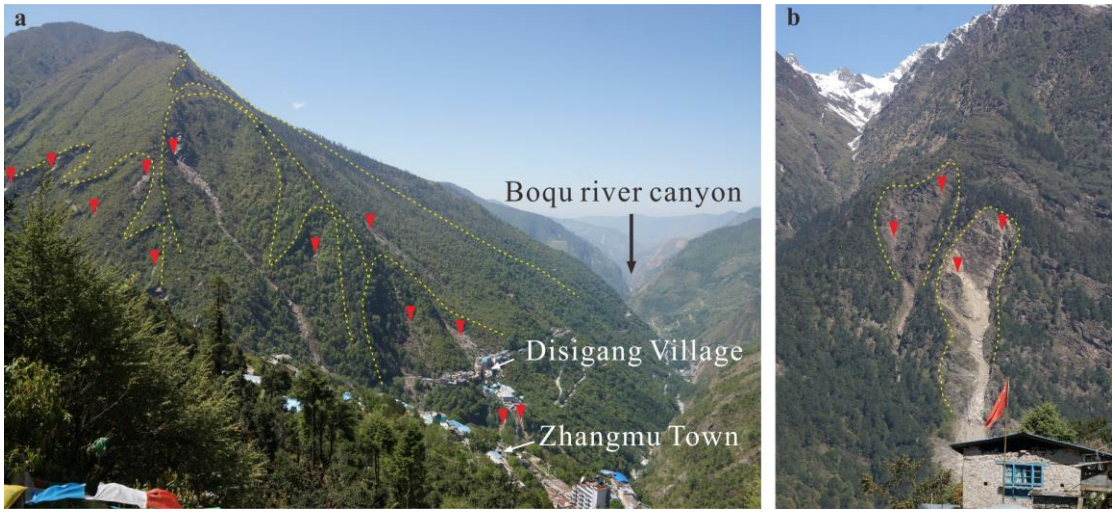
245 The collapses and landslides commonly result from reactivation of older ones and
246 similar effects produced by historic earthquakes occurred near the same position as in
247 this earthquake. Such features are notable on both banks of the Boqu River near
248 Zhangmu (Figs. 7a and 7b). At Disigang Village of Zhangmu, for example, a house
249 built on the side of a large rock brought down previously was destroyed by a new large
250 rockfall (Fig. 6c). This is a warning that reconstruction after the earthquake, not only
251 should avoid as far as possible potential new hazards, but at the same time be aware of
252 previous ones and make a comprehensive assessment of their stability.

All of Zhangmu is located on a group of old landslides (Figs. 4a, 7a and 7b). Discontinuous tension fissures, which are tens to hundreds of meters long, about 10 cm wide and 2 to 4 m deep, were found at its upper edge and on its sides after the earthquake (Figs. 8a and 8b). These fissures indicate the possibility of the failure of the entire landslide group.

Fig. 7 New and old collapses and landslides on both banks of the Boqu River in Zhangmu Town; a. the east bank; b. the west bank. Explanation: yellow dotted line, boundary of old collapse and landslide; red triangle, new collapse during the Nepal earthquake.

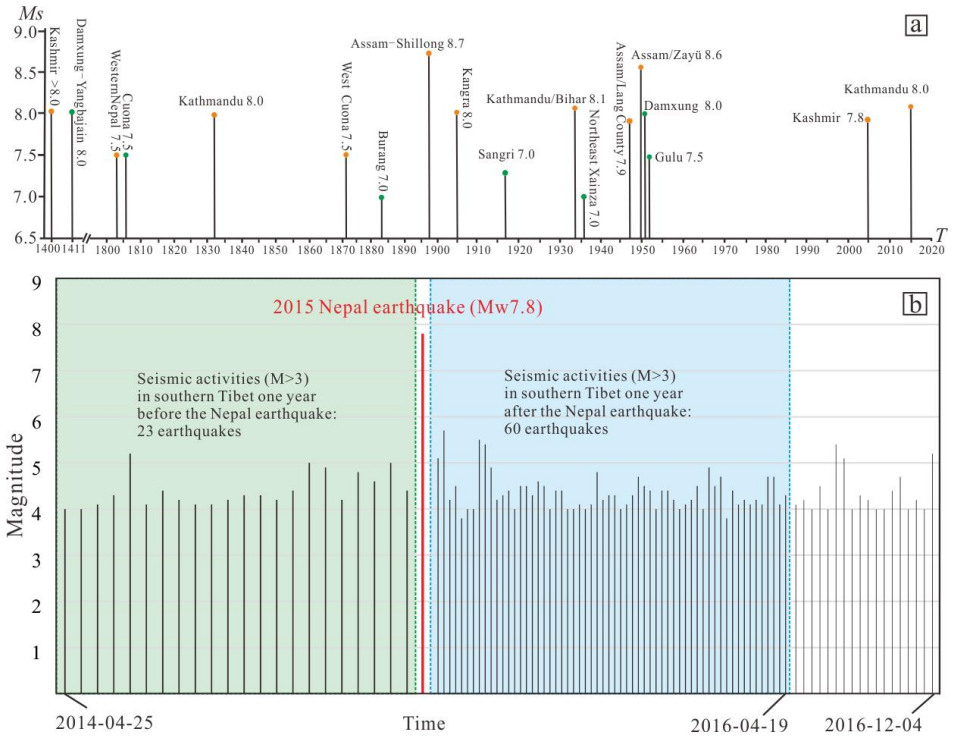
Often within a short time interval of about one to 10 years after great earthquakes on the Main Himalaya Thrust, strong earthquakes occur on the N-S-trending normal faults in the southern Tibet region (Fig. 9). For example, the great Kashmir earthquake of 1400 was followed by a M 8.0 earthquake in the Damxung-Yangbajain sector of the northern Yadong-Gulu Rift in 1411; a M 8.1 earthquake in the western part of Nepal in 1803 was followed by a M 7.5 earthquake in the southern sector of the Cona-Oiga Rift in 1806, and the M 7.8 Kashmir earthquake of 1905 was followed by a M 7.5 earthquake at Sangri in the northern sector of the Cona-Oiga Rift in 1915. Similarly, after the M 8.1 1934 Nepal earthquake, a M 7.0 earthquake in the same year occurred in the N-S-trending Gomang Co graben in northeastern Xainza County and after the 1950 M 8.6 China-Indian border earthquake, a M 7.5 earthquake occurred in 1952 in the northern sector of the Yadong-Gulu Rift in Nagqu County.

Fig.9 a: Magnitude (Ms) –Time (T) distribution of historical seismic activity along Himalaya and southern Tibet with the magnitude >7.0. The orange circles show the earthquakes occurred along Himalaya while the green circles show the earthquakes along southern Tibetan rift. b: Magnitude (M) –Time (T) distribution of seismic activity in southern Tibet in the period of one year before and after the 2015 Nepal earthquake (data came from USGS)
