Monitoring of the reconstruction process in a high mountainous area affected by a major earthquake and subsequent hazards

Abstract. Recovering from major earthquakes is a challenge, especially in mountainous environments where post-earthquake hazards may cause substantial impacts for prolonged periods of time. Although such phenomenon was reported in the 1923 Kanto earthquake and the 1999 Chi-chi earthquake, careless reconstruction in hazard-prone areas and consequently huge losses was witnessed following the 2008 Wenchuan earthquake in Sichuan province of China, as several reconstructed settlements were severely damaged by mass movements and floods. In order to summarize experiences and identify problems in the reconstruction planning, a monitoring of one of the settlements, Longchi town, was carried out by image interpretation and field investigation. Seven inventories containing buildings, farmlands, roads and mitigation measures were made to study the dynamics in element-at-risk and exposure over a period of 11 years. It was found that the total economic value of the new buildings in was several times more than the pre-earthquake situation in 2007, because of enormous governme

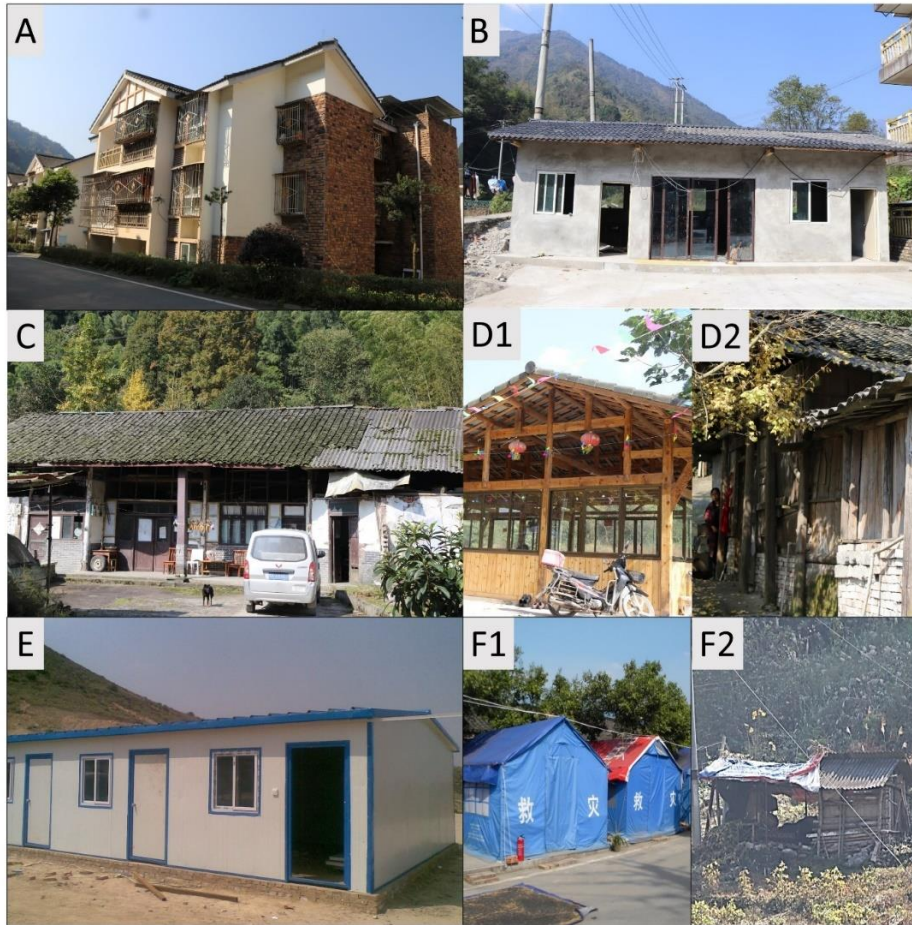
A total of seven building construction types were found in this region, including three types served as

175 temporary shelters. *Reinforced concrete frame* (RCF) (Figure 2 A), *reinforced masonry* (RCM) (Figure 2 B), *wood and brick* (WB) (Figure 2 C), *wooden* (W) structures (Figure 2 D1 & D2) are permanent buildings, and *pre-fabricated metal houses* (PFM) (Figure 2 E), tents (Figure 2 F1), and shacks (Figure 2

Figure 2: Examples of building construction types in the study area. A: RC frame (RCF) structure residences built by the reconstruction teams from Shanghai city. B: reinforced masonry (RCM) building of a hostel. C: wood and brick residence (WB). D1: wooden structure (W) serving as restaurant. D2: wooden residence with walls made by wooden plates and bricks. E: pre-fabricated metal (PFM) temporary houses. F1: tents distributed by the government. F2: a shack made from wood, asbestos tiles and waterproof cloth.

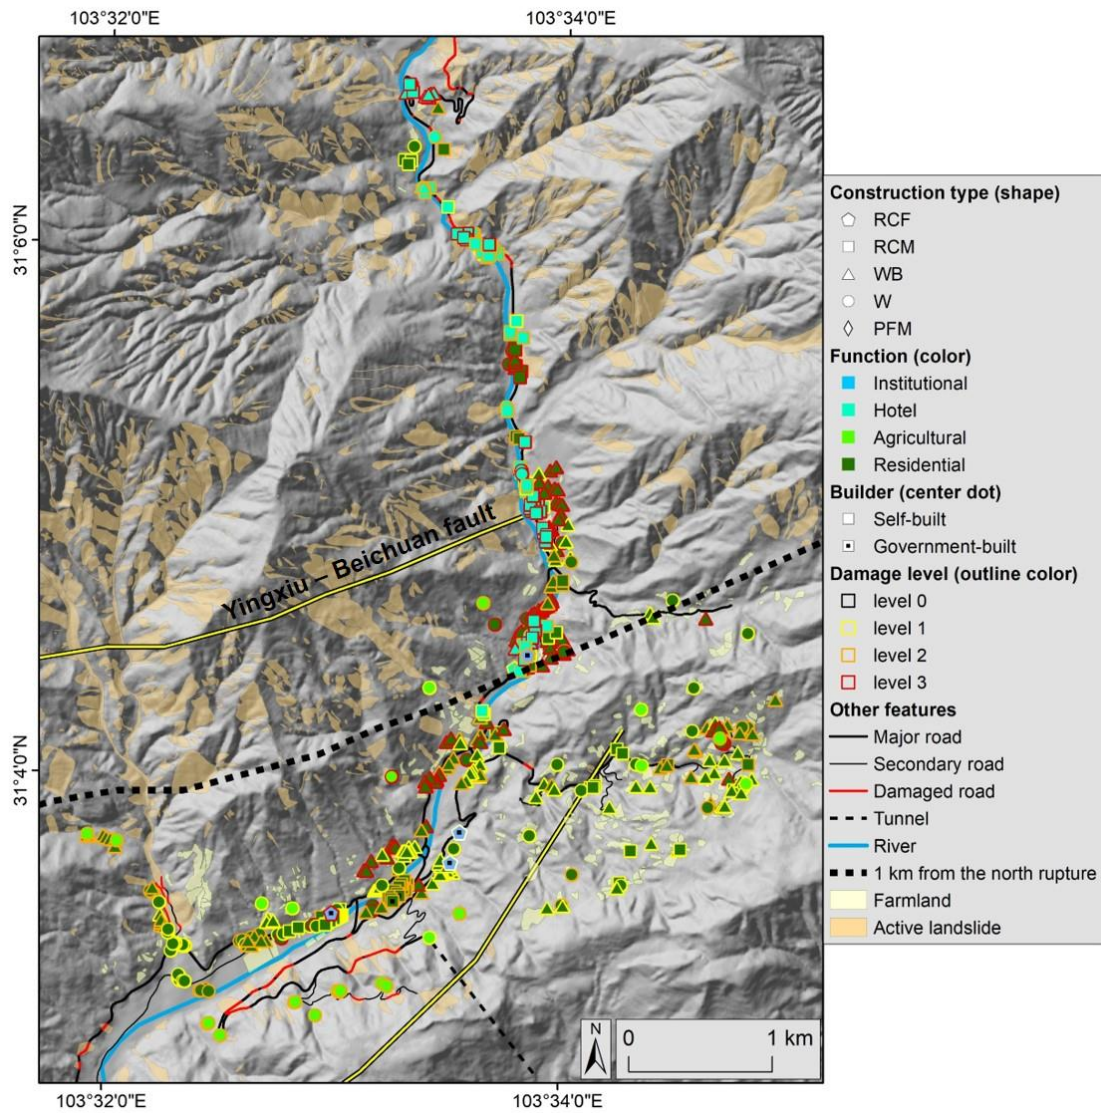
Figure 3: A map showing the damage level of buildings and the distribution of co-seismic landslides. Buildings on the foot wall (Southeast) and 1 km away from the north fault rupture (indicated by the thick dotted line) took significantly less damage.

A damage pattern controlled by fault rupture was found. Building damage was more serious on the hanging wall or within one-kilometer distance of the Yingxiu – Beichuan fault rupture (indicated by a thick dotted line in Figure 3). The ratio of buildings being destroyed in the northwest was much higher (Figure 4 B and C) than in the southeast, as only 17 of the 81 survived buildings are located in the northwest. The damage was not influenced by the construction types in the north, probably indicating the shaking was so strong that it exceeded the resistance of all the three types (Figure 4 B). The southern side showed a significance difference in damage for the construction types, as the RCM buildings had the lowest collapse ratio while wooden buildings had the highest (Figure 4 C). The landslide area density in the northwest is much higher than the southeast, further suggesting the existence of a localized ground shaking difference (Figure 3).

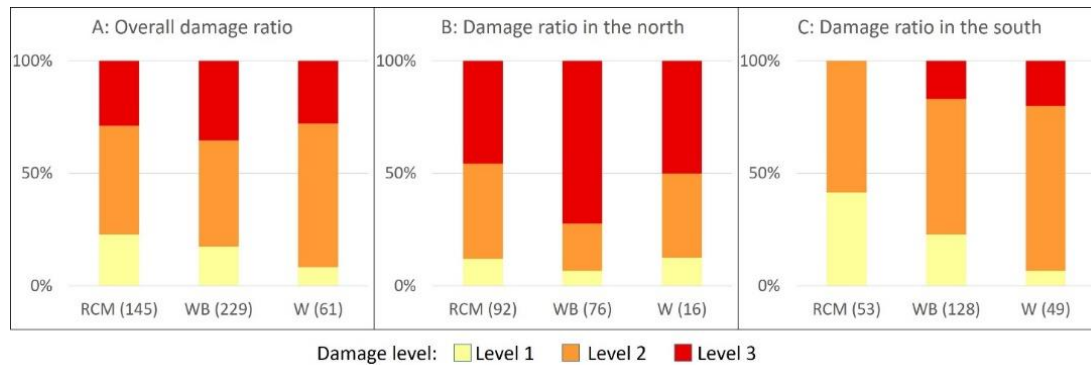
Figure 4: Damage ratio statistics of the three major structural types in 2008. The numbers in brackets under the x axis indicate the total numbers of buildings. A: damage ratio of all the earthquake-affected buildings. B: damage ratio on the northern side of the dotted line in Figure 5. C: damage ratio on the southern side of the dotted line in Figure 3.

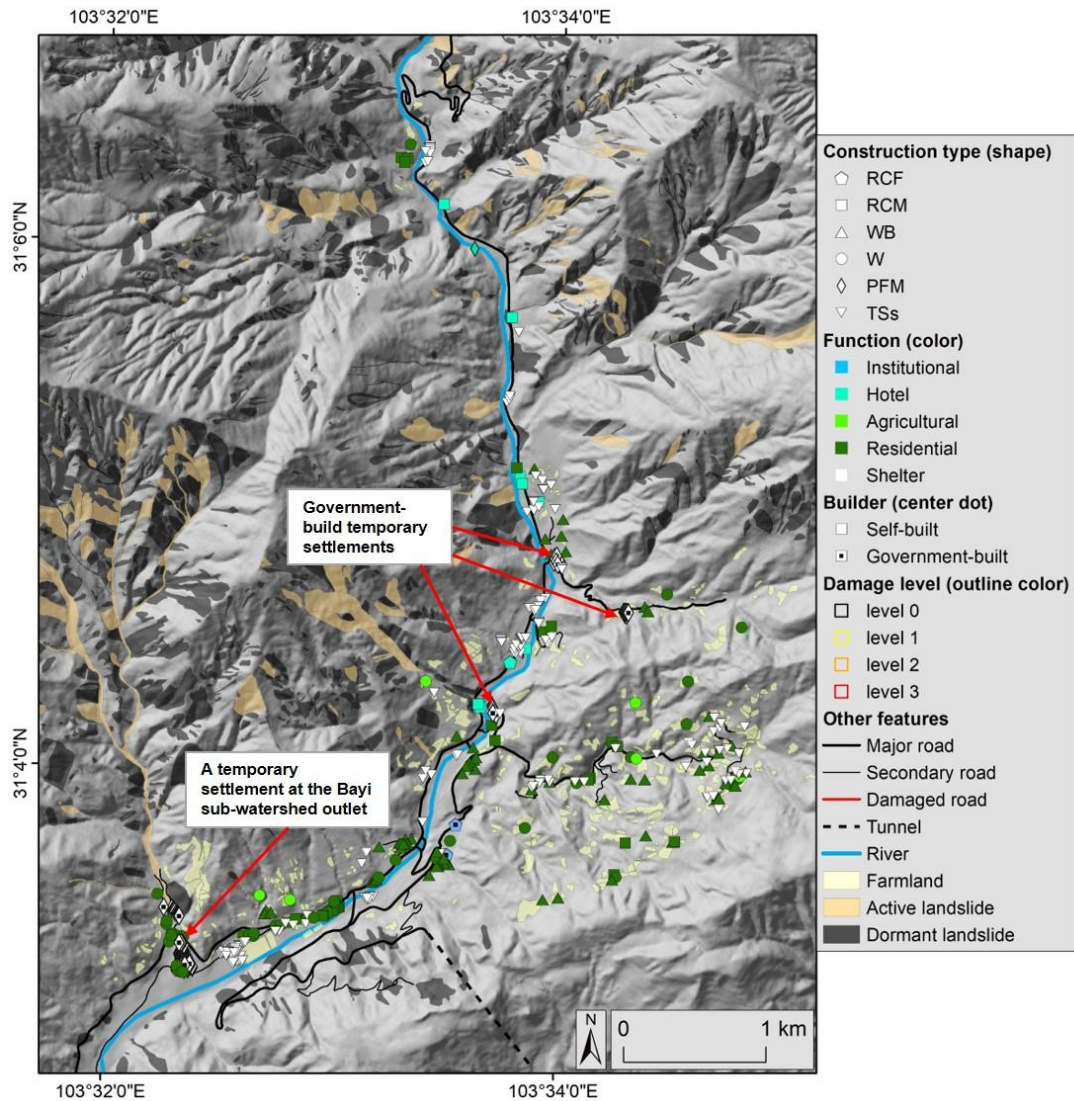
Figure 5: Map of the buildings that survived the earthquake and location of temporary shelters. Many Local residences set TSs near their destroyed houses. The government established four PFM temporary settlements, and one of them was located at the outlet of the Bayi catchment, which posed a great debris flow threat due to a 29% landslide area density.

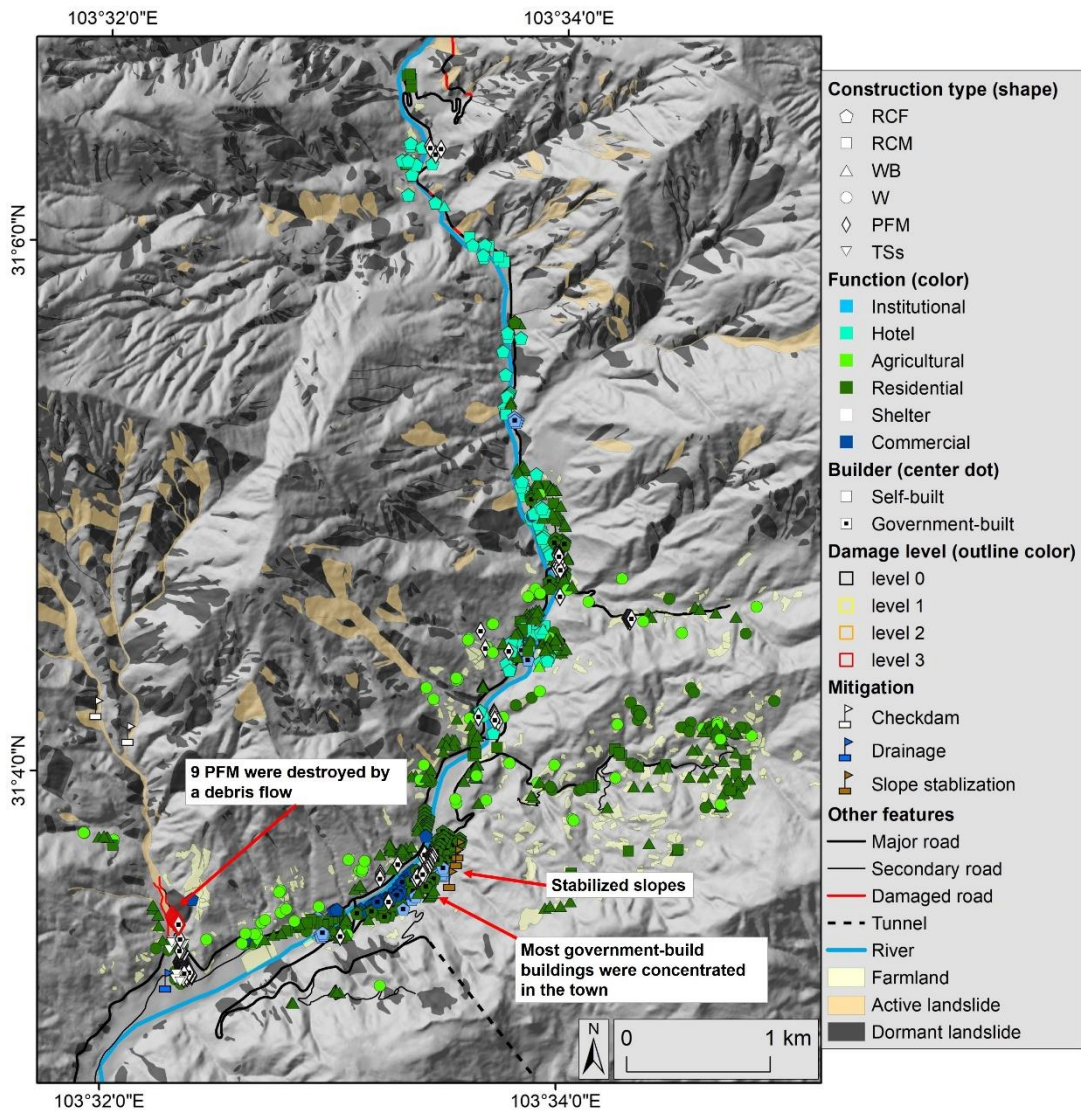
Figure 6: The inventory of the situation in 2010 before the monsoon, showing the buildings, roads, and remedial measures for the period between 2008 and 2010. Overlain are the active landslides in 2009. A debris flow destroyed 9 PFM shelters, after which two check dams a drainage were installed.

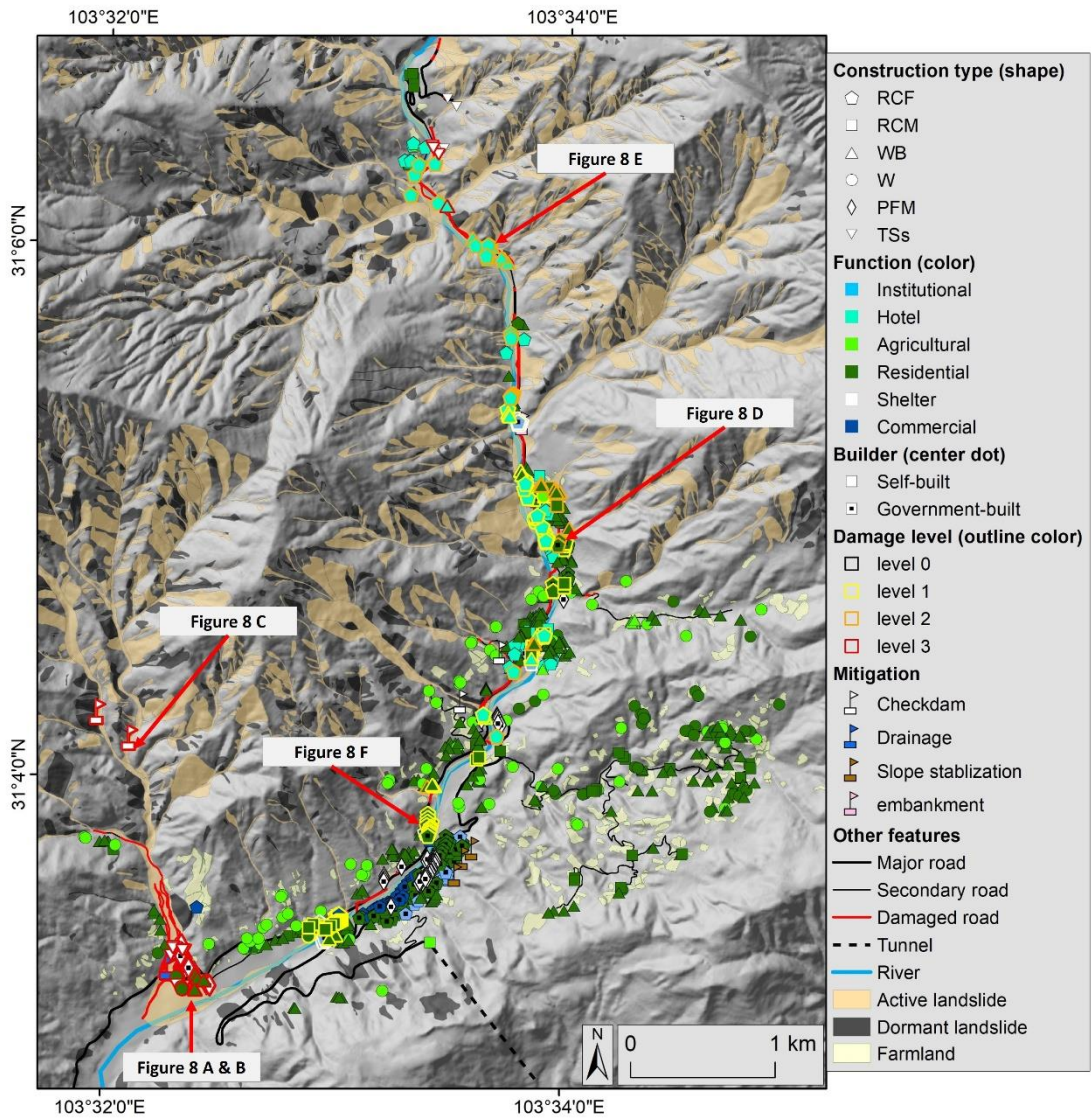
Nearly one-fourth of all buildings in the study are were impacted by debris flows and subsequent floods. Among all the 213 affected buildings, 70 were destroyed, 41 were severely damaged and 102 were

Figure 7: The building and landslide inventories mapped based on a Worldview-2 image captured in April 2011, showing the changes brought by the August 2010 debris flow disaster. A total of 213 buildings were affected. The losses were largest for those buildings located either near sub-catchment outlets or close to the river.

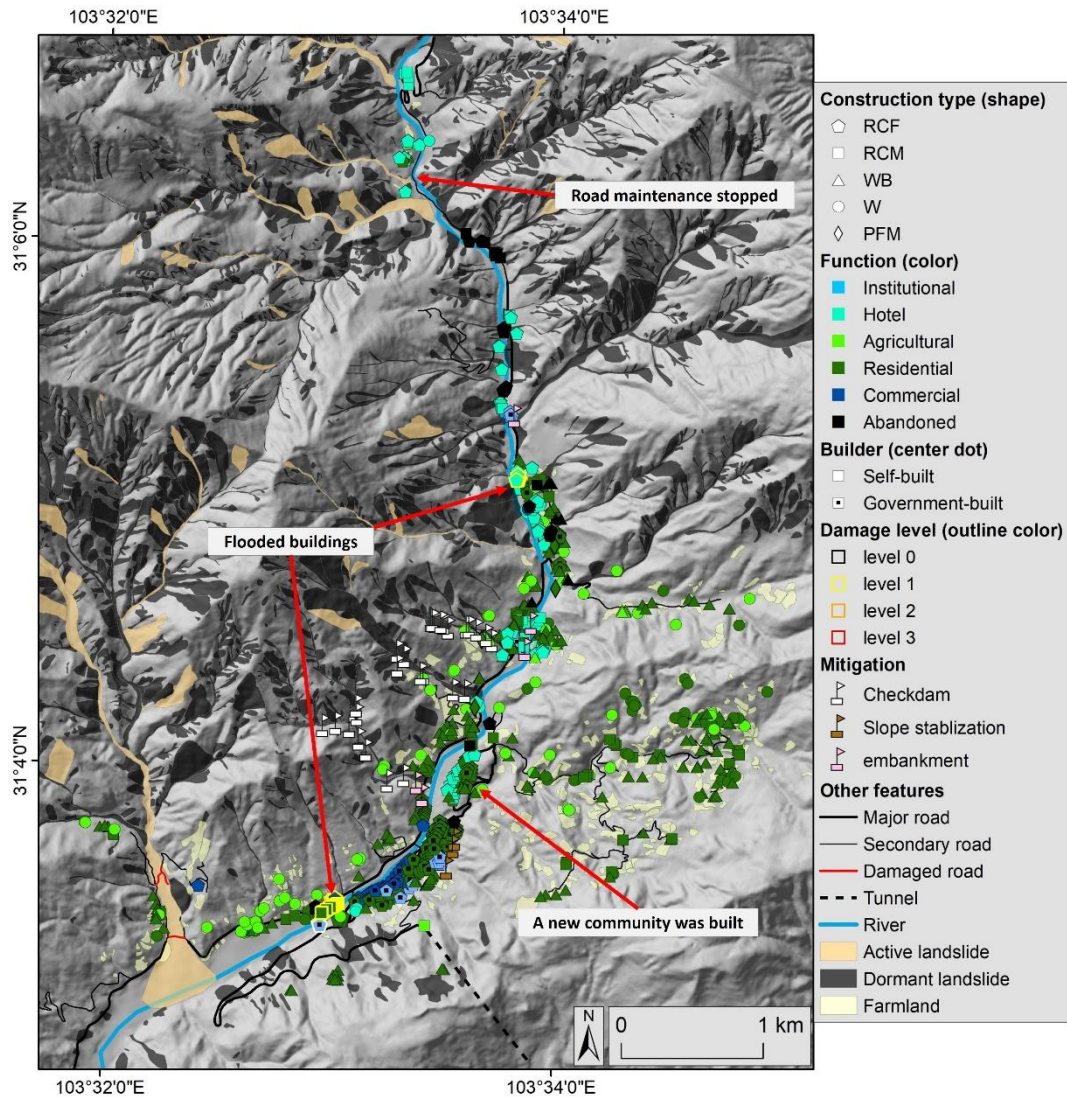
Figure 9: The inventory of mapped based on the 2013 Pleiades image, showing the situation shortly after the official announcement of reconstruction completion. A new community was built to make up the loss caused by the 2010 debris flow and many mitigation measures were installed. The debris flows caused a rise of the riverbed and led to flooding.

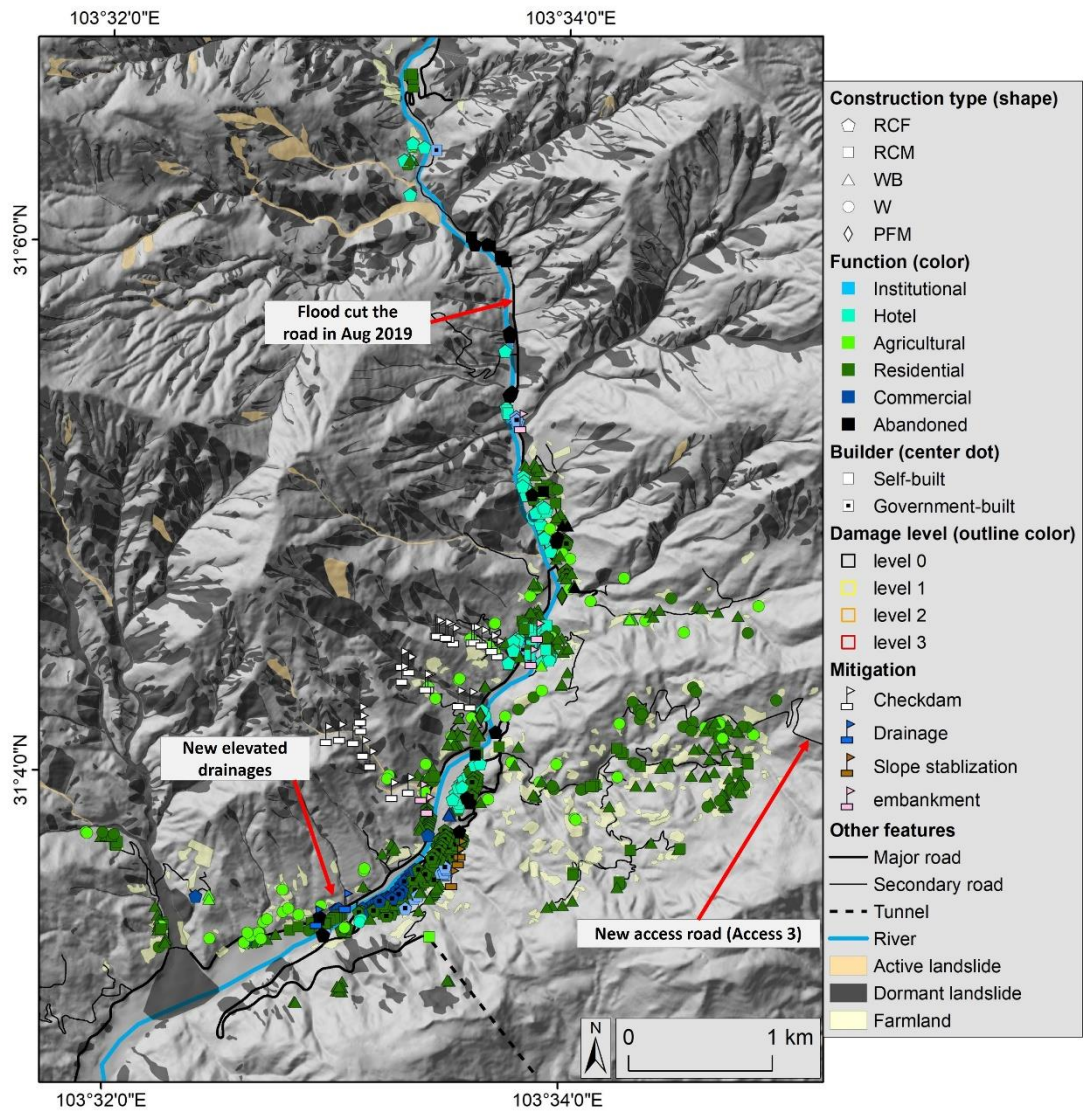
Figure 10 The inventory made based on the 2018 Pleiades image, overlaying with landslide polygons made based on the standards of Tang et al. (2016). The society developed in a slow and stable manner, without major disruptions from 2013 to 2018. The last reported disaster was a flood cut the dirt road in the north on August 20, 2019.

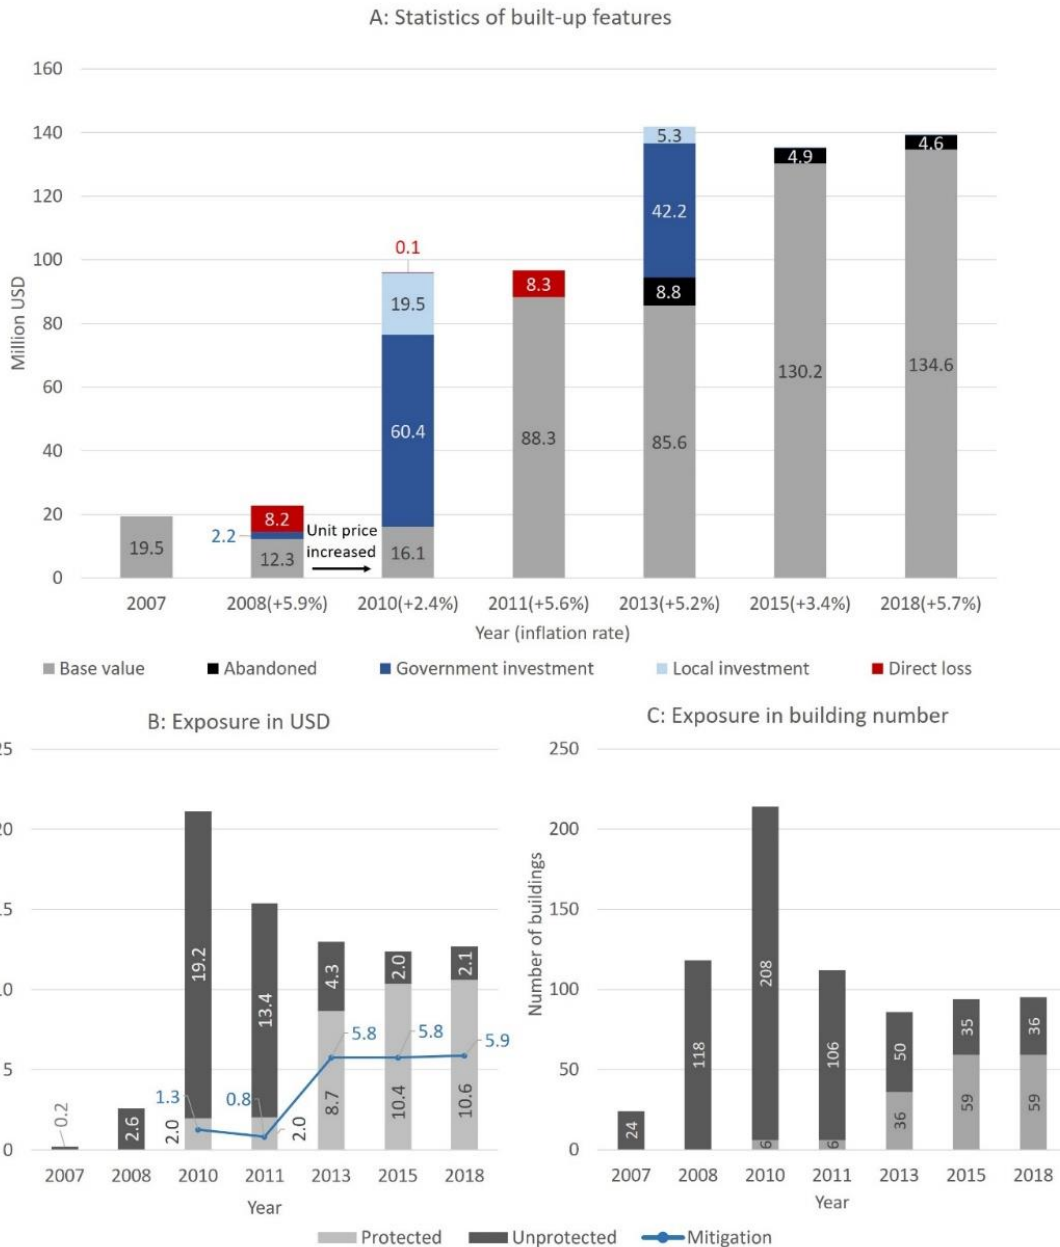
The total direct loss during the monitored period was 16.5 million USD, out of which 8.4 Million was government losses and 8.1 million USD private losses. The disaster in August 2010 caused a loss of 8.3 million USD, which was slightly more than the loss caused by the Wenchuan earthquake. It is because many expensive RCF buildings were carelessly built in areas exposed to debris flows and were severely damaged beyond repair. The loss was further increased in 2013 in the form of buildings being abandoned by the local residents in fear of debris flow and flood threat.

Figure 11: A: the total values of the built-up features, investments and direct economic losses over the period between 2007 and 2018 in the Longxi area. B: The total value of element-at-risk exposed to debris flows and floods. The values were adjusted with the inflation rate. C: The total number of buildings that exposed to debris flows and floods.
