Tsunami damage to ports: Cataloguing damage to create fragility functions from the 2011 Tohoku event

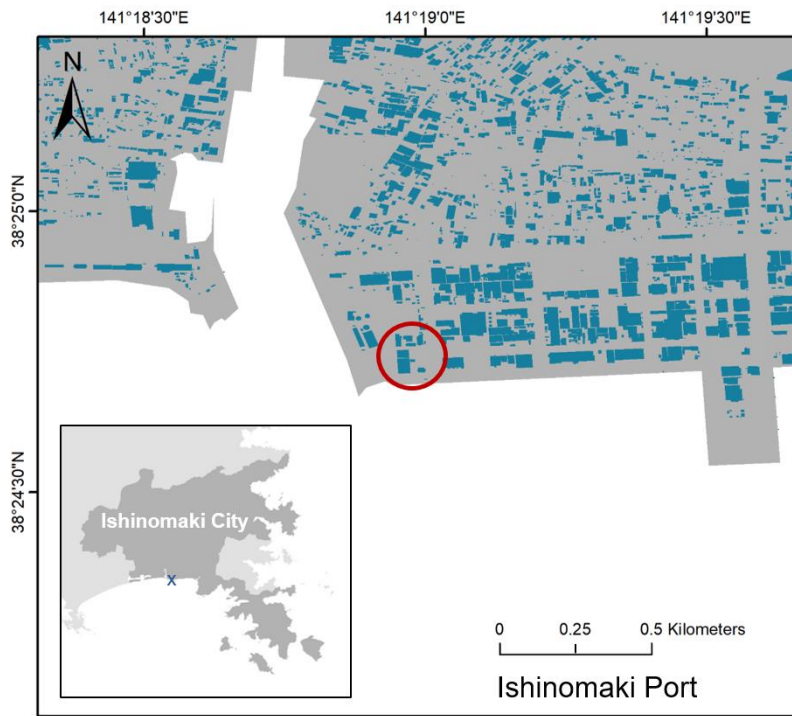
Fig. 4. A building (circled in red) in Ishinomaki Port has been selected to demonstrate how spatiotemporal damage assessment had been conducted in this study. For every port structure, we reviewed four main sources of data (©Google Earth 2020, ©Google Street View 2020, GSI Aerial and Oblique images) to estimate the level of damage sustained during the tsunami.
