Brief Communication: Critical Infrastructure impacts of the 2021 mid-July western European flood event

Elco E. Koks[1,2] , Kees C.H. Van Ginkel[3,1*], Margreet J.E. Van Marle[3], Anne Lemnitzer[4]

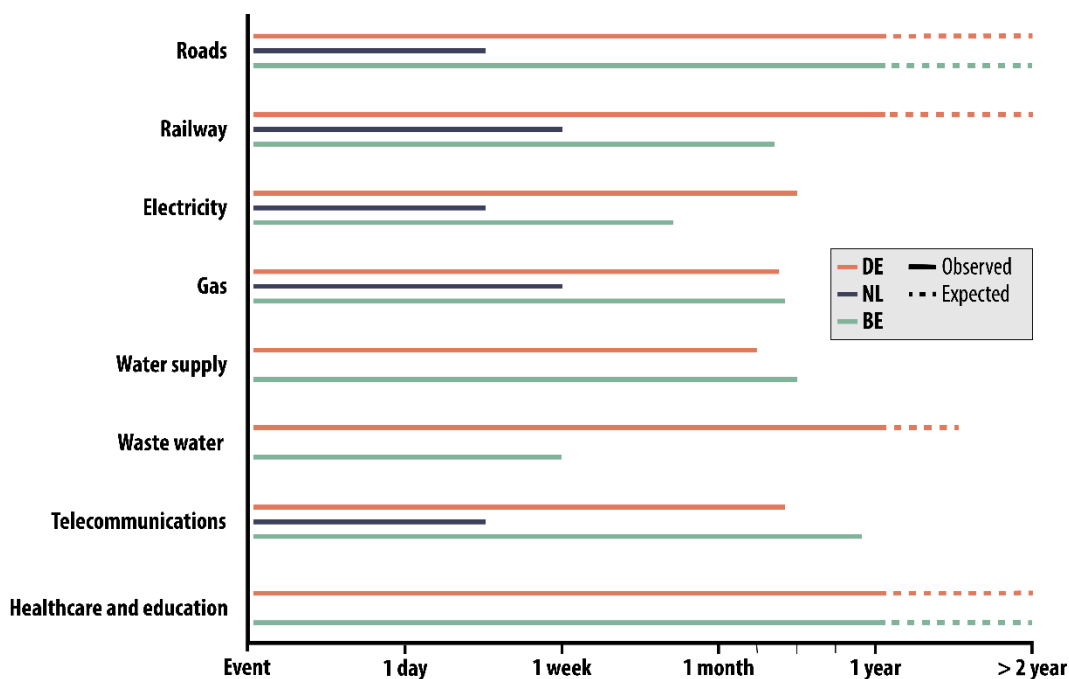
Figure 2. Overview of observed and expected reconstruction duration of each infrastructure sector considered in this study. It should be noted that this figure presents reconstruction efforts of the system. No line indicates that no impacts are observed. Solid waste is
