Rapid assessment of abrupt urban mega-gully and landslide events with Structure-from-Motion photogrammetric techniques validates link to water resources infrastructure failures. in an urban periphery

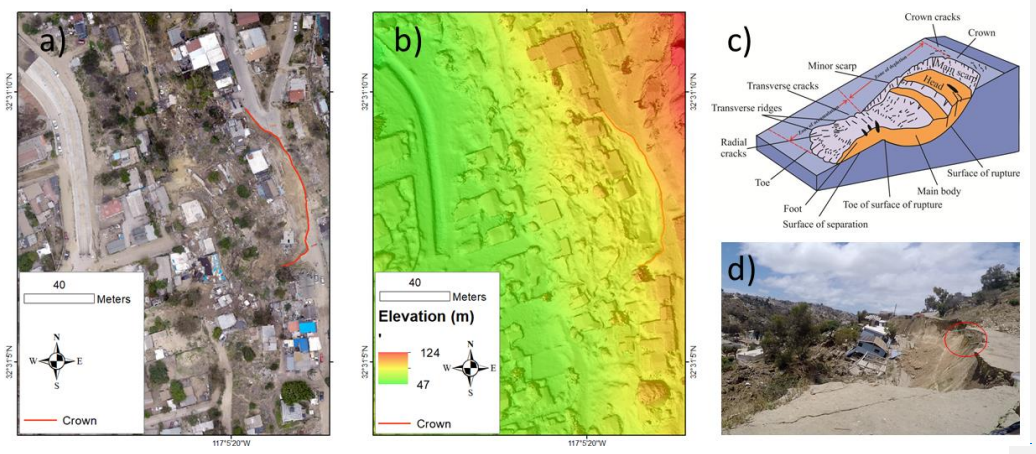
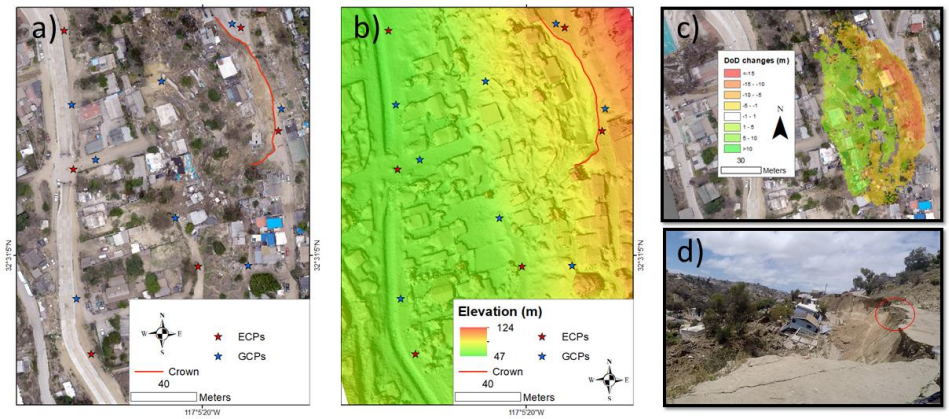
A large rotational landslide occurred during a storm event on 15 May 2015 (Fig. ~~2~~3a). More than 20 houses were damaged affecting more than 100 people (Fig. ~~2b, 2c~~3b, 3c). Based on the daily rainfall total (23 mm) and the long-term rainfall record at the NOAA Tijuana River Estuary Gage, the return period of the storm is 1 year. The landslide was attributed to a WRIF based on resident reports that seepage from the slope along with incipient cracks were observed for several days immediately before the failure incident. This observation led to the evacuation of the residents when the evolution of the cracks was evident. The infrastructure failure wetted the soil, and the landslide was then triggered by the rain event. Broken water mains were also observed after the landslide (Fig. ~~2c~~3c, red circle). The ~~dimensions of the landslide are~~main scarp was approximately 20 m high and approximately 75 m long, with a maximum width of 40 m measured from the main scarp to the toe of the hill. SfM photogrammetry leads to an estimate for the sediment volume and mass: 19,900 ± ~~580~~170 m^3 and 31,900 ± ~~928~~280 metric tons. The reported uncertainties (± value) are obtained by propagating ~~horizontal and~~ vertical RMSEs of individual DSMs in the ~~DSMs~~DoD calculation.

Figure ~~2~~3. Landslide event on 15 May 2015 triggered by water main leak and rainfall: (a) Orthophoto acquired after the WRIF showing the upper limit of the main scarp (crown) with the red line, and (b) the resulting ~~DEM~~DSM, (c) ~~a schematic diagram of~~DoD changes from the ~~anatomy of a landslide (USGS, 2021),~~multi-temporal analysis, and (d) a ground-based ~~photographs~~photograph of the landslide showing broken water mains inside the red circle aligned with the main scarp.

The RMSE (ECPs, n=6) of the DSM obtained from SfM was 3 cm in the horizontal and 7 cm in the vertical coordinates. ~~James and Robson (2012) introduced the relative precision ratio for UAS-SfM applications (i.e., ratio of measurement precision to observation distance), and found that 1:950 indicates acceptable accuracy over a range of scales. For a flight height of 75 m, the James and Robson (2012) standard gives a desired DSM error of 7.8 cm, which compares well with the horizontal and vertical errors estimated here.~~ Elevation differences outside of the disturbed area were ~~0-7 cm.~~<7 cm. Therefore, the co-registration error is assumed to be negligible. The mean difference between measured and ~~modeled~~modelled lengths of objects at the site (e.g., sewer manhole covers) was less than 3 cm. These different methods all suggest the error was less than 7 cm and within the range expected for the observation distance. The DoD map (Fig. 3c) shows the geometry of the landslide as a deep rotational slope failure, which is consistent with the model proposed by Highland and Bobrowsky (2008) in USGS (2021).

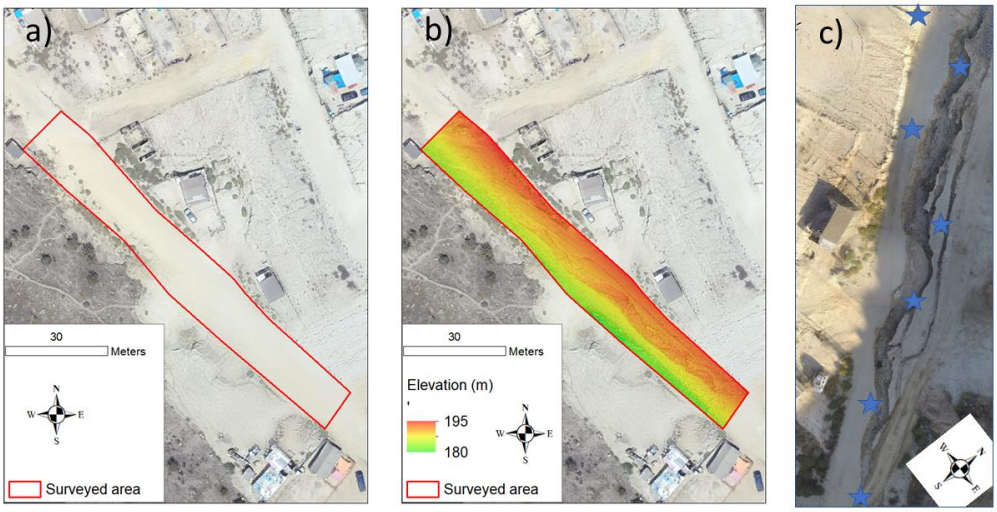
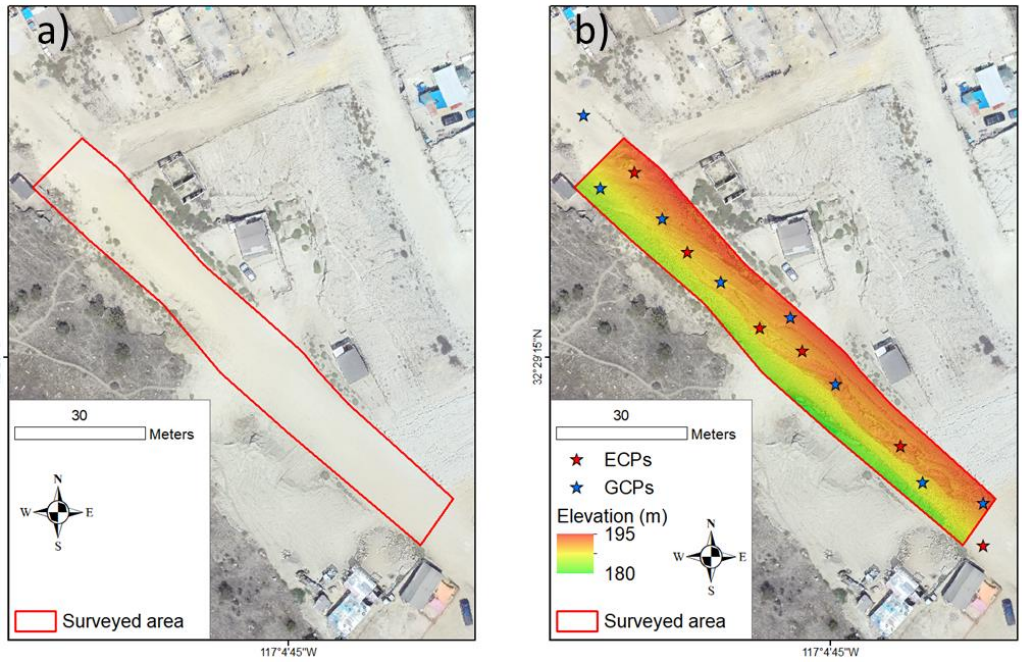
~~A mega~~Mega-gully A formed along an unpaved road during and immediately following a storm event on 15 September 2015. Based on the daily rainfall total (31 mm) and the long-term rainfall record at the NOAA rain gauge, the return period of the storm was 1-2 years. This mega-gully was attributed to a WRIF based on resident reports that ~~leakage~~discharge from a broken pipe was observed upstream immediately after the failure event (personal communication, Tijuana Metropolitan Planning

Institute). In this case, erosion caused by the storm event undermined the water main, which subsequently broke and enlarged the gully as a result of high velocity water jets from the pressurized water main. The mega-gully was 98 m long, with a maximum width of 8 m and maximum depth of 4 m (Fig. ~~3~~4). The generated sediment mass was estimated as 1,360 ± ~~65~~35 tons.

Figure ~~34~~. Mega-gully formed on 15 September 15, 2015 by WRIF: (a) Orthophoto acquired before the WRIF showing the extent of the surveyed area centred in the red rectangle, and (b) the resulting ~~DEM and (c) an orthophoto acquired after~~DSM showing the ~~WRIF, the blue stars represents ground control points.~~spatial distribution of Ground and Error Control Points (GCPs and ECPs, respectively).

The RMSE (ECPs, n=6) of the DSM obtained from SfM was 3 cm horizontal and 5 cm vertical. Elevation differences outside of the disturbed area were 0-5 cm. Field measurements of the mega-gully width and depth differed from the SfM-derived width and depth by less than 2 cm on average. This WRIF caused the interruption of water supply for 1 month, affecting more than 300 residents (personal communication, Tijuana Metropolitan Planning Institute). The corresponding erosional feature impacted public transportation and life quality to the neighbourhood for 6-9 months (available Google Earth imagery 11 December2015- 08 August 2016) before the road was repaired.

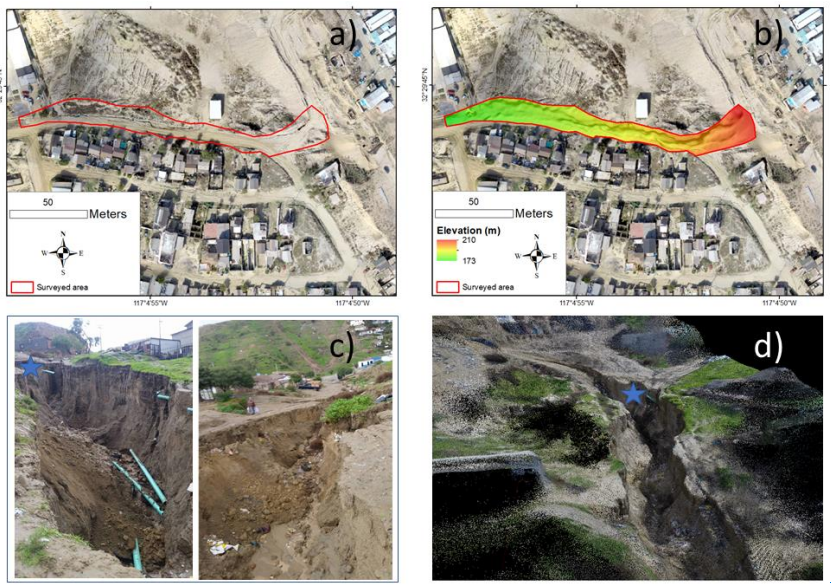
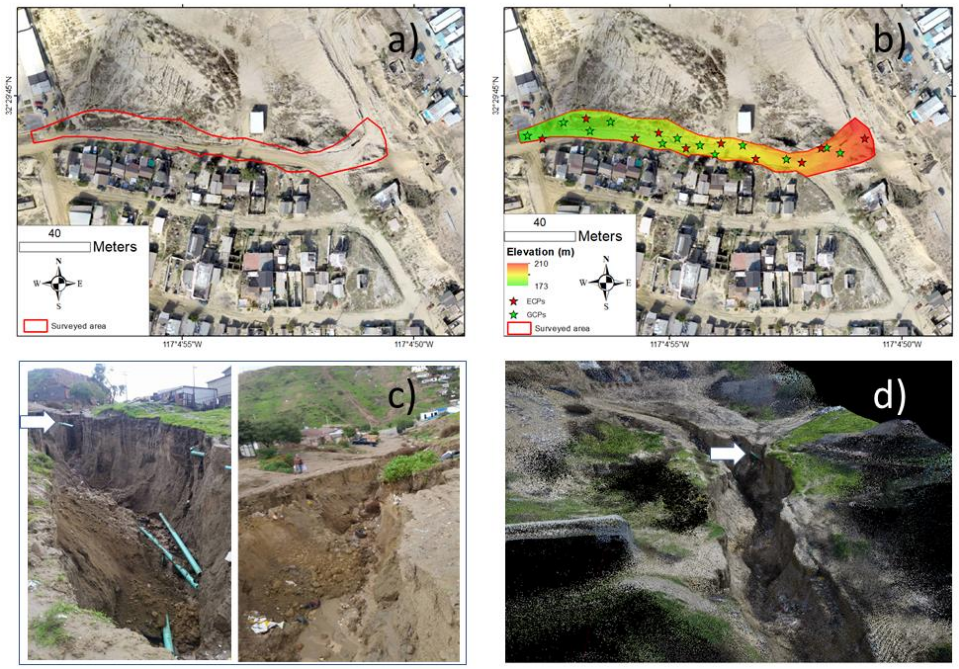
A second mega-gully (B) formed along an unpaved road (Fig. 5a) following a storm event on 16 December 2016. Based on the daily rainfall total (33 mm) and the long-term rainfall record at the NOAA rain gauge, the return period of the storm is 1-2 years. The mega-gully was largest at the upslope position and decreased in cross sectional area with distance from the broken pipeline. The mega-gully was 202 m long, with a maximum width of 10 m and maximum depth of 7 m. Imagery was collected for the SfM processing using a telescoping painter's pole ~~(Fig. 4d),~~ and sediment generation was estimated to be 4,340 ± ~~408~~155 tons.

Figure 45. Mega-gully formed on 16 December 2016 triggered by WRIF: (a) Orthophoto acquired before the WRIF showing the extent of the surveyed area centred in the red polygon, (b) the resulting ~~DEM~~DSM after the WRIF, (c) Images depicting the mega-gully with view angles looking upslope and downslope of the WRIF, and (d) a screenshot of the resulting point cloud.

The RMSE (ECPs, n=10) of the DSM (Fig. 5b) obtained from SfM was 3.5 cm in the horizontal and 5 cm in the vertical. Elevation differences outside of the disturbed area were 0-5 cm, which is consistent with the accuracy of the method. For example, differences between measured and modelled lengths of not-deforming objects at the site (e.g., water supply pipes shown as ~~blue stars~~white arrows in Fig. ~~4c~~5c and Fig. ~~4d~~5d) were less than 1 cm.

For this second mega-gully event, mass movement was again triggered by erosion that undermined the water main, which subsequently broke and enlarged the gully by discharging piped water directly onto the hillslope. Broken water main pipes were noted during the rapid-response survey (Fig. ~~4a and 4c~~5c). The mega-gully also impacted public transportation and life quality in the neighbourhood for 6 months (based on Google Earth imagery) and interrupted water supply for 1 month, affecting more than 200 people (personal communication, Tijuana Metropolitan Planning Institute).

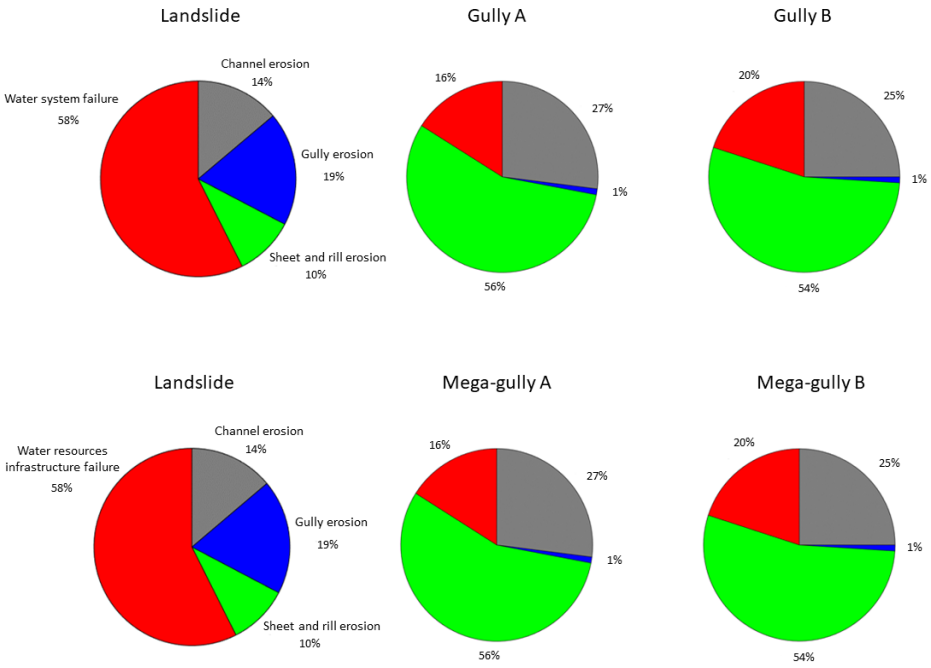
2018b). The WRIF-triggered landslide mobilized more sediment than all of the rainfall-based processes combined, while the mega-gullies triggered by pipe failures and hydraulic mining were responsible for 16 and 20% of the total sediment generation across the watershed (Fig. ~~5~~6).

The proportion of sediment generated by each erosional process differed markedly between the landslide event and the two mega-gully events (Fig. ~~5~~6); rainfall-generated gullies contributed more sediment during the landslide event because peak discharge, the main control on gully formation, was higher during the landslide storm event (19.5 cms at the outlet) than during the two mega-gully events (~5 cms) (Gudino-Elizondo et al., 2019b).

Figure ~~5~~6. Relative contribution of sheet and rill erosion, gully erosion, channel erosion and water ~~system~~ resources infrastructure failure (WRIF) towards sediment generation for three storm events with ~~water resources infrastructure failures~~WRIF.

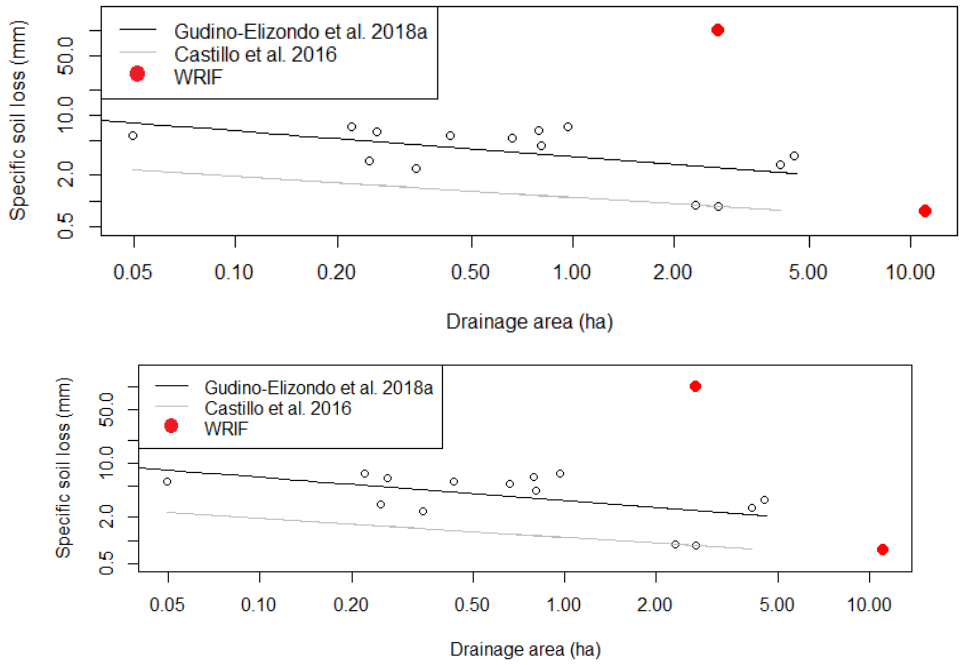
Figure 8 shows that the specific soil loss (SSL, the average depth of soil loss in the watershed) from mega-gully B was exceptionally high compared to rainfall-runoff gullies in the LLCW (Gudino-Elizondo et al., 2018a) and compared to sites reported by Castillo and Gómez (2016), which included sites spanning different land uses and precipitation regimes. The SSL from mega-gully A was comparable to other gullies observed in the study watershed, which has higher rates of SSL than the set of sites reported by Castillo and Gómez (2016).

Figure 68. Specific soil loss of mega-gullies caused by WRIF (red dots) compared to previously reported gullies in Tijuana, Mexico (circle points and black line, Gudino-Elizondo et al., 2018a) and trends for ephemeral gullies reported from other sites (gray line, Castillo and Gómez 2016).
