Rapid assessment of abrupt urban mega-gully and landslide events with Structure-from-Motion photogrammetric techniques validates link to water resources infrastructure failures in an urban periphery

Napoleon Gudino-Elizondo[1,2,3], Matthew W. Brand[2], Trent W. Biggs[3], Alvaro Gomez-Gutierrez[4], Eddy Langendoen[5], Ronald Bingner[5], Yongping Yuan[6], Brett F. Sanders[2]

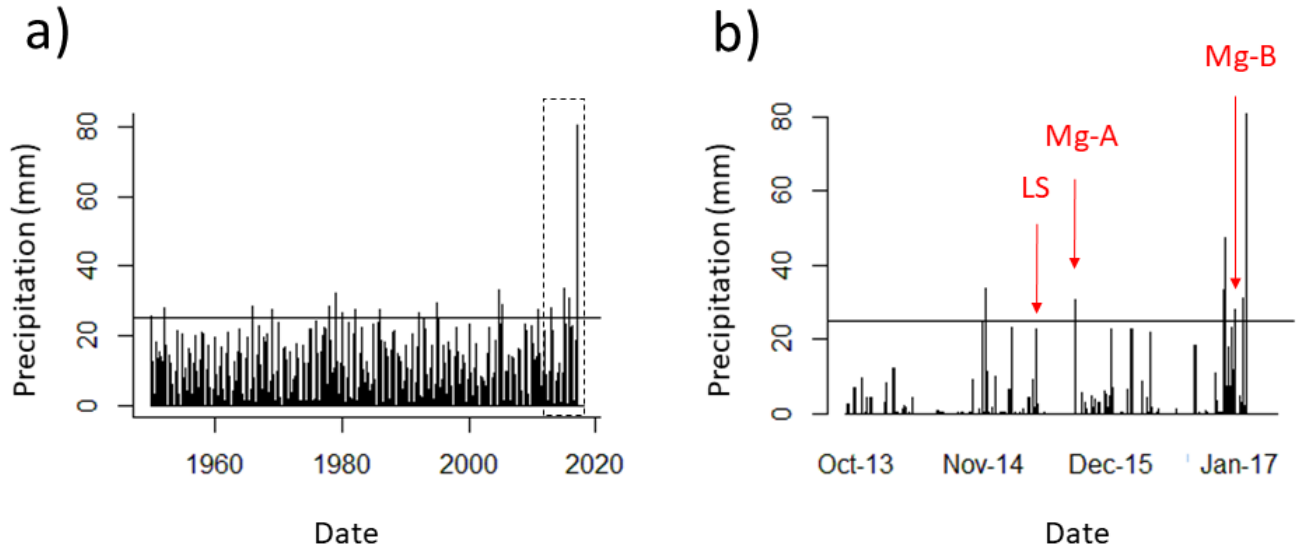
Figure 2. a) Reconstructed daily rainfall time series measured at the watershed outlet for 1950-2017, with horizontal line representing the rainfall threshold for rainfall-runoff gullies formation (Gudino-Elizondo et al., 2018a); and b)

205 **measured rainfall for 2013-2017 and timing of the observed mega-gullies (Mg) and landslide (LS).**

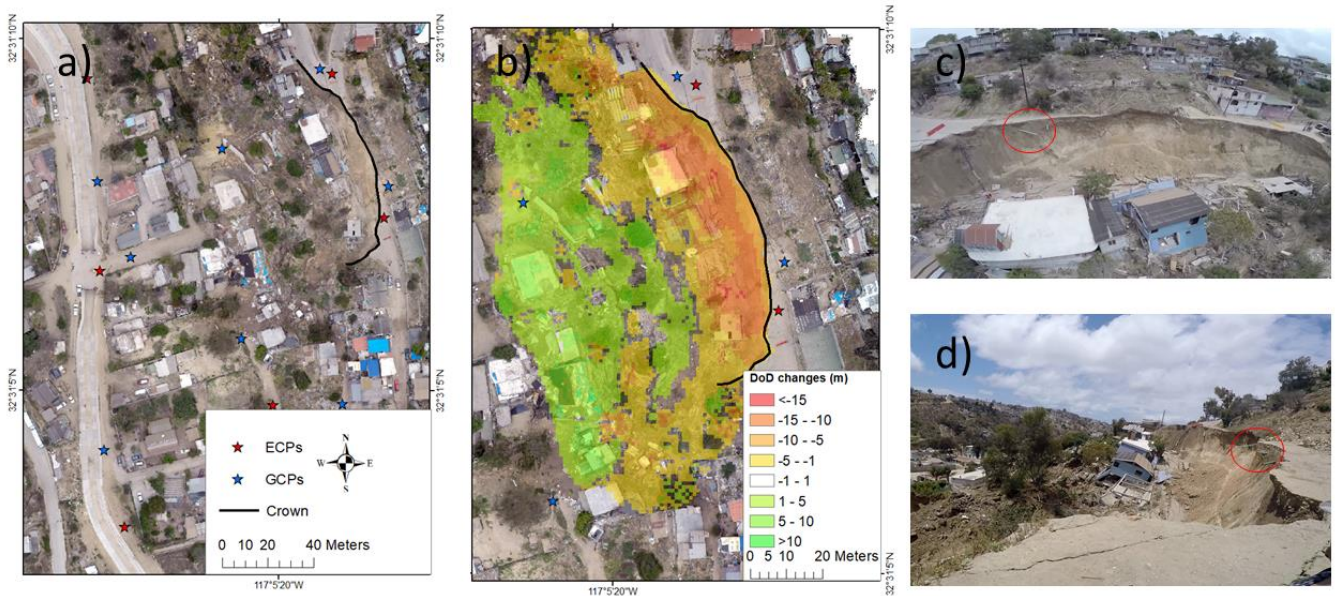
210 A large rotational landslide occurred during a storm event on 15 May 2015 (Fig. 3a and 3b). More than 20 houses and public transportation were damaged permanently, affecting 100's of people. Based on the daily rainfall total (23 mm) and the long-term rainfall record at the NOAA Tijuana River Estuary Gage, the return period of the storm is 1 year. The landslide was attributed to a WRIF based on resident reports of seepage from the slope several days immediately before the failure incident and prior to rainfall, and of broken water mains observed after the landslide (Fig. 3c, and 3d, red circle). Observation of

215 incipient cracks in the soil prior to failure also triggered the evacuation of the residents. The main scarp was approximately 20 m high and approximately 75 m long, with a maximum width of 40 m measured from the main scarp to the toe of the hill. SfM photogrammetry leads to an estimate for the sediment volume and mass: $19,900 \pm 170$ m^3 and $31,900 \pm 280$ metric tons. The reported uncertainties ($\pm$ value) are obtained by propagating vertical RMSEs of individual DSMs in the DoD calculation.

220 **Figure 3. Landslide event on 15 May 2015 triggered by water main leak and rainfall: (a) Orthophoto acquired after the WRIF showing the upper limit of the main scarp (crown) with the black line, (b) the DoD changes from the multi-temporal analysis, (c) oblique aerial and (d) ground-based photographs of the landslide showing broken water mains inside the red circle aligned with the main scarp.**

distance. The DoD map (Fig. 3c) shows the geometry of the landslide as a deep rotational slope failure, which is consistent
230   with the model proposed by Highland and Bobrowsky (2008).

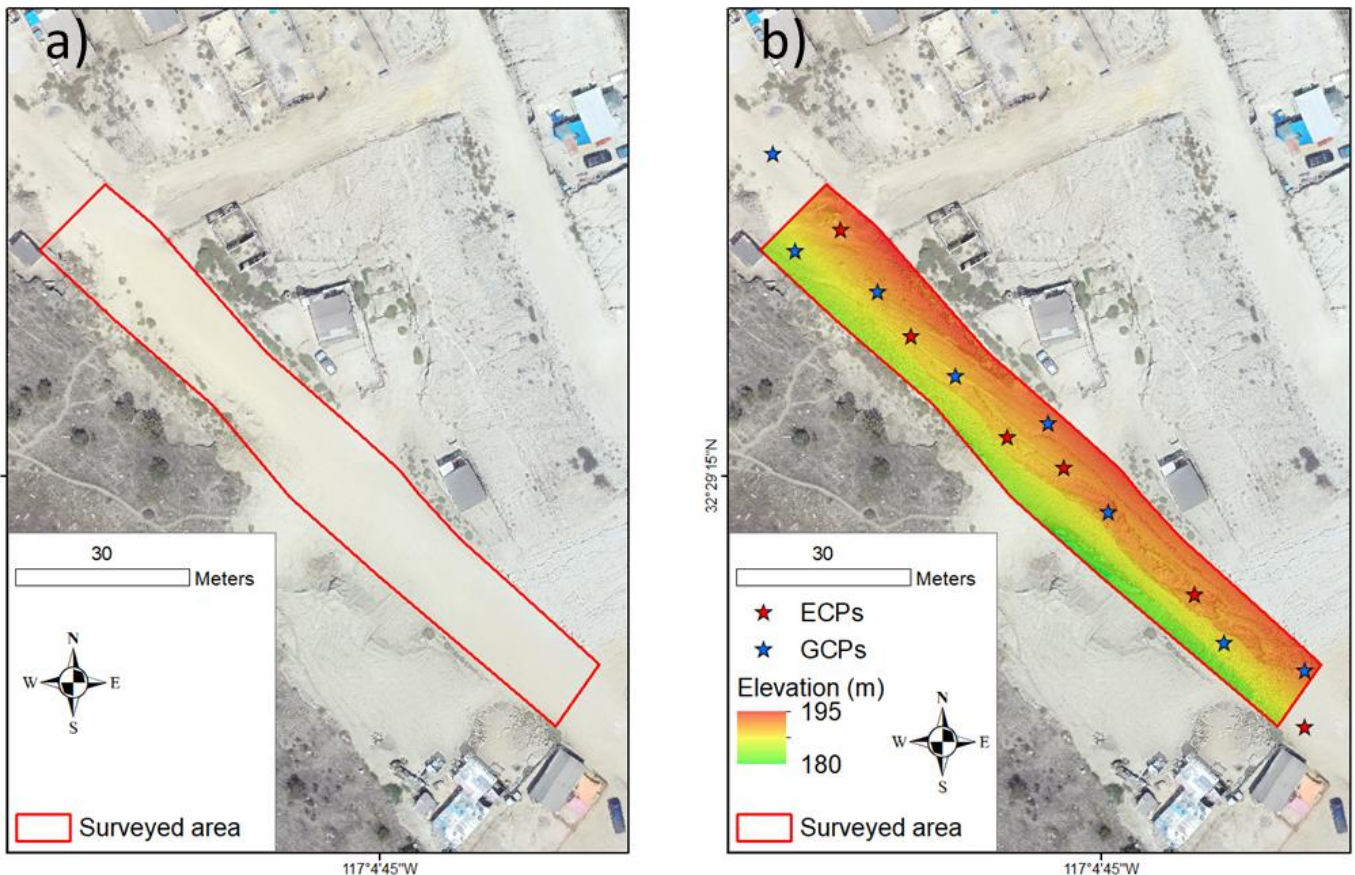
Mega-gully A formed along an unpaved road during and immediately following a storm event on 15 September 2015. Based
on the daily rainfall total (31 mm) and the long-term rainfall record at the NOAA rain gauge, the return period of the storm
was 1-2 years. This mega-gully was attributed to a WRIF based on resident reports that discharge from a broken pipe was
235   observed upstream immediately after the failure event (personal communication, Tijuana Metropolitan Planning Institute). In
this case, erosion caused by the storm event undermined the water main, which subsequently broke and enlarged the gully as
a result of high velocity water jets from the pressurized water main. The mega-gully was 98 m long, with a maximum width
of 8 m and maximum depth of 4 m (Fig. 4). The generated sediment mass was estimated as 1,360 ± 35 tons.

240   **Figure 4. Mega-gully formed on 15 September 15, 2015 by WRIF: (a) Orthophoto acquired before the WRIF showing

the extent of the surveyed area centred in the red rectangle, and (b) the resulting DSM showing the spatial
distribution of Ground and Error Control Points (GCPs and ECPs, respectively).**

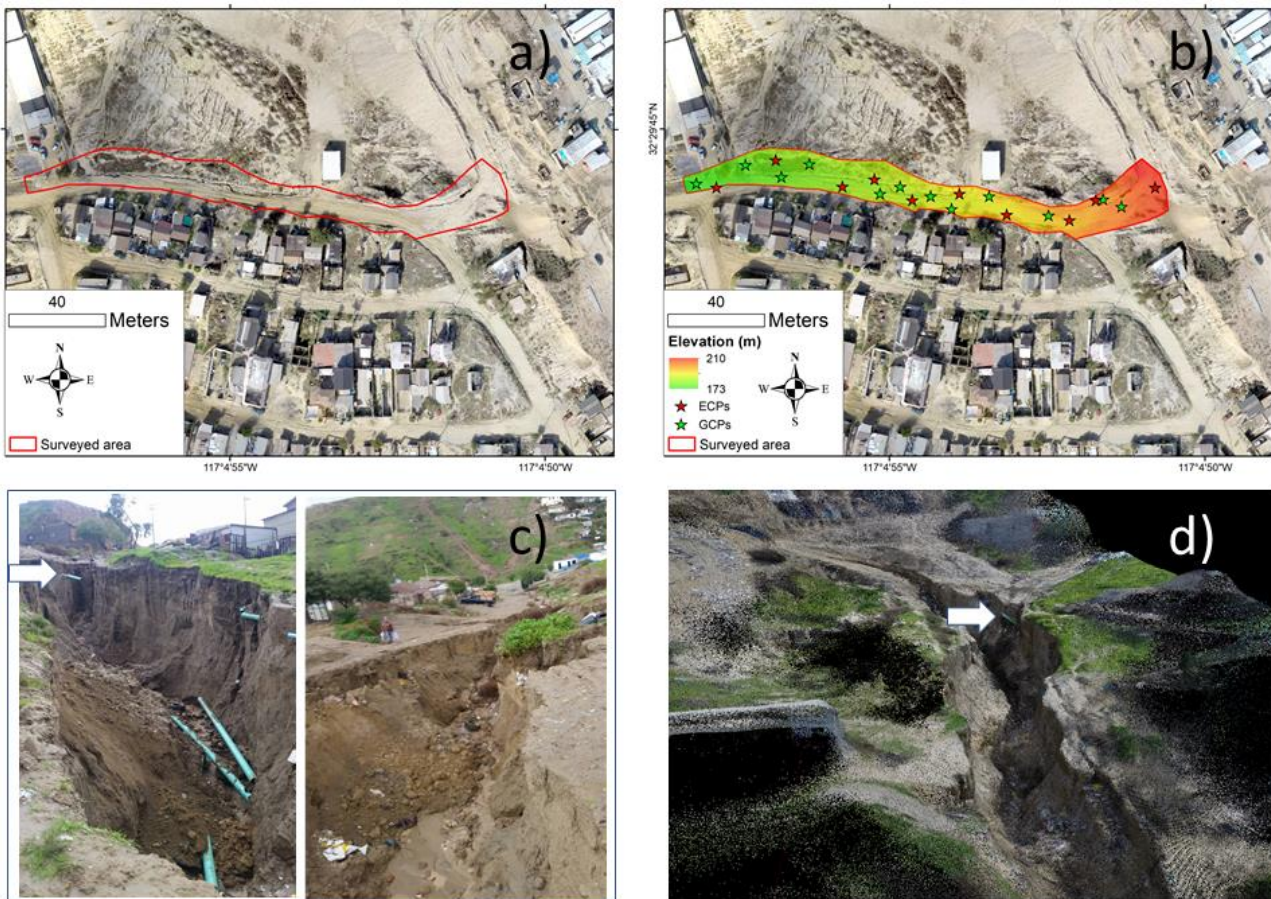
A second mega-gully (B) formed along an unpaved road (Fig. 5a) following a storm event on 16 December 2016. Based on the daily rainfall total (33 mm) and the long-term rainfall record at the NOAA rain gauge, the return period of the storm is 1-2 years. The mega-gully was largest at the upslope position and decreased in cross sectional area with distance from the broken pipeline. The mega-gully was 202 m long, with a maximum width of 10 m and maximum depth of 7 m. Imagery was collected for the SfM processing using a telescoping painter's pole, and sediment generation was estimated to be 4,340 ± 155 tons.

Figure 5. Mega-gully formed on 16 December 2016 triggered by WRIF: (a) Orthophoto acquired before the WRIF showing the extent of the surveyed area centred in the red polygon, (b) the resulting DSM after the WRIF, (c) Images depicting the mega-gully with view angles looking upslope and downslope of the WRIF, and (d) a screenshot of the resulting point cloud.

The RMSE (ECPs, n=10) of the DSM (Fig. 5b) obtained from SfM was 3.5 cm in the horizontal and 5 cm in the vertical. Elevation differences outside of the disturbed area were 0-5 cm, which is consistent with the accuracy of the method. For example, differences between measured and modeled lengths of non-deforming objects at the site (e.g., water supply pipes shown as white arrows in Fig. 5c and Fig. 5d) were less than 1 cm.

For this second mega-gully event, mass movement was again triggered by erosion that undermined the water main, which subsequently broke and enlarged the gully by discharging piped water directly onto the hillslope. Broken water main pipes were observed during the rapid-response survey (Fig. 5c). The mega-gully also impacted public transportation and life quality in the neighbourhood for 6 months (based on Google Earth imagery) and interrupted water supply for 1 month, affecting more than 200 people (personal communication, Tijuana Metropolitan Planning Institute).

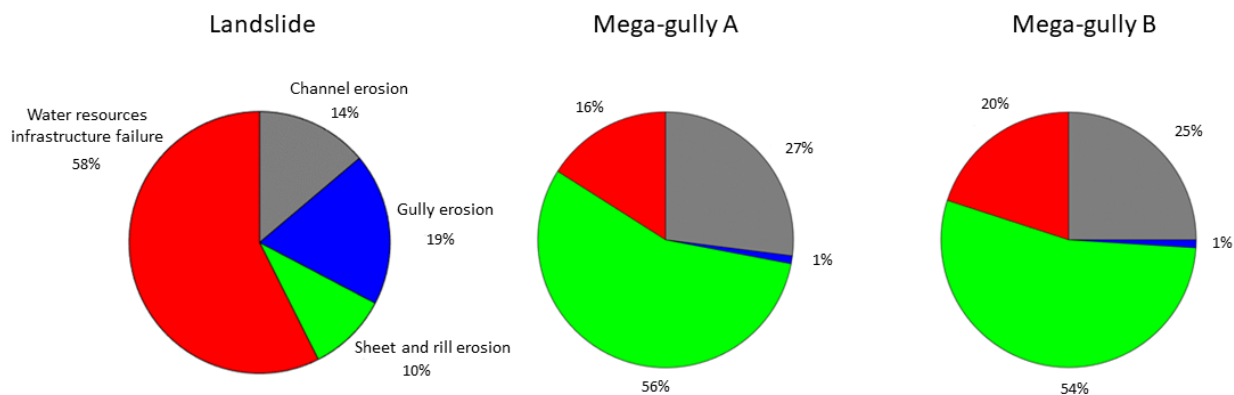
The proportion of sediment generated by each erosional process differed markedly between the landslide event and the two mega-gully events (Fig. 6); rainfall-generated gullies contributed more sediment during the landslide event because peak discharge, the main control on gully formation, was higher during the landslide storm event (19.5 cms at the outlet) than during

Figure 6. Relative contribution of sheet and rill erosion, gully erosion, channel erosion and water resources infrastructure failure (WRIF) towards sediment generation for three storm events with WRIF.

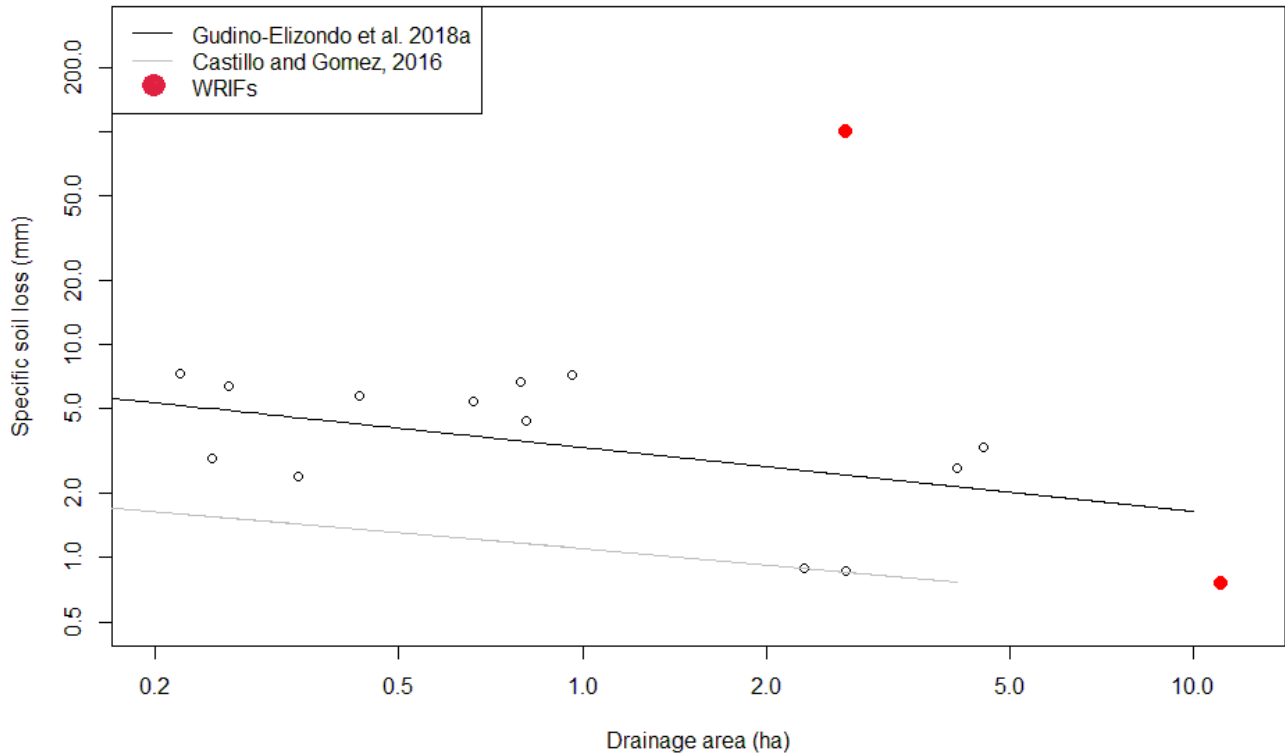
Figure 8 shows that the specific soil loss (SSL, the average depth of soil loss in the watershed) from mega-gully B was
325   exceptionally high compared to rainfall-runoff gullies in the LLCW (Gudino-Elizondo et al., 2018a) and compared to sites reported by Castillo and Gómez (2016), which included sites spanning different land uses and precipitation regimes. The SSL from mega-gully A was comparable to other gullies observed in the study watershed, which has higher rates of SSL than the set of sites reported by Castillo and Gómez (2016).

Figure 8. Specific soil loss of mega-gullies caused by WRIF (red dots) compared to previously reported gullies in Tijuana, Mexico (circle points and black line, Gudino-Elizondo et al., 2018a) and trends for ephemeral gullies reported from other sites (gray line, Castillo and Gómez 2016).
