Rapid assessment of abrupt urban mega-gully and landslide events with Structure-from-Motion photogrammetric techniques validates link to water resources infrastructure failures in an urban periphery

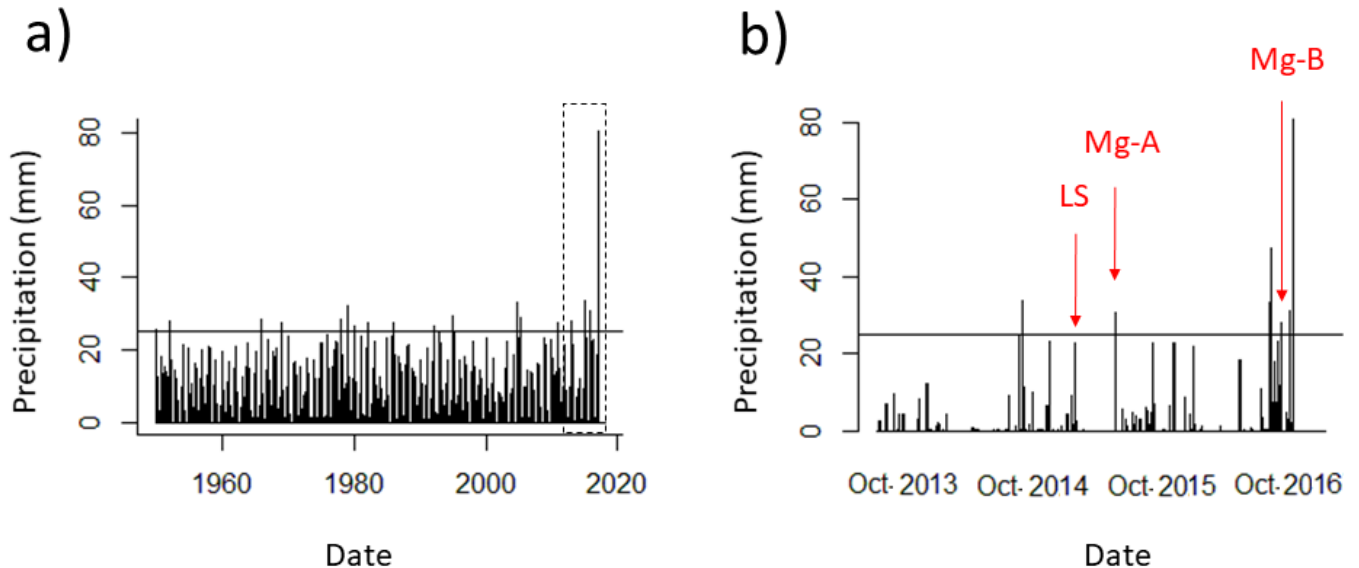
200　mega gullies events are associated with rainfall that exceeds the threshold for rainfall-driven gully formation reported by Gudino-Elizondo et al. (2018a) but is not exceptional in magnitude considering the long-term record. The year of urbanization of the neighborhoods was 1980 (landslide), 2010 (mega-gully A), and 2002 (mega-gully B), respectively. Hence, the landslide is associated with a later stage of urbanization (34 years) compared to mega-gully A (4 years) and mega-gully B (15 years).

205　**Figure 2. a) Reconstructed daily rainfall time series measured at the watershed outlet for 1950-2017, with horizontal line representing the rainfall threshold for rainfall-runoff gullies formation (Gudino-Elizondo et al., 2018a); and b) measured rainfall for water years 2013-2017 and timing of the observed mega-gullies (Mg) and landslide (LS).**

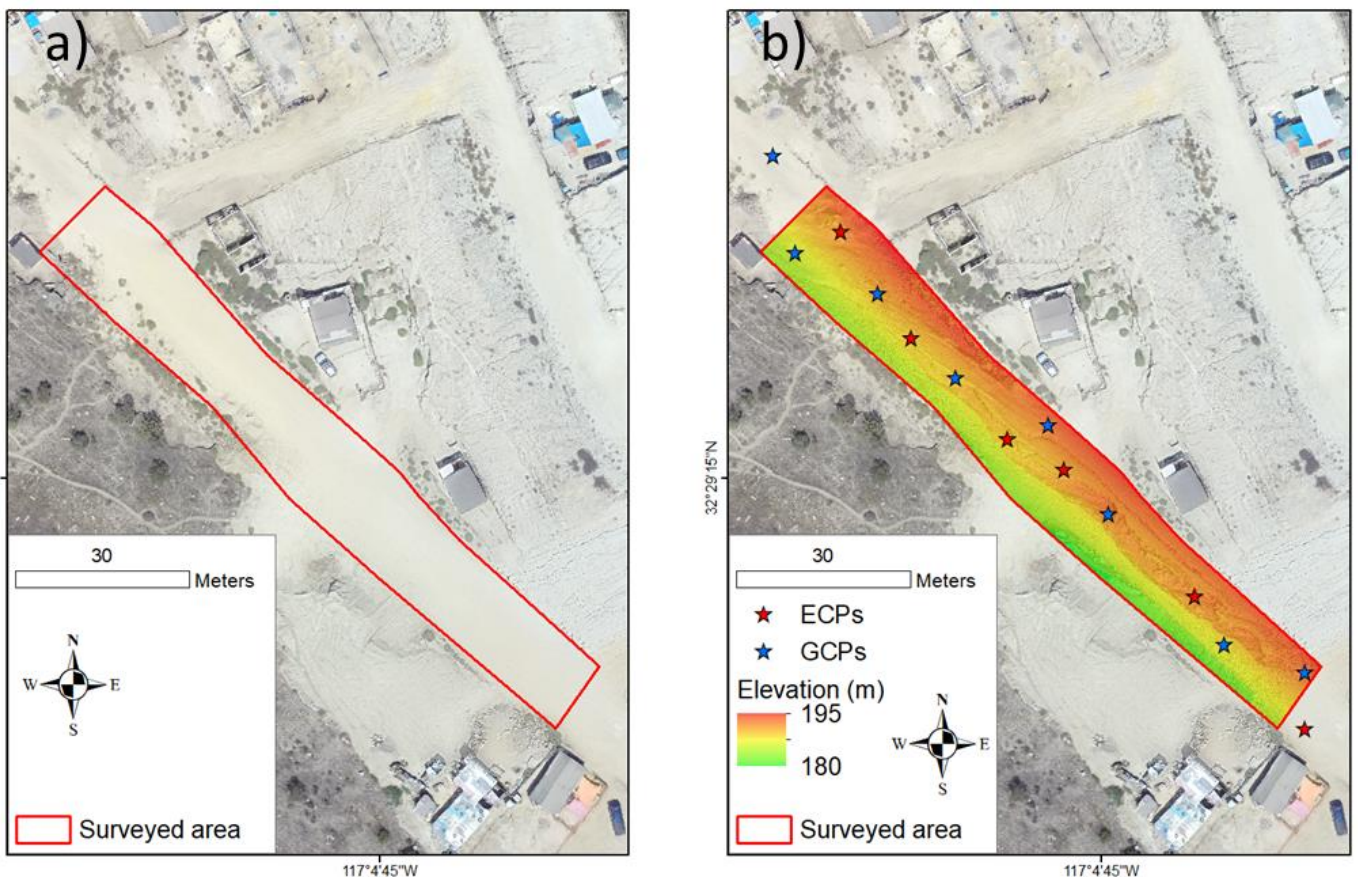
Mega-gully A formed along an unpaved road during and immediately following a storm event on 15 September 2015. Based
on the daily rainfall total (31 mm) and the long-term rainfall record at the NOAA rain gauge, the return period of the storm
was 1-2 years. This mega-gully was attributed to a WRIF based on resident reports that discharge from a broken pipe was
235 observed upstream immediately after the failure event (personal communication, Tijuana Metropolitan Planning Institute). In
this case, erosion caused by the storm event undermined the water main, which subsequently broke and enlarged the gully as
a result of high velocity water jets from the pressurized water main. The mega-gully was 98 m long, with a maximum width
of 8 m and maximum depth of 4 m (Fig. 4). The generated sediment mass was estimated as 1,360 ± 35 tons.

240 **Figure 4. Mega-gully formed on 15 September 15, 2015 by WRIF: (a) Orthophoto acquired before the WRIF showing
the extent of the surveyed area centred in the red rectangle, and (b) the resulting DSM showing the spatial
distribution of Ground and Error Control Points (GCPs and ECPs, respectively).**

The RMSE (ECPs, n=6) of the DSM obtained from SfM was 3 cm horizontal and 5 cm vertical. Elevation differences outside of the disturbed area were 0-5 cm. Field measurements of the mega-gully width and depth differed from the SfM-derived width and depth by less than 2 cm on average. This WRIF caused the interruption of water supply for 1 month, affecting more than 300 residents (personal communication, Tijuana Metropolitan Planning Institute). The corresponding erosional feature impacted public transportation and life quality to the neighbourhood for 6-9 months (available Google Earth imagery 11 December 2015- 08 August 2016) before the road was repaired.
