Rapid assessment of abrupt urban mega-gully and landslide events with Structure-from-Motion photogrammetric techniques validates link to water resources infrastructure failures in an urban periphery

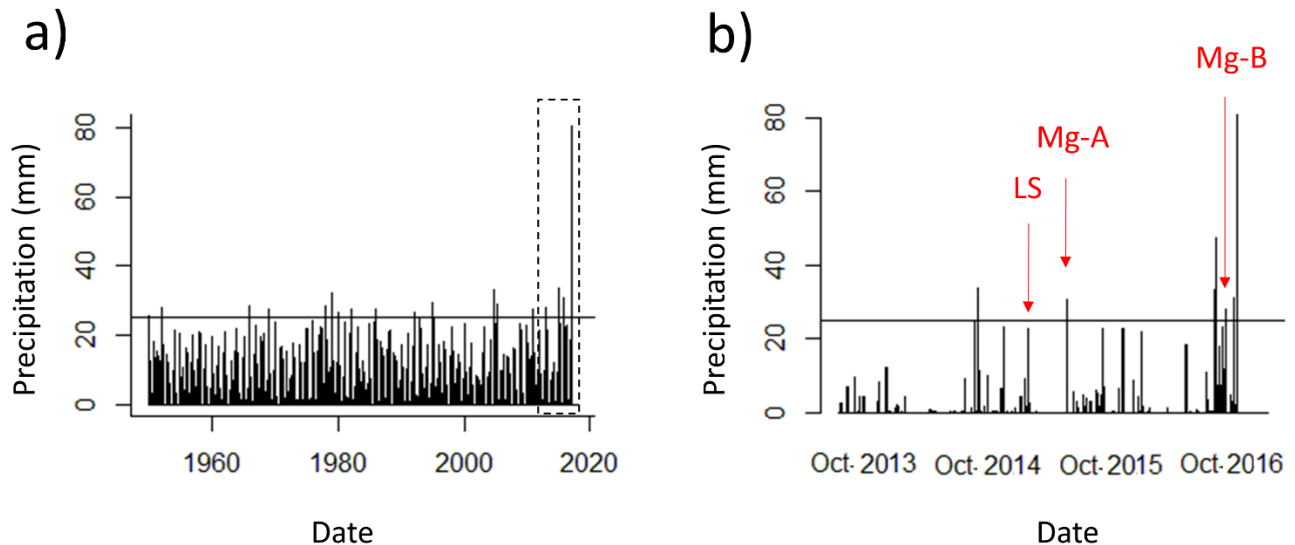
200   mega gullies events are associated with rainfall that exceeds the threshold for rainfall-driven gully formation reported by Gudino-Elizondo et al. (2018a) but is not exceptional in magnitude considering the long-term record. The year of urbanization of the neighborhoods was 1980 (landslide), 2010 (mega-gully A), and 2002 (mega-gully B), respectively. Hence, the landslide is associated with a later stage of urbanization (34 years) compared to mega-gully A (4 years) and mega-gully B (15 years).

205   **Figure 2. a) Reconstructed daily rainfall time series measured at the watershed outlet for 1950-2017, with horizontal line representing the rainfall threshold for rainfall-runoff gullies formation (Gudino-Elizondo et al., 2018a); and b) measured rainfall for water years 2013-2017 and timing of the observed mega-gullies (Mg) and landslide (LS).**

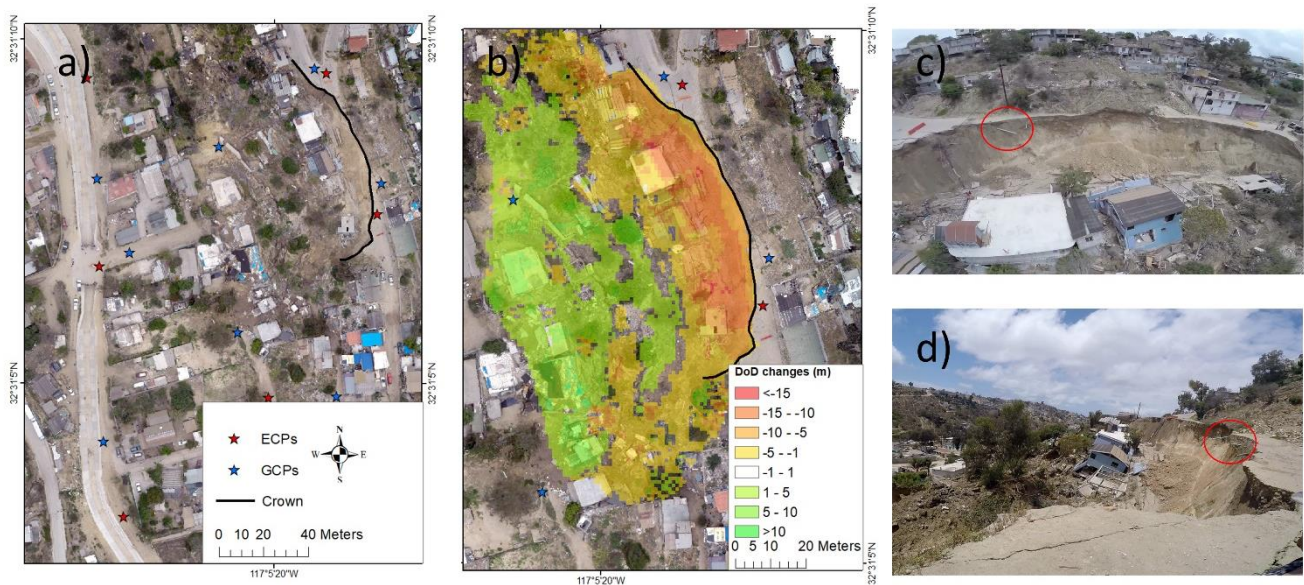
210 A large rotational landslide occurred during a storm event on 15 May 2015 (Fig. 3a and 3b). More than 20 houses and public transportation were damaged permanently, affecting 100's of people. Based on the daily rainfall total (23 mm) and the long-term rainfall record at the NOAA Tijuana River Estuary Gage, the return period of the storm is 1 year. The landslide was attributed to a WRIF based on resident reports of seepage from the slope several days immediately before the failure incident and prior to rainfall, and of broken water mains observed after the landslide (Fig. 3c, and 3d, red circle). Observation of

215 incipient cracks in the soil prior to failure also triggered the evacuation of the residents. The main scarp was approximately 20 m high and approximately 75 m long, with a maximum width of 40 m measured from the main scarp to the toe of the hill. SfM photogrammetry leads to an estimate for the sediment volume and mass: $19,900 \pm 170 \ \text{m}^3$ and $31,900 \pm 280$ metric tons. The reported uncertainties (± value) are obtained by propagating vertical RMSEs of individual DSMs in the DoD calculation.

220 **Figure 3. Landslide event on 15 May 2015 triggered by water main leak and rainfall: (a) Orthophoto acquired after the WRIF showing the upper limit of the main scarp (crown) with the black line, (b) the DoD changes from the multi-temporal analysis, (c) oblique aerial and (d) ground-based photographs of the landslide showing broken water mains inside the red circle aligned with the main scarp.**

distance. The DoD map (Fig. 3c) shows the geometry of the landslide as a deep rotational slope failure, which is consistent
230   with the model proposed by Highland and Bobrowsky (2008).

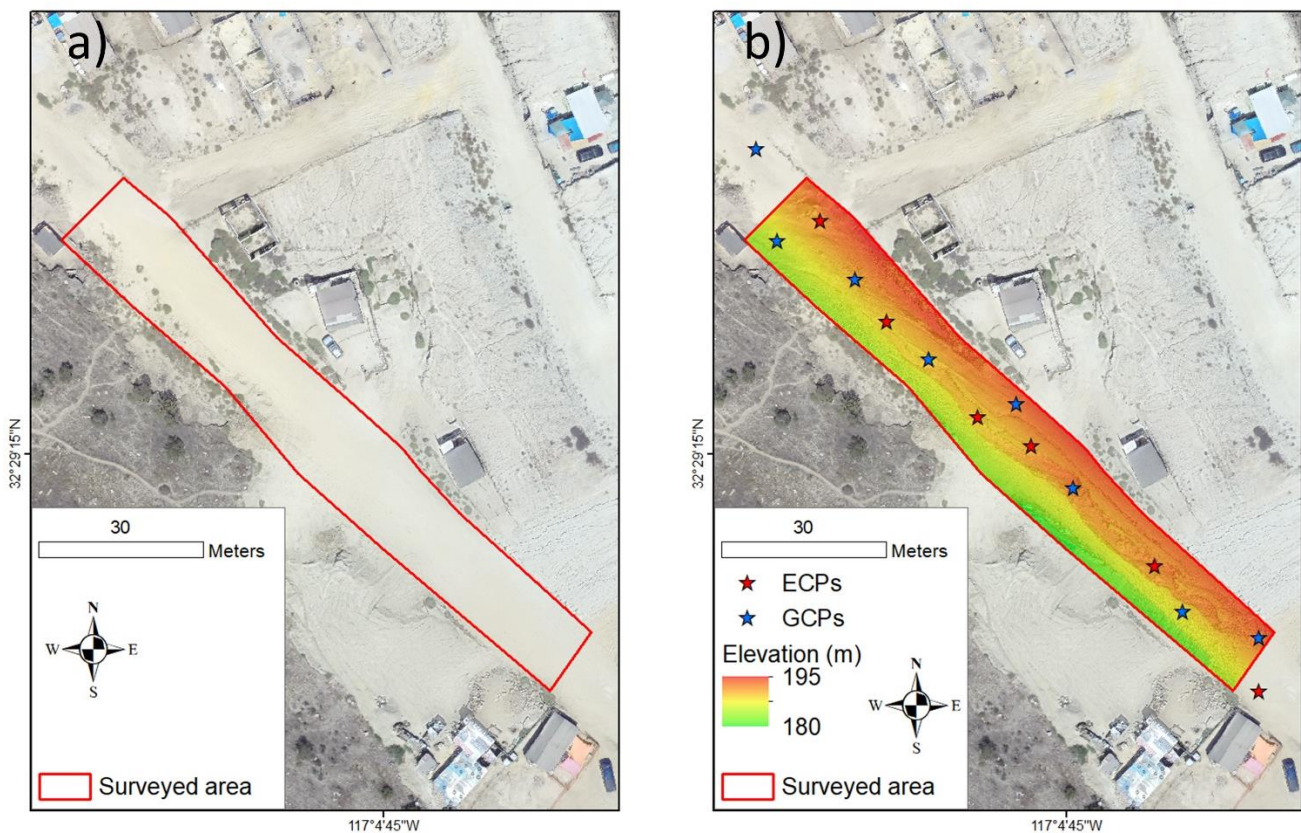
Mega-gully A formed along an unpaved road during and immediately following a storm event on 15 September 2015. Based
on the daily rainfall total (31 mm) and the long-term rainfall record at the NOAA rain gauge, the return period of the storm
was 1-2 years. This mega-gully was attributed to a WRIF based on resident reports that discharge from a broken pipe was
235   observed upstream immediately after the failure event (personal communication, Tijuana Metropolitan Planning Institute). In
this case, erosion caused by the storm event undermined the water main, which subsequently broke and enlarged the gully as
a result of high velocity water jets from the pressurized water main. The mega-gully was 98 m long, with a maximum width
of 8 m and maximum depth of 4 m (Fig. 4). The generated sediment mass was estimated as 1,360 ± 35 tons.

240   **Figure 4. Mega-gully formed on 15 September 15, 2015 by WRIF: (a) Orthophoto acquired before the WRIF showing the extent of the surveyed area centred in the red rectangle, and (b) the resulting DSM showing the spatial distribution of Ground and Error Control Points (GCPs and ECPs, respectively).**

The RMSE (ECPs, n=6) of the DSM obtained from SfM was 3 cm horizontal and 5 cm vertical. Elevation differences outside
245 of the disturbed area were 0-5 cm. Field measurements of the mega-gully width and depth differed from the SfM-derived width
and depth by less than 2 cm on average. This WRIF caused the interruption of water supply for 1 month, affecting more than
300 residents (personal communication, Tijuana Metropolitan Planning Institute). The corresponding erosional feature
impacted public transportation and life quality to the neighbourhood for 6-9 months (available Google Earth imagery 11
December 2015- 08 August 2016) before the road was repaired.

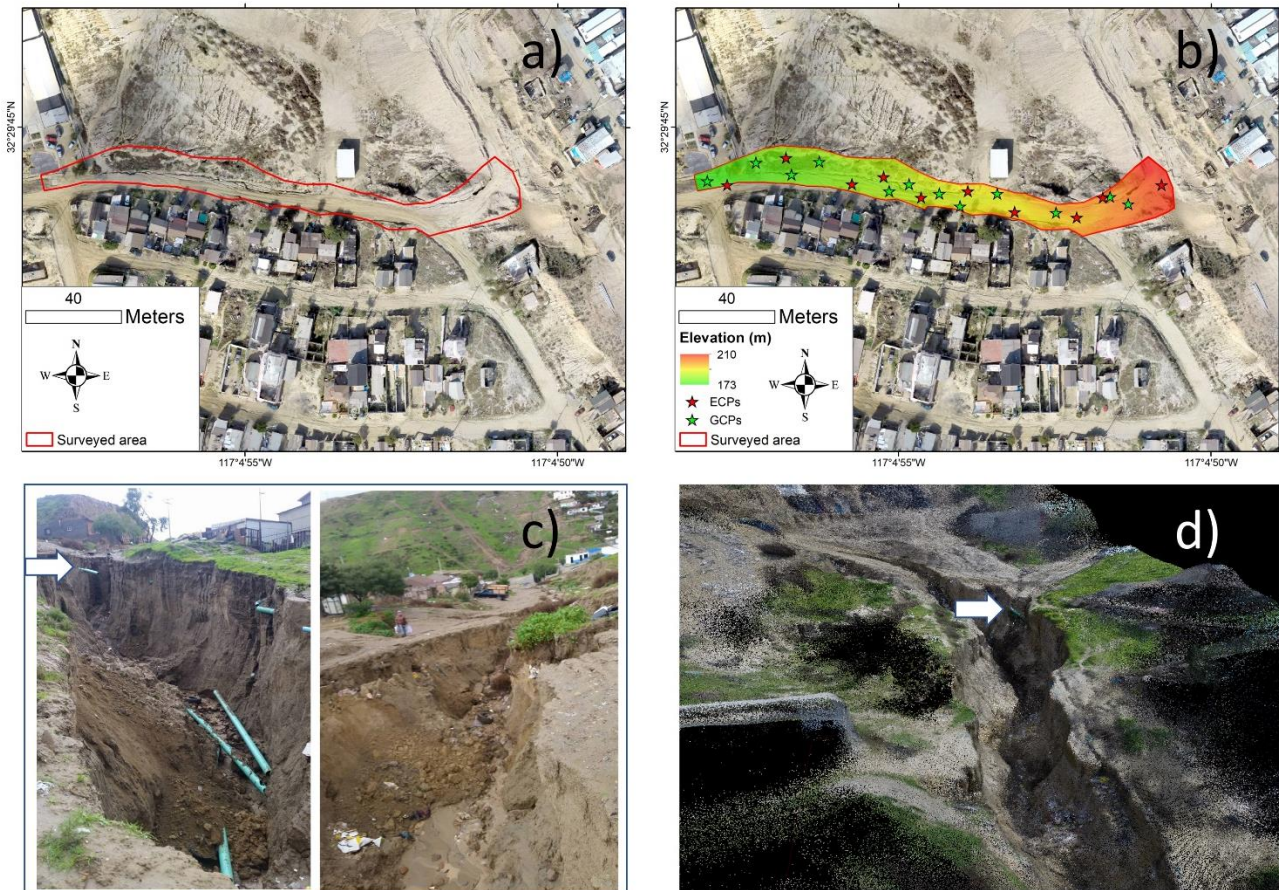
A second mega-gully (B) formed along an unpaved road (Fig. 5a) following a storm event on 16 December 2016. Based on
the daily rainfall total (33 mm) and the long-term rainfall record at the NOAA rain gauge, the return period of the storm is 1-
2 years. The mega-gully was largest at the upslope position and decreased in cross sectional area with distance from the broken
pipeline. The mega-gully was 202 m long, with a maximum width of 10 m and maximum depth of 7 m. Imagery was collected
255 for the SfM processing using a telescoping painter's pole, and sediment generation was estimated to be 4,340 ± 155 tons.

Figure 5. Mega-gully formed on 16 December 2016 triggered by WRIF: (a) Orthophoto acquired before the WRIF showing the extent of the surveyed area centred in the red polygon, (b) the resulting DSM after the WRIF, (c) Images depicting the mega-gully with view angles looking upslope and downslope of the WRIF, and (d) a screenshot of the resulting point cloud.

The RMSE (ECPs, n=10) of the DSM (Fig. 5b) obtained from SfM was 3.5 cm in the horizontal and 5 cm in the vertical. Elevation differences outside of the disturbed area were 0-5 cm, which is consistent with the accuracy of the method. For example, differences between measured and modelled lengths of non-deforming objects at the site (e.g., water supply pipes shown as white arrows in Fig. 5c and Fig. 5d) were less than 1 cm.

For this second mega-gully event, mass movement was again triggered by erosion that undermined the water main, which subsequently broke and enlarged the gully by discharging piped water directly onto the hillslope. Broken water main pipes were observed during the rapid-response survey (Fig. 5c). The mega-gully also impacted public transportation and life quality in the neighbourhood for 6 months (based on Google Earth imagery) and interrupted water supply for 1 month, affecting more than 200 people (personal communication, Tijuana Metropolitan Planning Institute).

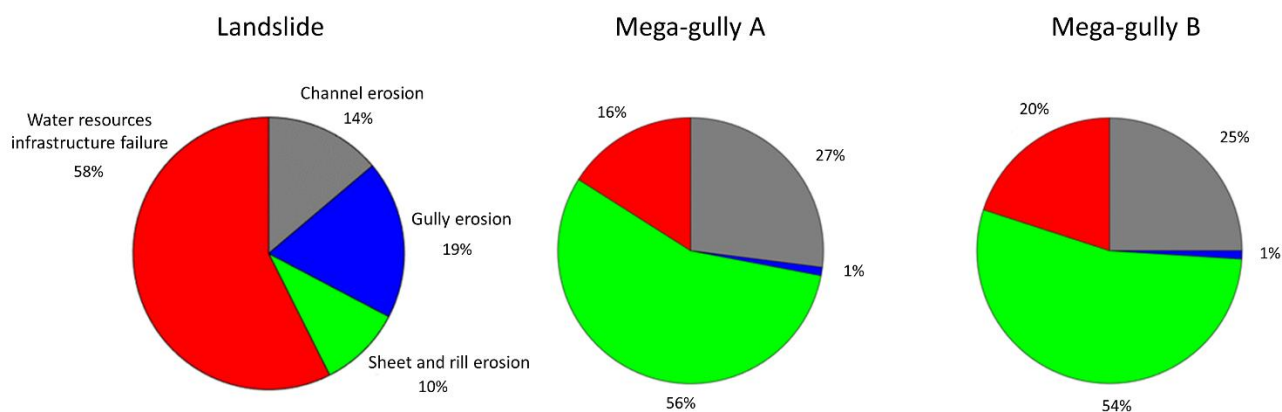
The proportion of sediment generated by each erosional process differed markedly between the landslide event and the two mega-gully events (Fig. 6); rainfall-generated gullies contributed more sediment during the landslide event because peak discharge, the main control on gully formation, was higher during the landslide storm event (19.5 cms at the outlet) than during

290 the two mega-gully events (~5 cms) (Gudino-Elizondo et al., 2019).

Figure 6. Relative contribution of sheet and rill erosion, gully erosion, channel erosion and water resources infrastructure failure (WRIF) towards sediment generation for three storm events with WRIF.

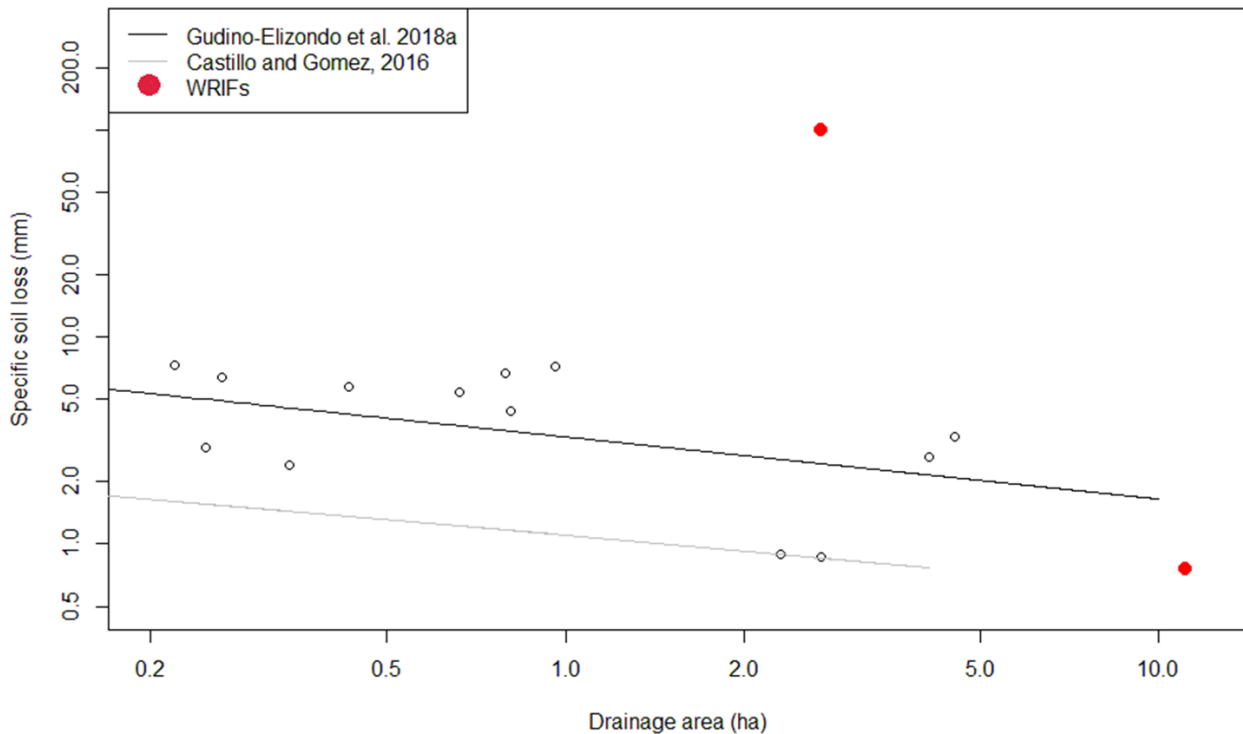
Figure 8 shows that the specific soil loss (SSL, the average depth of soil loss in the watershed) from mega-gully B was
325   exceptionally high compared to rainfall-runoff gullies in the LLCW (Gudino-Elizondo et al., 2018a) and compared to sites reported by Castillo and Gómez (2016), which included sites spanning different land uses and precipitation regimes. The SSL from mega-gully A was comparable to other gullies observed in the study watershed, which has higher rates of SSL than the set of sites reported by Castillo and Gómez (2016).

Figure 8. Specific soil loss of mega-gullies caused by WRIF (red dots) compared to previously reported gullies in Tijuana, Mexico (circle points and black line, Gudino-Elizondo et al., 2018a) and trends for ephemeral gullies reported from other sites (gray line, Castillo and Gómez 2016).
