Brief communication: Landslide activity on the Argentinian Santa Cruz river mega dam works confirmed by PSI DInSAR

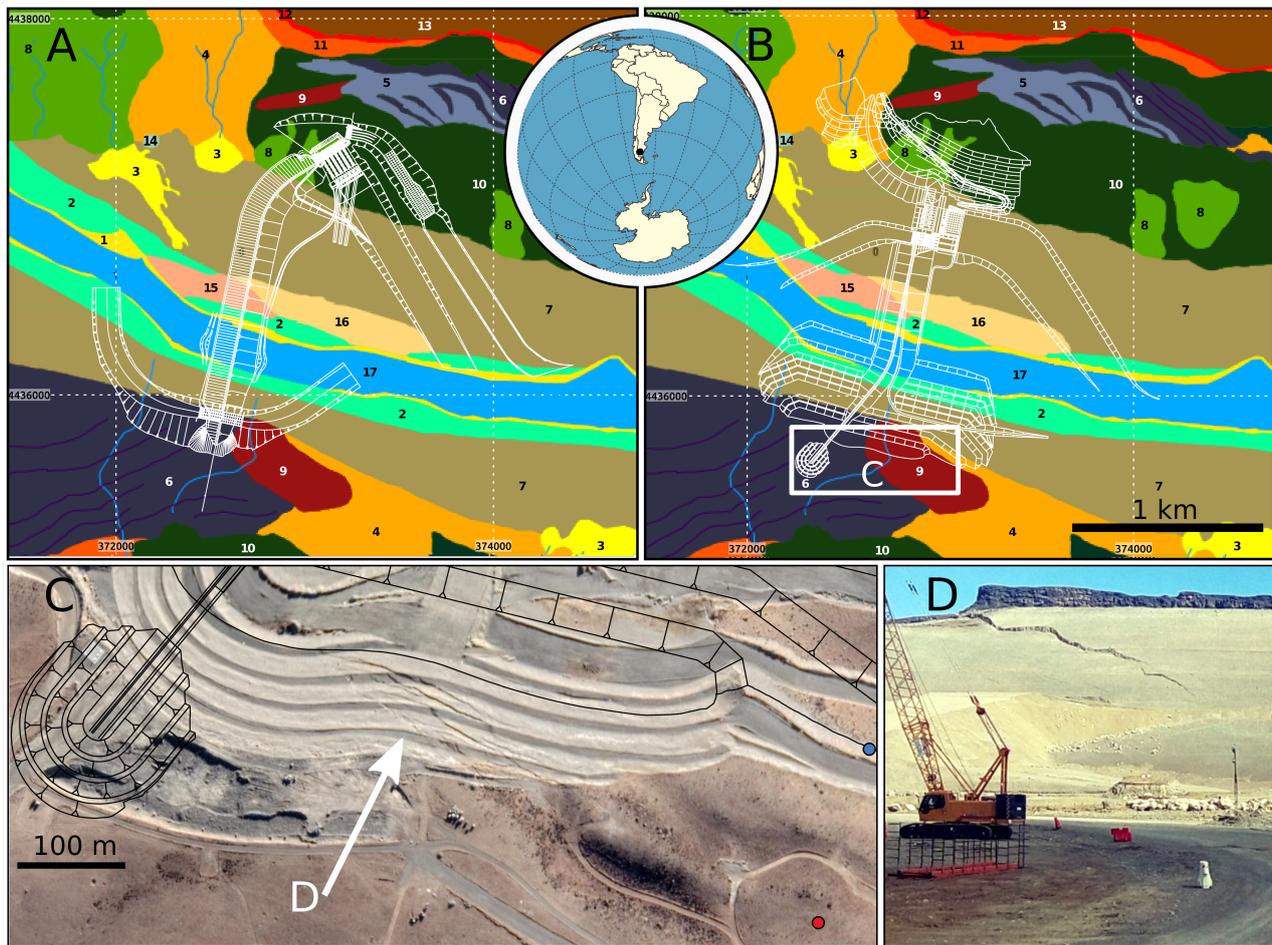
According to official documentation (IEASA, 2020), at the end of 2018 and beginning of 2019, during the foundation excavations of the main wall of the CC-NK dam, several landslides appeared in the areas of the abutments on both banks of the river, endangering the construction and, therefore, leading to the interruption of the works and the complete redesign of the dam. The new design keeps its productive characteristics, but with a completely different morphology (Fig. 1 A and B). Because of this

situation, project deadlines and costs have substantially been affected, threatening its financial viability. Large sectors of the work already done until 2019 had to be removed to readapt the project from 2020 onwards. The structure has been substantially modified: without moving the central sector of the dam axis, its anchors have been diverted a few hundred meters upstream, also readapting the location of other key dam elements (deviation channel, machines hall, etc.) resulting in a roughly U-shaped dam very different from the original.

Figure 1. A dot in the very center of the planisphere (between A and B) shows the project location (50.21° South, 70.78° West), coordinates in planar system are UTM zone 19S. A: First design of the CC-NK dam (2015). B: Second design of the CC-NK dam after experiencing structural issues (2020). At the background, the geomorphological map with the following categories may be observed: 1, Alluvial plain. 2, Fluvial terraces. 3, Active alluvial fan. 4, Flank pediment. 5, Basal moraine. 6, Marginal moraine. 7, Glaciofluvial terrace covered by catastrophic flow deposits. 8, Rock avalanche deposits. 9, lateral spread and rotational landslides. 10, Rotational landslides. 11, Scree slope. 12, Rock fall. 13, Lava flow. 14, Seasonal lagoon. 15, Wind blowout. 16, Parabolic dune. 17, Santa Cruz river channel. Box C shows the optical satellite image where the cracks of the south bank can be seen. In D, a view from the ground of the crack on the south margin may be observed. Source: Our own elaboration based on (EBISA, 2017; IEASA, 2020), © Google Maps, www.worldmapgenerator.com [accessed August 2022] and on fieldwork.

The time series of the four sectors shown in Fig. 2 show no signs of stabilization, so it is possible to affirm that the sliding processes were still active in April 2021 (date of the last observation). The construction works in general, and the deformation phenomena in particular, are clearly located in areas of Quaternary sedimentation and materials resulting from paleo mass wasting processes that had already been described as potentially conflictive in the preliminary project reports (see Fig. 1 A and B), such as:

– on the north bank: basal moraine (8), lateral expansion and rotational slide (18), rotational slide (20);

– and on the south bank: marginal moraine (9) and lateral expansion and rotational slide (18).

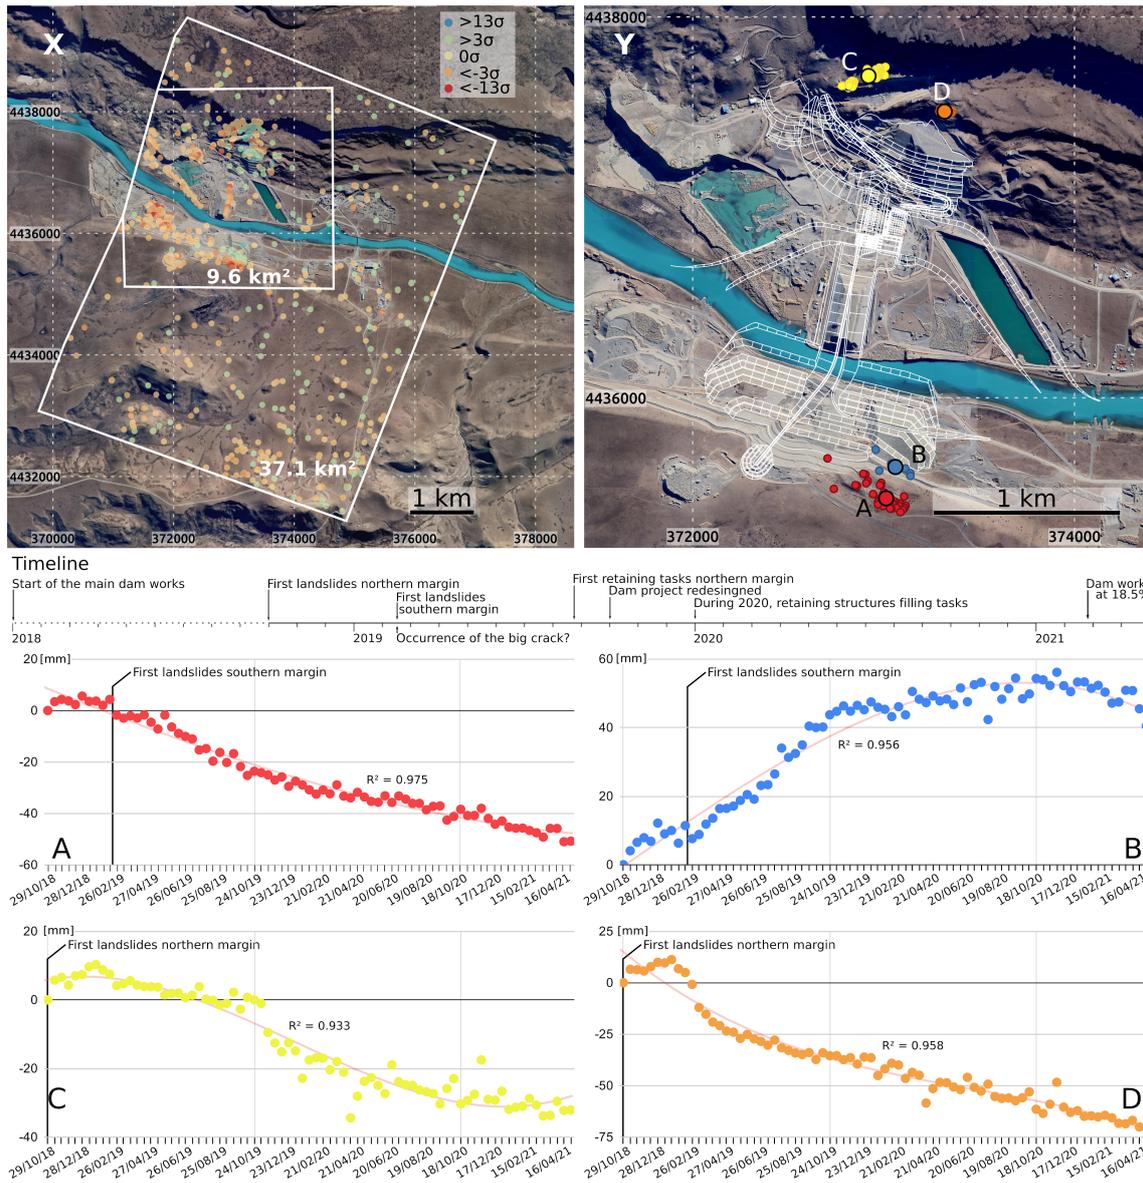
Figure 2. Top left (X). Area covered by the PSI processing. White polygons circumscribes the general (big polygon) and the detailed (small polygon) areas under study. The optical background image is from Google from July 2022 (© Google Maps). Coordinates are UTM zone 19S. Only reflectors showing deformation $>3\sigma$ are represented, magenta negative and cyan positive deviation, scale ranges until 13σ. Top right (Y): construction site. The PSs of each landslide subgroup are represented on the southern (A, B) and northern (C, D) margins. Charts A to D correspond with the deformation time series of the calculated average for each one of the landslide (A to D). The plan of the second dam design has been superimposed. A timeline showing the phases in the dam construction is found at the figure center. The period not covered by the PSI analysis is shown as a dashed line over the timeline axis.

The results are presented in Fig. 2. On the south bank, two deformation phenomena are identified, sector A with 51 (red) PSs and sector B with 18 (blue). On the north bank the identified deformation phenomena are: sector C with 33 PSs (yellow) and D with 15 (orange).

Maximum accumulated displacements between extreme values range from 40 to 80 mm. This represents 16 mm/yr for area C, and 32 mm/yr in sector D. A polynomial fit line with a determination coefficient R^2 (Mirmazloumi et al., 2022) has been superimposed in the chart to show the absence of noise in the measurements. It is worth underlining that the magnitudes measured do not accurately reflect the real magnitude of the movements since:

Sector A is located in a flat area, so it could be said that most of the movement is vertical, which, according to the orbit direction of the satellite, is in agreement with the negative values of the LOS measurement showing subsidence.

Sector B is located on the slope, so horizontal and vertical displacements are measured. The general orientation of this area is not the optimal to be observed with the descending satellite trajectory, but the considerable magnitude of the deformation facilitated obtaining to obtain results. Presumably, deformation to the west and east of the A-B locations became invisible to the radar either by the large magnitude of the ground displacements (at west, in the crack, where data decorrelation is present, see Fig. B1-I in Appendix B) or due to the deficient orientation of the slope and the smaller magnitude of the displacements (to the east).

Observing the situation on sectors A and B (with inverse trend sign), it is possible to suggest that a rotational mass wasting is taking place, which agrees with the bibliography (Astini et al., 2015), but additional information is required to provide a more definitive conclusion.

Since sector C is mainly flat, it is possible to infer a relevant vertical component of the displacement. However, the PSI information is not enough to determine the exact direction of the deformation vector. In the chart (Fig. 2-C), a step in the trend is visible in October 2019, which coincides with the start of containment works in the area as revealed by the optical sources.

Finally, as sector D is found in a steep slope, both vertical and horizontal displacements are relevant, but further measurements are required to fully understand the situation. The strong slope of the curve around February 2019 (Fig. 2-D) confirms the ground instability trends described in the company reports (IEASA, 2020).

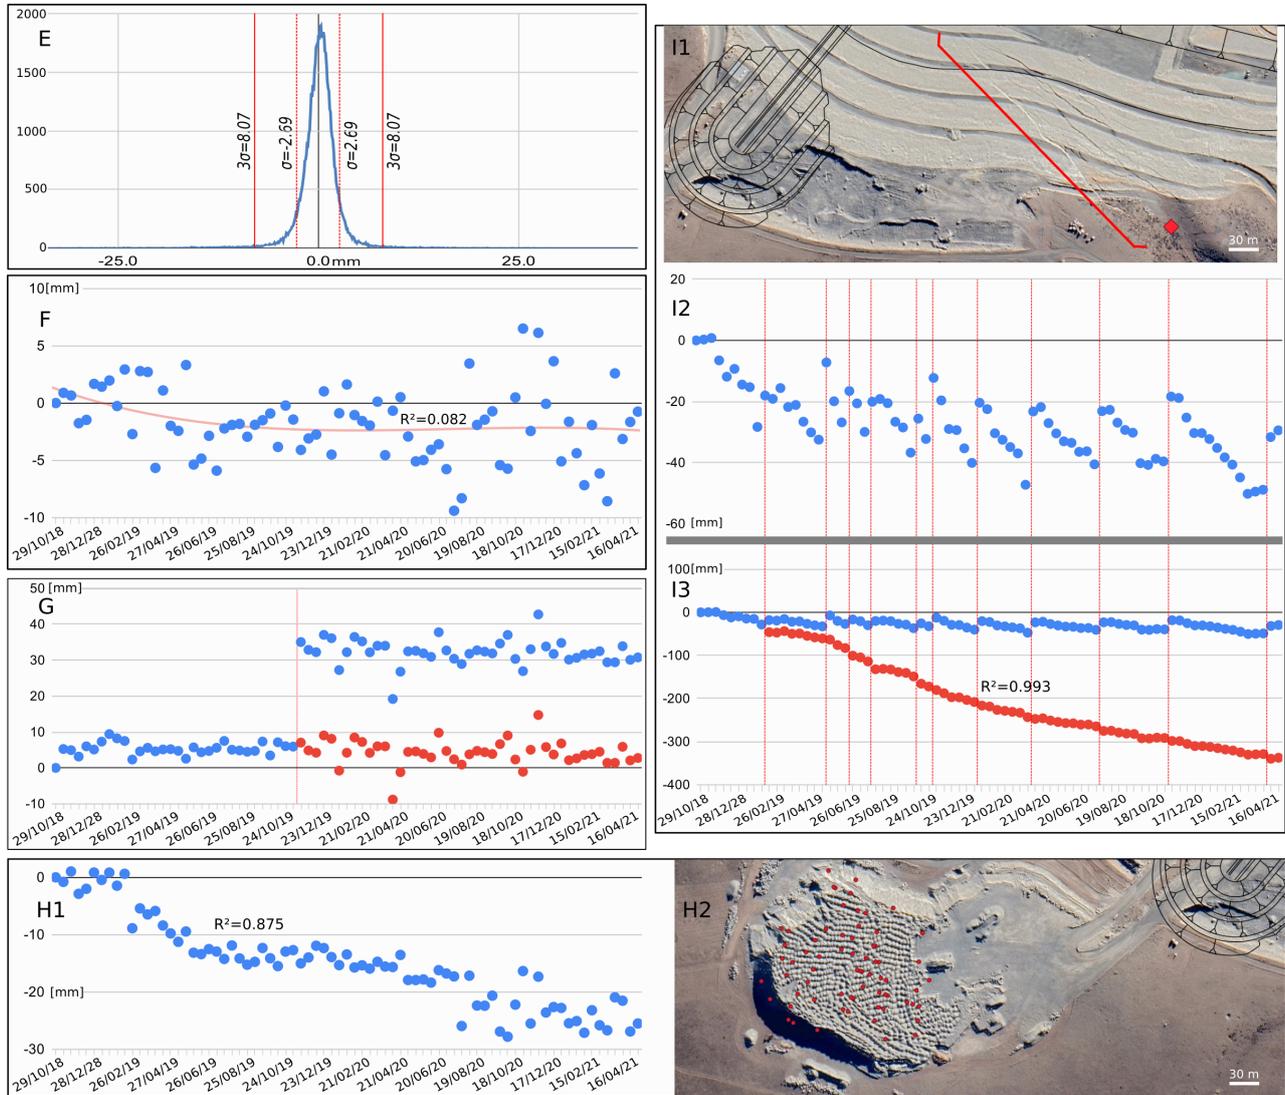
- E. Frequency distribution graph of the accumulated displacement of the PSs reflectors in the study area and the 3σ threshold.

235
- F. Time series of a stable PS with dispersed measurements due to random errors. Elevated σ between 2 and 3, R^2=0.082.

- G. Phase unwrapping error (PUE). 40 reflectors average. Red dots in the chart in Fig. B1 represent the series after applying a manual PUE correction jump of 28 mm (Mirmazloumi et al., 2022).

- H. Deformation trend (Fig. B1-H1) caused by construction works (B1-H2). 72 reflectors average.

- I. 11 phase unwrapping errors for a single reflector located in the root of the big crack in the southern margin (west
240   of studied sectors A and B). This is an exceptional and isolated sample which preserved the coherence along the time series despite the high deformation rate. Chart in Fig. B1-I2 indicates the deformation trend without PUE correction. I3 corresponds to the same chart after applying a manual PUE correction. A visual detail of the crack is shown in Fig. B1-I.3 and the location of that reflector in Fig. B2 as a grey diamond. Official documentation describes the occurrence of the landslide on 14th February 2019. This is clearly visible in the charts (first vertical dashed red line). At the same time,
245   it is clear that the trend was present before (at lower rates) and after this date. Dashed red vertical lines indicate the enforcement of a PUE correction, eleven times in this case. Official reports (IEASA, 2021) describe ground displacements up to 15 mm/day (5.5 m/yr) in the main sector of this big crack, where we could not obtain PSI. Observing this chart, we cannot confirm the end of the deformation trend in April 2021.

Figure B1. Examples of PSs with high σ values which, as presented in page 6 and following the same number notation, have not been studied in this work. Optical satellite images from © Google Maps

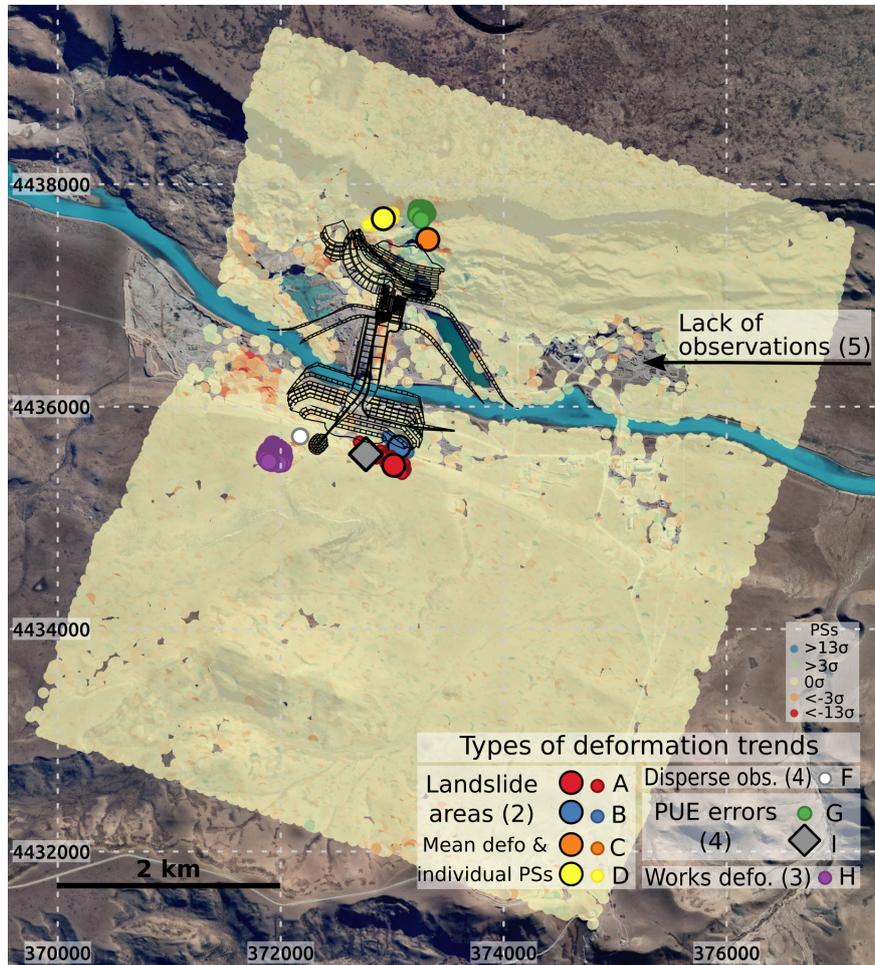
Figure B2. Map of the full PSI results and examples of the identified deformation trends, 1 to 5, as described on the items on page 6 or presented in previous B1. A to D are landslides studied in this work. F to I are the other time series trends briefly described in this Appendix. Arrow (number 5 as in page 6) is an example of the absence of observations due to the surface changes produced by the construction work. Our own elaboration. Background satellite image © Google Maps

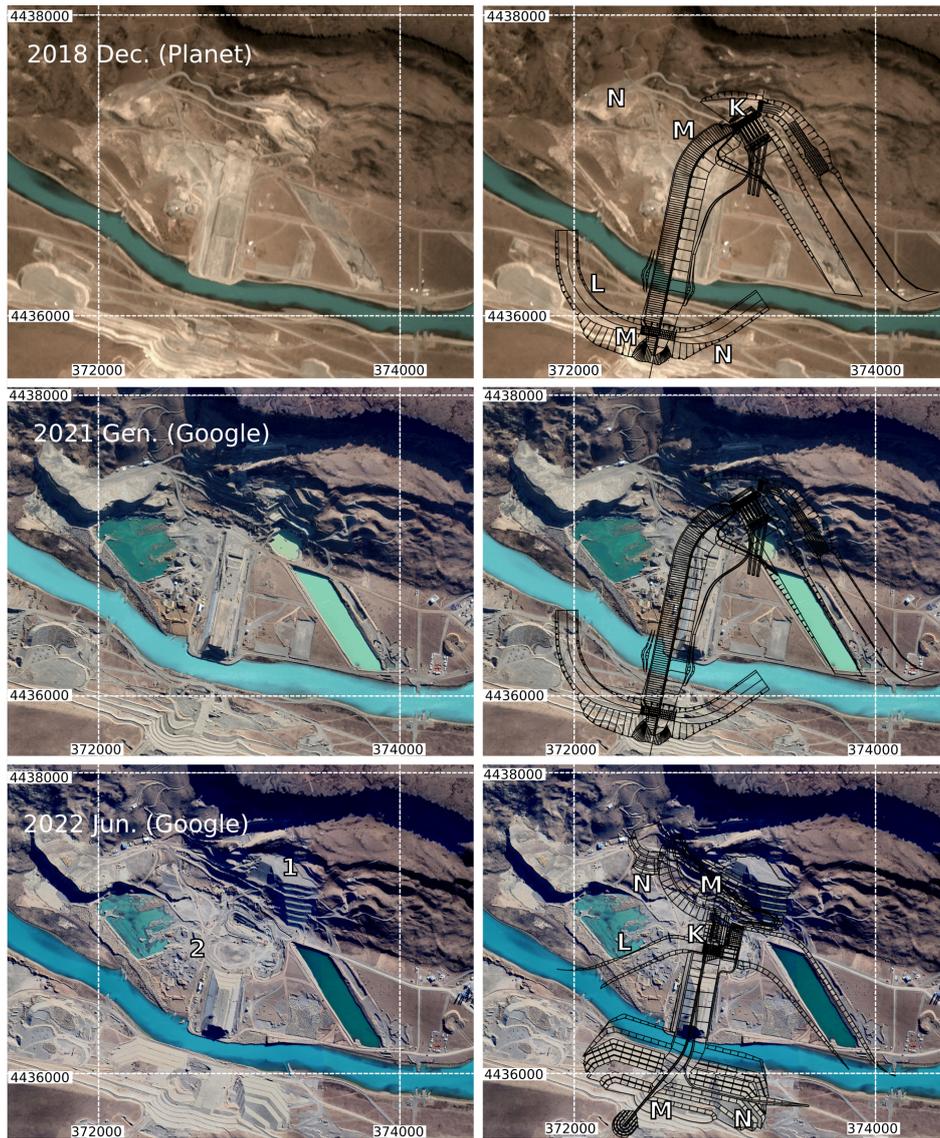
Figure B3. Three moments of the dam construction. In the left column, optical image, in the right, the dam plans have been superimposed (the third row corresponds to the new project). Letters identify main structural changes: K) machines hall, L) deviation channel, M) change of the dam wall direction, N) structural retaining walls. Numbers identify main correction works to the original project (modification of structures already built): 1) the space prepared to the main hall have been filled in again (over 1 million m^3), 2) an important part of the dam wall (which was originally planned to have 12.1 millions m^3) has been retired, and a big 10 m wide and 36 m deep exploratory well is built there to study the rock substratum. To dig the well, a volume of around 70,000 m^3 had to be previously removed at the ground level in the area which had already been filled with basement materials of the dam wall. Our own elaboration. Background images from Planet^{TM} and © Google Maps.
