Brief communication on the NW Himalayan towns; slipping towards potential disaster

Yaspal Sundriyal[1], Vipin Kumar[2], Neha Chauhan[1], Sameeksha Kaushik[1], Rahul Ranjan[3], Mohit K. Punia[4]

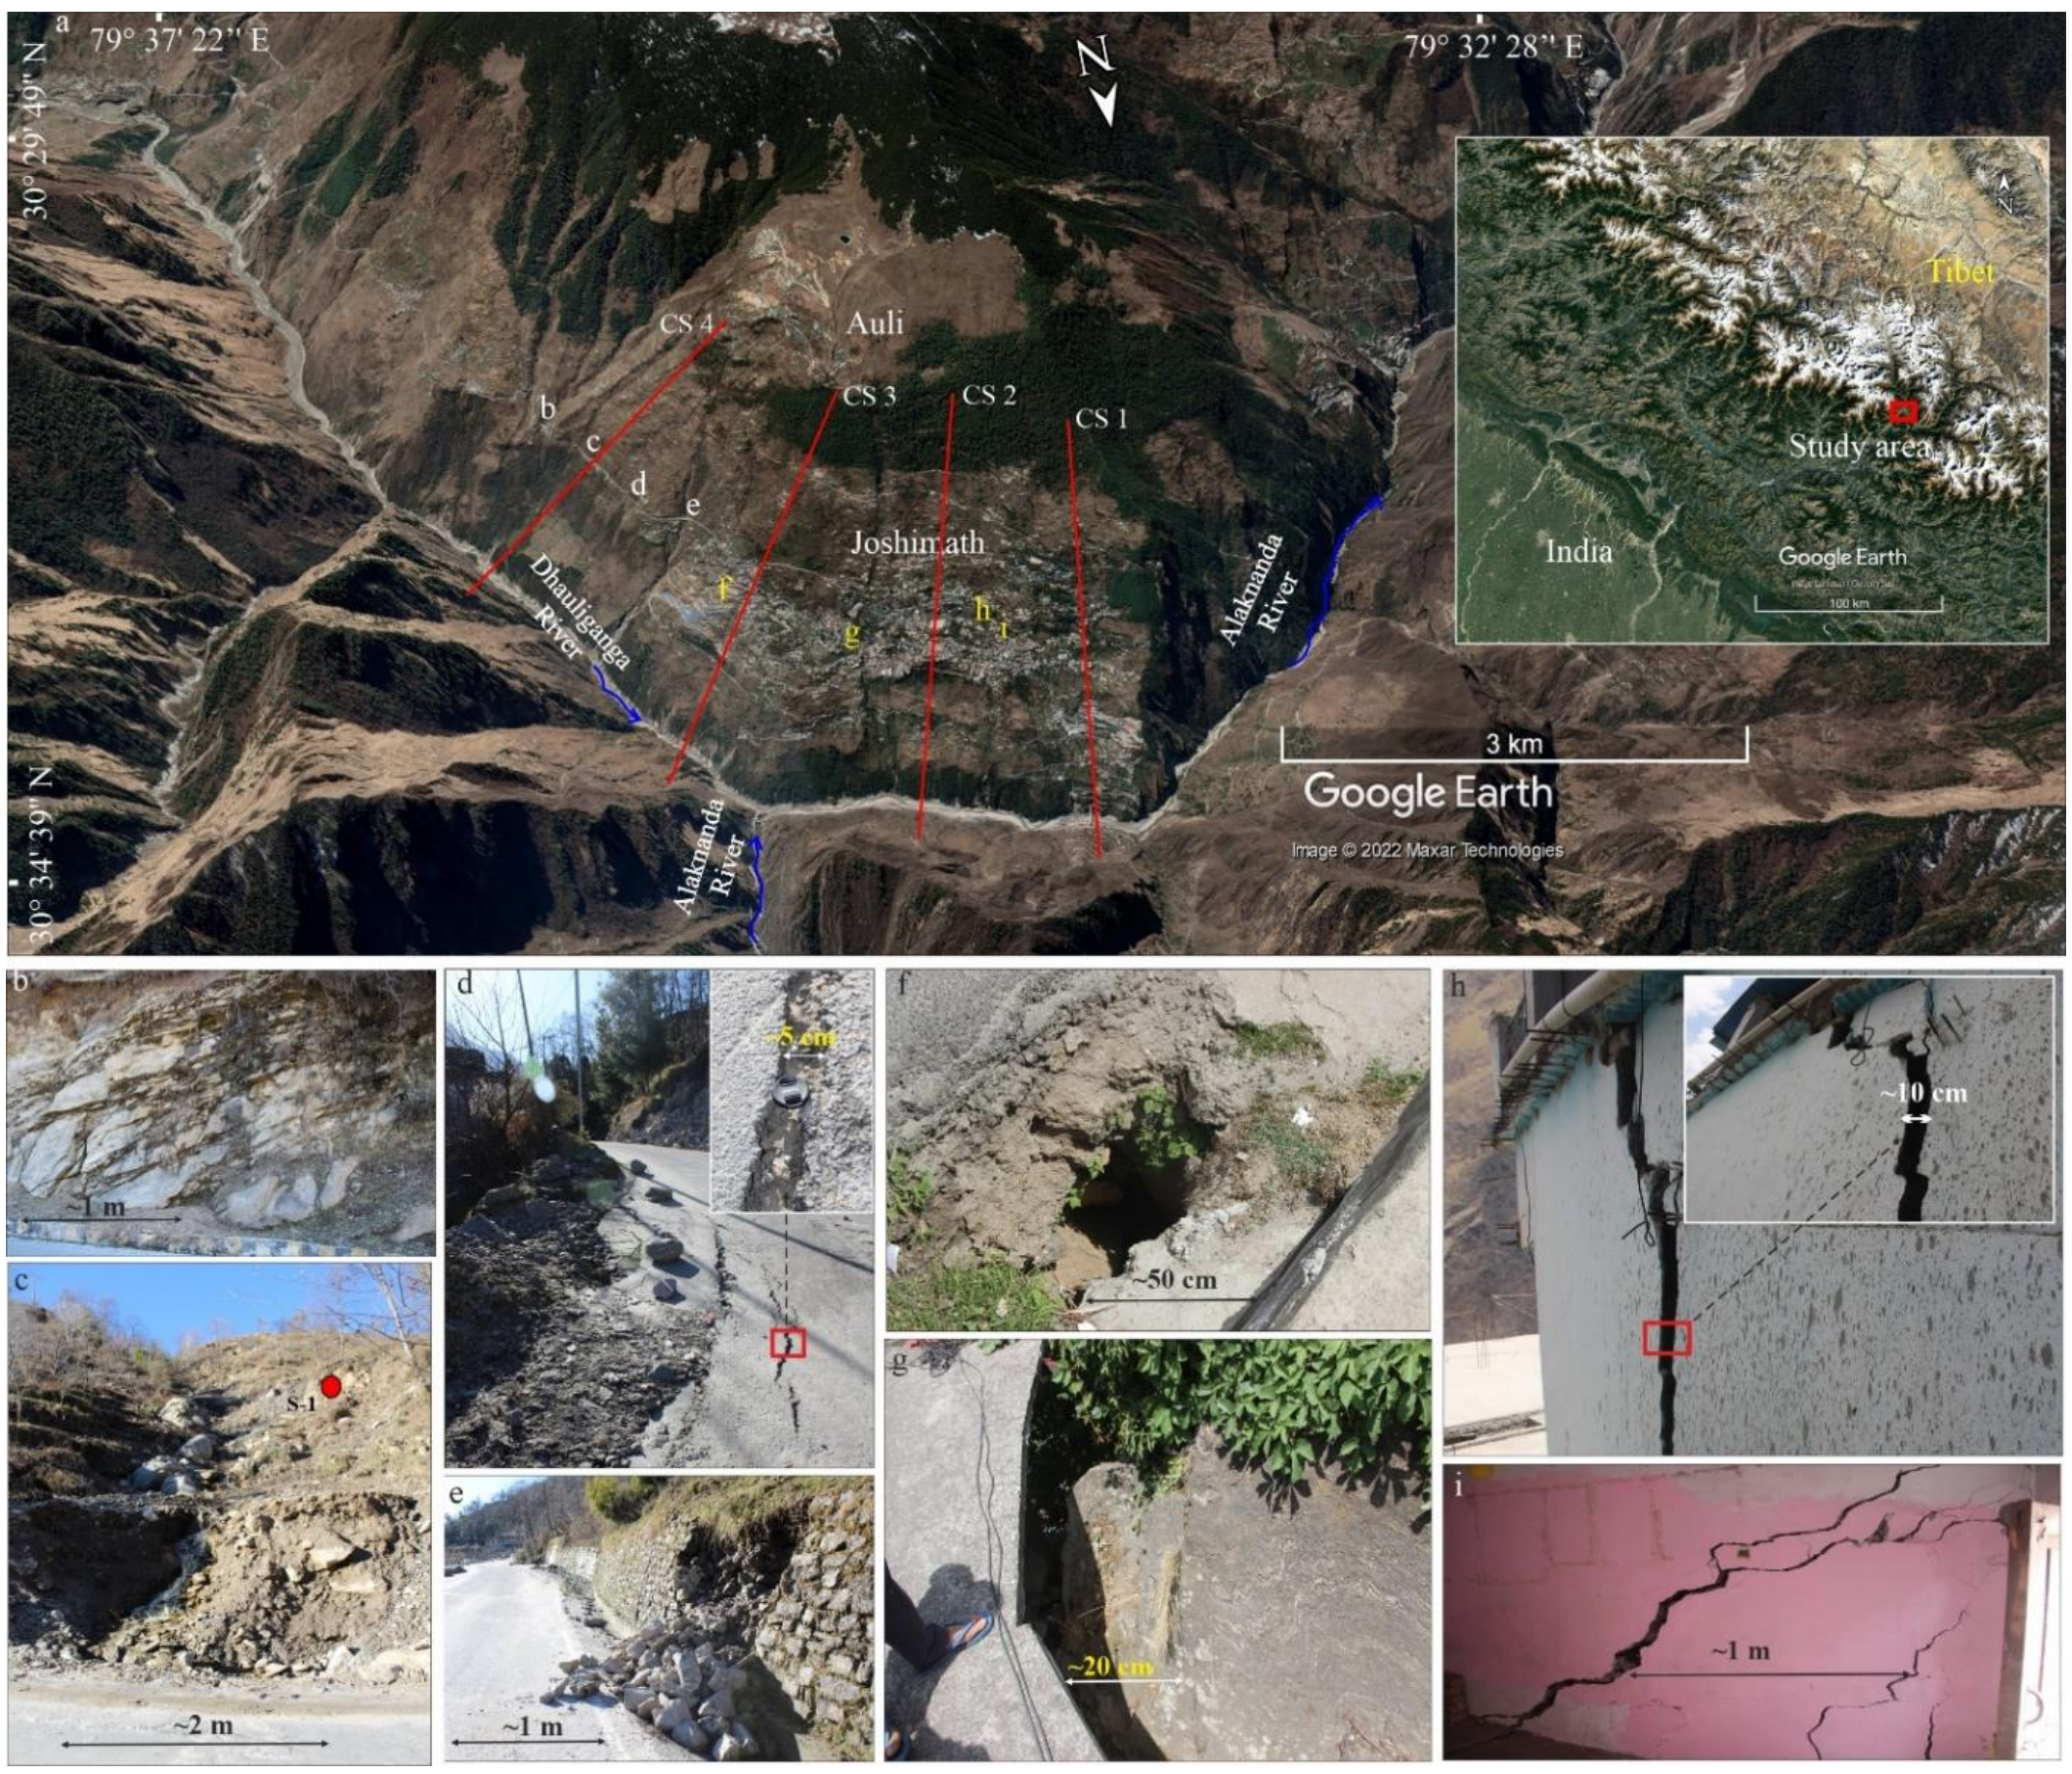
Fig. 1. Field observation of Joshimath town. (a) Location of Joshimath town with inset highlighting the position in the NW Himalaya. CS 1 to CS 4 mark the position of 2D slope sections used for the slope stability evaluation; (b) Rockmass exposure; (c) Natural drainage (Nala) through hillslope. Position of soil sampling site (S-1); (d) Cracks and displacement of road; (e) Bulging and failure of retaining wall; (f-g) Displacing hillslope material and hence pavements; (h-i) Cracks in houses. Picture (f-i) courtesy: Mr. Atul Sati.

This town has witnessed widespread cracks in more than 500 houses, even in temples in the last 1-2 weeks that is creating the social unrest. Various media reports involving interviews of experts aim at the potential role of infrastructural projects in promoting instability in this region (https://timesofindia.indiatimes.com/city/dehradun/uttarakhand-joshimath-land-subsidence-cracks-sinking-news-live-updates-8-january 2023/liveblog/96843072.cms). The town is situated along a narrow gorge at the confluence of two major rivers; Dhauliganga and Alaknanda. The gorge owes its existence to exhumation along Main Central Thrust (MCT) fault passing through the southern side of town (Supp. Fig. 1). This orographic barrier results in ~3672 mm/month rainfall in the town (Supp. Fig. 2). In a recent study by Agarwal et al. (2022), the town belongs to a hotspot, which is experiencing changing climate and rapid anthropogenic influence. Field observation of the town revealed that hillslope of town comprises highly jointed gneisses with schistose interlayers rockmass, subsidence in road, broken retaining wall, holes, displacing boulders, and cracks in the houses (Fig. 1). Loose hillslope material comprising sandy-gravel soil (Fig. 1c), exposed in the eastern part of town points towards the possibility of paleo-landslide on which most of the town is located. The last big earthquake (29 Mar. 1999: M_w 6.6) occurred within 26 km hypocentral distance from this town.

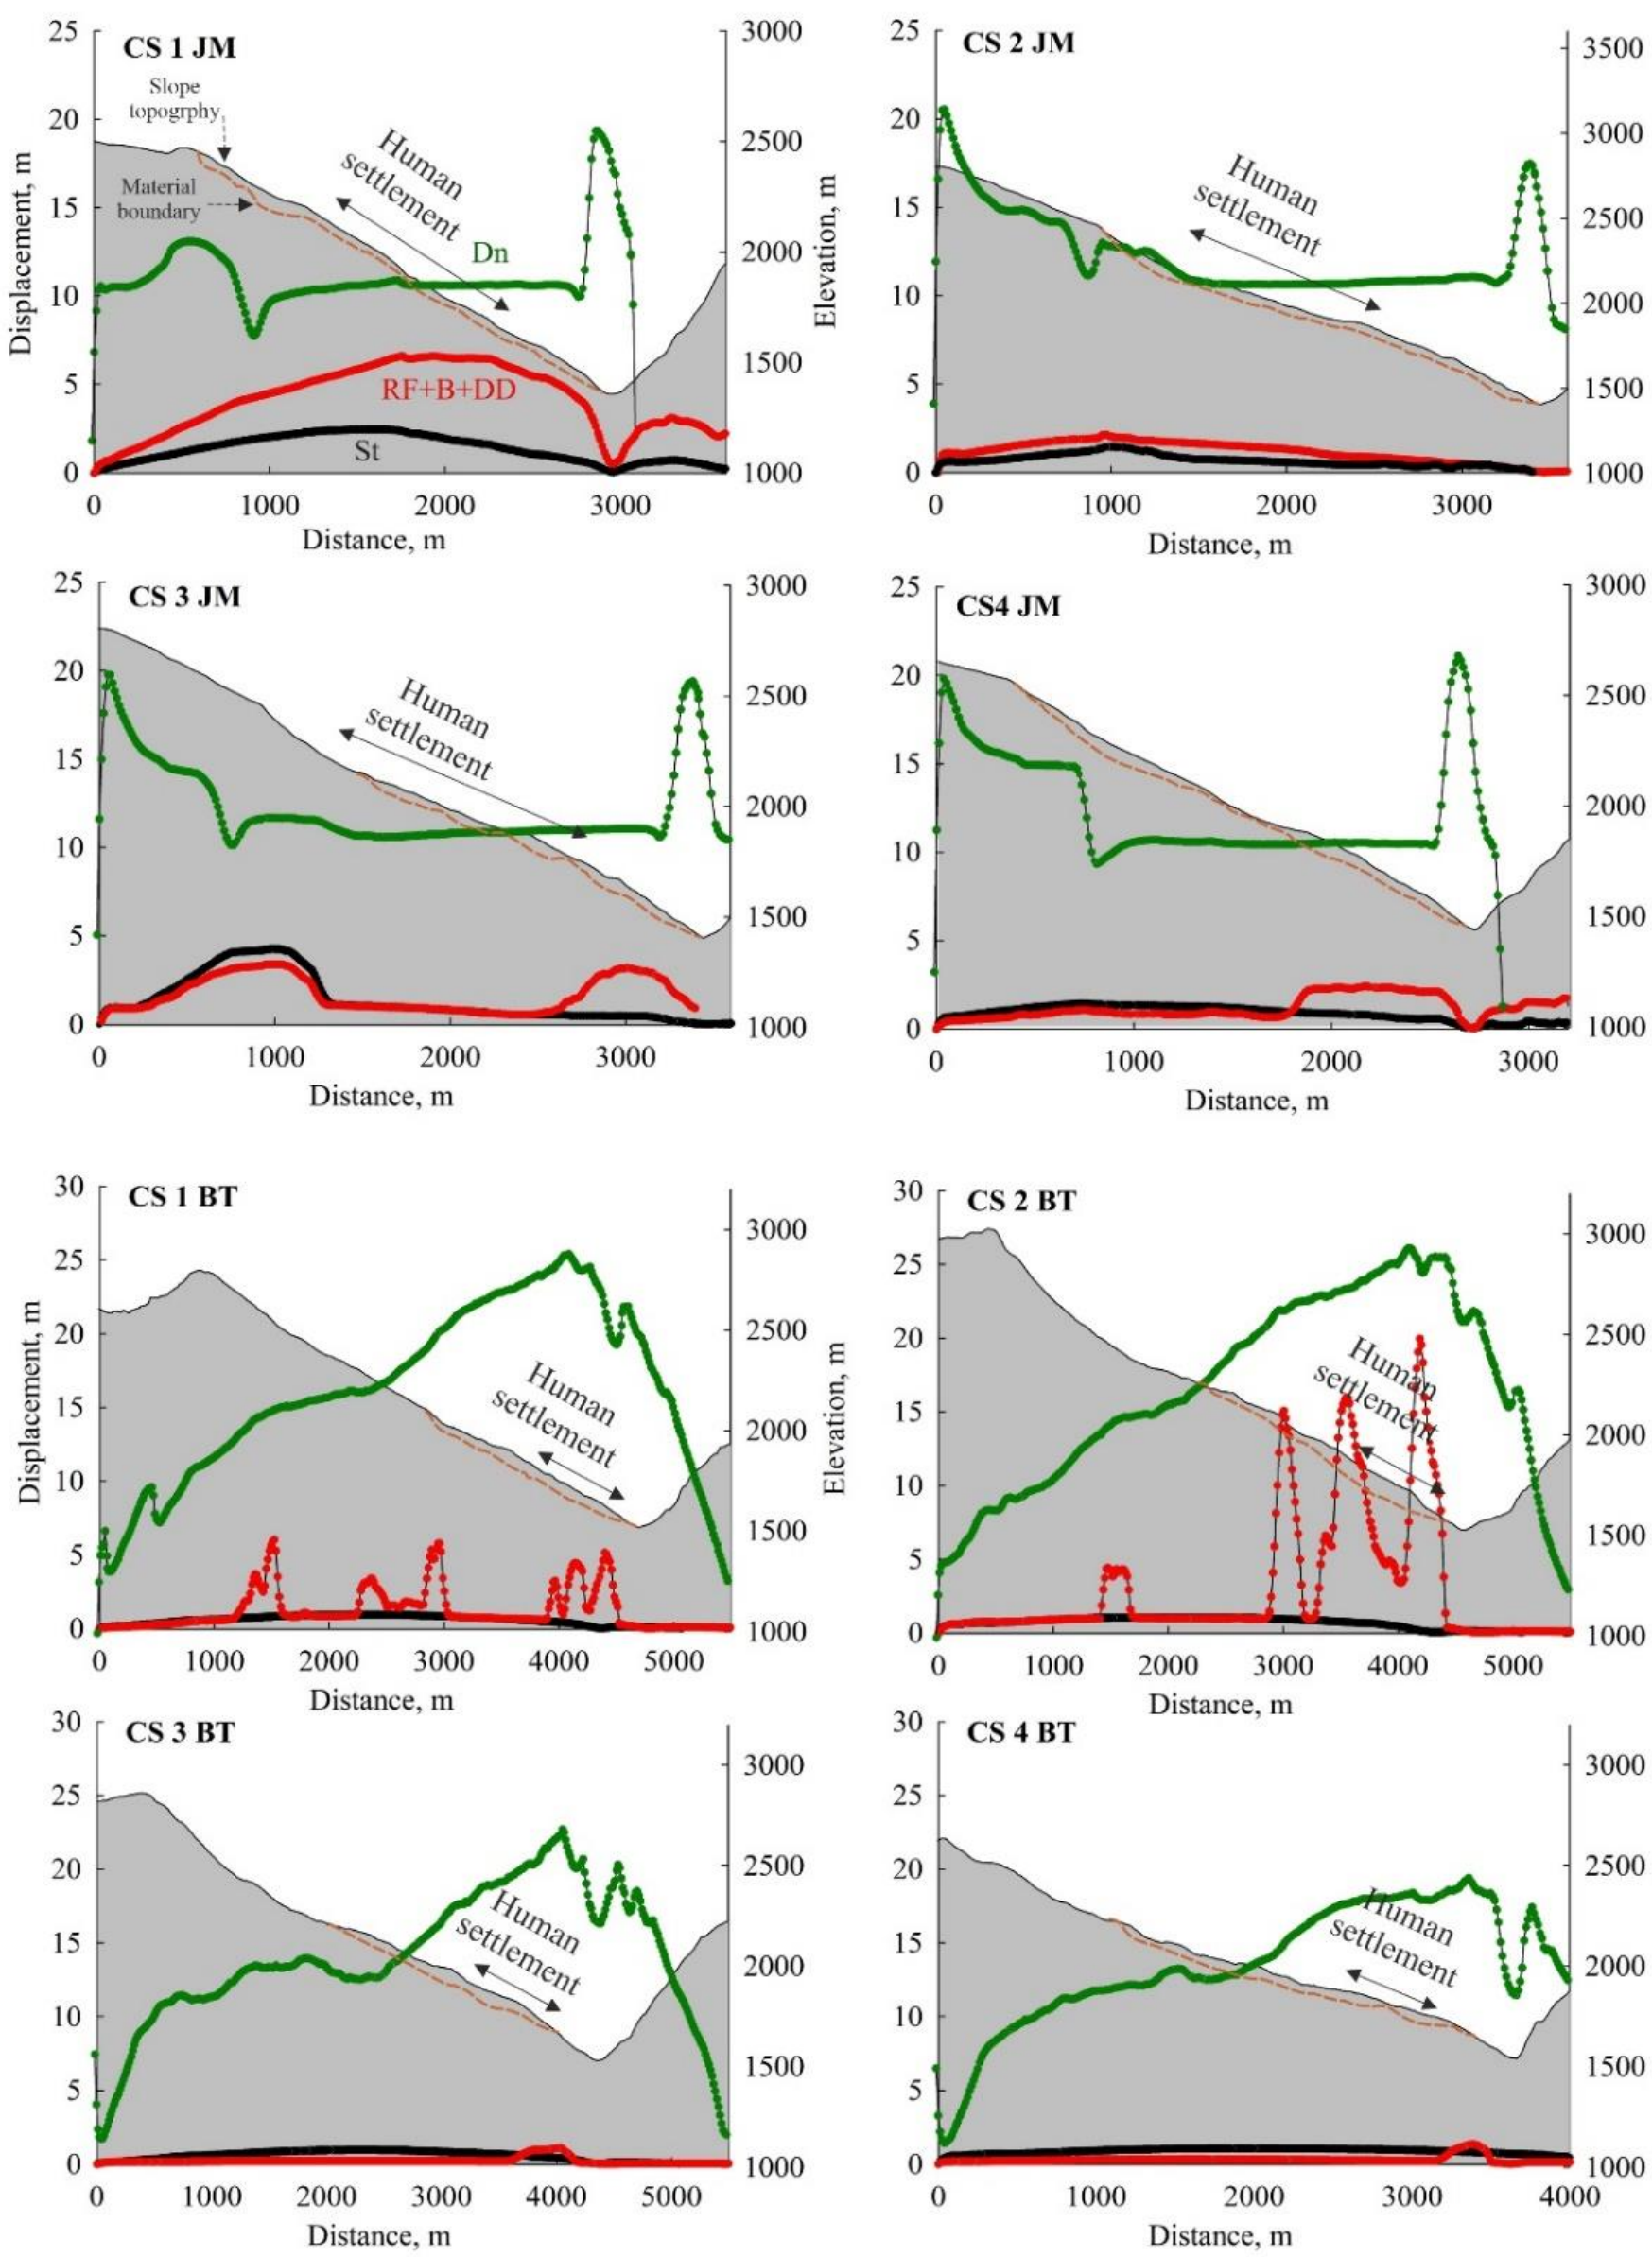
Stability evaluation results for both the locations are discussed using the total (horizontal & vertical component) displacement in the top 5-10 m material layer along the slope surface. Displacement profiles for Joshimath revealed that slope may yield 1-4 m displacement under gravity conditions that might increase up to 6 m under combined effect of rainfall (RF) infiltration, building/house load (B), and domestic discharge (DD) (CS 1 JM to CS 4 JM in Fig. 3). The CS 1 and CS 3 sections of Joshimath town yield relatively higher displacement under these loads, particularly near slope toe. Under seismic load conditions, displacement increase rapidly in the range of 8-22 m, particularly at the knickpoints of slope surface and near the slope toe. Relatively higher seismic displacement at the slope toe is attributed to stress accumulation at slope toe and narrow geomorphic setting resulting in constructive seismic interference, as also

Fig. 3. Results of the Slope stability evaluation. CS 1 JM to CS 4 JM refer to Joshimath Slope sections, whereas CS 1 BT to CS 4 BT refer to slope sections of Bhatwari town hillslope. Dn, RF, B, DD, and St refer to Dynamic, Rainfall infiltration, Building load, Domestic discharge, and Static load, respectively

Similar to Joshimath town hillslope, displacement profiles for the Bhatwari town hillslope show dominance of higher displacement (up to ~25 m) at the slope toe under seismic load conditions (Fig. 3). Notably, under combined effect of rainfall, domestic discharge, and building load, CS 1 and CS 2 sections of Bhatwari town slope comprises pockets of higher displacement (5-20 m), particularly near slope toe. This could be attributed to thicker debris deposit and cluster of human settlement at the location of these slope sections (CS 1 and CS 2).
