Back analysis of a building collapse under snow and rain loads in Mediterranean area

Isabelle Ousset[1], Guillaume Evin[1], Damien Raynaud[1], and Thierry Faug[1]

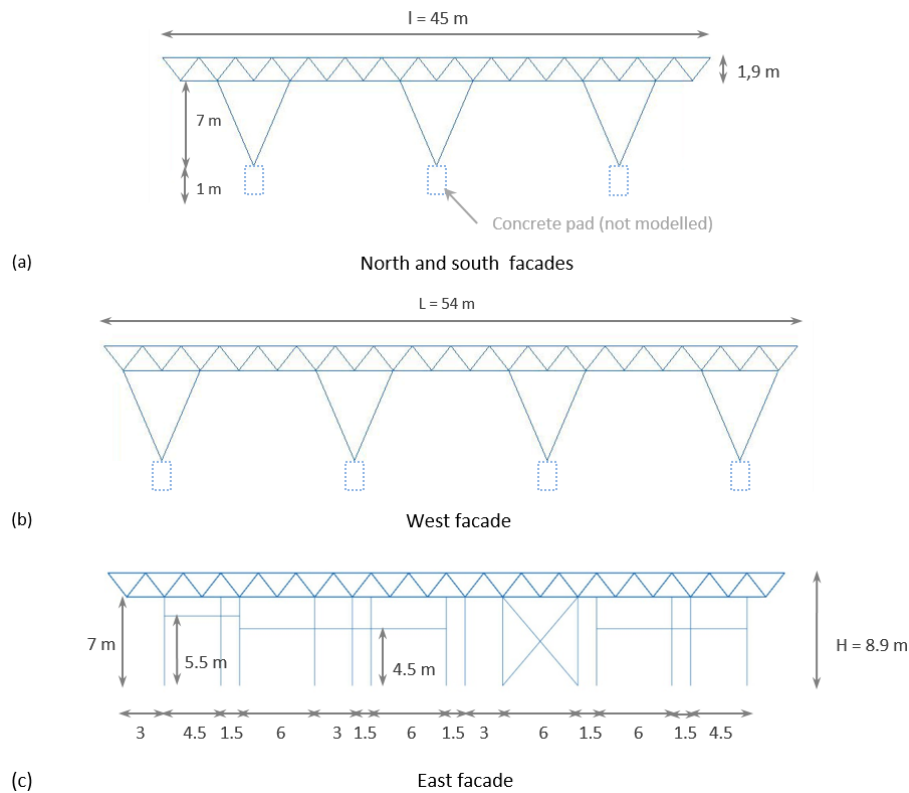
Figure 8. Sketches showing the geometrical details (size and shape) of the metallic structure of every facade of the Irstea Cévennes building.

170 The supporting structure of the building consisted of three-dimensional vertical metallic trusses designed to support the (nearly) flat roof (see an example shown in Figure 7a) and themselves supported by metal tubular pylons that were arranged along the facades of the building. The lattice structure, consisting of elements welded or bolted together, extends over the entire roof surface and withstands all the forces acting upon it. For the southern, western and northern facades of the building, these the tubular pylons consisted of two round tubular profiles arranged in V-shape and sealed on concrete blocks anchored in the

175 ground (see photograph on Figure 7b, and sketches on Figures 8a and 8b). For the eastern facade of the building, they consisted of rectangular tubular profiles and a Saint Andrew's cross obtained with T-profiles (see sketch on Figure 8c). It is worth noting here that no such tubular pylons had been settled inside the building in order to allow the movement of large-size vehicles, such as agricultural tractors.

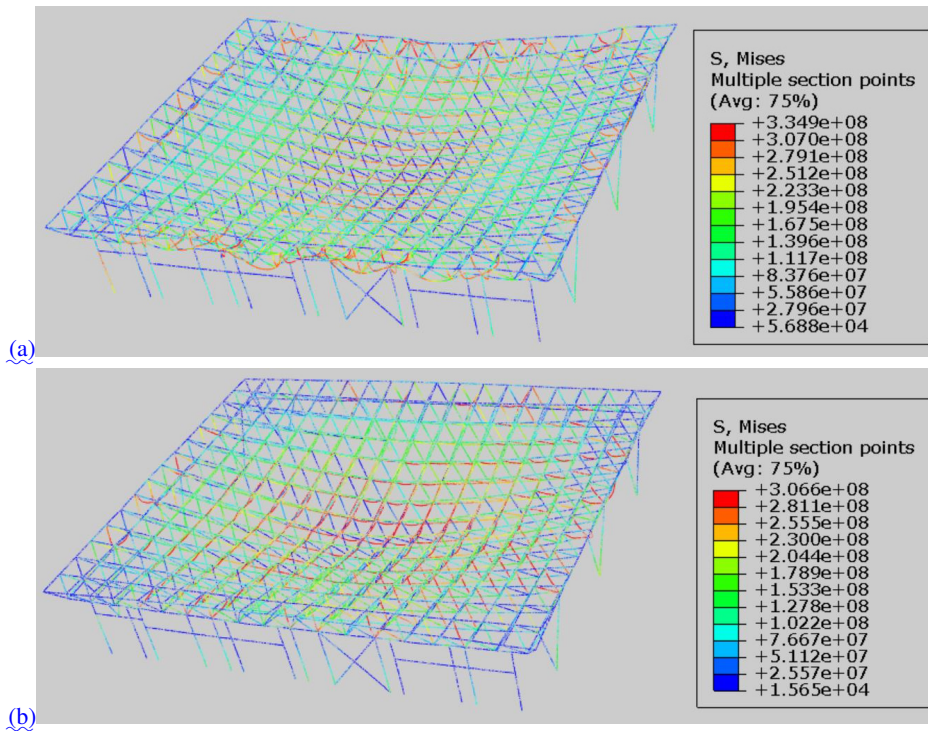
Figure 16 ~~shows~~ depicts the stress field of the structure at the ~~failure step . The maximum stresses occurred at the eastern facade~~ last convergence step obtained by the pushover simulations in the cases of a pressure field with an accumulation on the sides and a central accumulation. In both cases, the maximum stresses occur at the bottom horizontal T-profiles located in the central part of the roof and at the crossbars located on the perimeter of the ~~eastern facade. The stresses equal to the steel~~
315   ~~ultimate strength are observed at the locations of the supporting pylons of the eastern facades, whereas the stresses~~ roof. In the case of a pressure field with accumulation on the sides, more crossbars on the perimeter of the roof, particularly above the west facade, yield and buckle, while more horizontal bars in the center of the roof ~~are around 300 MPa. This result clearly means that the failure firstly occurred by buckling at the eastern facade and then also by~~ yield in the case of a pressure field with a central accumulation. These results clearly indicate that failure occurred due to both buckling of the crossbars ~~on the eastern~~

320   ~~edges~~ and bending of the bottom horizontal T-profiles. Other ~~damages~~ damage, such as those ~~actually~~ observed on the round tubular poles as shown in Figure A2c and A2d, likely occurred after, during the collapse of the structure. No such damage was

Figure 16. Von Mises stress field inside the structure at the last convergence step, given by the FE model simulation for a snow pressure field with (a) an accumulation on the sides and (b) a central accumulation.
