Back analysis of a building collapse under snow and rain loads in Mediterranean area

Isabelle Ousset[1], Guillaume Evin[1], Damien Raynaud[1], and Thierry Faug[1]

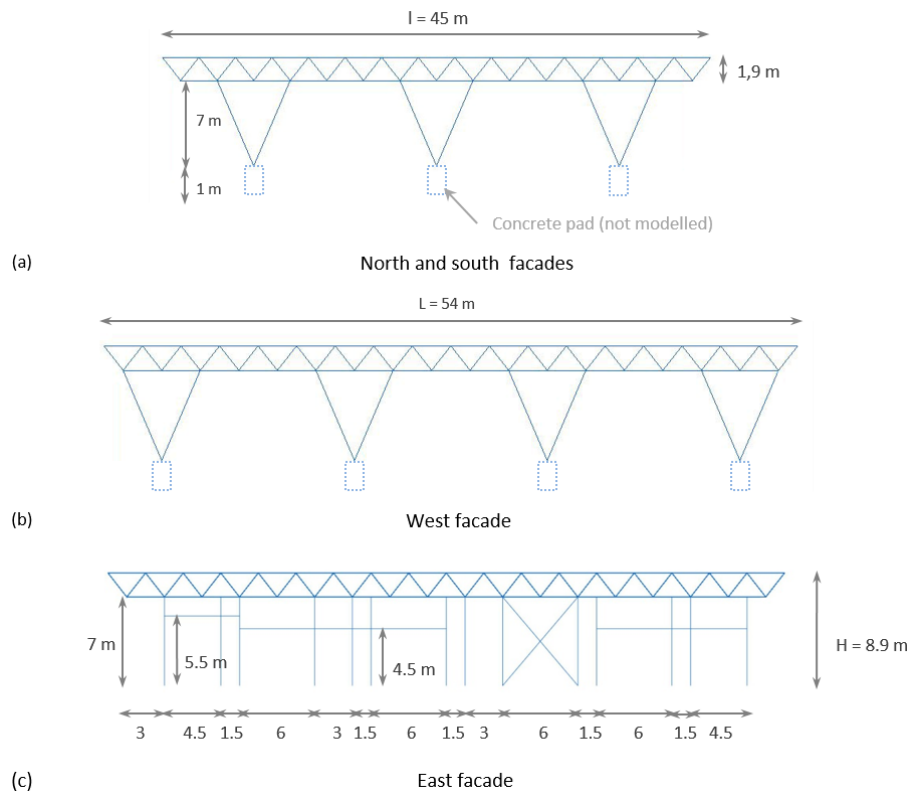
Figure 8. Sketches showing the geometrical details (size and shape) of the metallic structure of every facade of the Irstea Cévennes building.

175 ground (see photograph on Figure 7b, and sketches on Figures 8a and 8b). For the eastern facade of the building, they consisted of rectangular tubular profiles and a Saint Andrew's cross obtained with T-profiles (see sketch on Figure 8c). It is worth noting here that no such tubular pylons had been settled inside the building in order to allow the movement of large-size vehicles, such as agricultural tractors.

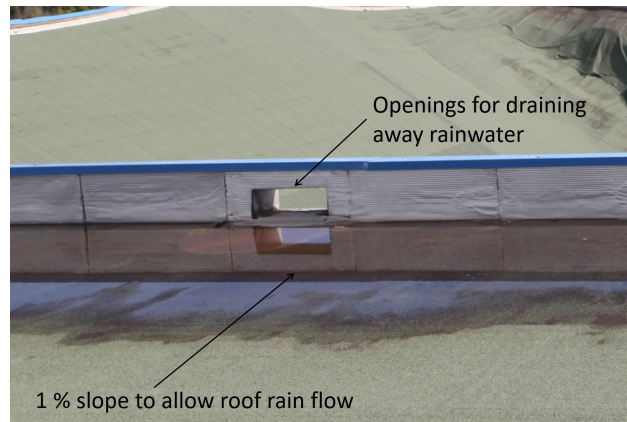
Figure 9. Close-up view of the roof rain drainage system of the Irstea Cévennes building.

Finally, the roof rain drainage system, consisting exclusively of vertical openings positioned in the lower part of the roof perimeter (see Figure 9), did not allow for the evacuation of rain once the roof was covered with snow. Indeed, significant water stagnation was observed on the roof of the similar nearby building a few days after the 2018 incident. Such a device thus led to a significant increase of the load supported by the lattice. This is ~~probably one of the~~ another strongest structural weakness of the building, as evidenced by the following two scenarios considering no water evacuation, as depicted on the plots of Figure 17 ~~. A hypothetic scenario for which rain would have brought more water (horizontal grey dashed line)~~ ~~suggests that a snow density on the roof (of about 690 kg. m^{-3}) a bit greater than typical densities of very wet snowpacks in natural environment (about 600 kg.m^{-3}) would lead to full collapse even under (optimistic) uniform pressure fields applied to the structure. Another (more realistic) scenario considering the maximum amount of water brought by the rain during the 2018 event suggests that the pressure (iso-pressure drawn in blue in Figure 17) would stay close to the red zone during a long time thus causing significant cumulative damage to the structure. It can be concluded that culverts might have been preferable to side openings. This may raise the question of proscribing roof terraces on large-scale buildings in areas where extreme~~ (horizontal blue lines). In the future, it would be interesting to conduct more thorough studies of rainwater drainage on near-flat roofs during rain-on-snow ~~events might occur in the future. In the next subsection, we discuss the snow loads in the Mediterranean area of Montpellier city in the context of climate change~~events. It is important to clarify the effectiveness of various drainage solutions under snowy roof conditions, and to provide corresponding recommendations regarding the required roof slopes and the selection and design of downstream evacuation devices.

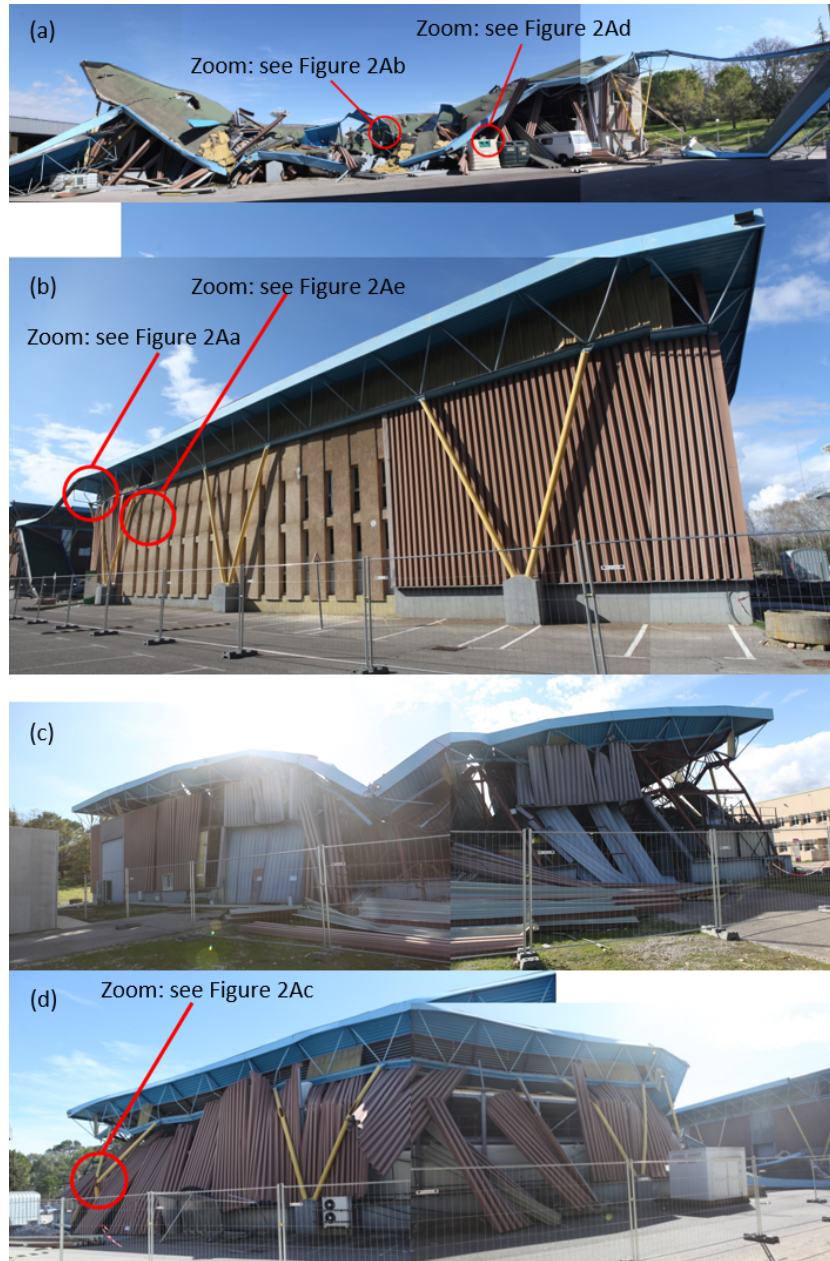
and eastern facades were ~~hardly~~ heavily damaged, as seen in Figs. 11a and 11c. On the contrary, the other two facades (see Figure 11b and 11d) were much less damaged due to the presence of the inner concrete walls of the offices and of the inner metal frames of the laboratory rooms along the south and north facades, respectively.

Figure 11. Different pictures showing the hierarchy of ~~the damages~~ damage as observed on 18 March 2018 on western (a), southern (b), eastern (c) and northern (d) facades of the Irstea Cévennes building.

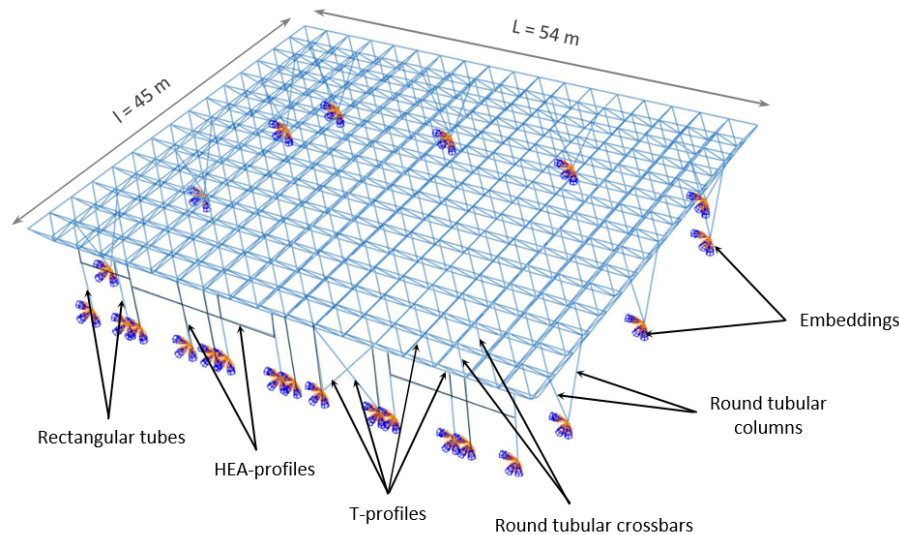
Figure 12. Overview of the metal structure of the Cévennes building modelled with the FE Abaqus software.

~~A quasi-static pushover analysis was performed in order to obtain an estimate of the load which led to the structure failure during the rain-on-snow event.~~ Figure 12 shows an overall sketch of the modelled structure with respect to the description of the building provided in the previous subsection. The details of the roof metal frame which was fully modelled by the FE Abaqus are shown in Figure A3. The dimensions of the structure and of all its components are given in Table A1.

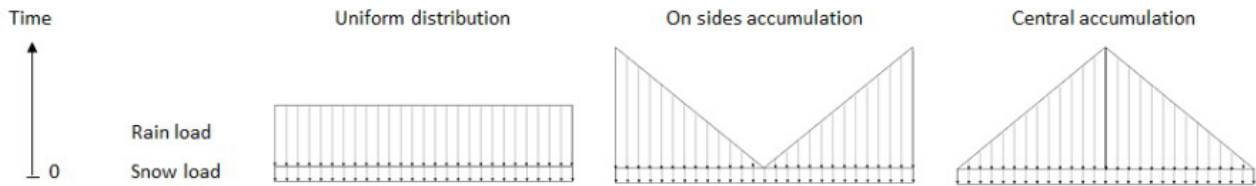
Figure 13. Three different assumptions made for the distribution of snow and rain loads on the roof.

225 the slope of the roof changed due to an increase in deflection (i.e. when the deflection of the roof became too important and counter-balanced the initial 22.5 cm roof height). All the rainwater is assumed to have remained on the roof until the building collapsed because the outlets were blocked by snow. After that, rainwater accumulated in the center of the roof. Therefore, three different cases of pressure distribution were studied, as shown in Figure 13: a uniform distribution, a case where water rapidly flowed on the edges of the roof, and a case where water mainly accumulated in the center of the roof. In the case of a uniform

230 distribution, the pressure mimicking snow load varies between 0 and a maximum pressure of 4905 N.m^{-2} (Table 2), which corresponds to a ~~(simple) uniform pressure field imparted to the structure. We will discuss more in detail these assumptions in Section 4~~two-meter high snowpack with a density of 250 kg.m^{-1} or a one-meter high wet snowpack with a mean density of 500 kg.m^{-1}. In the other two cases, snow-and-rain line loads applied to the structure after rainfall are identified in Table 3 based on the location of the T-Rebars mentioned in Figure 14.

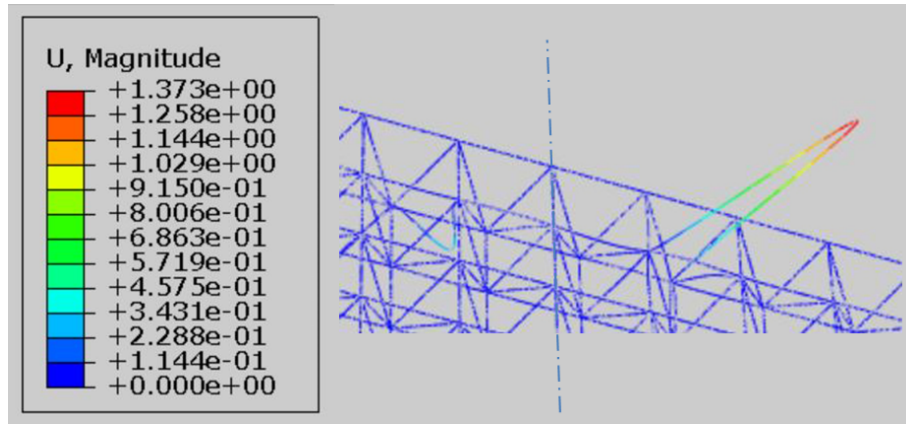
Figure 15. ~~Von Mises stress field inside~~ First buckling mode shape of the structure~~at the failure step~~, ~~given by~~ located over the ~~FE model simulation~~west facade.

The snow loads that cause buckling, as obtained from the FE simulations, are similar regardless of the distribution of the snowpack. This is because the load that causes buckling (645 kN.m^{-2}) is lower than the pressure exerted by a uniform snowpack of 30 cm thickness (which is 735 kN.m^{-2}). However, when considering other criteria, the case of a central accumulation of snow always proves to be the most critical.

Firstly, as indicated above, crossbars located at the perimeter of the lattice roof are clearly prone to buckling. Although this
405   buckling is localized, it gradually weakens the structure and could potentially lead to its collapse. Similar phenomena were also observed after the 2018 incident on the nearby building.

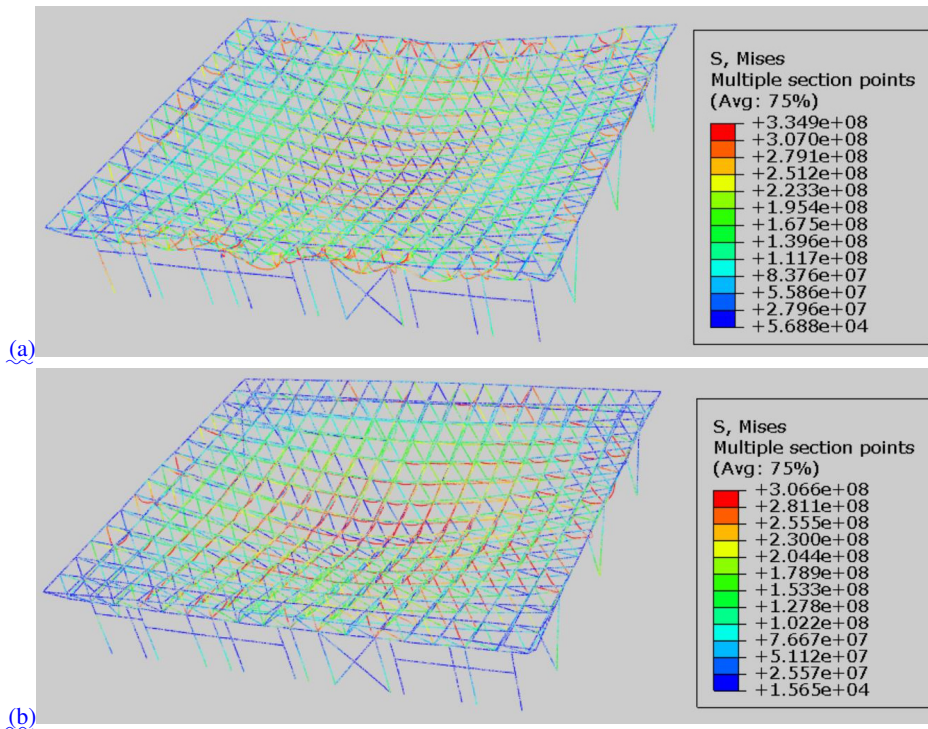
Figure 16 ~~shows~~ depicts the stress field of the structure at the ~~failure step . The maximum stresses occurred at the eastern facade~~ last convergence step obtained by the pushover simulations in the cases of a pressure field with an accumulation on the sides and a central accumulation. In both cases, the maximum stresses occur at the bottom horizontal T-profiles located in the central part of the roof and at the crossbars located on the perimeter of the ~~eastern facade. The stresses equal to the steel~~ 315 ~~ultimate strength are observed at the locations of the supporting pylons of the eastern facades, whereas the stresses~~ roof. In the case of a pressure field with accumulation on the sides, more crossbars on the perimeter of the roof, particularly above the west facade, yield and buckle, while more horizontal bars in the center of the roof ~~are around 300 MPa. This result clearly means that the failure firstly occurred by buckling at the eastern facade and then also by~~ yield in the case of a pressure field with a central accumulation. These results clearly indicate that failure occurred due to both buckling of the crossbars ~~on the eastern~~ 320 ~~edges~~ and bending of the bottom horizontal T-profiles. Other ~~damages~~damage, such as those ~~actually~~ observed on the round tubular poles as shown in Figure A2c and A2d, likely occurred after, during the collapse of the structure. No such damage was

Figure 16. Von Mises stress field inside the structure at the last convergence step, given by the FE model simulation for a snow pressure field with (a) an accumulation on the sides and (b) a central accumulation.

observed on the nearby building, whereas slight buckling phenomena were identified on its roof. This subsequent damage was further modified by the presence of the offices and mezzanine walls along the north and south facades as shown in Figure A2e.

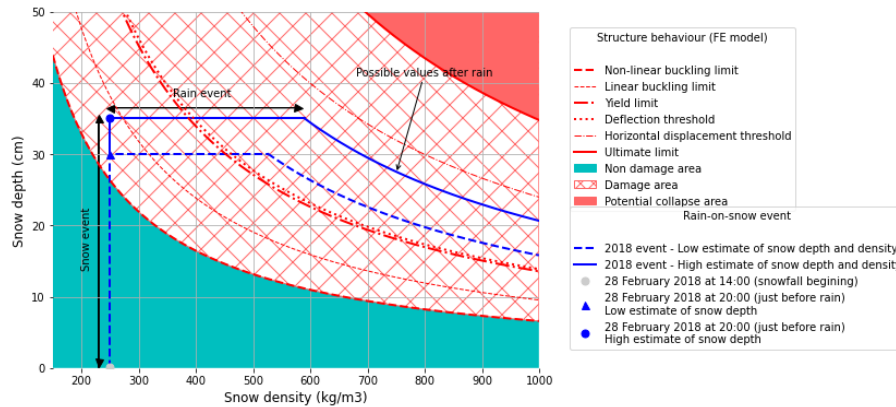
Figure 17 graphically summarizes the results of the quasi-static pushover ~~FE simulations graphically~~and buckling FE simulations in the case of a uniform pressure distribution. Based on the hydrostatic pressure assumption ($\rho g h$), the iso-pressure curves corresponding to the different failure criteria used (see Table 4) can be plotted in the $(\rho, h)-$plane and this defines the safe and unsafe zones for the structure in terms of snowpack height h and density ρ. Below the dashed red-colored line (~~yield~~buckling limit), the structure remains intact. Above ~~,~~the continuous red-colored line (~~collapse limit or~~ultimate criterion), the structure

collapses. In between (hatched zone in Figure 17), the structure undergoes irreversible ~~damages that are~~ damage that is more
and more significant when approaching the continuous red-colored line. The dashed-dotted, dotted, and fine dashed-dotted
red-colored ~~line defines the~~ lines define the yield limit, curvature limit based on the deflection of the structure~~.~~, and horizontal
displacement limit, respectively. Additionally, the buckling load obtained via the linear buckling analysis is represented by the
fine dashed red-colored line.

There are several sources of explanation for the fact that our analysis displayed on Figure 17 does predict irreversible ~~damages~~ damage but not a full collapse of the building. One reason is associated with the initial state of the structure which we assume as perfect with no previous ~~damages~~ damage experienced by the structure. An unknown initial damage which would have been taken into account in the FE simulatons could have easily brought the horizontal blue lines in the red zone. Another reason is ~~associated with the assumption made that the pressure field imparted to the structure remains uniform during the pushover FE simulations . The real interaction of the quickly evolving snowpack during rain and the deforming structure is not modelled in detail. In want of any available numerical tool to model this strong coupling between the snow cover dynamics and the behaviour~~ that pushover simulations do not account for the buckling of the structure, ~~a solution would be to impart non-uniform pressure fields to the structure during the pushover simulations. Such scenarios are uncertain and would have required ad-hoc assumptions but some of them would certainly move the iso-pressure curves (yield limit and collapse limit) below the curves currently shown in Figure 17, thus leading to full collapse of the building~~while post-buckling analysis fails to predict the collapse of the structure.

Figure 17. Comparison ~~for different combinations~~ of ~~snow depth and density between~~ the snow ~~load~~ loads leading to ~~the~~ different failure criteria of the Cévennes building, as calculated by ~~the~~ FE model simulations, with different combinations of snow depth and ~~the~~ density, assuming a uniform pressure field. The estimated scenario for the rain-on-snow event of 2018, as ~~back analysed~~ back-analyzed in Section ~~2~~2, is also included in the comparison.

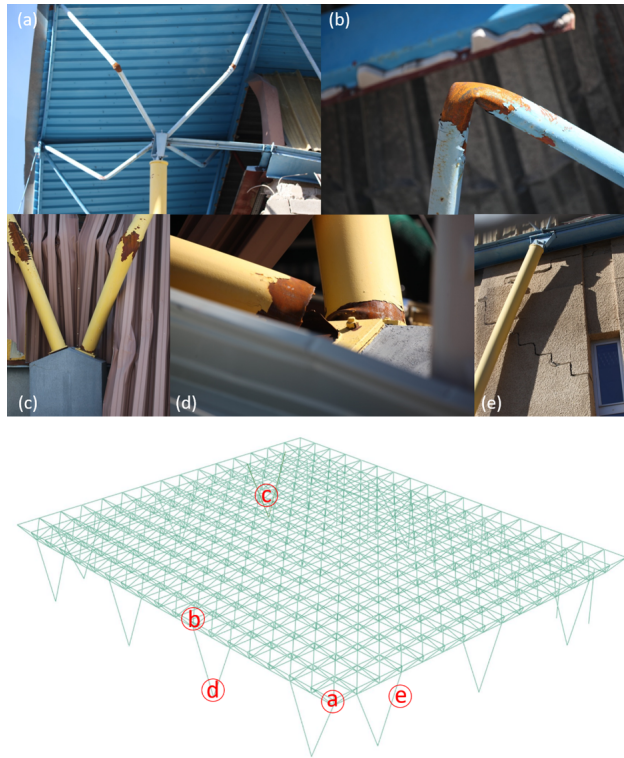
Local ~~damages~~ damage observed on structural elements consist in (i) buckling and bending for the roof tubular profiles, (ii) bending and shear for the tubular supporting pylons and (iii) cracking for the offices' walls. Close-up views of those ~~damages~~ damage are shown in Figure A2.

Figure A2. Close-up views of ~~the damages~~ damage to the structure of the Irstea Cévennes hall, as observed on March 18, 2018: buckling and bending failure of roof tubular profiles (a,b), bending and shear failures of tubular supporting pylons (c,d) and cracking of the inner offices' walls made of concrete and located along the southern face of the building.

Figure A2 gives close-up views of the different types of ~~damages~~ damage to the structure of the Irstea Cévennes building, as observed on March 18, 2018, a couple of weeks after the roof collapse.

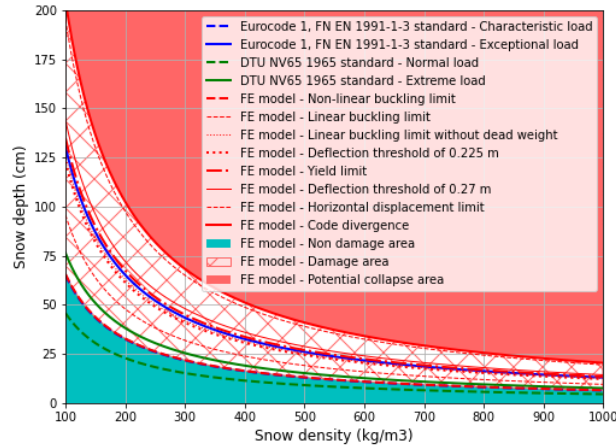
~~In~~ So, in Figure B1, roof snow loads leading to the ~~collapse~~ failure criteria of the Cévennes supporting structure according to the FE model simulations in the most critical case of pressure field with a central accumulation (in the range ~~$1000 - 2375$~~ $645 - 1915$ N.m^{-2} for criteria other than the ultimate limit) are compared to values (without safety factors) recommended by 550 the French DTU NV65 standard, valid at the moment of the building construction in 1982 (450 and 750 N.m^{-2} for ~~permanent and accidental~~ normal and extreme design loads) and the NF EN 1991-1-3 standard, adopted in application of Eurocode 1 (~~640 and 1280~~ $0.8 * 550 + 200 = 640$ and $0.8 * 1350 + 200 = 1280$ N.m^{-2} for ~~permanent and accidental~~ characteristic and exceptional design loads, respectively).

Figure B1. Comparison for different combinations of snow depth and density between the snow ~~load~~ loads leading to the different failure criteria of the Cévennes building, as calculated by the FE model, and the snow load values recommended by Eurocode 1 and the DTU NV65 without taking into account safety factors (both in terms of loads and the steel behaviour law) in the case of a snow pressure field with a central accumulation.
