Back analysis of a building collapse under snow-and-rain loads in Mediterranean area

Abstract. At the end of February 2018 the Mediterranean area of Montpellier in France was struck by a significant snowfall that turned into an intense rain event caused by an exceptional atmospheric situation. This rain-on-snow event produced pronounced damage to many buildings of different types. In this study, we report a detailed back analysis of the roof collapse of a large building, namely the Irstea Cévennes building. Attention is paid to the dynamics of the climatic event, on the one hand, and to the mechanical response of the metal roof structure to different snow-and-rain loads, on the other hand. The former aspect relies on multiple sources of information that provide reliable estimates of snow heights in the area before the rain came into play and substantially modified the load on the roof. The latter aspect relies on detailed finite element simulations of the mechanical behavior of the roof structure in order to assess the pressure due to snow-and-rain loading which could theoretically lead to failure. By combining the two approaches, it is possible to reconstruct the most probable sc

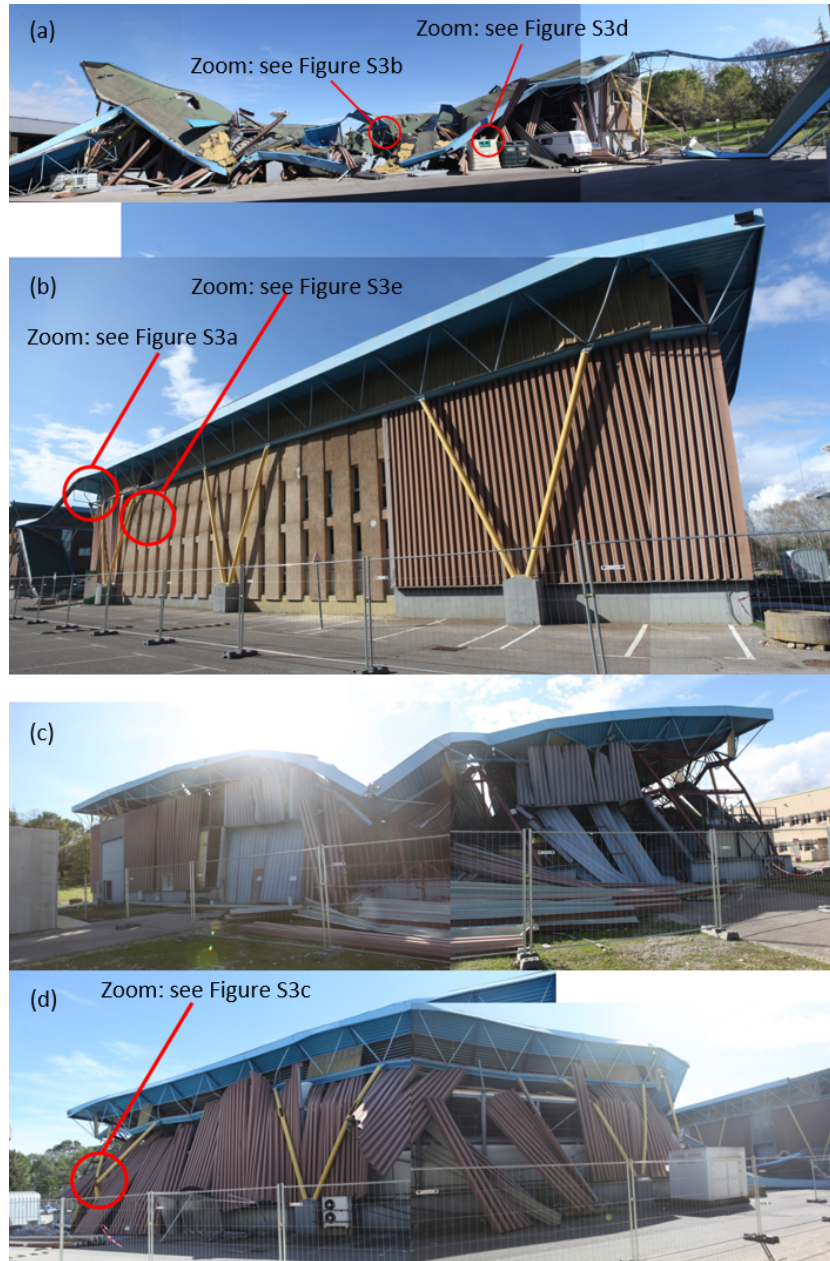
Figure 2 shows the main damage observed during a field visit on 18 March 2018, shortly after the collapse of the experimental hall of the Irstea Cévennes building in the central part of the structure, in the east-west direction. The western and eastern facades were heavily damaged, as seen in Fig. 2a and 2c. On the contrary, the other two facades (see Figure 2b and 2d) were much less damaged due to the presence of the inner concrete walls of the offices and of the inner metal frames of the laboratory rooms along the southern and northern facades, respectively. Local damage observed on structural elements consists of (i)

buckling and bending for the roof tubular profiles, (ii) bending and shear for the tubular supporting pylons and (iii) cracking on the walls of the offices (see close-up views of the damage shown in Figure S3 in the Supplementary Material (SM)).

Figure 2. Different pictures showing the hierarchy of damage as observed on 18 March 2018 on the western (a), southern (b), eastern (c), and northern (d) facades of the Irstea Cévennes building.

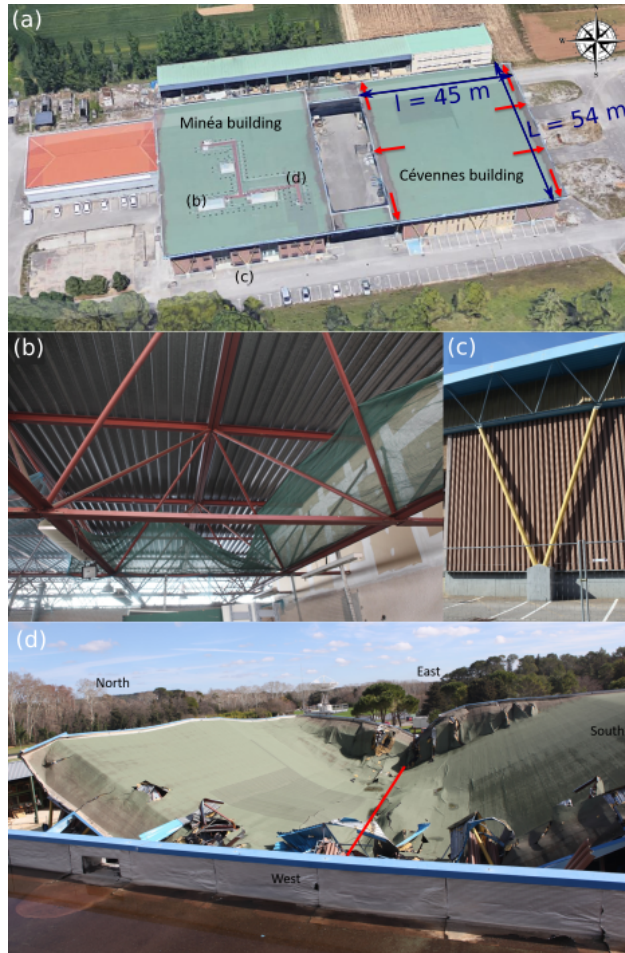
Figure 6. (a) Overview of the Irstea Cévennes building before the damage, with rainwater drainage points indicated by red arrows. The dimensions of the roof are given in blue, and the height of the building is 10 m. The letters indicate where the photos of the other subplots were taken (photo credit: ©Google Earth 2014, adapted by I. Ousset). (b-c) View of the supporting structure of the Irstea Cévennes building before its damage: (b) red-coloured metal roof frame and (c) supporting tubular pylons (in yellow) along the facades. (d) Overview of the damaged Irstea Cévennes building. The red line indicates the direction perpendicular to the direction of the main deflection of the roof after the collapse.

damage. The dimensions of the roof were $l = 45$ m in the east-west direction and $L = 54$ m in the north-south direction and 10 m high.

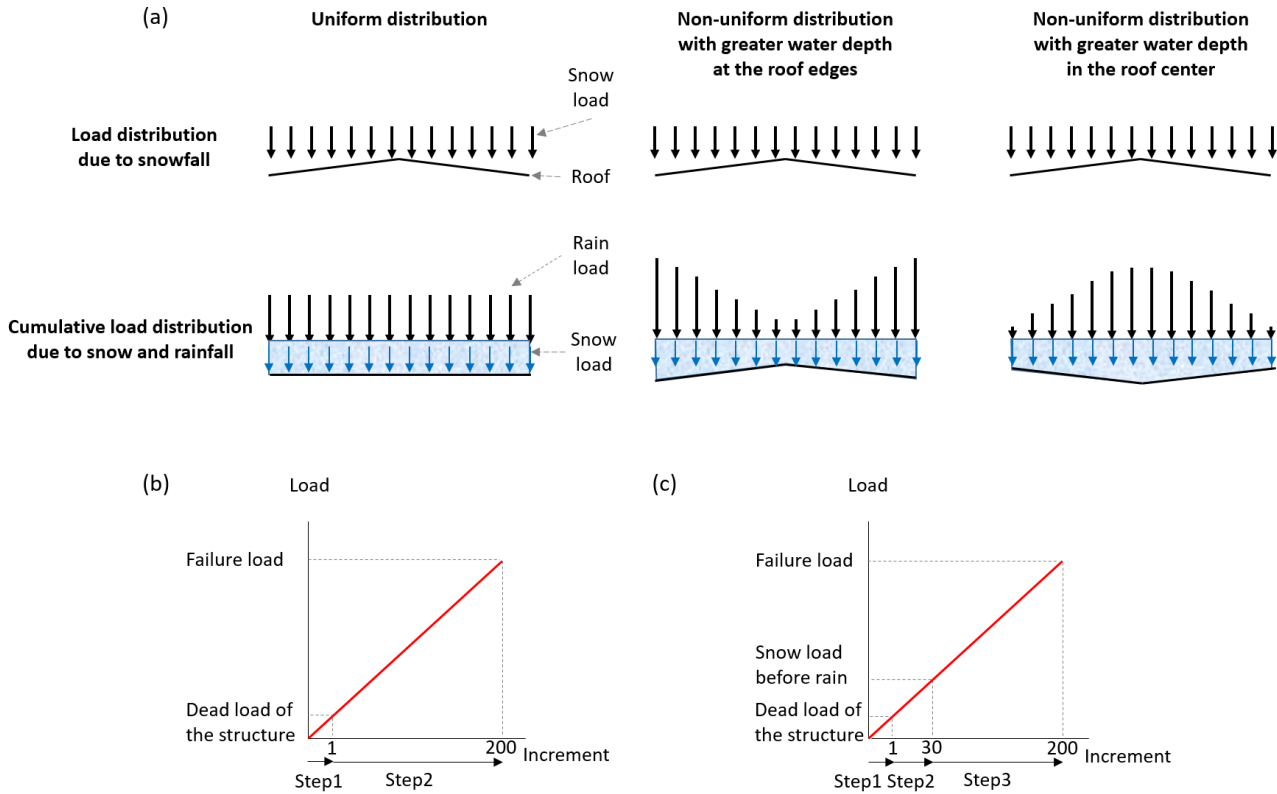
Pushover analyses are quasi-static analyses (without dynamic effects) that determine how far the building can go before it collapses completely or partially. Figure 7 illustrates the main steps of this analysis. The first step (Step 1 in Figs. 7b-c) takes into account the self-weight of the structure. Then the snow-and-rain pressure on the structure is gradually and linearly incremented to mimic the load increase during the rain-on-snow event until the structure fails by reaching either the elastic limit of the material or the ultimate limit of the material for a snow-and-rain pressure equal to the failure force. This linear increase is performed in one step for uniform loads (step 2 in Fig. 7b) and two steps for non-uniform loads (steps 2 and 3

in Fig. 7c). In the latter case, step 2 corresponds to the increase of the uniform load of snow before the rain whereas step 3 corresponds to the increase of the non-uniform load of water on the snowpack.

Figure 7. (a) Different assumptions made for the spatial distribution of snow-and-rain loads and (b), (c) load evolution by incrementation for pushover analyses in the cases of a uniform distribution (b) and a non-uniform distribution (c) of rain loads. Note that the increment numbers of steps 2 and 3 are given here as examples only.

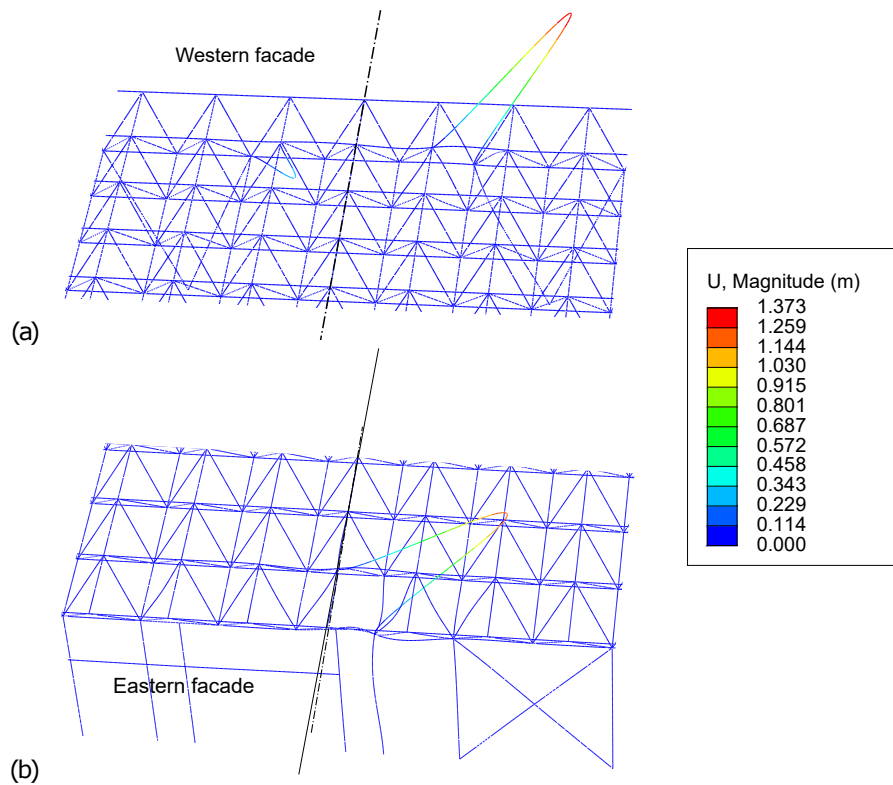
These results clearly indicate that the failure was due to both buckling of the crossbars (primary cause) and bending of the bottom horizontal T-profiles (aggravating effect). Other damage, such as that observed on the round tubular columns shown in Figure S3c-d in the SM, probably occurred during the collapse of the structure. No such damage was observed on the nearby building, whereas slight buckling was observed on its roof. This subsequent damage was further modified by the presence of the offices and mezzanine walls along the northern and southern facades (see Fig. S3e in the SM).

Figure 8. Buckling mode shapes of the structure under a uniform snow-and-rain pressure field (deformation scale factor = 5.4): (a) first mode, above the western facade and (b) fifth mode, above the eastern facade.

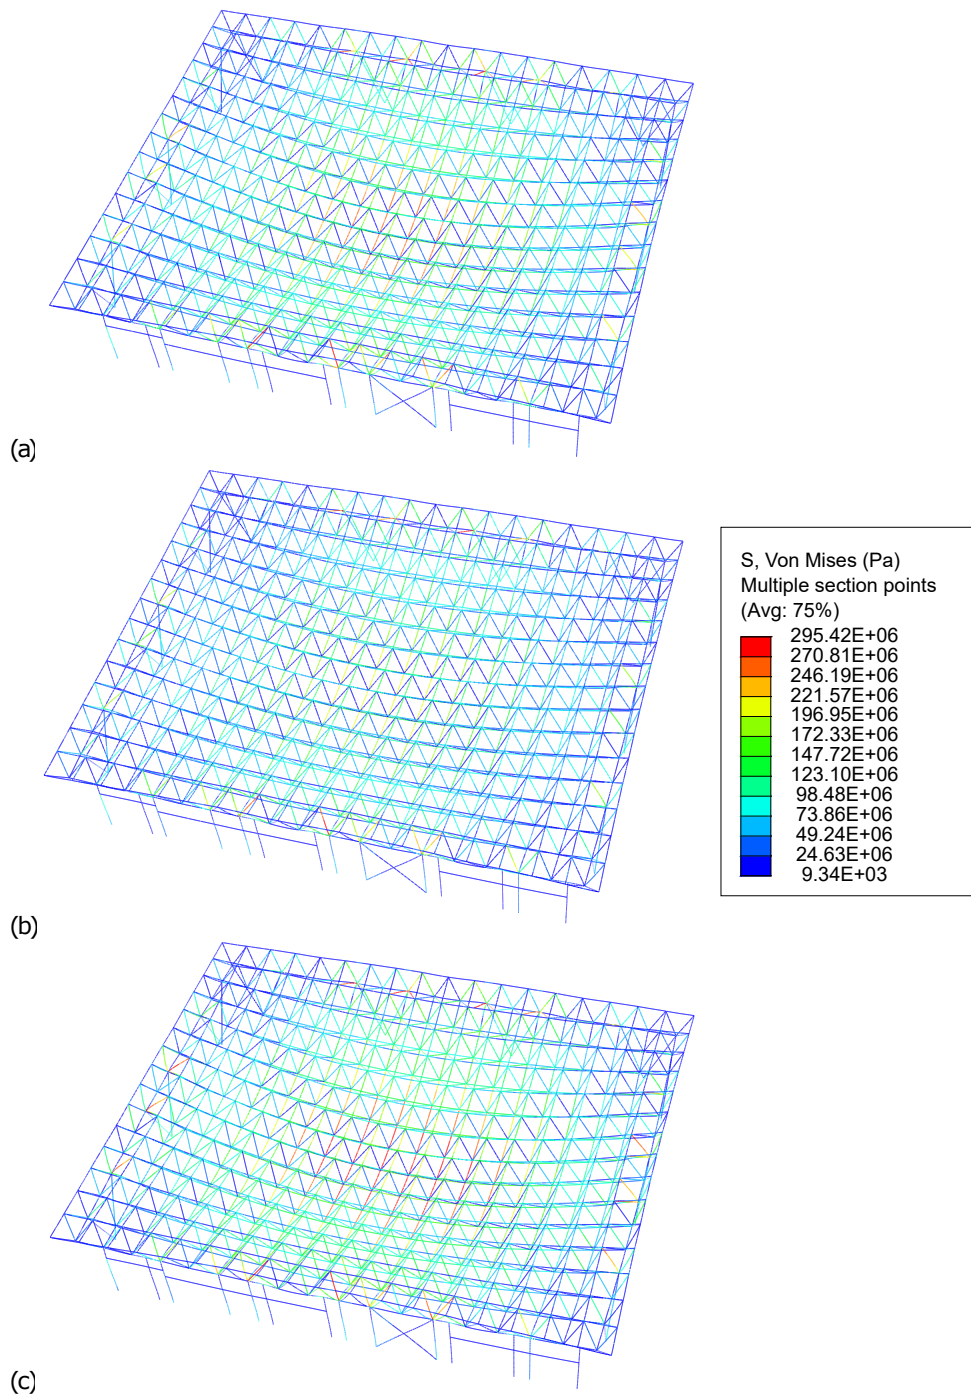
Figure 9. Von Mises stress field (Pa) inside the structure at the real snow-and-rain load of $1\,325$ N.m^{-2}, given by the FE model simulation for the different assumptions made for the spatial distribution of snow and rain: (a) uniform, (b) non-uniform with greater water depth at the edges and (c) non-uniform with greater water depth in the center (a deformation scale factor of 25 is applied to highlight the contrasts).

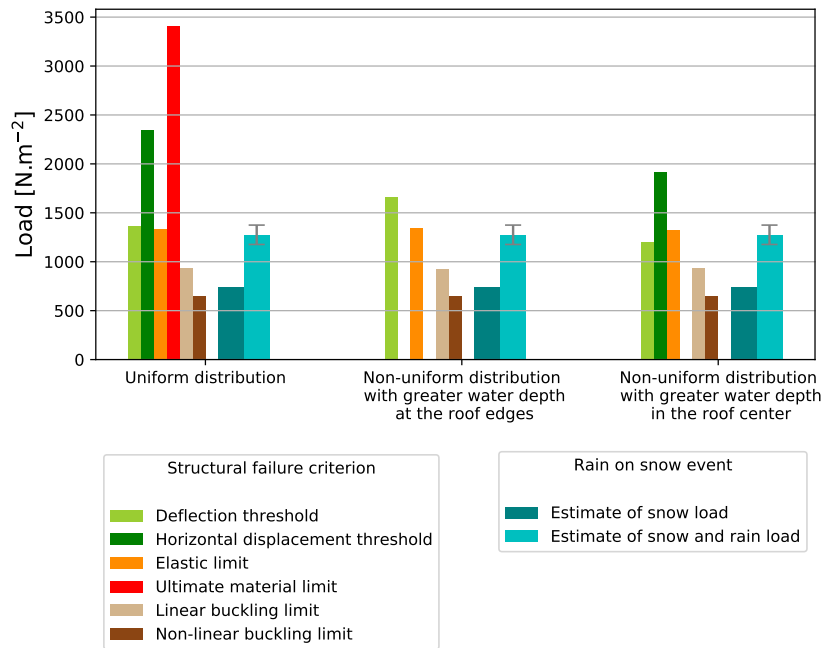
Figure 10 compares the critical loads that would cause a failure according to the FE simulations (Table 1) with the initial snow load of 736 N.m^{-2} before the rain and the final snow-and-rain load values of $1\,226$ to $1\,325$ N.m^{-2} estimated from different source of observations in Section 2.

The minimum of 645 N.m^{-2} (in brown) corresponds to the non-linear buckling load. This value is just below the uniform initial snow load before the rain (736 N.m^{-2}) (in teal) and does not depend on the assumption made for the distribution of the rain load. In contrast, the linear buckling analysis gives higher values for the load corresponding to the first eigenvalue mode (from 935 to 945 N.m^{-2}). All of these critical buckling loads (in beige) are well below the snow-and-rain load estimates. This means that this failure can have occurred with the observed snow-and-rain load. In addition, although it should be noted that the buckling failures remained localized (on a few crossbars located at the eastern and western edges, as shown in Section 3 and Figure 8), they occur on both sides of the east-west axis along which the structure collapsed, as shown in Figure 6d. Thus, it is very likely that buckling was involved at some stage in the roof collapse.

For a uniform load distribution, the other failure criteria (the elastic limit and the beam deflection) give intermediate values in the range $1\,330 - 1\,360$ N.m^{-2}, just above the snow-and-rain load estimates. For the scenario with greater water depth at the edges, the critical load values increase, particularly for the beam deflection criterion, which puts the structure on the safe side. For the scenario with water flowing towards the center of the roof, both critical load values (elastic limit, beam deflection) decrease close to or below the snow-and-rain load estimates.

Figure 10. Comparison of the snow loads leading to different failure criteria of the Cévennes building, as calculated by FE model simulations, with the estimated scenario for the rain-on-snow event of 2018, as back-analyzed in Section 2, in the different cases of snow-and-rain pressure field. The structure fails when the observed snow-and-rain load (on the right, for each assumption of snow-and-rain distribution) is greater than a calculated failure load (on the left). The latter calculated failure load could not be obtained when code divergence was observed, thus explaining some empty bars in the case of non-uniform rain distributions (see Table 1).
