Optimization strategy for flexible barrier structures: Investigation and back analysis of a rockfall disaster case in southwestern China

Li-Ru Luo[1], Zhi-Xiang Yu[1,2], Li-Jun Zhang[1], Qi Wang[3], Lin-Xu Liao[1], Li Peng[4]

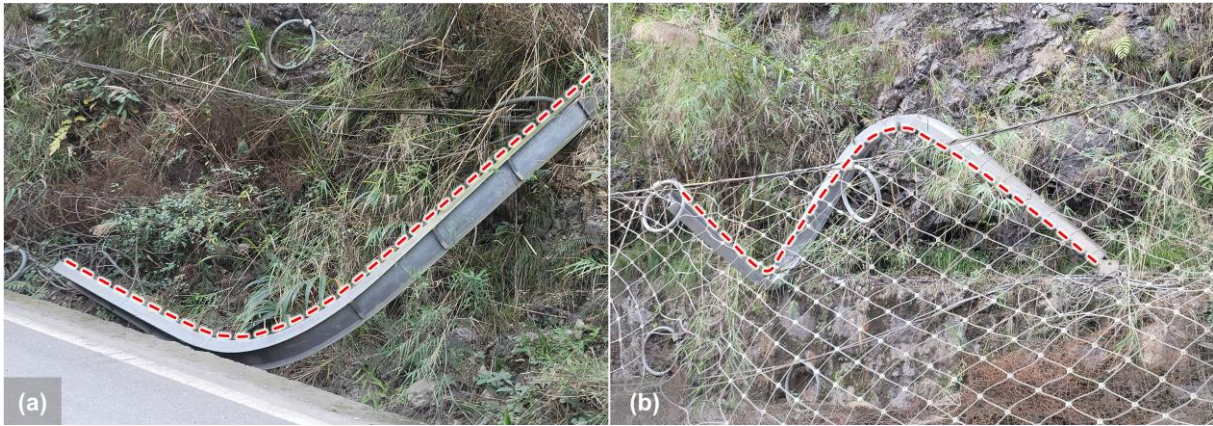
Figure 2: Steel column buckling forms of the other two flexible rockfall barrier projects: (a) "C"-shaped compression buckling and (b) "S"-shaped bending and torsion buckling.

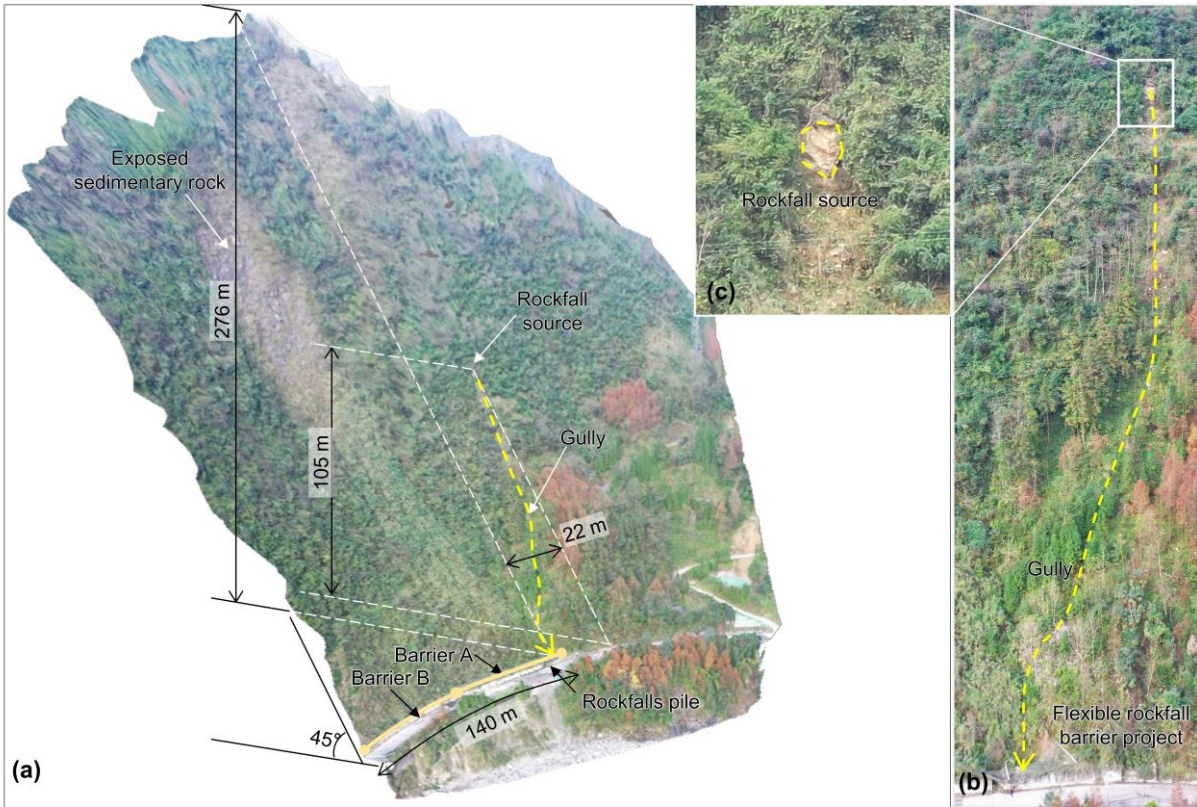
that divided the rock into broken blocks or pieces of various sizes. The area on the slope where new rock layers were exposed after rock spalling was presumed to be the source of rockfalls. The rockfall source was located 105 meters above the stopping point at the bottom of the hill and was 22 meters lateral along the road. A small amount of gravel and debris was scattered in the gully, and the vegetation along the front section of the gully was severely destroyed. About 2 meters wide, the gully had a minor quantity of rubble and garbage spread throughout it, and the vegetation along the front half of the gully had been severely devastated (Fig. 3). Rockfalls had been stopped by the retaining walls and the flexible rockfall barrier built at the foot of the slope.

Figure 3: Investigation results of the rockfall source area and trajectory. (a) The digital model of the slope; (b) Rockfall impact gully; (c) Rockfall source.

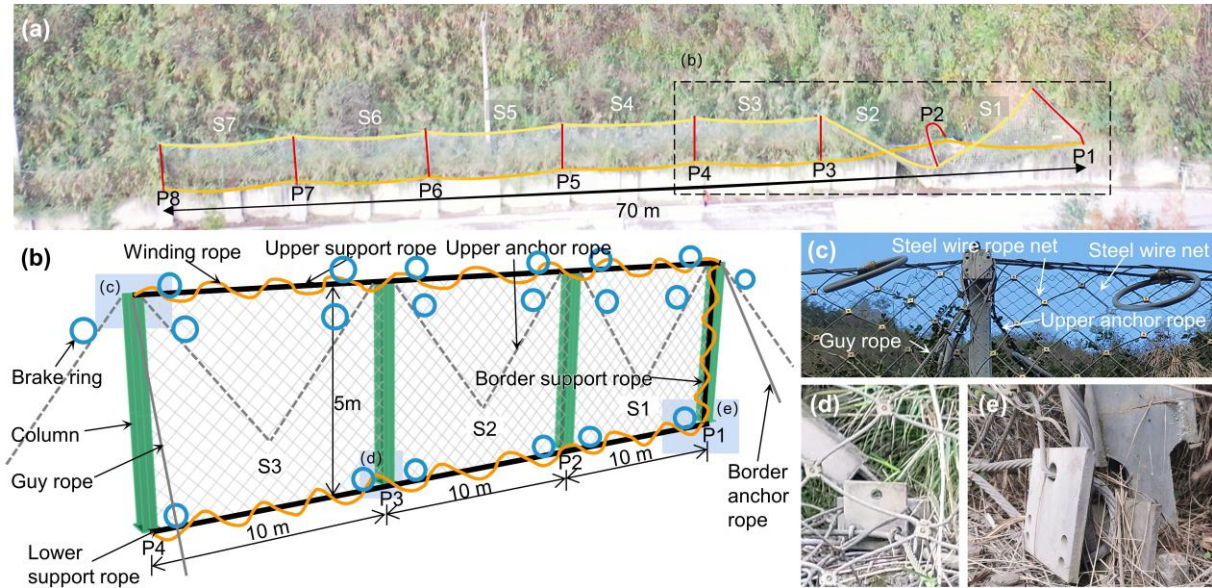
ropes were snapped to their top (Fig. 5c). The ends of steel columns P1 and P8 were fixed with support ropes (including upper, lower, and border support ropes) by rope buckles (Fig. 5e), the upper support rope of the middle spans was lapped to the top of the support posts (Fig. 5c), and the lower support rope of the middle spans passed through the rings on the column bases

(Fig. 5d). As energy-consuming devices, brake rings were connected to the upper anchor rope, and upper and lower support
cables near each column ends (Fig. 5b & 4c). Steel wire rope net and steel wire mesh net made up the interception unit (Fig.
5c). The steel wire mesh net was connected to the steel wire rope net and support ropes by steel wire. Steel wire rope net was
woven by winding ropes to the support ropes, and was hooked to the end of the column. All the steel's anti-rust and corrosion
plating remained intact, with no signs of rust or corrosion. The design protection energy of this project is determined to be 250
kJ based on the specifications of the major components presented in Table 1, which are consistent with the general
specifications of a specific flexible rockfall barrier with a protection energy of 250 kJ described in China's former industry
norm "JT/T 528-2004, Component of flexible system for protecting highway slope".

Figure 5: Structure composition of the flexible barrier. (a) Overall photo of the project; (b) Components connection relationship;
ling(c) Details of column head; (d) Failure of column base at the mid-span; (e) Failure of border column base.

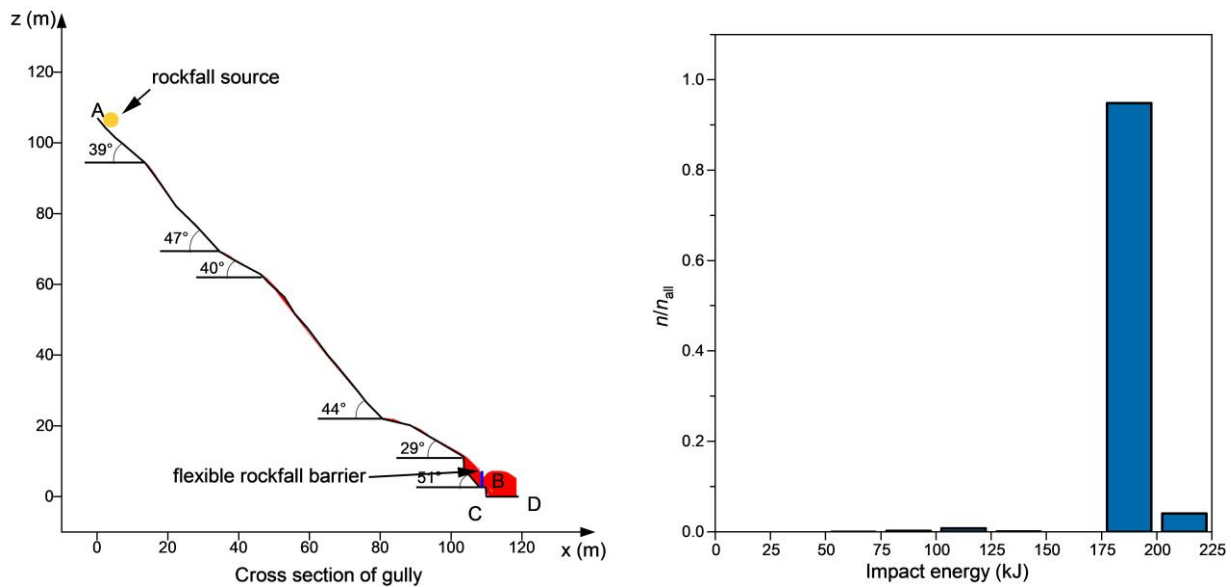
Figure 7: Rock mobility analysis : (a) Trajectory of rockfall and (b) Probability distribution of kinetic energy of falling rocks at the flexible barrier.

The number of rockfalls that reached the net (n_{all}) after 10,000 calculations was 3433. Fig. 7b depicts the distribution of the kinetic energy of rockfalls that impact the flexible barrier. The impact energy ranges from 73.64 kJ to 220.6 kJ, with a maximum value lower than the project's design protection energy level. The final determination of the impact energy of the stone impacted on the system was 100 kJ in the finite element simulation (Section 3.2), under seven trial calculations with the impact energy were 75, 100, 125, 150, 175, 200, and 225 (unit: kJ). This settled energy is outside the range analysed to be the most likely, 175kJ to 200kJ, the cause is speculated to be that Rocscience Rocfall primarily reflects the macroscopic scenario of rockfall movement on the slope, but less depicted about the specifics of the rockfall movement process. Fig. 6a indicates that rockfall hit the retaining wall before hitting the flexible barrier; this impact probably considerably reduced the energy of rockfall hitting the flexible barrier.

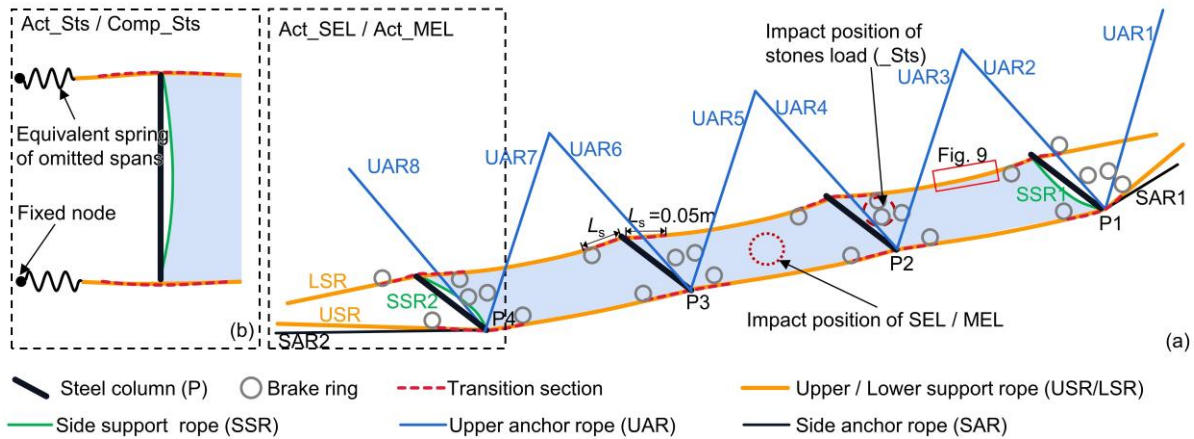
The lower right-side section of the P2 steel column's lower flange exhibited symptoms of localized damage, which leads to believe that this was where the collision occurred (Fig. 6a & Fig. 8a). Stone1's initial velocity in Section 3.2 was set to 0.5 m/s, -5 m/s, and 5.5 m/s to ensure it harms the net after hitting the steel column's flange in P2. And for Stones 2, 3, and 4, uniform initial velocities of -4.8 m/s, -7 m/s, and 4.8 m/s were defined (the velocities listed above are the x, y, and z-axis sub-velocities, shown in Fig. 10).

Figure 8: Structure representation of the actual model (Act_) and the comparative analysis model (Comp_). (a) Act_SEL and Act_MEL. (b) Act_Sts and Comp_Sts.

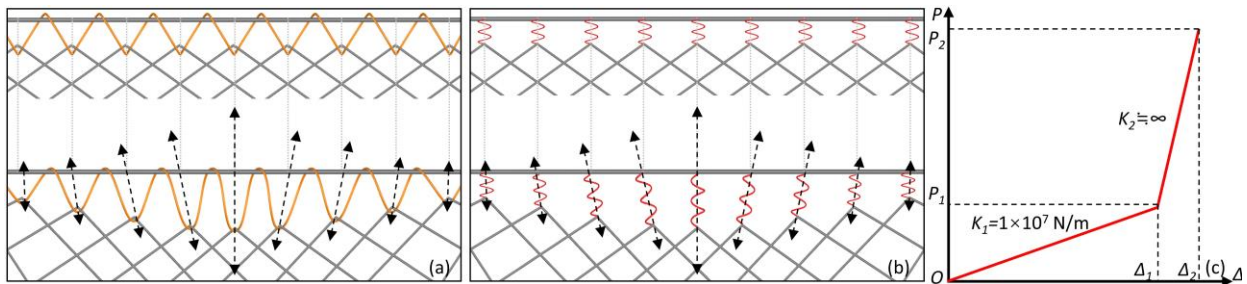
(2) The winding rope that connects the wire rope net to the support rope is relaxed while the barrier is not in service. However, once the system is impacted, the winding rope of the affected part will elongate, causing the gap between the net and the support rope to expand (Fig. 9a). As a result, extension spring units, which were applied to the connecting unit between the support rope and the flexible net, were used as equivalent to the winding rope (Fig. 9b). The winding rope spring's ends were

fixed. Its constitutive model was bilinear, where k_1 was 1×10^7 N/m, Δ_1 was 0.1 m, and k_2 was infinite in the model Act_Sts (Fig. 9c).

Figure 9: Spring equivalent model for winding rope. (a) Before and after winding rope deformation. (b) Before and after spring equal model deformation. (c) Bilinear constitutive model of the winding rope spring.

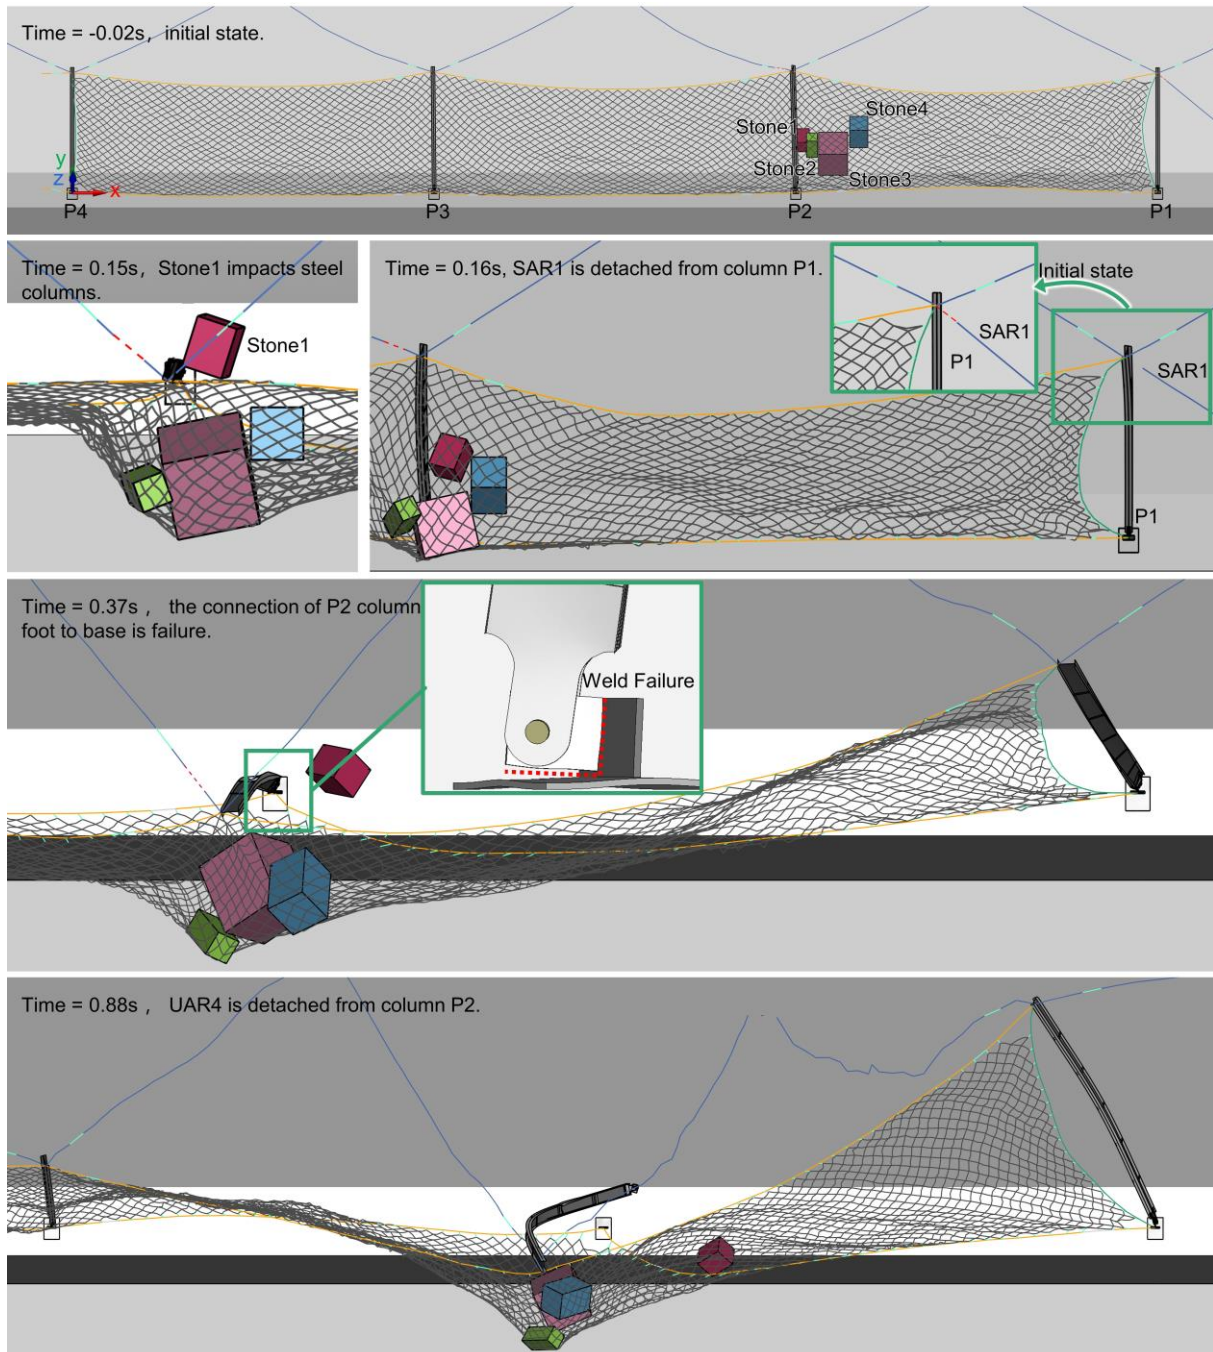
The process of rockfall impacting the flexible rockfall barrier is depicted in Fig. 10 as calculated by Act_Sts, restoring critical phenomena like anchor rope shedding, rope anchorage point failure, and base connection plates of column failure. Finally, the entire protection system was destroyed, and the rockfalls were piled up to the right of the S1 and S2 nets near the end of column P2, essentially in the same state as the actual project.

Figure 10: Keyframes of the impact process (the 0 instant occurs when Stone3 touches the wire rope net).

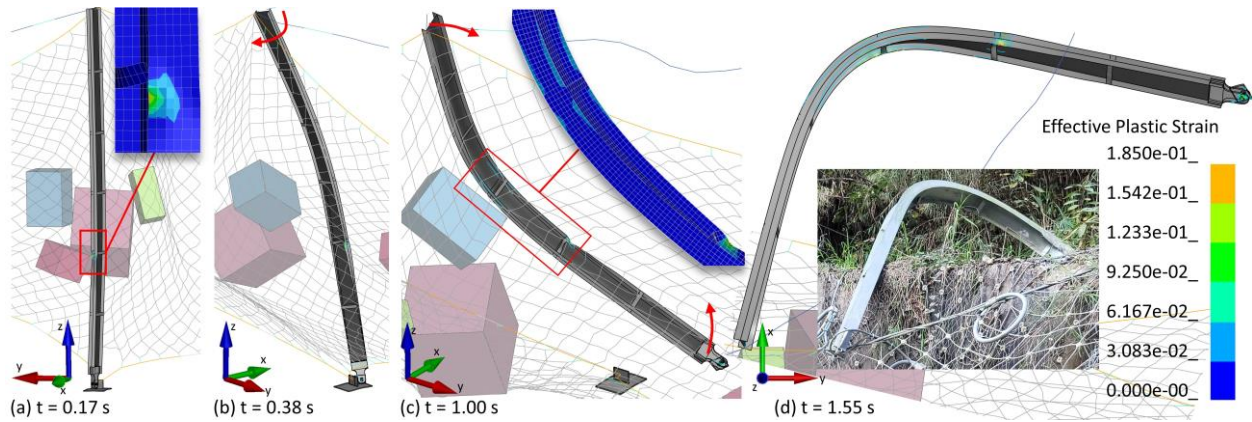
Like the actual project, the steel column P2 suffered substantial buckling damage, and the flange also sustained localized damage. And border column P1's foot damage caused the column to be dumped entirely. Fig. 11 depicts the buckling progression of steel column P2 in Act_Sts: At 0.15 s, Stone1 impacted steel column P2, causing localized damage at the impact point; at 0.25 s, the stress on both sides of the end of the steel column P2 was out of balance after the failure of the anchorage

245 point connected to the ropes UAR2 and UAR3, while the column foot was restrained and the column P2 was twisted; at 0.37 s, the base connection plate of the column P2 welded failed as a result of the column foot twisting, releasing the column P2 from the torsional restraint and turning it into a compression-bending member; at 0.98 s, the column P2 was impacted by the rebounding stone; finally, a C-shaped buckling state was created by constantly compressing and stressing the steel column P2. The numerical simulation reproduced the phenomena of rope failure, such as the failure of the rope anchorage point connected

Figure 11: Column P2 deformation development in Act_Sts.

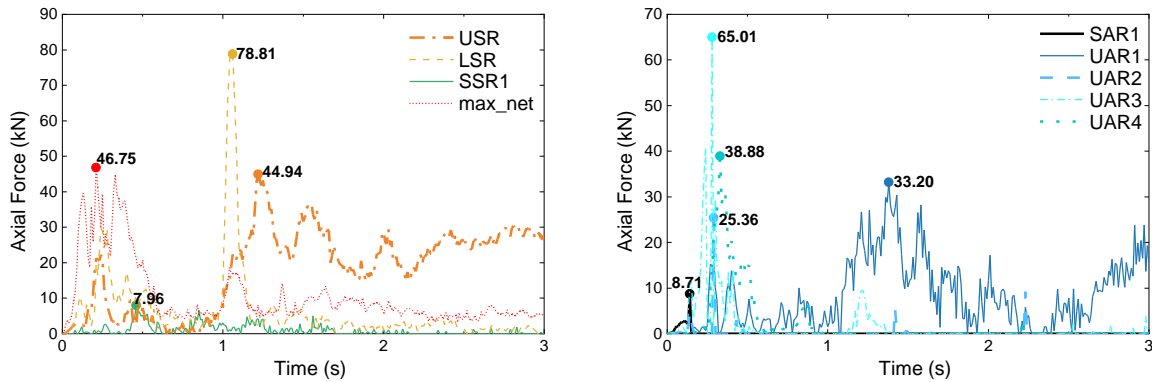
(4) After trial calculations, it was determined that the ropes UAR4 and SAR1 would fail at 0.14 seconds and 0.88 seconds after the rockfall contact with the net, respectively.

(5) Because the UAR2 and UAR3 anchorage points may break before or after impact, a failure tension value of 44.9 kN was determined after two trial calculations with zero and more than zero failure tension values.

Figure 12: Axial force of the wire ropes in Act_Sts

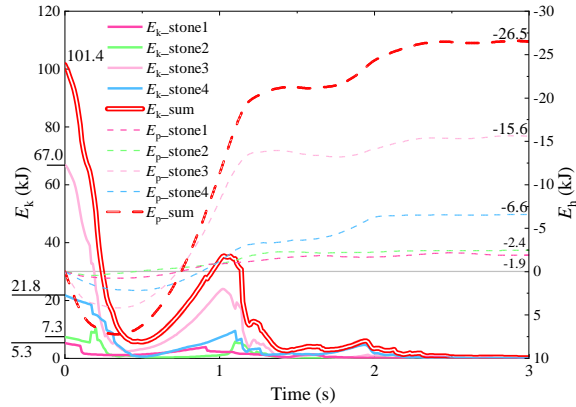
270 were taken from the moment when the first rock, Stone3, touched the barrier. The temporal evolution of kinetic energy and potential energy of rockfalls shows that the total impact kinetic energy was 101.4 kJ, which is 40.1% of the design protection energy of the flexible rockfall barrier (Fig. 13). During the protection process, the gravitational potential energy of rockfalls and flexible barrier decreased by 26.5 kJ and by 29.9 kJ, respectively. Therefore, the energy consumed in the protection process (E_{all}) was 157.8 kJ. Table 4 displays the energy distribution during the protection process: The three pathways of energy

275 consumption are material elastic-plastic deformation energy consumption, component contact friction energy consumption (including winding rope energy consumption), and system/air damping consumption, with energy consumption of 56.9kJ, 93.9kJ, and 7.0kJ, accounting for 36.06%, 59.51%, and 4.44% of the total energy consumption, respectively. Noteworthy, the steel column consumes 34.7kJ, about 60.83% of the energy consumed by material elastic-plastic deformation.

Figure 13: Temporal evolution of kinetic energy and potential energy of rockfalls.

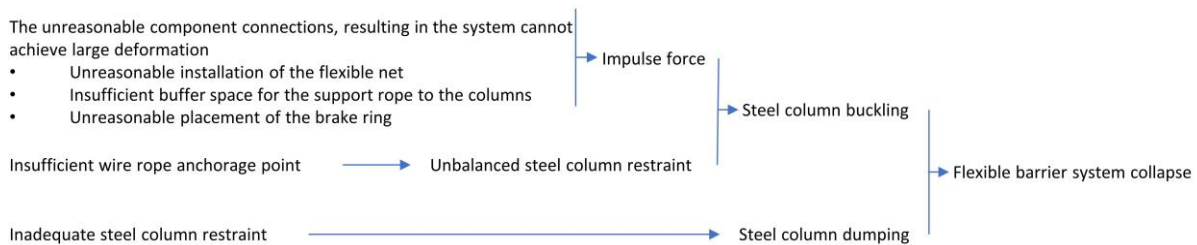
305   Model Comp_Sts strengthens the connections as well as the wire rope anchorage points. The result of Comp_Sts shows that column P1 was always in the normal working condition, column P2 did not enter the torsional force state, but column P2 still entered the C-shaped compression bending flexure state as in the Act_Sts working condition. Moreover, no damage to the members due to low material configuration was found in the field survey results, model Act_Sts or model Comp_Sts. It means that the three unreasonable connections—unreasonable flexible net installation, insufficient buffer space for the support rope

310   to the columns, and unreasonable placement of the brake ring—are the primary causes of this mitigation project's inability to withstand the rockfall impact. Due to the unreasonable component connection form, a sliding system could not be formed, and the flexible rockfall barrier's buffering mechanism also could not be developed. This resulted in an impulse force at the column end, which eventually caused the steel column to buckle and the system to collapse. Therefore, achieving substantial system deformation requires adequate relative sliding motion between the components, especially the sliding ability of the support

Figure 14: Analysis of the system damage mechanism of Act_Sts.

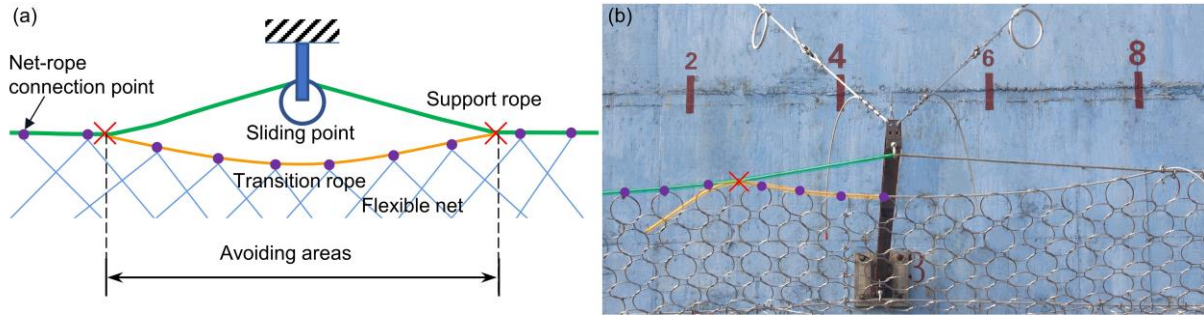
Figure 15: The transition rope applied between column ends and support ropes: (a) Structure schematic and (b) project photo.

320   Whether the support rope allows for sliding at the end of the steel column depends on the connection mechanism employed between the steel column end, the support rope, and the flexible net. The transition rope should be used in most cases where

the design protective energy is 1000kJ or less and the support rope does not slide a significant distance along the end of the column (Yu et al., 2018b). The transition rope can prevent the lateral force at the column end and the sharp rise in the axial force of the steel column generated by the net jamming, both of which cause the column to buckle (Fig. 15).

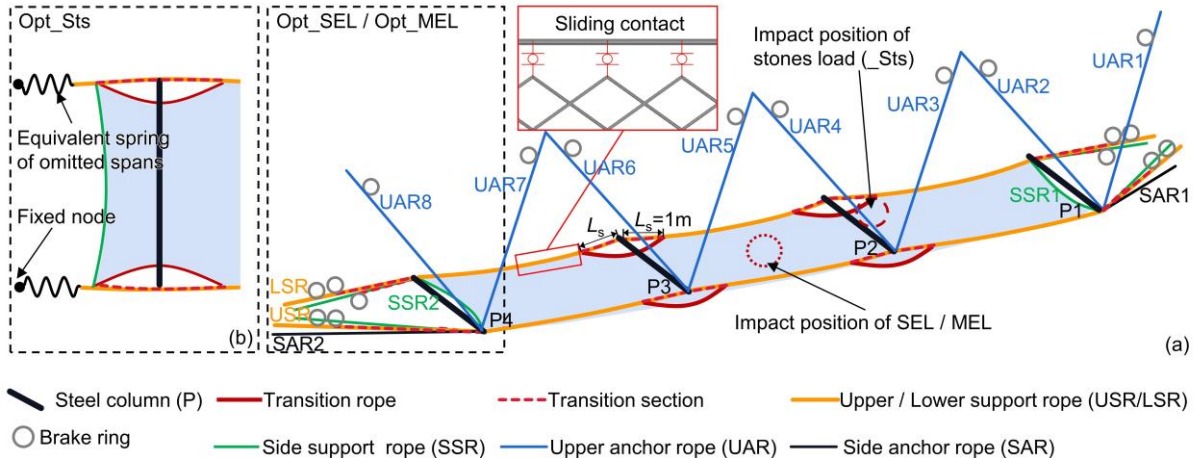
Figure 16: Structure representation of the model Opt_. (a) Simulation models Opt_SEL and Opt_MEL. (b) Simulation model Opt_Sts.

330   and all brake rings positioned at the wire rope's anchor end; (2) changing the connection between the column end and the support rope to a transition rope whose length of the transition section L_s set to 1 m, the maximum elongation of the linked brake ring; (3) extending the support rope from the end of the border column to the slope, and the support rope is in sliding relationship with the border column end; (4) using shackles to link the support ropes to the net or threading the support ropes through the net's holes to ensure that the relative sliding properties between the net and the support ropes; (5) setting an initial

335   x-axis angle of 10° for the barrier to reduce the chance of it being reverse-tipped after impact.

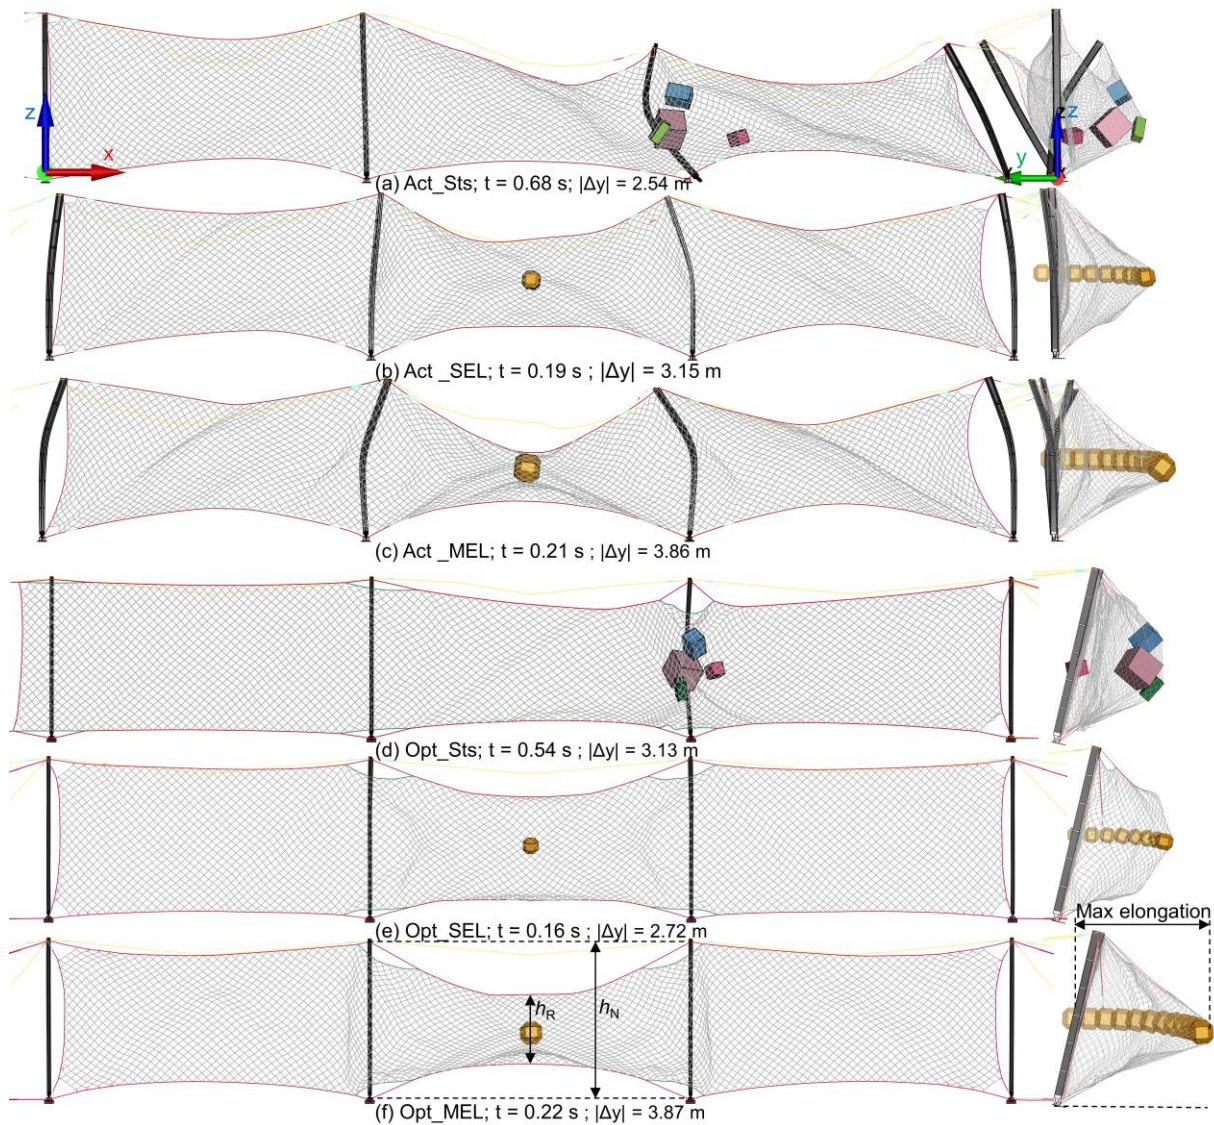
Fig. 17 and Table 5 display the six working conditions' outcomes and structure states. The rockfalls were stopped in all simulation conditions. Still, the model Act_ showed buckling of the steel columns in all impact conditions, significantly weakening the ability of the protection system to continue protecting. If this model had been used for the project, it would have
350 required component replacement and structural repairs before it could continue for protection employment. In the three impact conditions of model Opt_, the entire system maintained structural integrity following impact with no buckling column.

In Opt_SEL and Opt_MEL, the barrier successfully intercepted rockfalls, and the barriers were not broken. After completing the interception, the structure of Opt_MEL is described below: as shown in Fig. 17f, the maximum elongation L_{max} is 3.35 meters—the guidelines require L_{max} to be less than 5 meters, and the residual height of the net h_R is 2.85 meters—the guidelines
355 require h_R to be larger than 50% of the nominal height of the kit h_N, which meaning h_R needs to be larger than 2.5 meters. Therefore, the model Opt_ complies with standards for class A flexible rockfall barriers with 250kJ of energy in JT/T 1328-2020 and EAD 340059-00-0106.

Figure 17: System forms at the moment of maximum y-directional elongation.

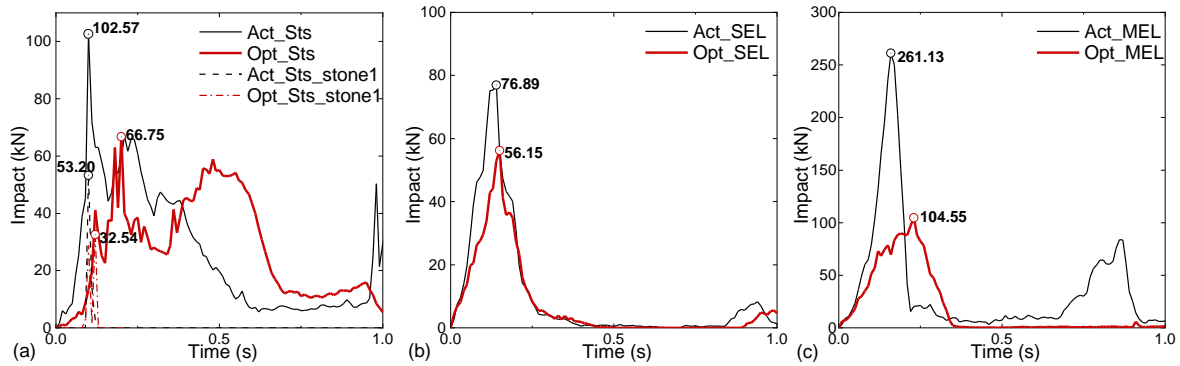
Compared to the model Act_, the impact force between the rockfalls and the barrier decreased dramatically due to the components' enhanced slid ability and the system's improved deformability, which reduced total system stiffness. According to Fig. 18, when model Opt_ is compared to model Act_, the peak impact force falls by 35%, 27%, and 60%, respectively, under the three computational circumstances of _Sts, _SEL, and _MEL. It is clear that the protection concept of the flexible protection system "roll with the punches" can be realized effectively and achieve the design protection energy level of the

Figure 18: Temporal evolution of the impact of rockfalls and barriers

Stone1 impacted the steel column P2 in Opt_Sts just as it did in the case. Still, due to the different system stiffness, the impact force was almost 39% lower in Opt_Sts than it was in Act_Sts (Fig. 18a). Although Opt_Sts's steel column P2 suffered numerous impacts, none of them seriously damaged it (Fig. 19a). The steel column P2 experienced overall bending at the moment of the most significant system deformation (Fig. 17g). After the impact passed, the steel column recovered, and the entire structure remained stable eventually (Fig. 19a), preventing the system from overthrowing due to the buckling of the steel columns in the Act_Sts (Fig. 19b).

barrier by altering the connection relationships of the column end to the supporting rope and the flexible net to wire rope and the brake ring arrangement position while maintaining the component specifications as-is.

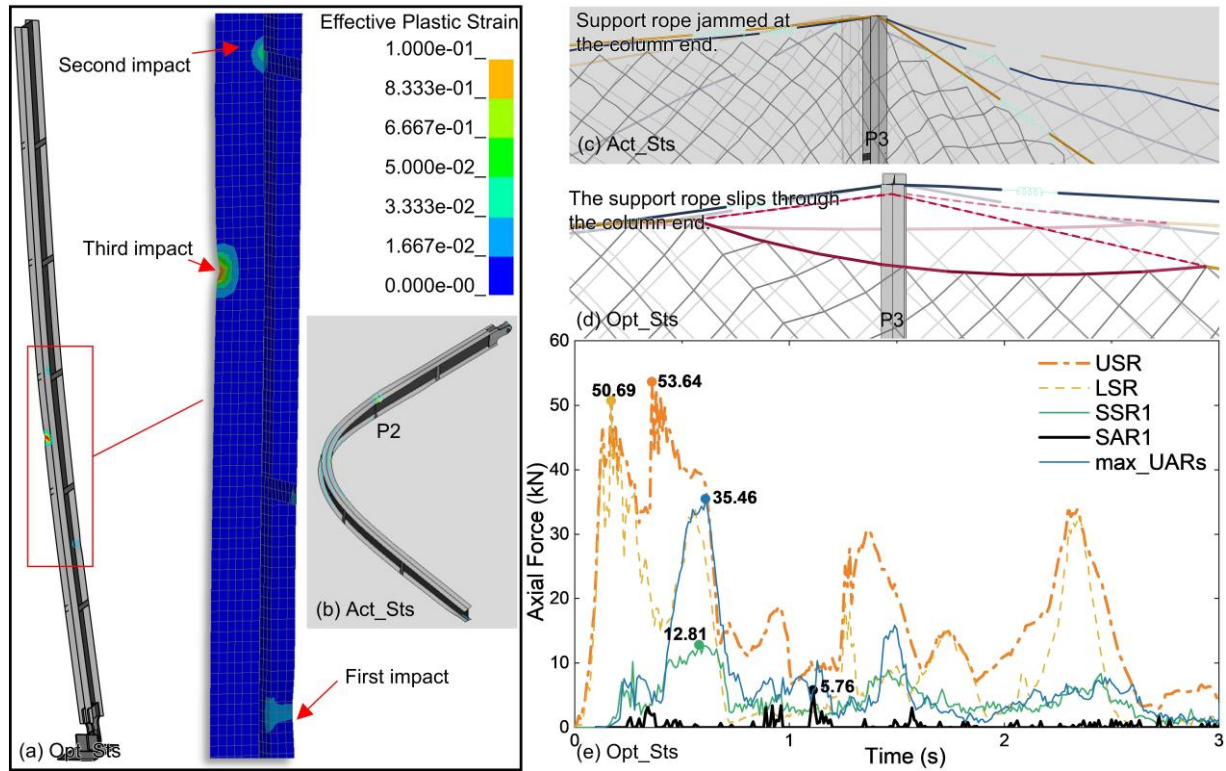
In Opt_Sts, the transition ropes prevented the net from jamming at the column end and lessened the deflection of the column caused by the tugging of the support ropes (Fig. 19c & Fig. 19d). Due to the system deformation capacity be improved, the internal force of the wire rope increased more gradually (Fig. 19e), and the phenomenon of the pulse force of the wire rope as it in Act_Sts did not occur (Fig. 12).

Figure 19: Opt_Sts calculation result: (a) The column P2 in Opt_Sts got local damages after several hits. (b) The column P2 in Act_Sts was buckling. (c) and (d) are the support rope sliding performance on the end of column P3 in Act_Sts and Opt_Sts,
400 **respectively, where semi-transparent for pre-impact and saturated colour for post-impact. (e) The internal force of part of the wire ropes in Opt_Sts.**
