Tangible and intangible ex-post assessment of flood-induced damages to cultural heritage

Claudia De Lucia, Michele Amaddii, Chiara Arrighi

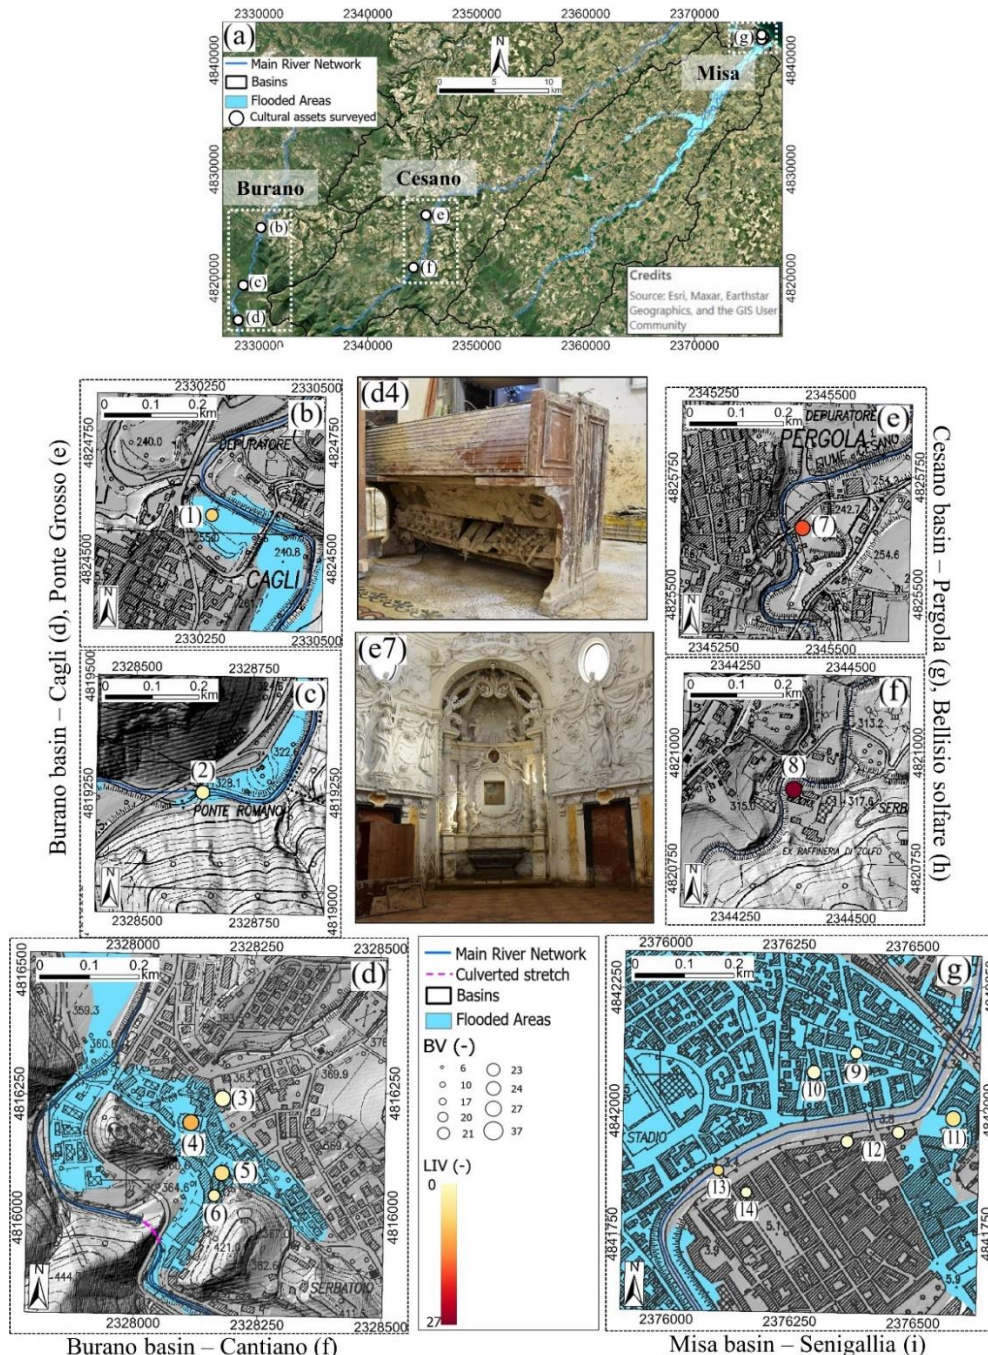
Ponte Garibaldi (Fig. 3a panel g13), namely the damaged bridge in Senigallia (Misa basin), has the lowest intangible value ($BV = 6$) for its limited historical value (it dates to the 1st mid of 20th century), as well as for its limited aesthetic value. Indeed, even if it is an example of the typical early 20th-century architectural style, it is not a valuable structure. On the other hand, the other damaged bridge in the Burano basin, Ponte Grosso in Cantiano (Fig. 3a, panel 3c), is characterized by a higher intangible value ($BV = 23$). In this case, even if its aesthetic value is limited, both the historical and evidential values are high, because it is a rare example of infrastructure of the Ancient Rome Empire.

Figure 3. (a) General view of the CH assets surveyed for each basin; (b-g) the maps showing the *BV* (graduate symbols) and *LIV* (scale colors) scores of the assets. Burano basin: (b) S. Emidio oratory in Cagli (1), (c) Ponte Grosso in Cantiano (2), and (d) the assets in Cantiano (3-6); Cesano basin: (e) S. Maria delle Tinte Church (7), and (f) Bellisio Solfare (8); Misa basin: (g) the assets in Senigallia (9-14). Panels d4 and e7 report post-event photos of S. Giovanni Battista collegiate and S. Maria delle Tinte church where damage as a result of mud deposition inside the buildings is visible. The shaded relief basemap of panels (b-g) was obtained from the DTM LIDAR of the Ministero dell'Ambiente e della Sicurezza Energetica (MASE, Geoportale Nazionale, 2024). The numerical technical map of panels (b-g) is from the Marche Region (REGIONE MARCHE, Ambiente, 2023). Both maps are distributed under the CC BY 4.0 license. Coordinate system: WGS 1984 UTM Zone 33N.

It is worth noting that the Bellisio Solfare refinery asset (Fig. 3a, panel f8), despite being mostly unknown among the most important tourist attractions and with a poor state of conservation, is characterized by high intangible value ($BV = 27$). Indeed, it represented an important proof of the past industrial activity of the Pergola municipality area (Burano basin). Furthermore, a high communal value is assigned to it, due to the presence of an organization that aims to rebuild the asset.
