Tangible and intangible ex-post assessment of flood-induced damages to cultural heritage

Claudia De Lucia, Michele Amaddii, Chiara Arrighi

Department of Civil and Environmental Engineering, Università degli Studi di Firenze, Via di S. Marta 3, 50139, Florence, Italy

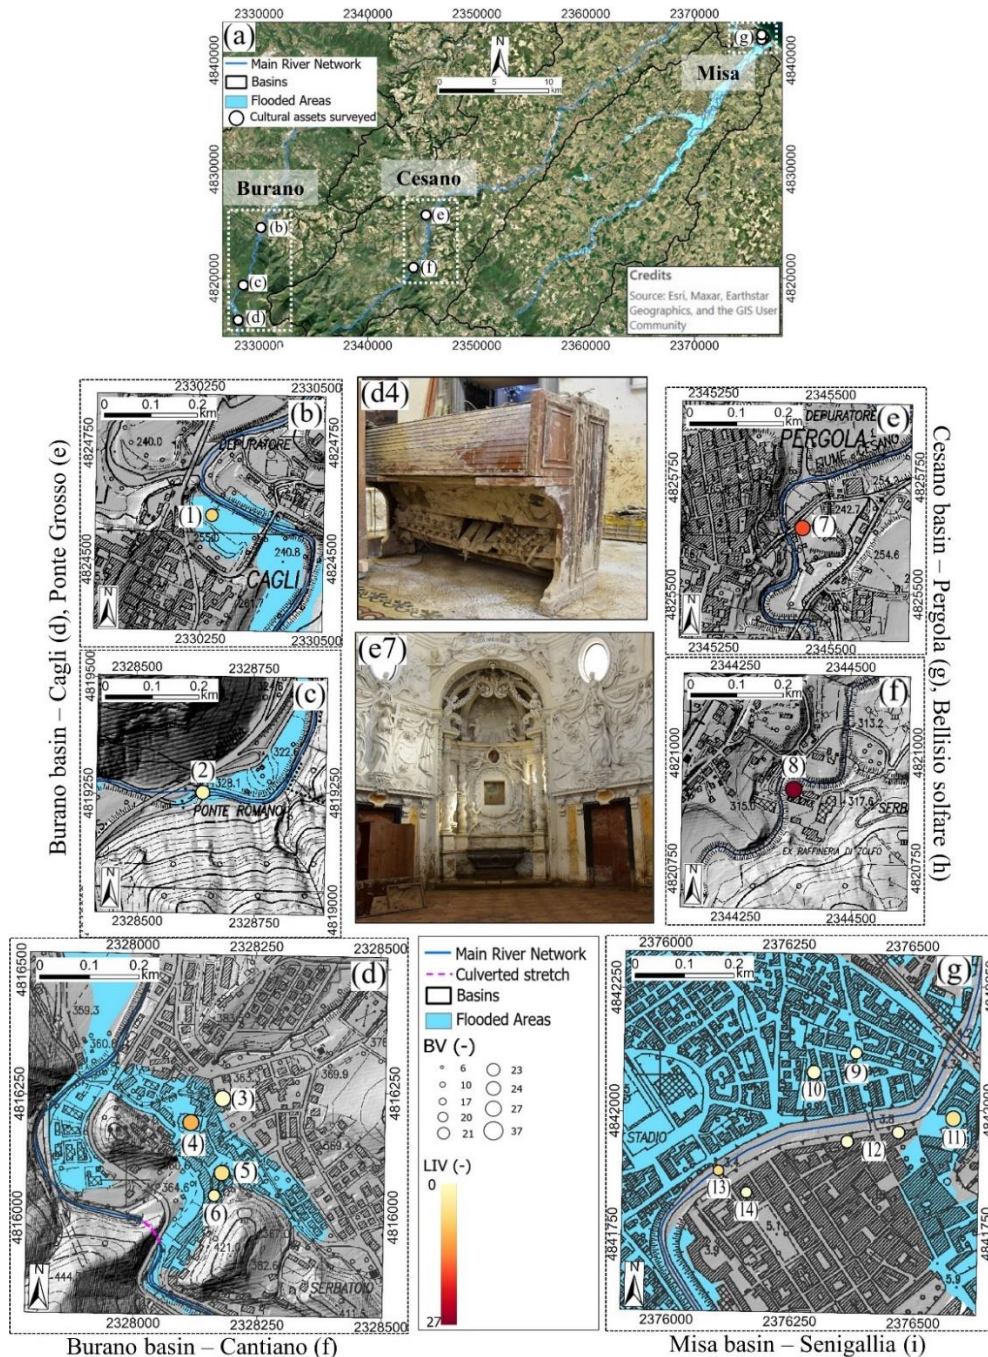
Ponte Garibaldi (Fig. 3a panel g13), namely the damaged bridge in Senigallia (Misa basin), has the lowest intangible value ($BV = 6$) for its limited historical value (it dates to the 1^{st} mid of 20^{th} century), as well as for its limited aesthetic value. Indeed, even if it is an example of the typical early 20^{th}-century architectural style, it is not a valuable structure. On the other hand, the other damaged bridge in the Burano basin, Ponte Grosso in Cantiano (Fig. 3a, panel 3c), is characterized by a higher intangible value ($BV = 23$). In this case, even if its aesthetic value is limited, both the historical and evidential values are high, because it is a rare example of infrastructure of the Ancient Rome Empire.

Figure 3. (a) General view of the CH assets surveyed for each basin; (b-g) the maps showing the *BV* (graduate symbols) and *LIV* (scale colors) scores of the assets. Burano basin: (b) S. Emidio oratory in Cagli (1), (c) Ponte Grosso in Cantiano (2), and (d) the assets in Cantiano (3-6); Cesano basin: (e) S. Maria delle Tinte Church (7), and (f) Bellisio Solfare (8); Misa basin: (g) the assets in Senigallia (9-14). Panels d4 and e7 report post-event photos of S. Giovanni Battista collegiate and S. Maria delle Tinte church where damage as a result of mud deposition inside the buildings is visible. The shaded relief basemap of panels (b-g) was obtained from the DTM LIDAR of the Ministero dell'Ambiente e della Sicurezza Energetica (MASE, Geoportale Nazionale, 2024). The numerical technical map of panels (b-g) is from the Marche Region (REGIONE MARCHE, Ambiente, 2023). Both maps are distributed under the CC BY 4.0 license. Coordinate system: WGS 1984 UTM Zone 33N.

It is worth noting that the Bellisio Solfare refinery asset (Fig. 3a, panel f8), despite being mostly unknown among the most important tourist attractions and with a poor state of conservation, is characterized by high intangible value ($BV = 27$). Indeed, it represented an important proof of the past industrial activity of the Pergola municipality area (Burano basin). Furthermore, a high communal value is assigned to it, due to the presence of an organization that aims to rebuild the asset.

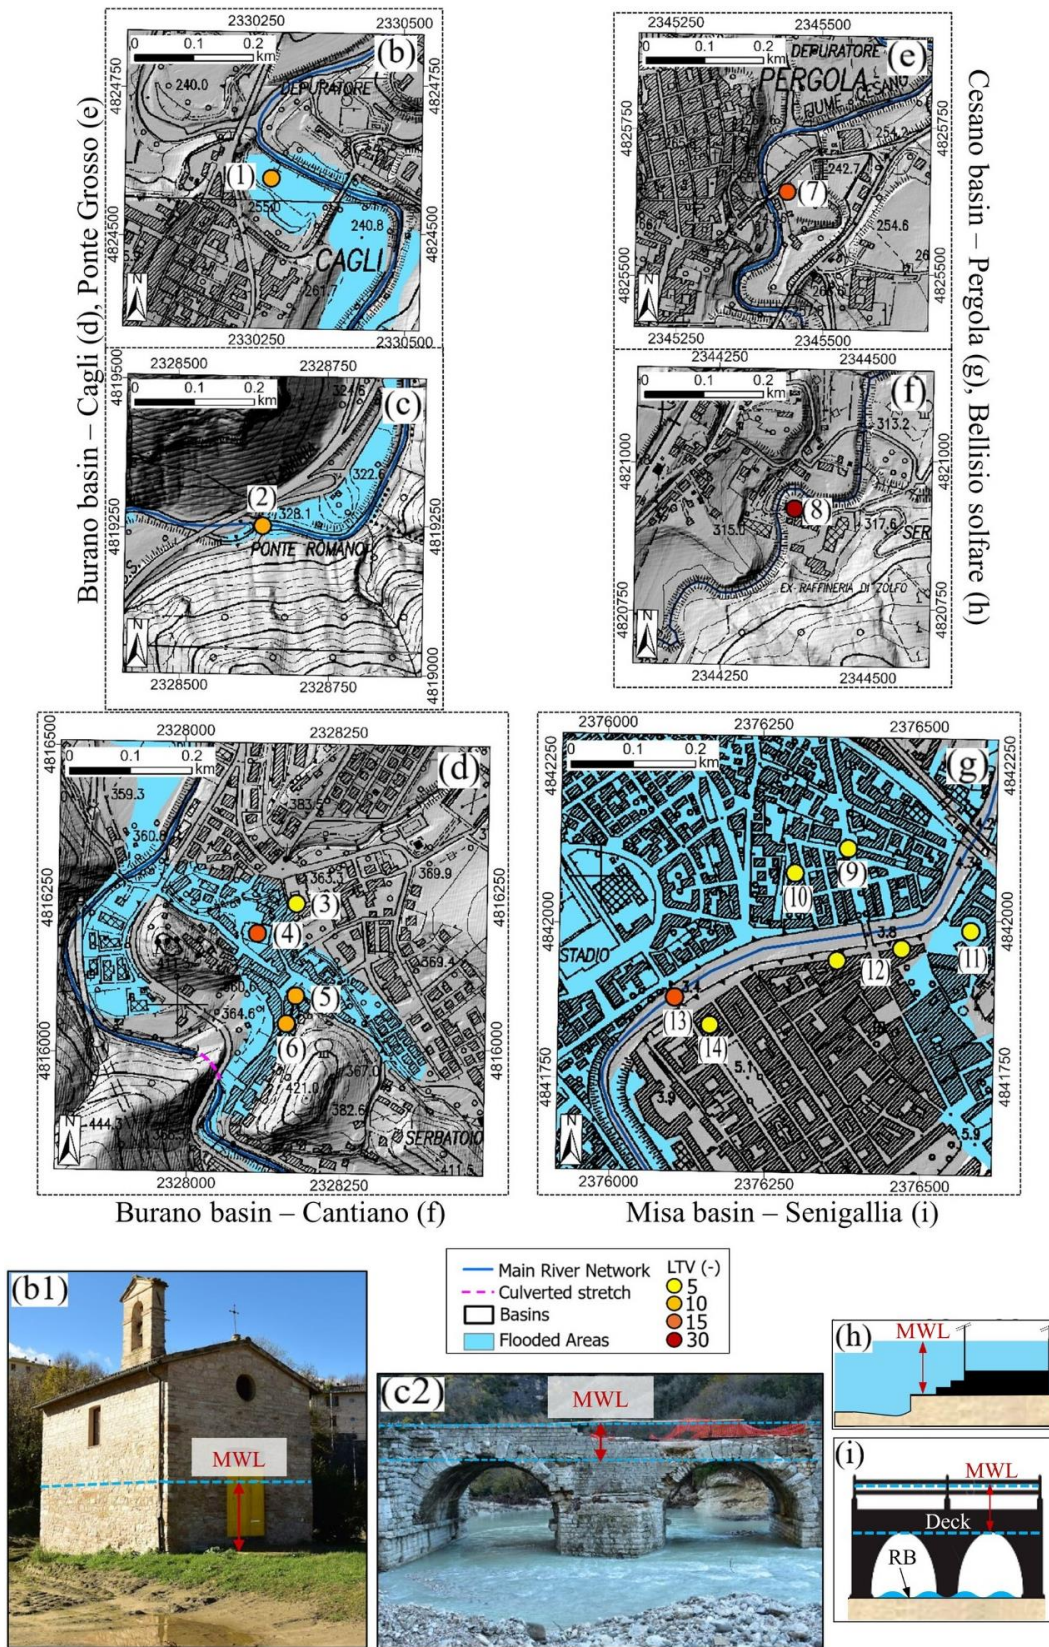
In Fig. 4 are reported the maps showing the spatial distribution of the LTV scores of each asset (panels b-g). Concerning the Bellisio Solfare refinery (Fig. 4, panel f8), the highest LIV and LTV were assigned as the flood destroyed completely the building, and during the survey, only ruins were observed (LIV = 27, and LTV=30). The historic S. Maria delle Tinte church (Fig. 4, panel e7) sustained considerable damage caused by the flood, both in terms of damage to intangible and tangible value (LIV = 20, and LTV=15). The inundation resulted in harm to the electricity system and the emergence of mold on both the floor and wall paintings. Additionally, the force of the floodwater partially wrecked the door and destroyed the 18th-century pews. As a result, the aesthetic value of the church was deemed lost. Moreover, its extended closure period led to a significant impact on its communal value. Even the S. Giovanni Battista collegiate (Fig. 4, panel 3f) experienced severe damage (LIV = 13, and LTV=15). In addition to the effects already observed for the other assets, floor tiles were broken, the wooden choir and altars were swollen due to the floodwater, and the 16th-century liturgical supply was covered by mud. In the case of S. Nicolò church (Fig. 4, panel d5), part of the floor collapsed, and the external stone and metal balustrade were swept away by the flowing water (LIV = 5.1, and LTV=10). Similar loss scores were observed for the St. Emidio oratory (Fig. 4, panel b1), in which, however, a significant loss was due to the wooden door as it was swept away.

Figure 4. (d-i) The maps of the LTV scores of the assets. Panels (b1) and (c2) display the post-event field survey photos depicting the damage to the S. Emidio oratory and Ponte Grosso, respectively. Panels (h) and (i) report the schematic view of the MWL estimation in the case of a generic building and a bridge, respectively (RP is the reference point used for the measurement of the MWL, and RB is the riverbed). The shaded relief basemap of panels (b-g) was obtained from the DTM LIDAR of the Ministero dell'Ambiente e della Sicurezza Energetica (MASE, Geoportale Nazionale, 2024). The numerical technical map of panels (b-g) is from the Marche Region (REGIONE MARCHE, Ambiente, 2023). Both maps are distributed under the CC BY 4.0 license. Coordinate system: WGS 1984 UTM Zone 33N.

The two affected bridges were significantly damaged as the maximum level reached by the water during the flood exceeded the height of the deck. Portions of the arch stones of the Ponte Grosso (Fig. 4, panel c2) collapsed leading to a moderate decrease in tangible value (LTV=10). However, the historical and evidential aspects remained unscathed, resulting in a relatively low decline in intangible value ($LIV = 2.1$). Conversely, the Ponte Garibaldi (Fig. 4, panel g13) sustained severe structural damage (LTV=15). Indeed, some months after the field survey, it ultimately had to be demolished (*ANSA, Regione Marche, 2023*), resulting in the loss of aesthetic and historical significance ($LIV = 6$).

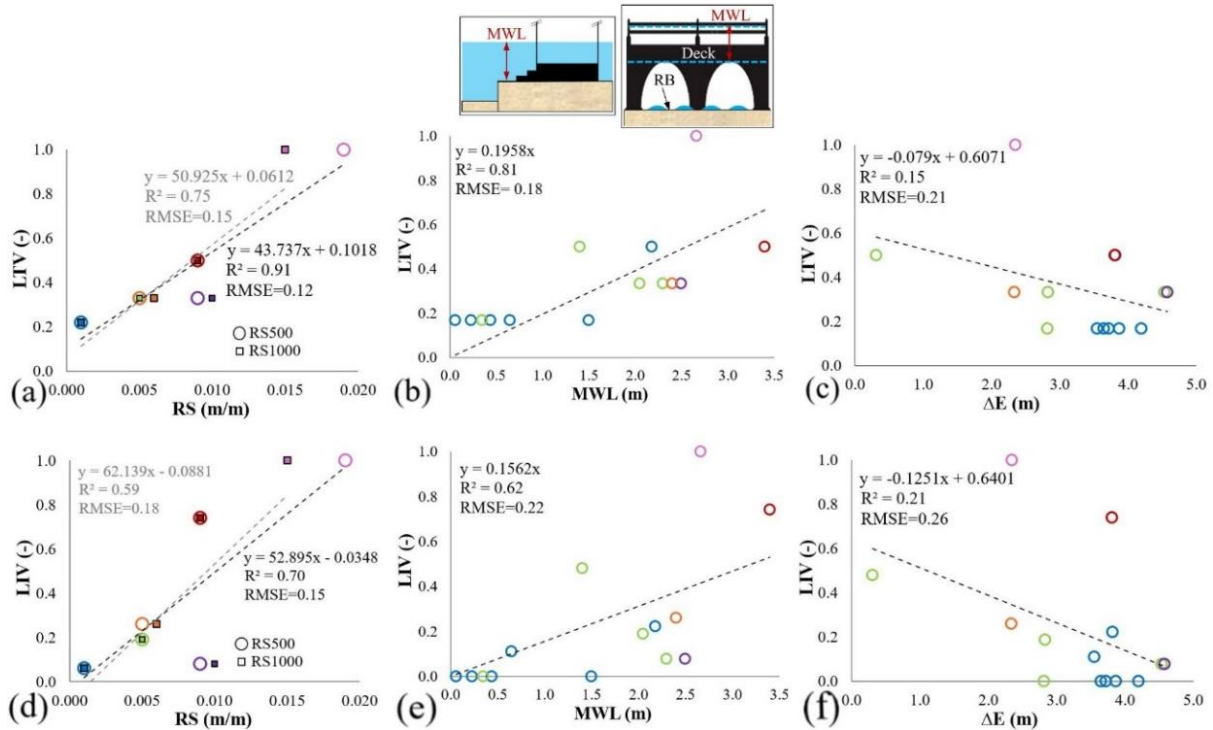
Figure 5. Relations between normalized LTV (a-c) and *LIV* (d-e) with influencing contributing factors: (a,d) RS, considering distances
of 500 m (black line and circles) and 1000 m (grey line and boxes) upstream from the single asset or group of assets; (b,e) MWL
measured as the height of the maximum water/mud mark level with respect to the outside ground floor of each asset; (c,f) ΔE, the
elevation difference between the asset and the riverbed.

507 The factors RS and LTV (Fig. 5a), considering the 500 m stretch upstream of the single asset of a group of assets (RS500),

515 3.2). In the case of the Misa River in Senigallia (RS500,1000=0.001 m/m), the flooding that occurred was mainly caused

516 by the overtopping of the 2 bridges present, which in turn caused a progressive and slow rise in water levels throughout

517 the city. This scenario resulted in damage to CH primarily attributable to water stagnation and the accumulation of fine

519 for all the CH assets, the minimum LTV (5) was observed (Table 4). The only exception is the Garibaldi Bridge, which

520 was more severely damaged (LTV=15) as it was obstructed due to the passage of woody debris and the related pressure
