Tangible and intangible ex-post assessment of flood-induced damages to cultural heritage

Claudia De Lucia, Michele Amaddii, Chiara Arrighi

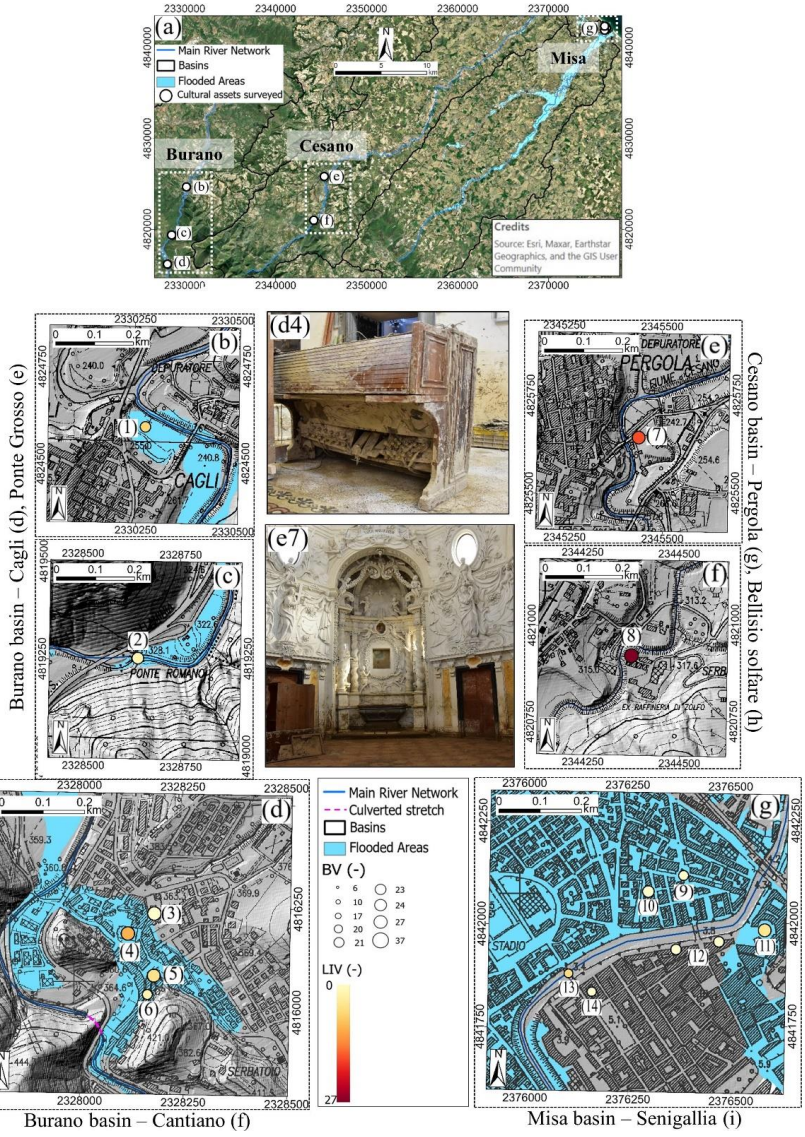
Ponte Garibaldi (Figure 3a panel g13), namely the damaged bridge in Senigallia (Misa basin), has the lowest intangible value ($BV = 6$) for its limited historical value (it dates to the 20th century), as well as for its limited aesthetic value. Indeed, even if it is an example of the typical early 20th-century architectural style, it is not a valuable structure. On the other hand, the other damaged bridge in the Burano basin, Ponte Grosso in Cantiano (Figure 3a, panel 3c), is characterized by a higher intangible value ($BV = 23$). In this case, even if its aesthetic value is limited, both the historical and evidential values are high, because it is a rare example of infrastructure of the Ancient Rome Empire.

Figure 3. (a) General view of the CH assets surveyed for each basin; (b-g) the maps showing the *BV* (graduate symbols) and *LIV* (scale colors) scores of the assets. Burano basin: (b) S. Emidio oratory in Cagli (1), (c) Ponte Grosso in Cantiano (2), and (d) the assets in Cantiano (3-6); Cesano basin: (e) S. Maria delle Tinte Church (7), and (f) Bellisio Solfare (8); Misa basin: (g) the assets in Senigallia (9-14). Panels d4 and e7 report post-event photos of S. Giovanni Battista collegiate and S. Maria delle Tinte church where damage as a result of mud deposition inside the buildings is visible. The shaded relief basemap of panels (b-g) was obtained from the DTM LIDAR of the Ministero dell'Ambiente e della Sicurezza Energetica (MASE, Geoportale Nazionale, 2024). The numerical technical map of panels (b-g) is from the Marche Region (REGIONE MARCHE, Ambiente, 2023). Both maps are distributed under the CC BY 4.0 license. Coordinate system: WGS 1984 UTM Zone 33N.

It is worth noting that the Bellisio Solfare refinery asset (Figure 3a, panel f8), despite being mostly unknown among the most important tourist attractions and with a poor state of conservation, is characterized by high intangible value ($BV = 27$). Indeed, it represented an important proof of the past industrial activity of the Pergola municipality area (Burano basin). Furthermore, a high communal value is assigned to it, due to the presence of an organization that aims to rebuild the asset.

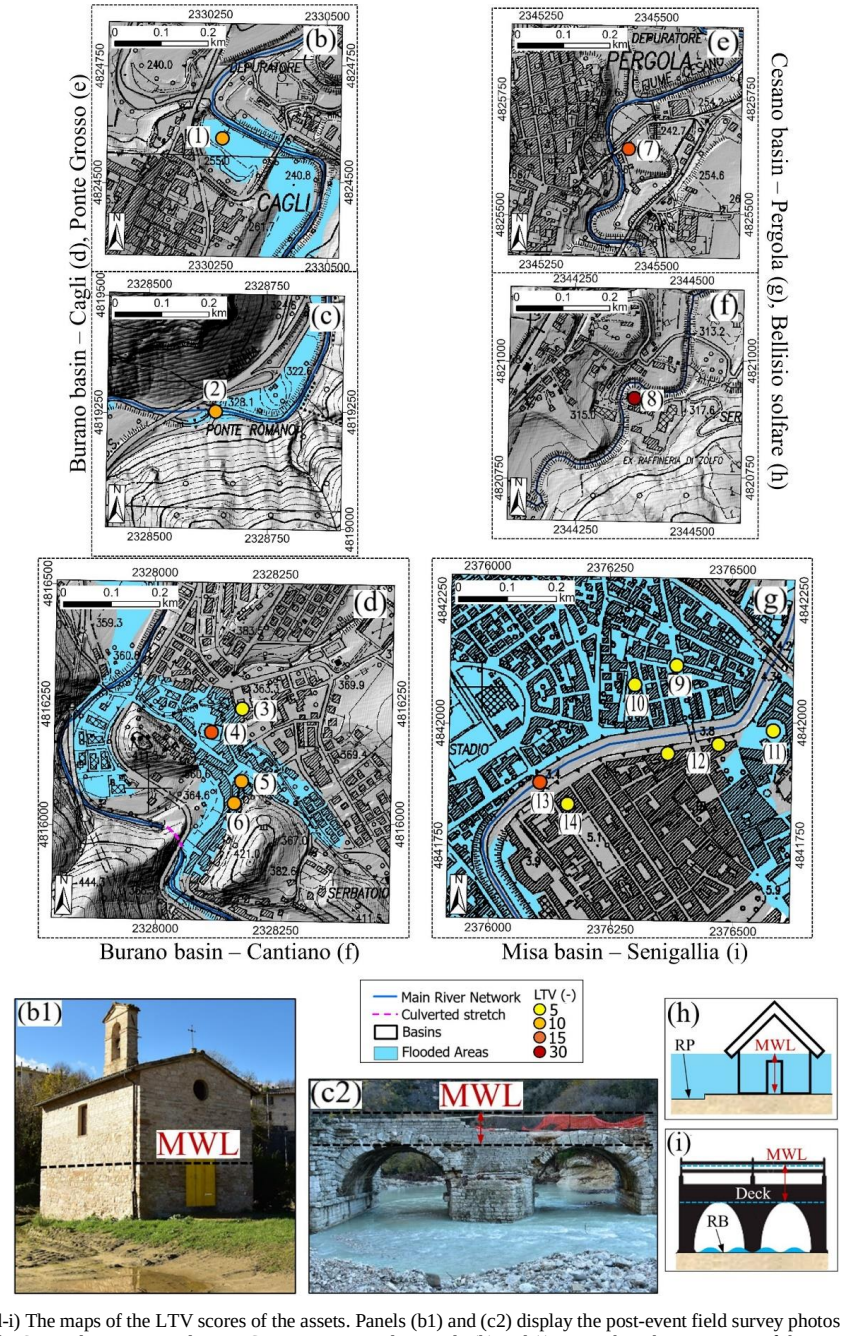
In Figure 4 are reported the maps showing the spatial distribution of the LTV scores of each asset (panels b-g). Concerning the Bellisio Solfare refinery (Figure 4, panel f8), the highest LIV and LTV were assigned as the flood destroyed completely the building, and during the survey, only ruins were observed (LIV $= 27$, and LTV=30). The historic S. Maria delle Tinte church (Figure 4, panel e7) sustained considerable damage caused by the flood, both in terms of damage to intangible and tangible value (LIV $= 20$, and LTV=15). The inundation resulted in harm to the electricity system and the emergence of mold on both the floor and wall paintings. Additionally, the force of the floodwater partially wrecked the door and destroyed the 18th-century pews. As a result, the aesthetic value of the church was deemed lost. Moreover, its extended closure period led to a significant impact on its communal value. Even the S. Giovanni Battista collegiate (Figure 4, panel 3f) experienced severe damage (LIV $= 13$, and LTV=15). In addition to the effects already observed for the other assets, floor tiles were broken, the wooden choir and altars were swollen due to the floodwater, and the 16th-century liturgical supply was covered by mud. In the case of S. Nicolò church (Figure 4, panel d5), part of the floor collapsed, and the external stone and metal balustrade were swept away by the flowing water (LIV $= 5.1$, and LTV=10). Similar loss scores were observed for the St. Emidio oratory (Figure 4, panel b1), in which, however, a significant loss was due to the wooden door as it was swept away.

Figure 4. (d-i) The maps of the LTV scores of the assets. Panels (b1) and (c2) display the post-event field survey photos depicting the damage to the S. Emidio oratory and Ponte Grosso, respectively. Panels (h) and (i) report the schematic view of the MWL estimation in the case of a generic building and a bridge, respectively (RP is the reference point used for the measurement of the MWL, and RB is the riverbed). The shaded relief basemap of panels (b-g) was obtained from the DTM LIDAR of the Ministero dell'Ambiente e della Sicurezza Energetica (MASE, Geoportale Nazionale, 2024). The numerical technical map of panels (b-g) is from the Marche Region (REGIONE MARCHE, Ambiente, 2023). Both maps are distributed under the CC BY 4.0 license. Coordinate system: WGS 1984 UTM Zone 33N.

Overall, a high level of losses was observed for most of the affected religious structures, where closure due to extensive damage contributed to a decrease in communal value. Conversely, the S. Agostino (Figure 4, panel d3), and Porta Lambertina, S. Maria del Porto, Portici Ercolani, and Filanda Serica assets (Figure 4, panels g9,10,12, and 14) incurred the lowest losses, both in intangible and tangible aspects $LIV = 0$, and LTV=5. Specifically, the two churches were not damaged as they are over-elevated from the ground floor. For all these assets, only mud marks dirtied the external walls. As regards the Foro Annonario (Figure 4, panel g11), the only damage is related to the mud marks along the porch perimeter. Nevertheless, the relative LIV is higher than 0 ($LIV = 4.5$) since the circular square in which the porches are located remained impracticable for some days.

The two affected bridges were significantly damaged as the maximum level reached by the water during the flood exceeded the height of the deck. Portions of the arch stones of the Ponte Grosso (Figure 4, panel c2) collapsed leading to a moderate decrease in tangible value (LTV=10). However, the historical and evidential aspects remained unscathed, resulting in a relatively low decline in intangible value ($LIV = 2.1$). Conversely, the Ponte Garibaldi (Figure 4, panel g13) sustained severe structural damage (LTV=15). Indeed, some months after the field survey, it ultimately had to be demolished (*ANSA, Regione Marche, 2023*), resulting in the loss of both its aesthetic and historical significance ($LIV = 6$).

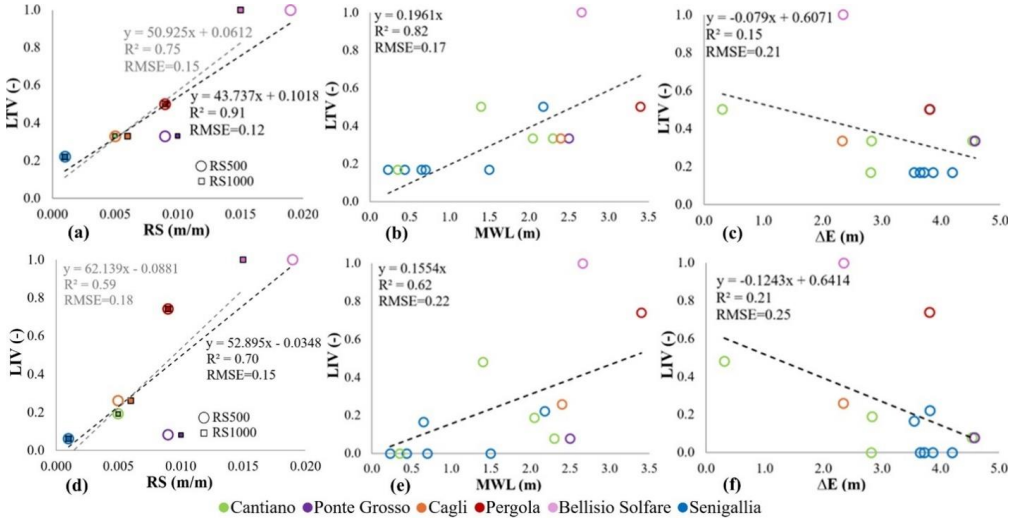
The procedures described in Sect. 2.2.2 allowed us to investigate which factors contributed significantly to both the LTV and LIV of the CH assets. Among all the factors analyzed, RS, MWL, and ΔE showed some correlation to LTV (Figure 5a-c), while for all others the correlation proved to be negligible. The same trend resulted also correlating the LIV with the same contributing factors (Figure 5d-e). This can be explained as the LIV is linked to the LTV. Indeed, if an asset is

The factors RS and LTV (Figure 5a), considering the 500 m stretch upstream of the single asset of a group of assets (RS500), exhibit both a higher correlation and a lower dispersion (R^2=0.91, RMSE= 0.12). Also considering the 1000 m stretch upstream from the CH (RS1000), the LTV-RS relationship is clear, although it results in a lower correlation and greater dispersion (R^2=0.75, RMSE=0.15) than considering the RS500 factor. These results show that an increase in RS corresponds to an increase in LTV. Both 500 m and 1000 m were considered as there are no clear recommendations in the literature on whether the flow of a river adapts to the slope of the riverbed. Nevertheless, considering these distances, it is reasonable to assume that the slope of the riverbed affects the energy of the flowing water and thus can be used as a valid proxy for current velocity. As observed, the dynamics of the flood event were different throughout the basins (Sect. 3.2). In the case of the Misa River in Senigallia (RS500,1000=0.001 m/m), the flooding that occurred was mainly caused by the overtopping of the 2 bridges present, which in turn caused a progressive and slow rise in water levels throughout the city. This scenario resulted in damage to CH primarily attributable to water stagnation and the accumulation of fine sediments (ranging from clays to sands), rather than the direct impact of hydrodynamic forces from flowing water. Indeed, for all the CH assets, the minimum LTV (5) was observed (Table 4). The only exception is the Garibaldi Bridge, which was more severely damaged (LTV=15) as it was obstructed due to the passage of woody debris and the related pressure exerted on it. On the other hand, for the sites in the Burano and Cesano basins, a steeper slope caused greater damage due to the hydrodynamic force of the water impacting the CH assets. This is evidenced by some videos recorded at Cantiano (as described in Sect. 3.2), but especially by the destruction of the Bellisio Solfare refinery (LTV=30). In this case, the slope of the Cesano River was sufficient to transport and deposit large amounts of floating and coarse debris, including wood, gravel, and boulders, which contributed to the destruction of the site. However, it is also worth noting that this site was in a poor state of conservation, that possibly reduced structural resistance.

As concerns the correlation between LTV and MWL, Figure 5b highlights a clear relationship. Namely, the higher the flood depth, the greater the damage, as generally found in the literature for stage-damage functions. However, a lower

The lowest correlation and the highest dispersion (R^2=0.15, RMSE=0.21) correspond to the LTV-ΔE relationship (Figure 5c).
