Engineering geologic assessment of the slope movements and liquefaction failures of the 23 October 2011 Van earthquake ($M_w = 7.2$)

A. Karakaş, Ö. Coruk, and B. Doğan

Kocaeli University, Engineering Faculty, Department of Geological Engineering, İzmit, Kocaeli, Turkey

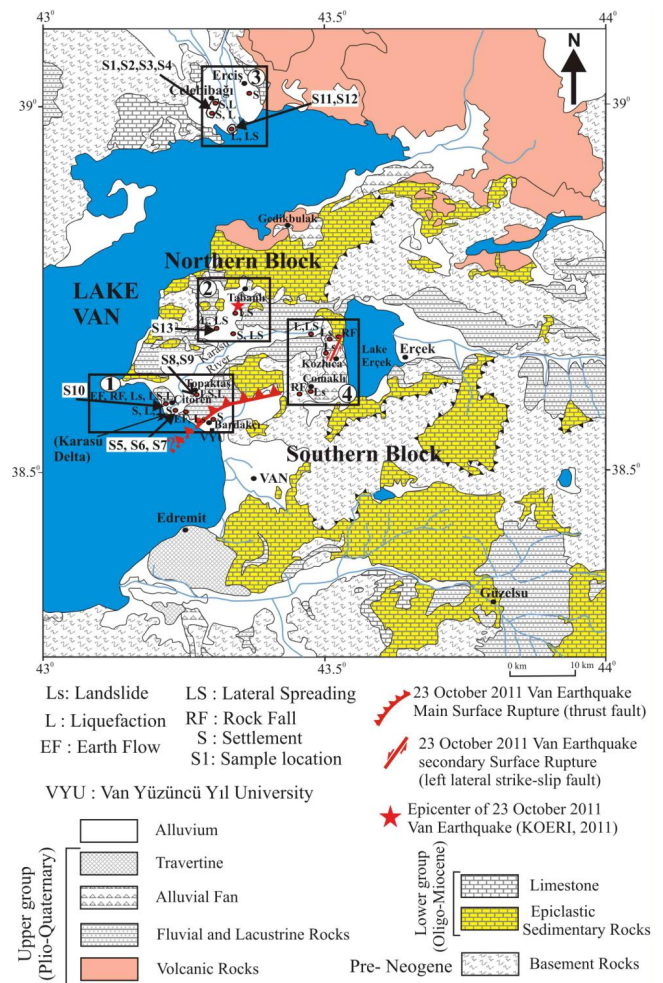
Fig. 2. Geology map of the Van region (MRE, 2002) and geographical distribution of mass movements and liquefaction features along with the main and secondary surface ruptures that occurred during the 23 October 2011 Van earthquake.

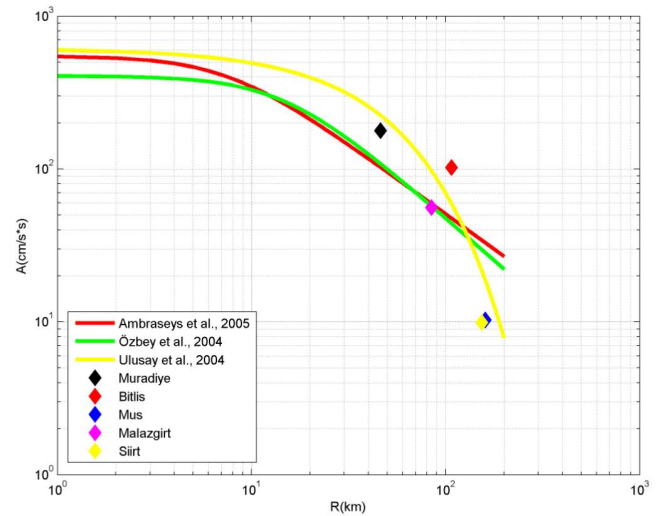
No record of ground acceleration is available in the near field of the Van earthquake, although the strong ground motion was recorded by the stations located in the neighboring provinces. The distances between the strong ground stations recording the ground accelerations and the epicenter varied from 42 km to 590 km. The Muradiye station, located approximately 42 km NE of the epicenter, was the closest station and recorded the highest PGA of 178.5 cm s^{-2} (0.182 g) in the N–S direction. The other stations recorded acceleration values between 0.1 g and 0.001 g within 95–590 km of the epicenter (DEMP-ED, 2011). A comparison of the PGAs recorded at the Muradiye, Bitlis, Muş, Malazgirt and Siirt stations with the attenuation relationships is shown in Fig. 4. These stations are within approximately 42 (Muradiye) to 158 (Siirt) kilometers of the epicenter.

Fig. 4. Comparison of recorded strong ground motions with ground motion prediction equations.

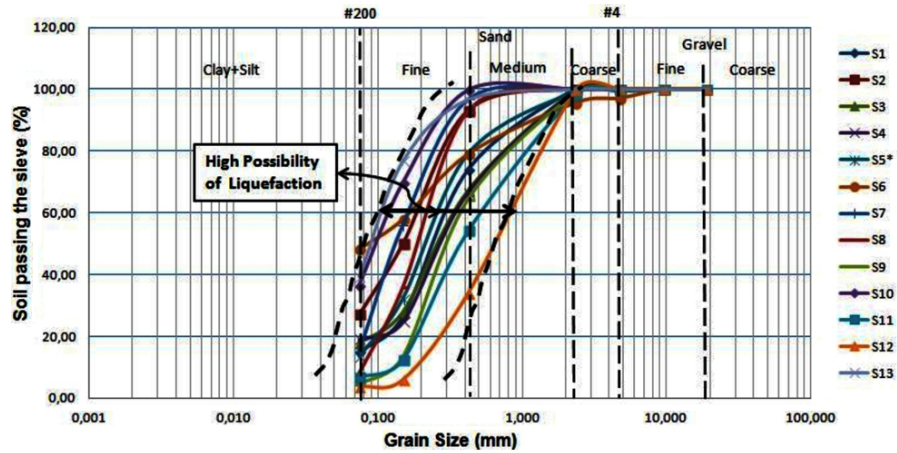
to the Unified Soil Classification System (USCS). One sample was classified as clayey sand (SC) due to its plasticity index (10.3). Two samples were classified as poorly sorted sands (SP). Sand grains in the soil samples were mainly fine–medium size. Only five samples had coarse-grained sand as up to 2 % of the sand portion (S11). One sample (S5) was taken from the sliding soil mass located in the Karasu Delta along the eastern shores of Lake Van. This soil sample tested for GSD resulted in 13.4 % silt+clay, 86.1 % sand and 0.5 % gravel, and was classified as silty sand (SM). D_{60} (mm) diameter sizes of the soil particles varied from 0.11 mm to 0.84 mm (Table 2). According to the GSD analyses of the liquefied soil samples, liquefied soils were mainly composed of fine–medium sized sand grains. Thus, the soil liquefaction is closely associated with the grain size. GSDs of ejected or boiled soils are placed between the high possibilities of liquefaction boundaries (Fig. 13). Sieve analysis results performed on sampled sand boils that occurred during the Van earthquake also indicated high potential for liquefaction (Çetin et al., 2011).

Fig. 13. Grain size distribution curves of liquefied soil samples.
