Nat. Hazards Earth Syst. Sci., 14, 545–556, 2014 www.nat-hazards-earth-syst-sci.net/14/545/2014/ doi:10.5194/nhess-14-545-2014 © Author(s) 2014. CC Attribution 3.0 License.

# Landslide and slope stability evaluation in the historical town of Kruja, Albania

### Y. Muceku and O. Korini

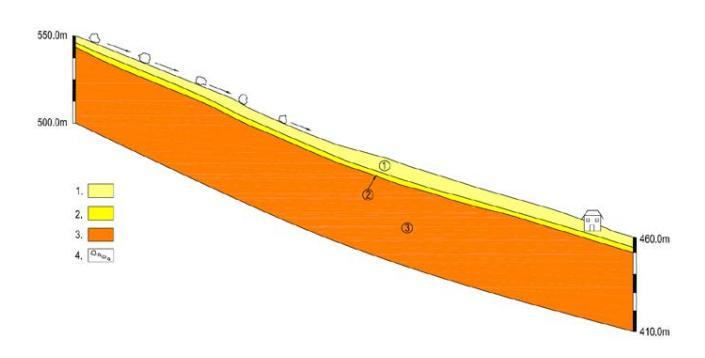
**Fig. 4.** Lithological profile of engineering geology site no.  $II_3$ . (1) inorganic silts and clays with fine sands, (2) weathering crust of flysch rocks, (3) flysch rocks, (4) breccia and limestone blocks.

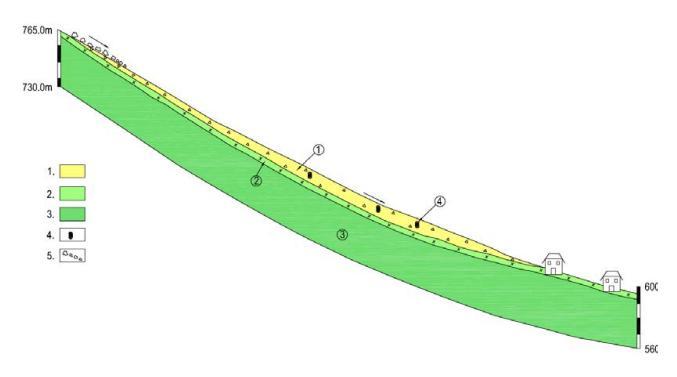
**Fig. 6.** Lithological profile of engineering geology site no.  $I_1$ . (1) gravel–cobble mixture with no fines, (2) weathering crust of limestone, medium strong rocks, (3) strong limestone rocks, (4) barrierstone masonry wall, (5) limestone blocks.

zone. They are deposited in ephemeral streams and are ready to move down in the form of debris flows (Fig. 6) that are open-sloped (Dahl et al., 2010). The debris flows have this dimension range: 120.0–250.0 m up to 350.0–400.0 m long, 50.0–100.0 m wide and 1.8–3.5 m up to 5.5–7.0 m. Two of these zones are located over Kruja. The volume of debris accumulated in these cones is 28 000 m<sup>3</sup> and 12000 m<sup>3</sup>, respectively, constituting a present risk for this part of town. The debris flow phenomena in this area have occurred several times in previous years, such as the debris flows of 2004 and 2010 that damaged several buildings, green landscape in the eastern part of Kruja and also adjacent traffic roads. Barrier-stone masonry walls were built for protection against debris flows

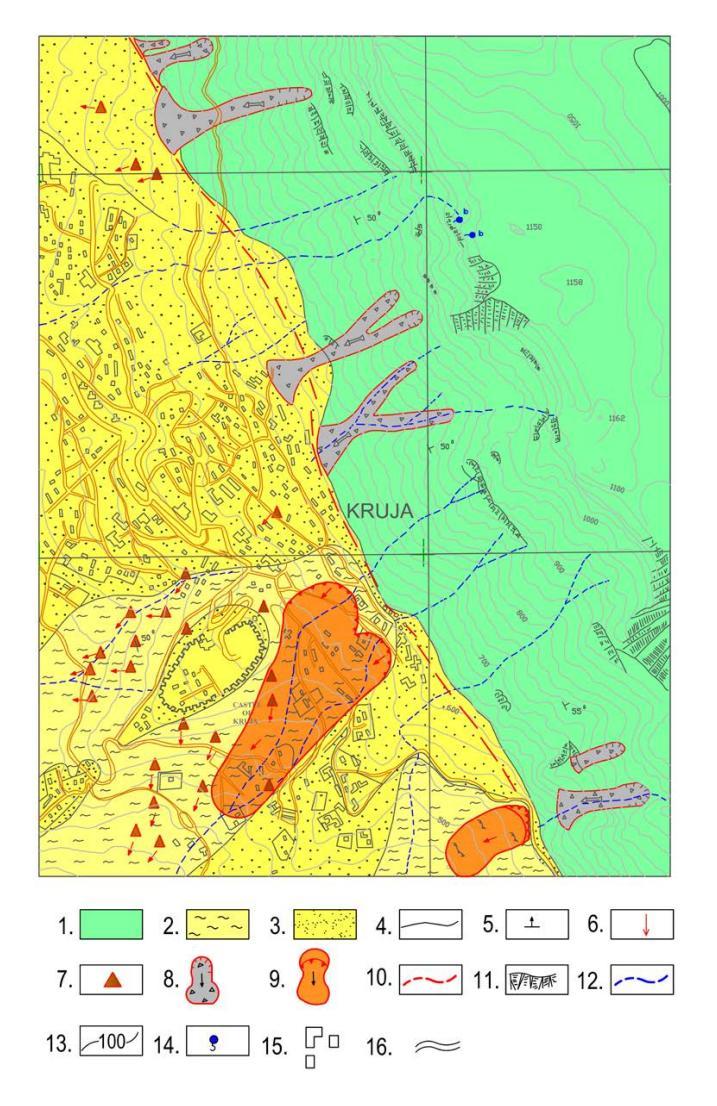
communication facilities. The upper part of the landslide body crown is situated directly in the tectonic fractured zone (Figs. 2 and 7), which is one of the main factors favoring this phenomenon (Muceku, 2008 and 2009), whereas the medium and lower part of the slide plane is situated on a weathering crust of flysch rocks, which is 1.4-2.2 m thick (Figs. 3, 4 and 5). The slide's body consists of silts and clays with fine sands. The other (smaller) earthslide is 220.0 m long, 120.0 m wide and 2.8-5.5 m thick (Fig. 7). On this slide a traffic road and green park are built, which are often damaged from its moving. Several geo-factors favor this mass movement. They are the soft rock flysch, which is intensively disturbed by tectonic activity, as well as rainfall and underground waters. The tectonic zone works as a collector of the karstic water of limestone rocks of "Skanderbeg" mountain. These waters flow out in the form of spring water at the point of contact of soil and flysch rocks on the landslide's crown, influencing the lowering of geotechnical properties of the soils and rocks. Furthermore, this area is very much affected by rainfall averaging  $1800-2000 \text{ mm yr}^{-1}$  (Themelko and Mustaqi, 1996). The rainfall reached its climaxes in 1959 (3160.6 mm) and

**Fig. 7.** Engineering geological map of Kruja, scale 1:5000 (Muceku, 2008). (1) Limestone rocks, (2) flysch rocks, (3) breccia rocks, (4) lithological boundary, (5) strata dip angle, (6) slide direction, (7) rock blocks, (8) debris flows, (9) earthslides, (10) tectonic line, (11) limestone cliff, (12) streams, (13) altitude line, (14) water spring, (15) buildings, (16) traffic road.

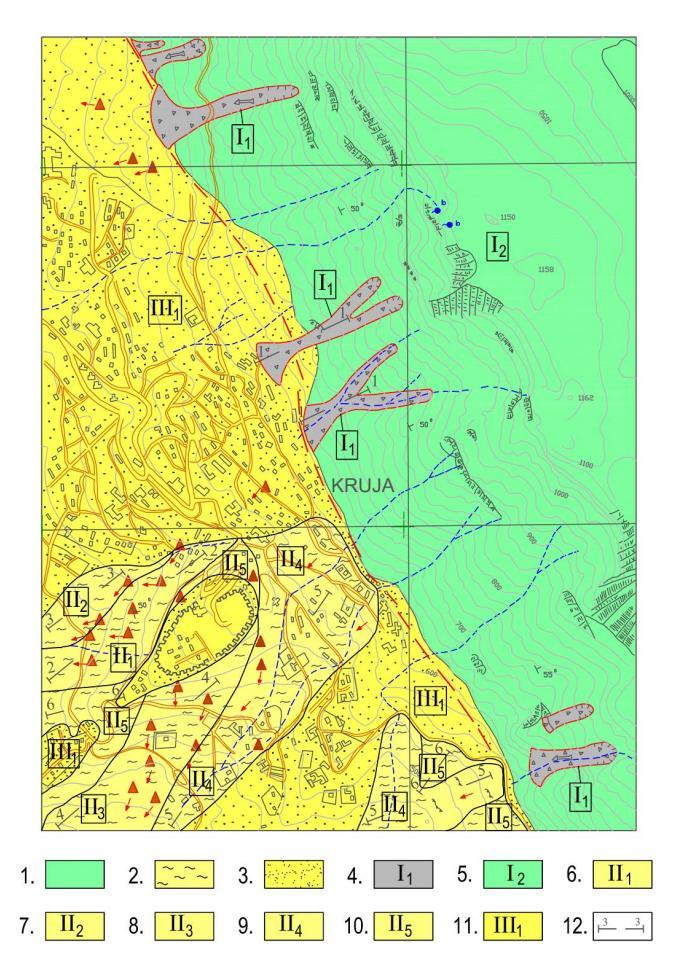
**Fig. 8.** Engineering geological zoning map of Kruja, scale 1 : 5000. (1) Engineering geology zone with basement built of limestone rocks, (2) engineering geology zone with basement built of flysch rocks, (3) engineering geology zone with basement built of breccia rocks, (4, 5, 6, 7, 8, 9, 10, 11) engineering geological sites, (12) profile trace.

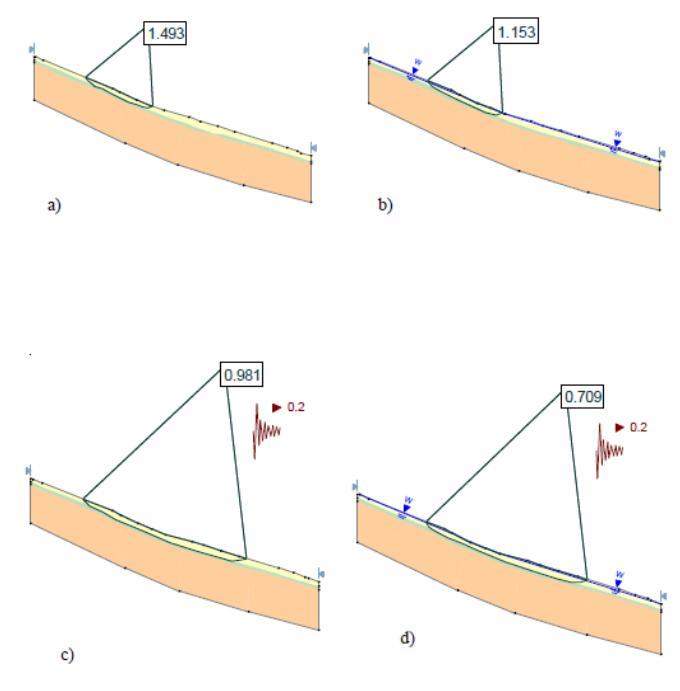
**Fig. 11.** Model of safety factor computed by limit equilibrium at engineering geology site no. II<sub>3</sub> in the case of (**a**) arid, (**b**) wet, (**c**) PGA and (**d**) wet and PGA.

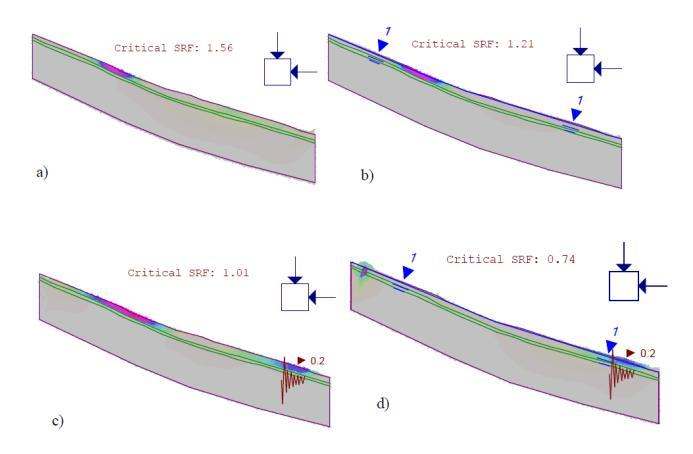
Fig. 12. Model of safety factor computed by finite element at engineering geology site no. II<sub>3</sub> in the case of (a) arid, (b) wet, (c) PGA and (d) wet and PGA.

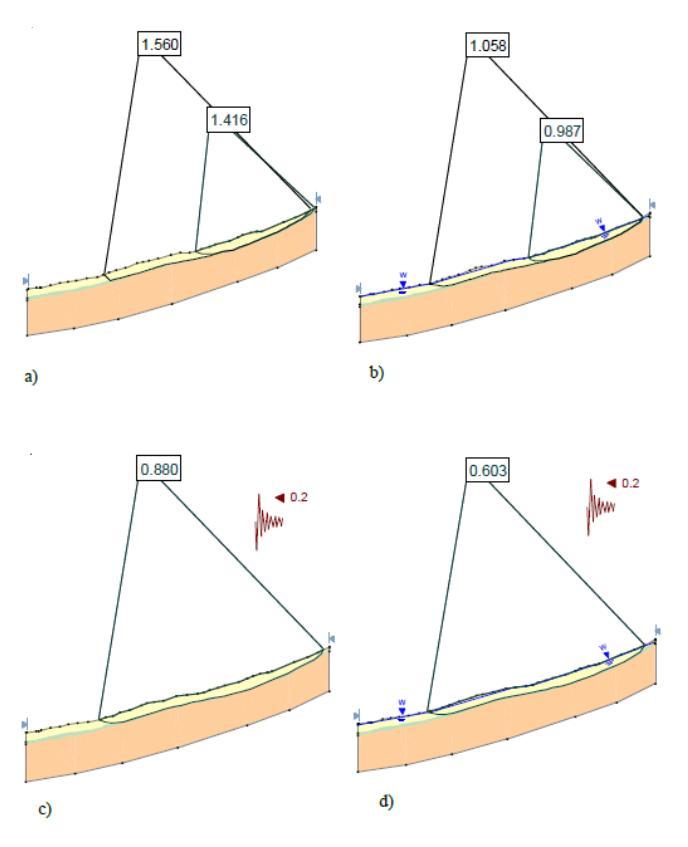
**Fig. 13.** Model of safety factor computed by limit equilibrium at engineering geology site no. II<sub>4</sub> in the case of (a) arid, (b) wet, (c) PGA and (d) wet and PGA.

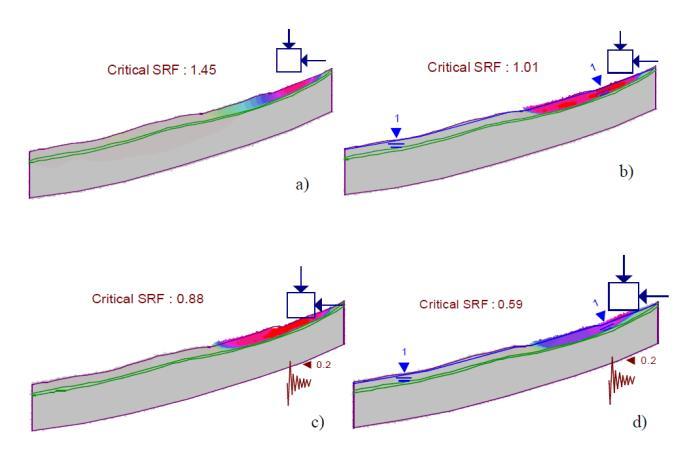
**Fig. 14.** Model of safety factor computed by finite element in engineering geology site no. II<sub>4</sub> in the case of (a) arid, (b) wet, (c) PGA and (d) wet and PGA.

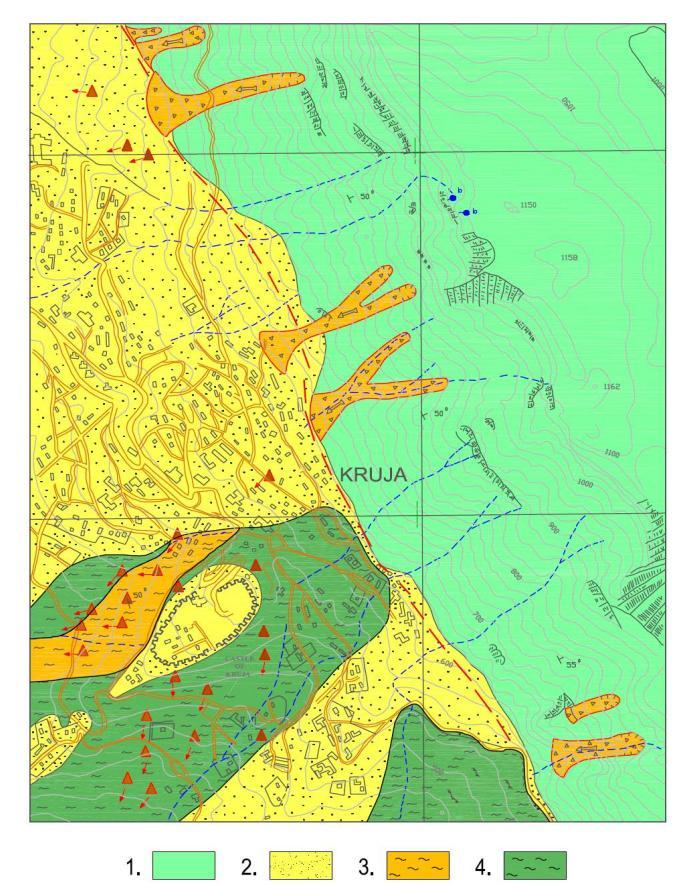
**Fig. 15.** Slope stability zonation map of Kruja in the case of arid periods, scale 1 : 5000. (1) engineering geology zone with basement of limestones rocks, stable, (2) engineering geology zone with basement of breccia rocks, stable, (3) engineering geology site in a critical state, (4) engineering geology site in a stable state.

The hill slopes in this category are in the limit equilibrium state. Here are included engineering geology sites nos. I<sub>1</sub> and II<sub>1</sub> (Fig. 15, arid condition), engineering geology sites nos. II<sub>3</sub>, II<sub>4</sub> and II<sub>5</sub> (Fig. 16, saturated

The hill slopes are stable from the mass movement occurrence point of view. They are shown in Fig. 15 (engineering geology site nos. II<sub>2</sub>, II<sub>3</sub>, II<sub>4</sub> and II<sub>5</sub>) and Fig. 16 (engineering geology site no. II<sub>2</sub>). Also, this category involves the engineering geology zone nos. I<sub>2</sub> and III built of a basement of limestone and breccia rocks (Figs. 15, 16, 17 and 18). Moreover, the slopes of the first category are included in the area with high hazards due to the fact that they will be moved down in one of the soil geotechnical conditions (rain, seismic activity and both rain and seismic activity); the second category slopes are included in the area with medium– high hazard because they are ready to move down, and the third category slopes are included in the stable area with no hazard.

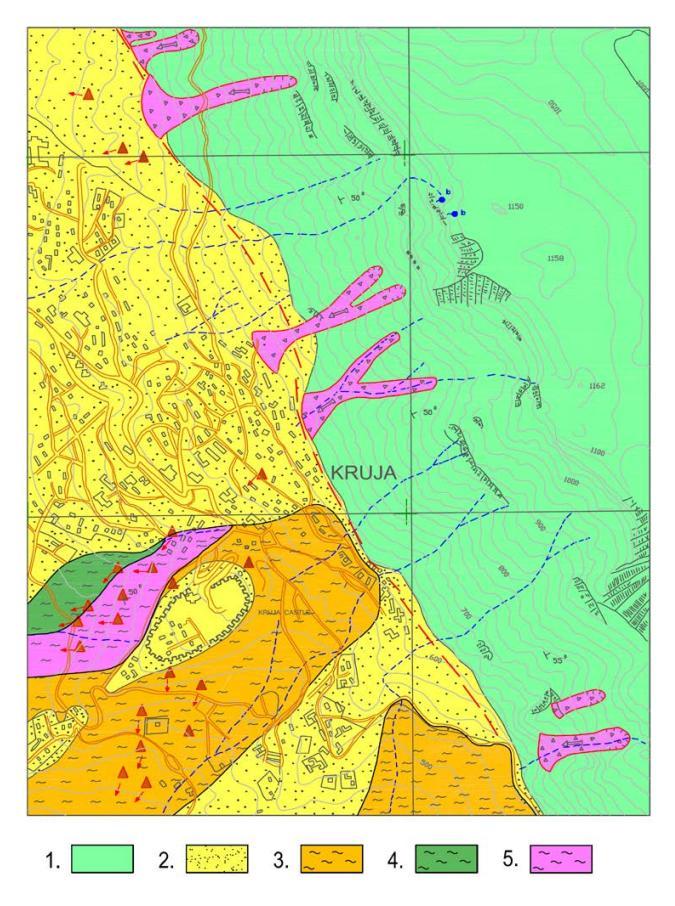
- a. In most slope areas that are built from breccia and limestone rocks the mass movements have not occurred, therefore they are considered stable areas (Figs. 15, 16, 17 and 18).
- b. The hill slopes that are located in the southern part of the urban area, covered by inorganic silts and clays with very fine sands, which are situated on flysch rocks and characterized by shallow underground water tables (0.8–2.0 m), are considered unstable (Figs. 16, 17 and 18).

c. Some areas of the hill slope (east of the urban area) on which are deposited diluvial soils (gravel–cobble mixture with no fines) over limestone rocks are evaluated as unstable (Figs. 16, 17 and 18).

**Fig. 16.** Slope stability zonation map of Kruja in the case of rainy days, scale 1 : 5000. (1) engineering geology zone with basement of limestone rocks, stable, (2) engineering geology zone with basement of breccia rocks, stable, (3) engineering geology site in a critical state, (4) engineering geology site in a stable state, (5) engineering geology site in a unstable state.

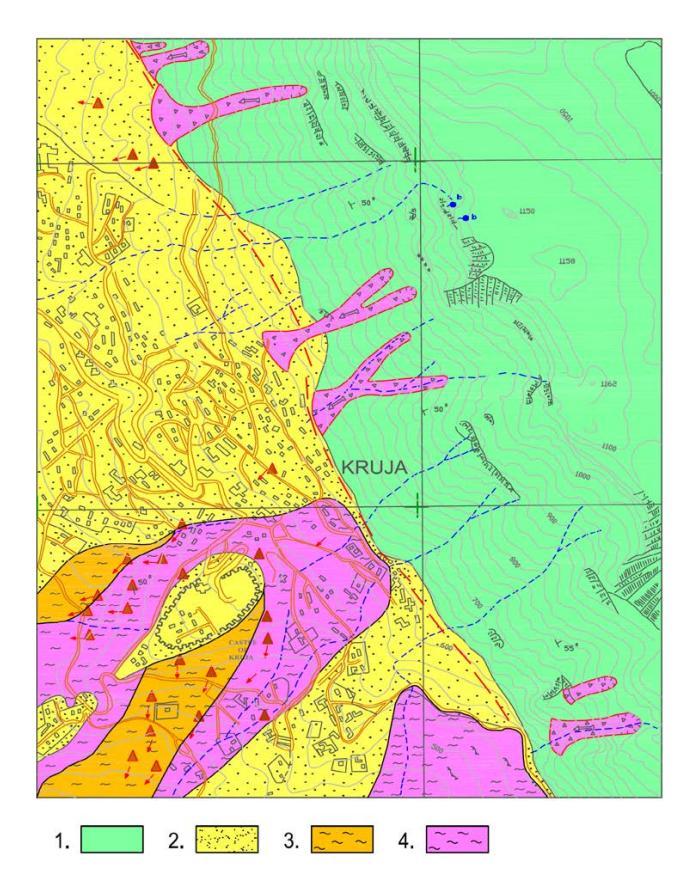
**Fig. 17.** Slope stability zonation map of Kruja in the case of seismic activity, scale 1 : 5000. (1) engineering geology zone with a basement of limestone rocks, stable, (2) engineering geology zone with a basement of breccia rocks, stable, (3) engineering geology site in a critical state, (4) engineering geology site in an unstable state.

conditions) and engineering geology sites nos.  $II_2$  and  $II_3$  (Fig. 17, seismic activity).
