# Causes and consequences of the sinkhole at El Trébol of Quito, Ecuador – implications for economic damage and risk assessment

Received: 12 January 2016 – Published in Nat. Hazards Earth Syst. Sci. Discuss.: 5 February 2016

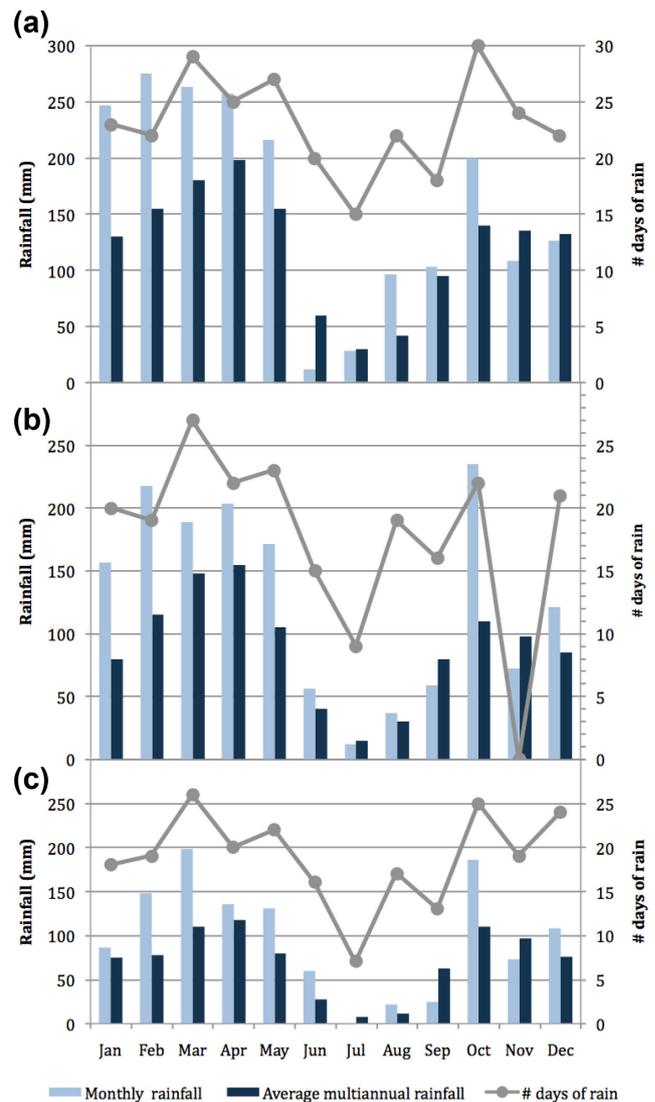
November, with 133 and 115 mm on average respectively, while the drier seasons correspond to June–September and December–January, with 42 mm on average (EMAAP-Q, 2006; INAMHI, 2010; Fig. 5). On the other hand, as for the multiannual distribution of rainfall, it is important to highlight that the wet season between January and March of 2008 was considered the strongest of the last 20 years with accumulated rainfall during the first three months of 2008 being much higher than the recorded during other heavy rainy seasons of 1989, 1993 and 2000 (Salazar et al., 2009). In particular, a peak of 21.2 mm was registered on 31 March 2008 during a heavy rainfall that lasted 4 h from 13:00 to 17:00 (INAMHI, 2008, 2010; Salazar et al., 2009). Additionally, within all of 2008 and coinciding in the three meteorological stations closest to El Trébol, March recorded continuous raining since it was the month with the highest number of days of rain, with 27 and 29 out of 31 days in Iñaquito and Izobamba respectively (Fig. 5a, b, c).

**Figure 5.** Total monthly rainfall, average multiannual rainfall (data since 1975) and number of days with rain per month (higher than 0.1 mm) of the three meteorological stations closest to El Trébol (a) Izobamba: latitude:  $-0.366089$ , longitude:  $-78.555061$ ; altitude: 3085.00 m a.s.l.; (b) Iñaquito: latitude:  $-0.175000$ ; longitude:  $-78.485278$ ; altitude: 2789.12; (c) La Tola: latitude:  $-0.231667$ ; longitude:  $-78.370333$ , altitude: 2480 m a.s.l. From INAMHI (2010).
